<b>Applicant:</b> Universidad Central Del Caribe, Inc.	<b>Damage Inventory:</b> 305240	<b>Category:</b> E
<b>WO #</b> 46525 <b>FIPS#</b> 021-UNUGB-00	<b>Date:</b> 09/04-17/2019 <b>GPS:</b> 18.365953, -66.153767	
<b>Inspector:</b> Gregory Sondergeld / Alexander Nieves	<b>Damage Facility:</b> Main Bldg.

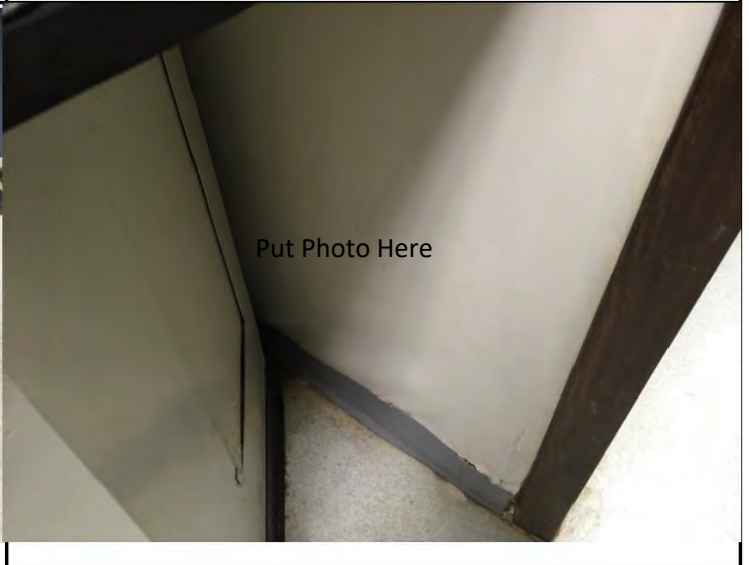
<b>Damage Description:</b>	<b>Item #:</b> 2
Wall, drywall, repair and paint, cracked, caused by rainwater intrusion (Main Bldg., Floor 2, Laboratory R175)	
<b>Additional Comments:</b>

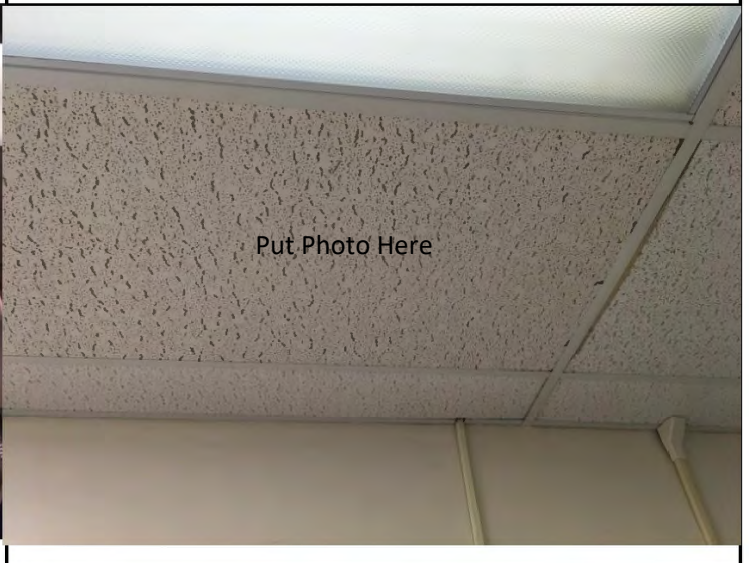
<b>Damage Description:</b>	<b>Item #:</b> 4
Ceiling, 2 FT x 4 FT acoustic tile, suspended, grid only, dislodged, caused by rainwater intrusion (Main Bldg., Floor 2, Laboratory R176)	
<b>Additional Comments:</b>

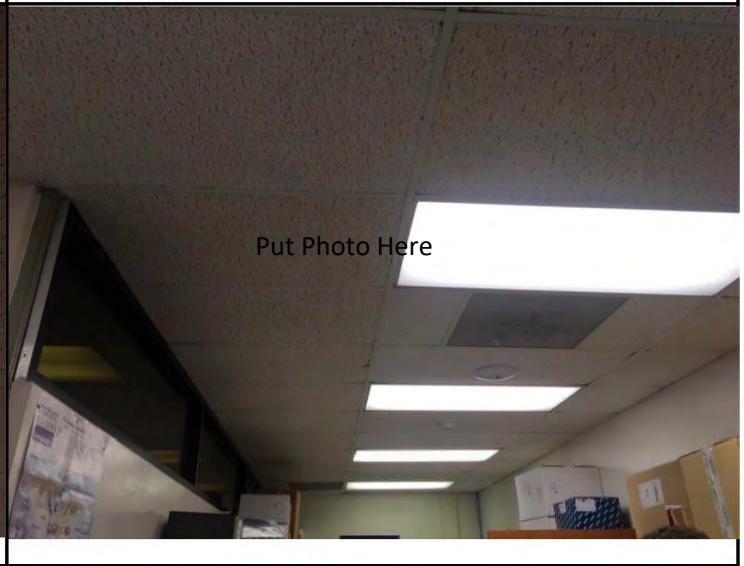
<b>Damage Description:</b>	<b>Item #:</b> 6
Ceiling, 2 FT x 4 FT acoustic tile, suspended, deformed, caused by rainwater intrusion (Main Bldg., Floor 2, Laboratory R383)	
<b>Additional Comments:</b>

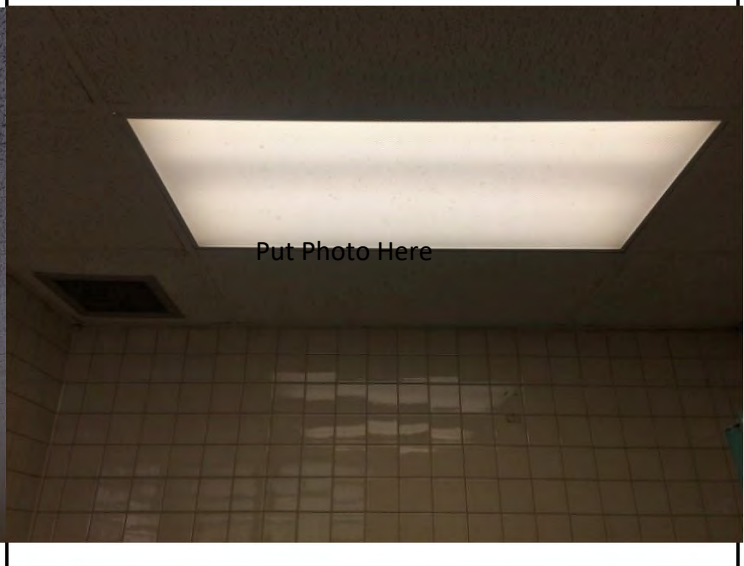
<b>Damage Description:</b>	<b>Item #:</b> 8
Light, fluorescent, recessed Troffer, acrylic prismatic lens only, discolored, caused by rainwater intrusion (Main Bldg., Floor 2, Bathroom R163)	
<b>Additional Comments:</b>

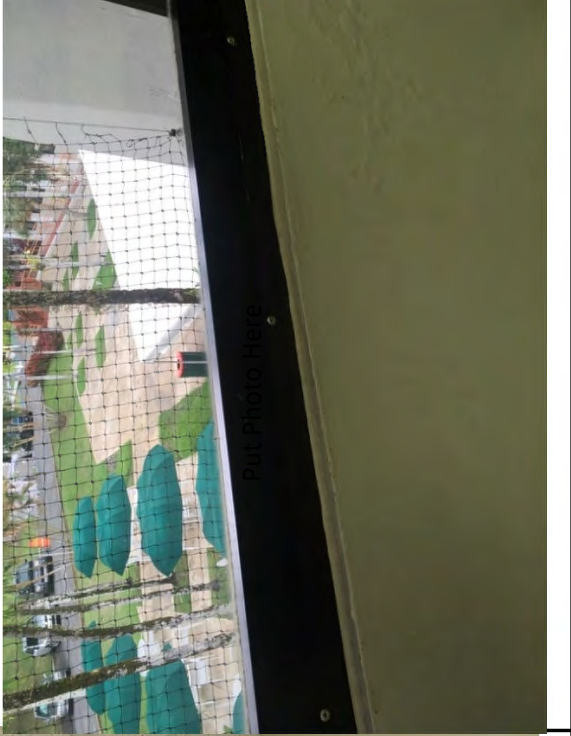
<b>Damage Description:</b>	<b>Item #:</b> 14
Window, Alum. window frames, perimeter caulking/sealing only, cracked, caused by rainwater intrusion (Main Bldg., Floor 2, Presidential Conference)	
<b>Additional Comments:</b>

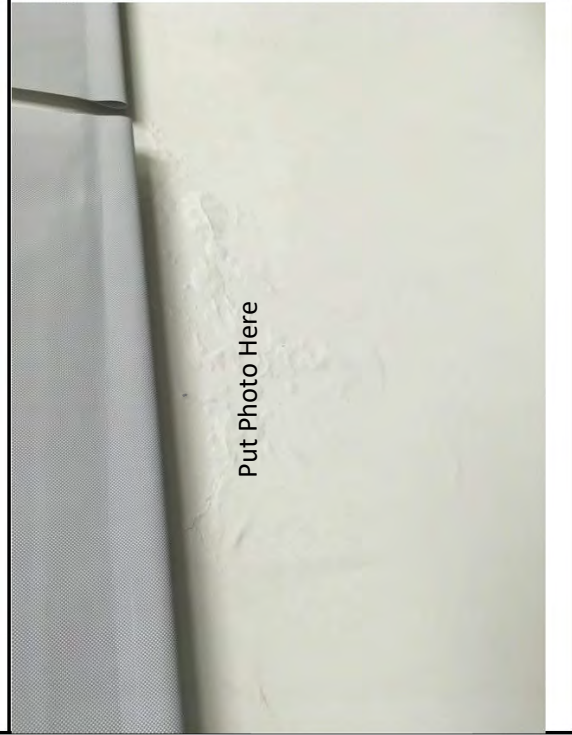
<b>Damage Description:</b>	<b>Item #:</b> 15
Wall, 1/4 IN thick plaster on concrete, repair, cracked, caused by rainwater intrusion (Main Bldg., Floor 2, Presidential Conference)	
<b>Additional Comments:</b>

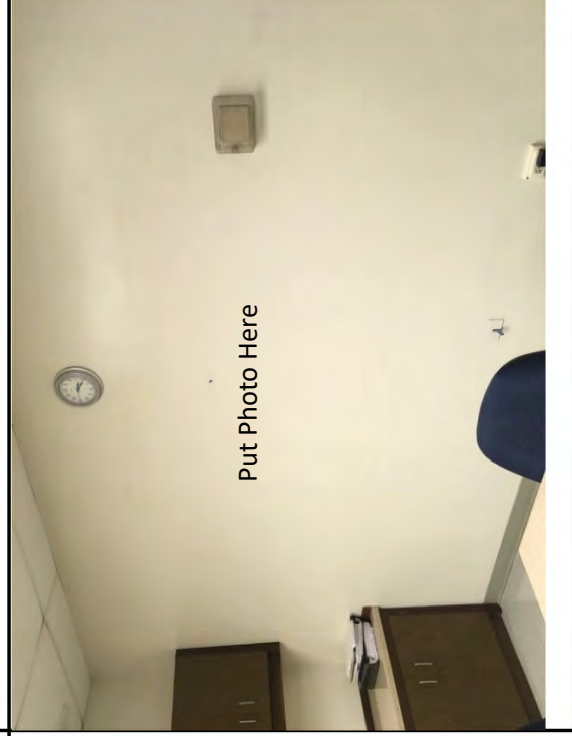
<b>Damage Description:</b>	<b>Item #:</b> 16
Wall, 1/4 IN thick plaster on concrete, painted, discolored, caused by rainwater intrusion (Main Bldg., Floor 2, Presidential Conference)	
<b>Additional Comments:</b>

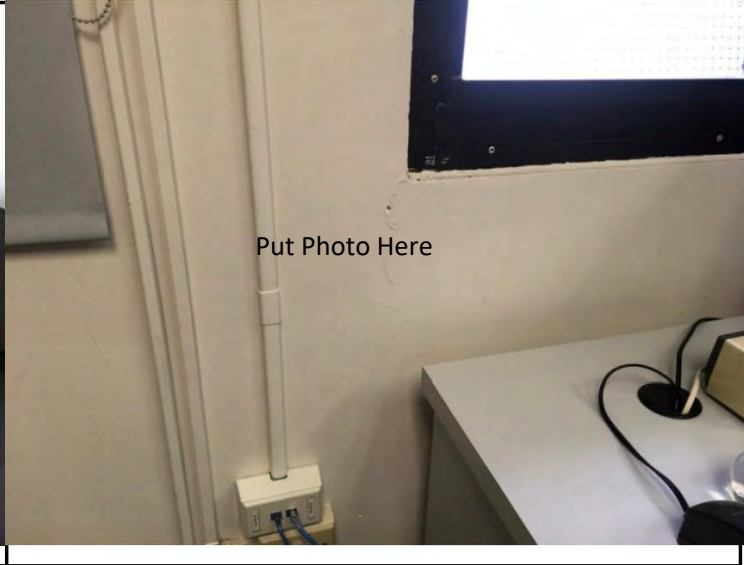
<b>Damage Description:</b>	<b>Item #:</b> 18
Wall, ¼ IN thick plaster on concrete, repair, cracked, caused by rainwater intrusion (Main Bldg., Floor 2, Office R224)	
<b>Additional Comments:</b>

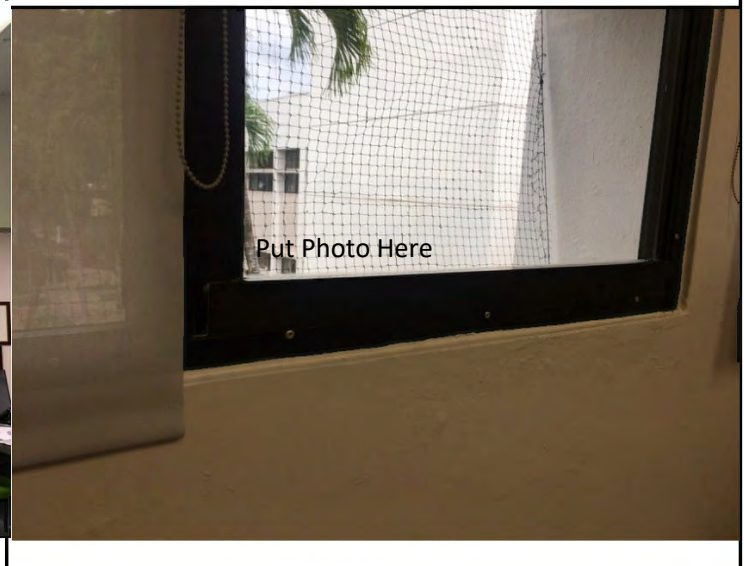
<b>Damage Description:</b>	<b>Item #:</b> 20
Window, Alum. window frames, perimeter caulking/sealing only, cracked, caused by rainwater intrusion (Main Bldg., Floor 2, Office R223)	
<b>Additional Comments:</b>

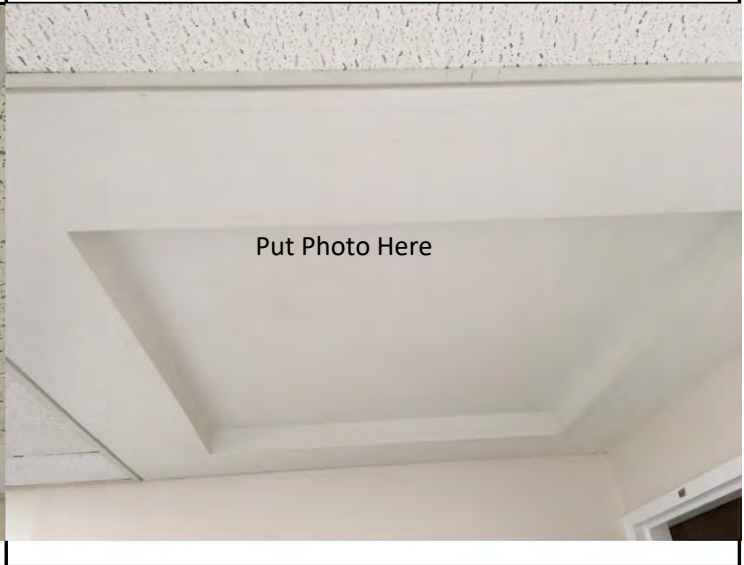
<b>Damage Description:</b>	<b>Item #:</b> 24	<b>Damage Description:</b>	<b>Item #:</b> 26
Ceiling, 2 FT x 4 FT acoustic tile, suspended, grid only, broken components, caused by rainwater intrusion (Main Bldg., Floor 2, Hallway)		Ceiling, drywall, repair and paint, cracked, caused by rainwater intrusion (Main Bldg., Floor 2, Hallway)	
<b>Additional Comments:</b>		<b>Additional Comments:</b>

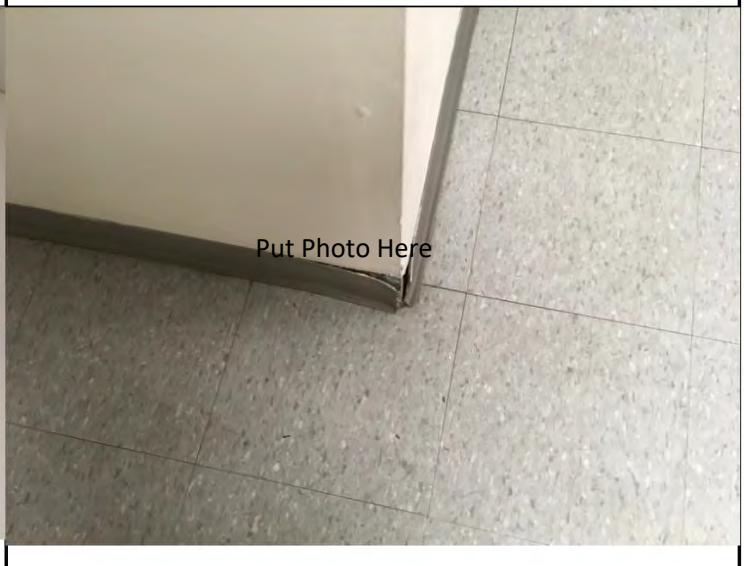
<b>Damage Description:</b>	<b>Item #:</b> 28	<b>Damage Description:</b>	<b>Item #:</b> 27
Ceiling, drywall, repair and paint, cracked, caused by rainwater intrusion (Main Bldg., Floor 2, Hallway R117)		Base Lining, vinyl, 4 IN, dislodged, caused by surface water flooding (Main Bldg., Floor 2, Hallway)	
<b>Additional Comments:</b>		<b>Additional Comments:</b>

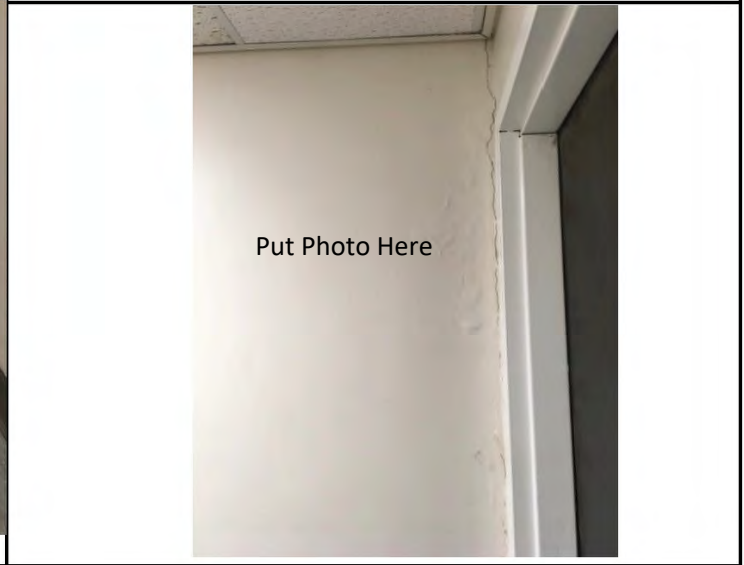
<b>Damage Description:</b>	<b>Item #:</b> 30
Wall, ¼ IN thick plaster on concrete, repair, cracked, caused by rainwater intrusion (Main Bldg., Floor 2, Hallway)	
<b>Additional Comments:</b>

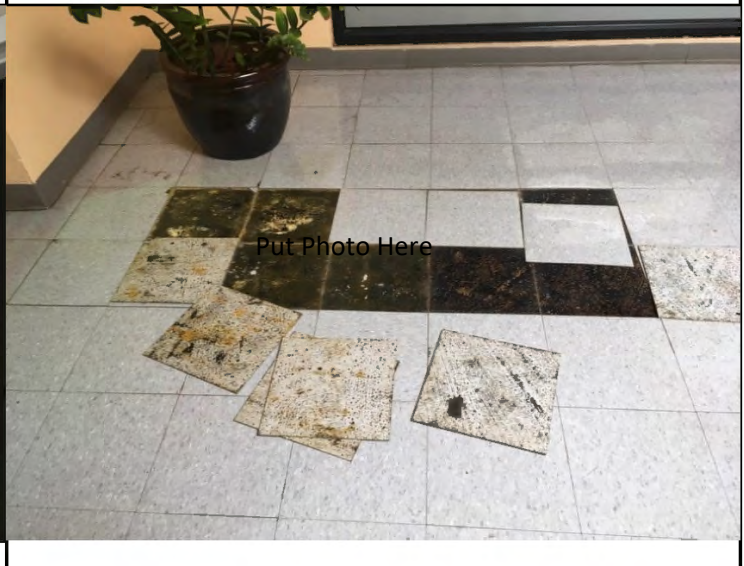
<b>Damage Description:</b>	<b>Item #:</b> 32
Floor, VCT, 12x12 IN, dislodged, caused by surface water flooding (Main Bldg., Floor 2, Presidential Lobby)	
<b>Additional Comments:</b>

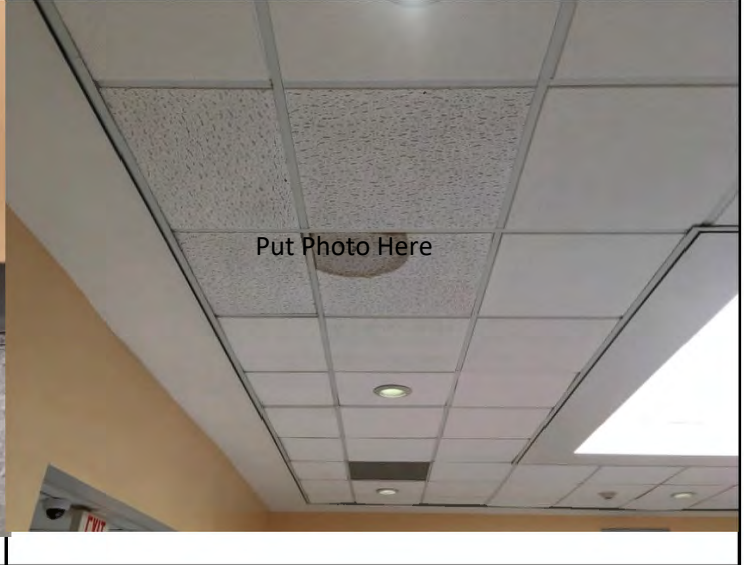
<b>Damage Description:</b>	<b>Item #:</b> 34
Ceiling, 2 FT x 2 FT acoustic tile, suspended, tegular, deformed, caused by rainwater intrusion (Main Bldg., Floor 2, Presidential Lobby)	
<b>Additional Comments:</b>

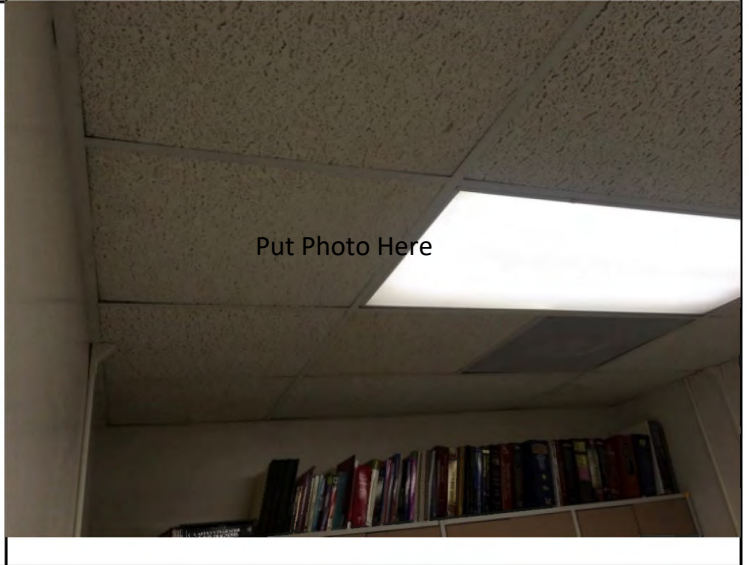
<b>Damage Description:</b>	<b>Item #:</b> 42
Ceiling, 2 FT x 4 FT acoustic tile, suspended, deformed, caused by rainwater intrusion (Main Bldg., Floor 2, Office R215)	
<b>Additional Comments:</b>

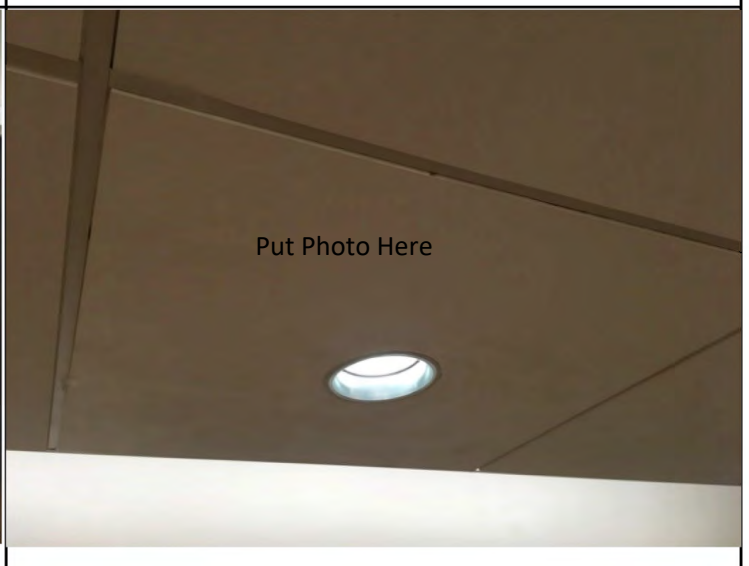
<b>Damage Description:</b>	<b>Item #:</b> 44
Ceiling, 4 FT x 4 FT acoustic tile, suspended, tegular, deformed, caused by rainwater intrusion (Main Bldg., Floor 2, Conference)	
<b>Additional Comments:</b>

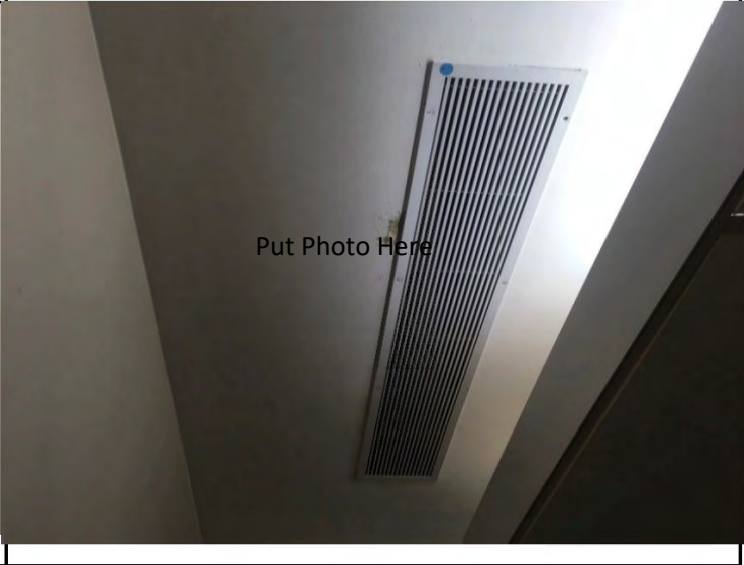
<b>Damage Description:</b>	<b>Item #:</b> 46
Ceiling, drywall, repair and paint, dislodged, caused by rainwater intrusion (Main Bldg., Floor 2, Conference)	
<b>Additional Comments:</b>

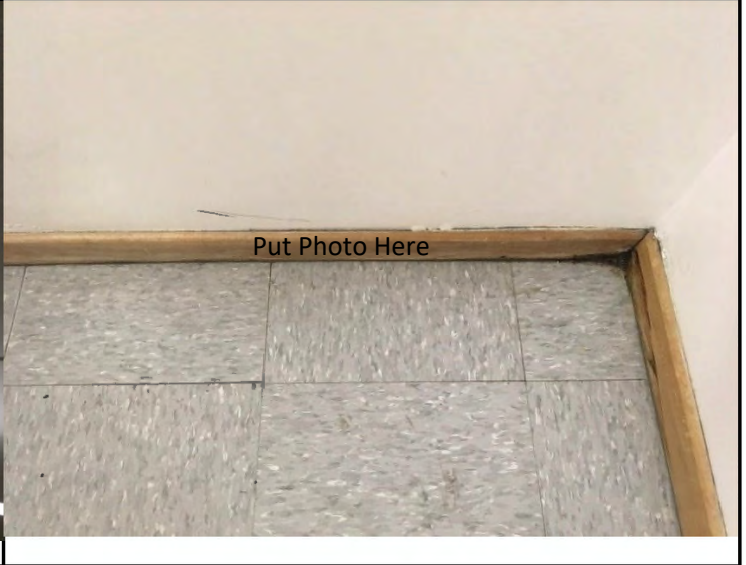
<b>Damage Description:</b>	<b>Item #:</b> 49	<b>Damage Description:</b>	<b>Item #:</b> 50
Ceiling, drywall, paint, discolored, caused by rainwater intrusion (Main Bldg., Floor 2, Classroom R542)		Base Lining, Base molding, wood, 2 5/8 IN x 1/2 IN, stained and urethane-finished, dislodged, caused by rainwater intrusion (Main Bldg., Floor 2, Classroom R542)	
<b>Additional Comments:</b>		<b>Additional Comments:</b>

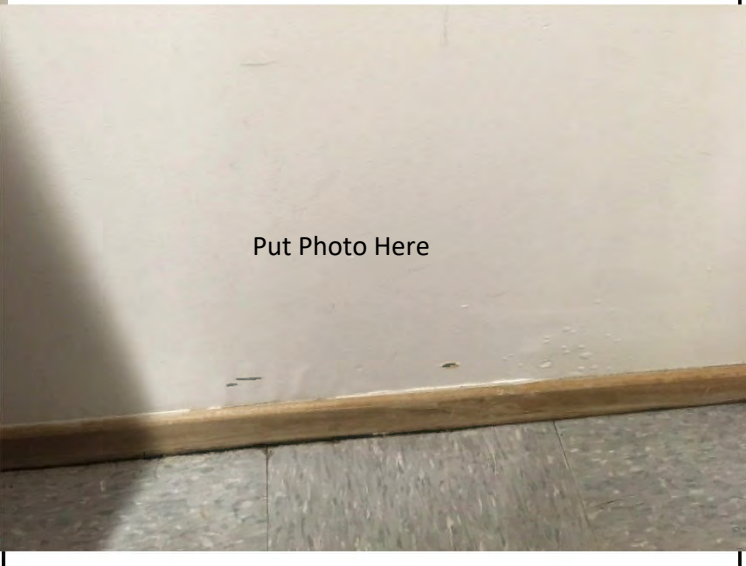
<b>Damage Description:</b>	<b>Item #:</b> 51	<b>Damage Description:</b>	<b>Item #:</b> 52
Wall, drywall, paint, discolored, caused by rainwater intrusion (Main Bldg., Floor 2, Classroom R542)		Wall, drywall, repair, deformed, caused by rainwater intrusion (Main Bldg., Floor 2, Classroom R542)	
<b>Additional Comments:</b>		<b>Additional Comments:</b>

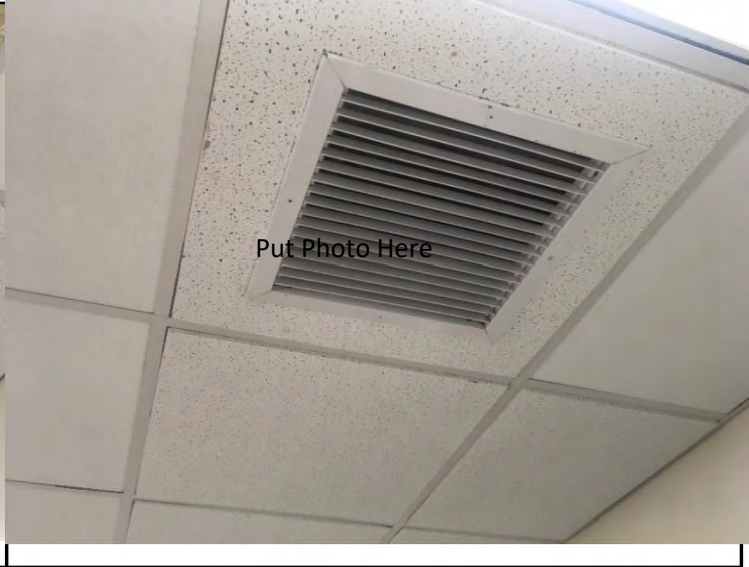
<b>Damage Description:</b>	<b>Item #:</b> 58
HVAC return grill, ceiling-mounted, aluminum, bladed, 16 IN x 16 IN, dislodged, caused by rainwater intrusion (Main Bldg., Floor 2, Office R544)	
<b>Additional Comments:</b>
