Applicant: Universidad Central Del Caribe, Inc.	Damage Inventory: 305240	Category: E
WO # 46525 FIPS# 021-UNUGB-00	Date: 09/04-17/2019 GPS: 18.365953, -66.153767	
Inspector: Gregory Sondergeld / Alexander Nieves	Damage Facility: Main Bldg.

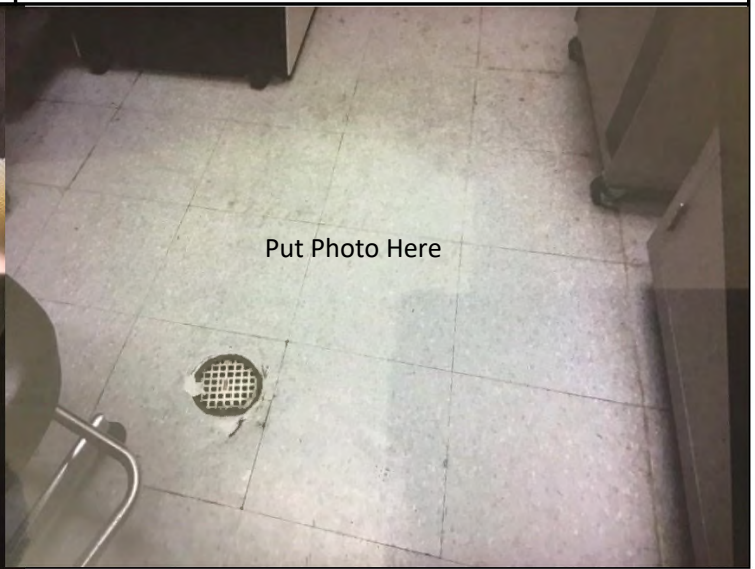
Damage Description:	Item #: 1	Damage Description:	Item #: 2
Light, fluorescent, recessed Troffer, acrylic prismatic lens only, discolored, caused by rainwater intrusion (Main Bldg., Basement, Laboratory ARC 010)		Floor, VCT, 12x12 IN, detached, caused by surface water flooding (Main Bldg., Basement, Laboratory ARC 010)	
Additional Comments:		Additional Comments:

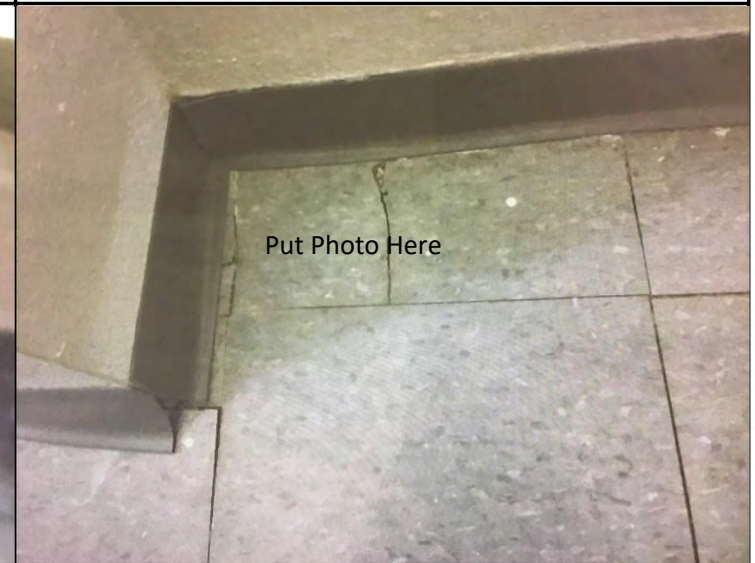
Damage Description:	Item #: 3	Damage Description:	Item #: 4
Base Lining, vinyl, 4 IN, detached, caused by surface water flooding (Main Bldg., Basement, Laboratory ARC 010)		Floor, VCT, 12x12 IN, detached, caused by surface water flooding (Main Bldg., Basement, Laboratory ARC 014)	
Additional Comments:		Additional Comments:

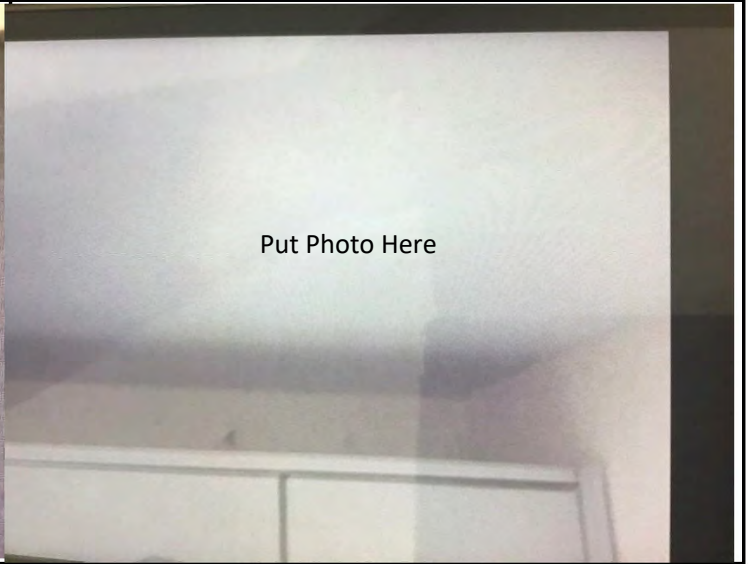
Damage Description:	Item #: 5	Damage Description:	Item #: 6
Base Lining, vinyl, 4 IN, detached, caused by surface water flooding (Main Bldg., Basement, Laboratory ARC 014)		Wall, ¼ IN thick plaster on concrete, repair spalling and paint, cracked, caused by rainwater intrusion (Main Bldg., Basement, Laboratory ARC 015)	
Additional Comments:		Additional Comments:

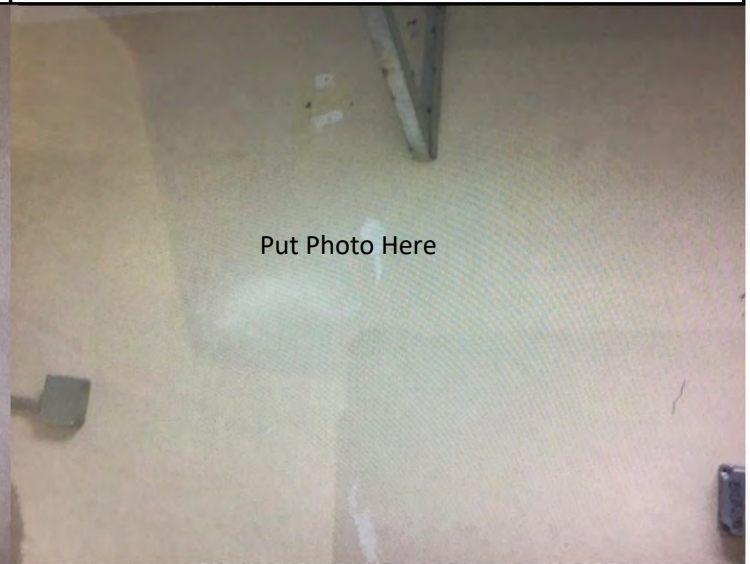
Damage Description:	Item #: 7	Damage Description:	Item #: 8 Wall,
Wall, ¼ IN thick plaster on concrete, repair spalling and paint, cracked, caused by rainwater intrusion (Main Bldg., Basement, Laboratory ARC 016)		¼ IN thick plaster on concrete, painted, peeling paint, caused by rainwater intrusion (Main Bldg., Basement, Laboratory ARC 017)	
Additional Comments:		Additional Comments:

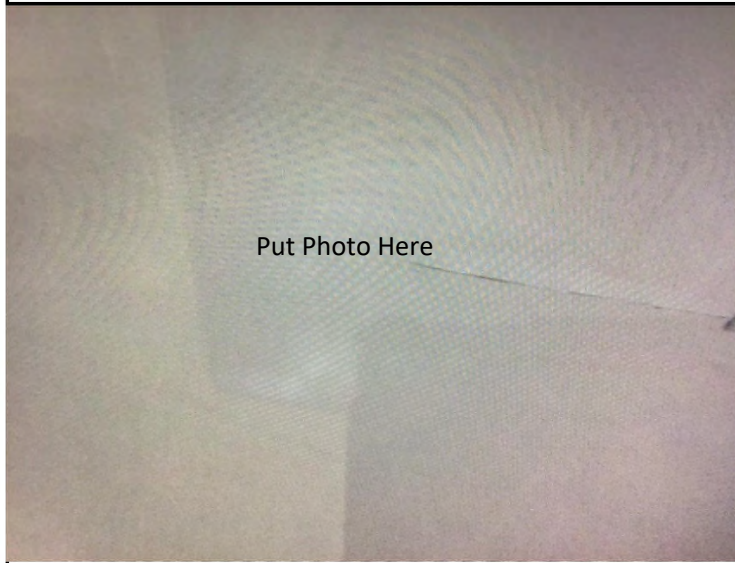
Damage Description:	Item #: 9
Ceiling, drywall, repair, cracked, caused by rainwater intrusion (Main Bldg., Basement, Laboratory ARC 017)	
Additional Comments:

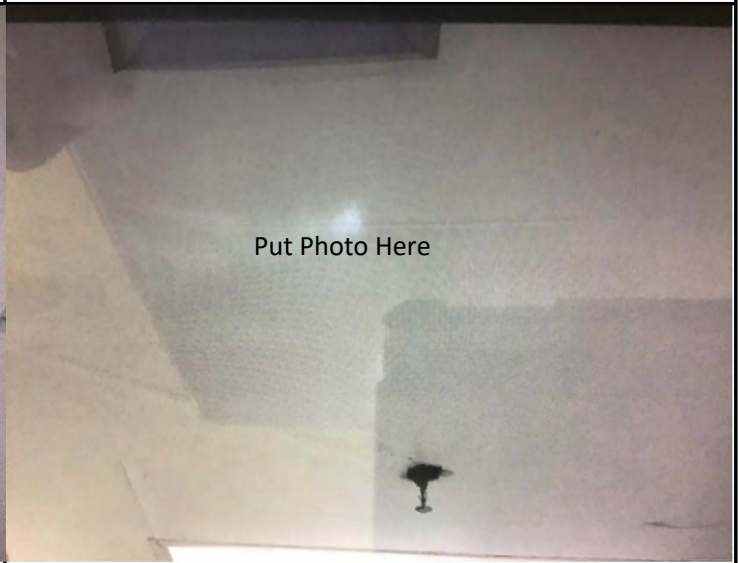
Damage Description:	Item #: 10
Ceiling, drywall, paint, discolored, caused by rainwater intrusion (Main Bldg., Basement, Laboratory ARC 017)	
Additional Comments:

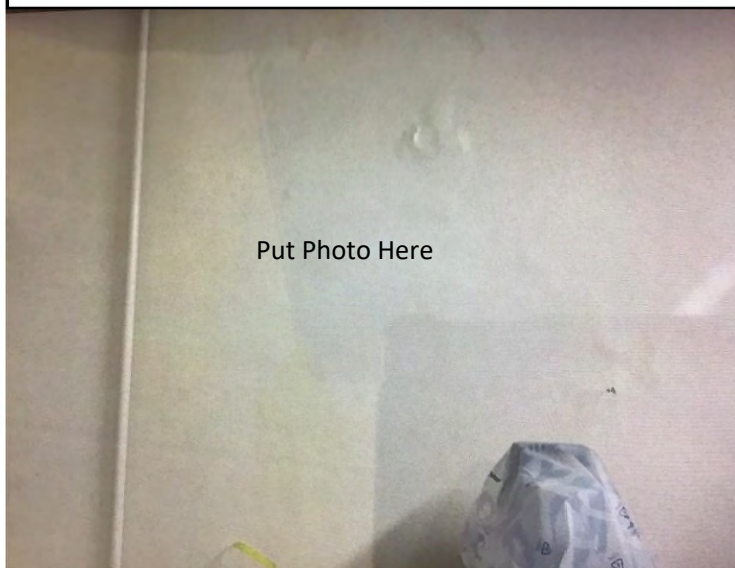
Damage Description:	Item #: 11
Wall, ¼ IN thick plaster on concrete, repair spalling and paint, cracked, caused by rainwater intrusion (Main Bldg., Basement, Laboratory ARC 023)	
Additional Comments:

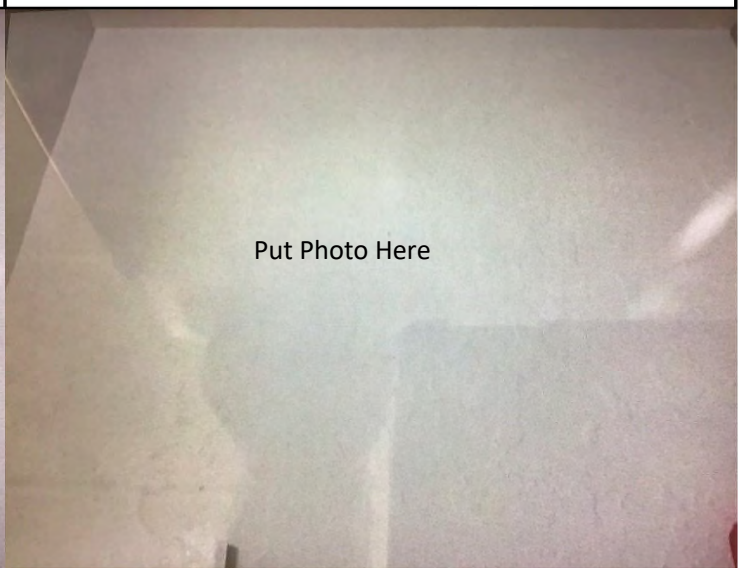
Damage Description:	Item #: 12
Wall, ¼ IN thick plaster on concrete, repair spalling and paint, cracked, caused by rainwater intrusion (Main Bldg., Basement, Laboratory ARC 024)	
Additional Comments:

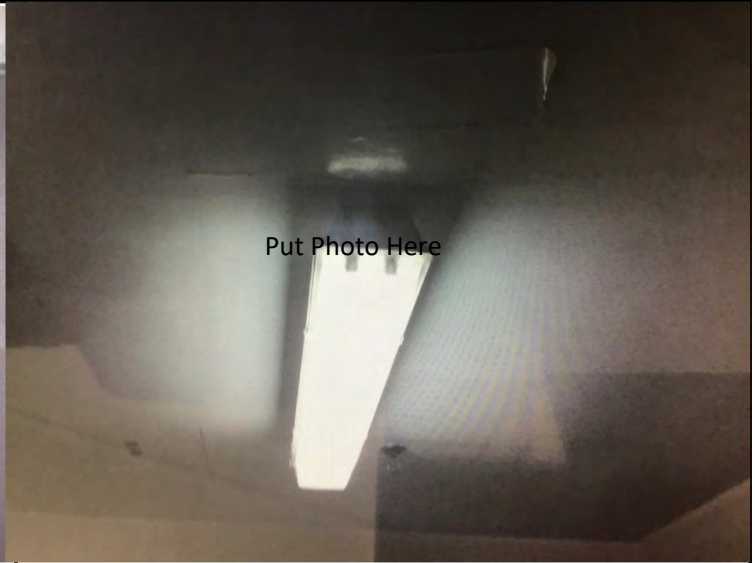
Damage Description:	Item #: 13	Damage Description:	Item #: 14
Ceiling, drywall, repair, detached, caused by rainwater intrusion (Main Bldg., Basement, Laboratory ARC 024)		Wall, ¼ IN thick plaster on concrete, painted, discolored, caused by rainwater intrusion (Main Bldg., Basement, Laboratory ARC 024)	
Additional Comments:		Additional Comments:

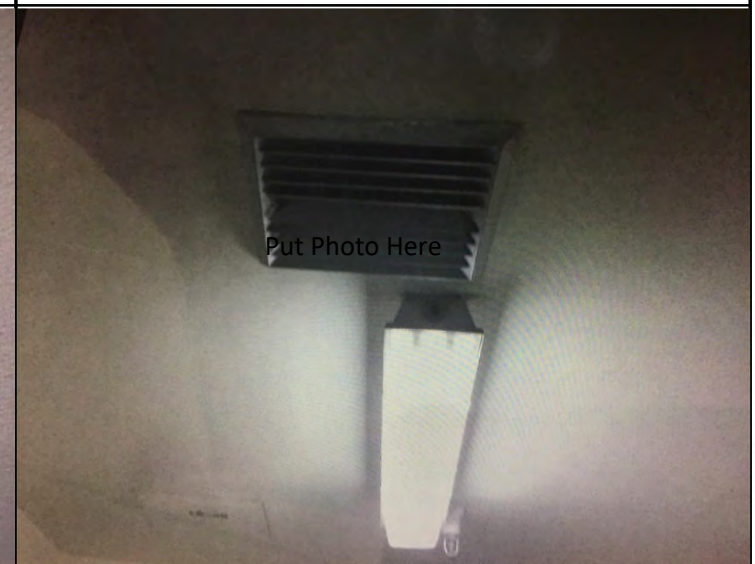
Damage Description:	Item #: 15	Damage Description:	Item #: 16
Wall, ¼ IN thick plaster on concrete, repair spalling and paint, cracked, caused by rainwater intrusion (Main Bldg., Basement, Laboratory ARC 025)		Light, fluorescent, surface-mounted, vapor-resistant, 6 IN x 48 IN, acrylic lens cover only, discolored, caused by rainwater intrusion (Main Bldg., Basement, Laboratory ARC 025)	
Additional Comments:		Additional Comments:

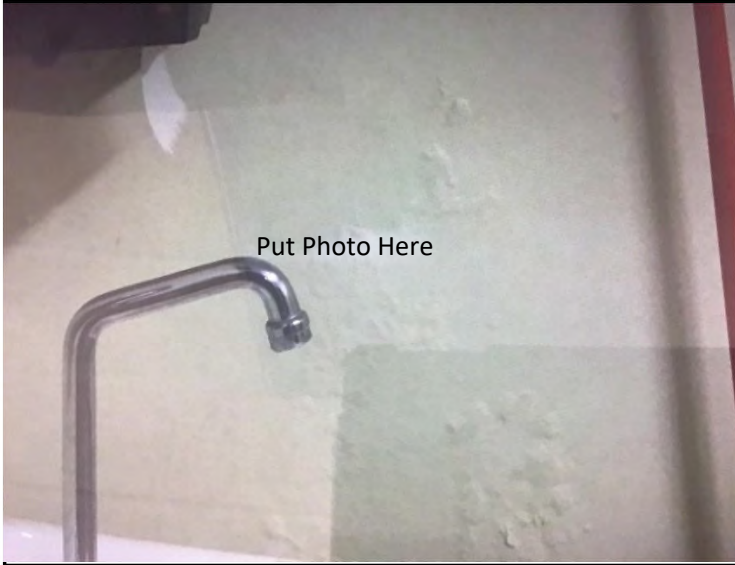
Damage Description:	Item #: 17
Wall, ¼ IN thick plaster on concrete, repair spalling and paint, cracked, caused by rainwater intrusion (Main Bldg., Basement, Laboratory ARC 026)	
Additional Comments:

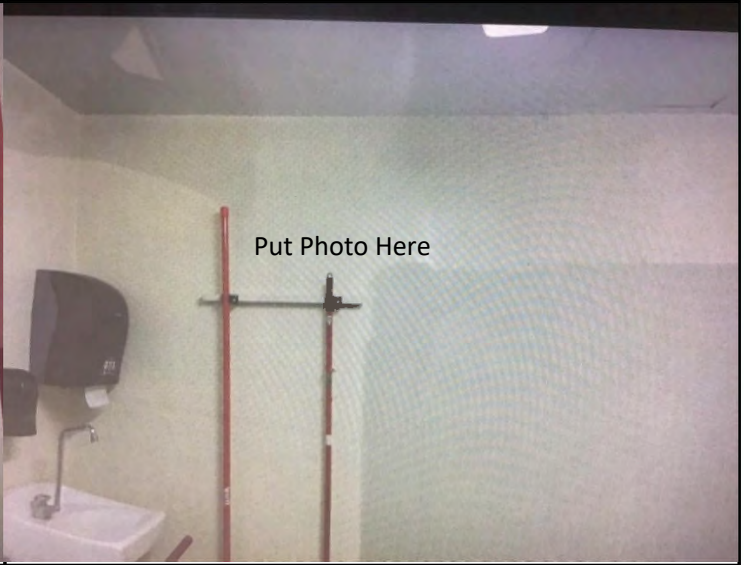
Damage Description:	Item #: 18
Wall, ¼ IN thick plaster on concrete, painted, discolored, caused by rainwater intrusion (Main Bldg., Basement, Laboratory ARC 026)	
Additional Comments:

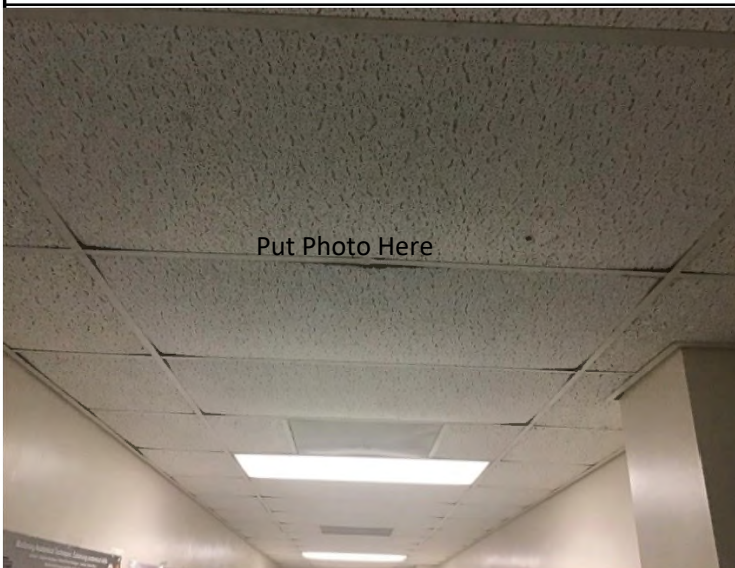
Damage Description:	Item #: 19
Ceiling, 2 FT x 4 FT acoustic tile, suspended, deformed, caused by rainwater intrusion (Main Bldg., Floor 1, Hallway)	
Additional Comments:

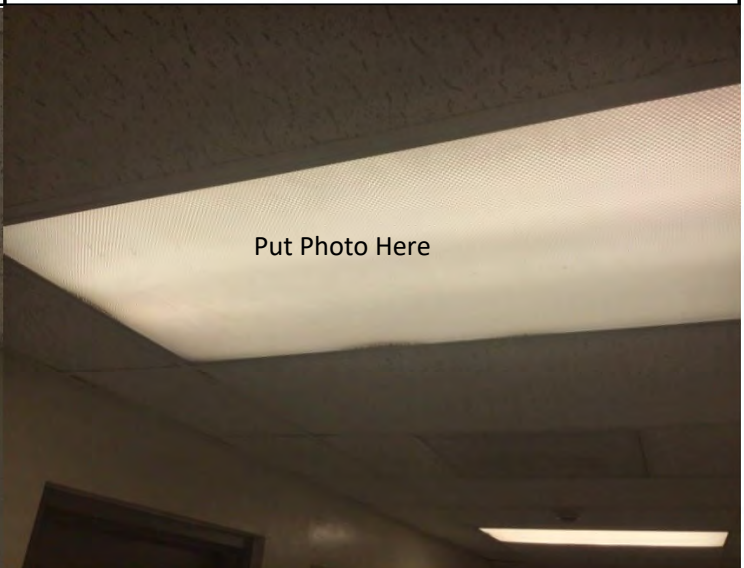
Damage Description:	Item #: 20
Light, fluorescent, recessed Troffer, acrylic prismatic lens only, deformed, caused by rainwater intrusion (Main Bldg., Floor 1, Hallway)	
Additional Comments:

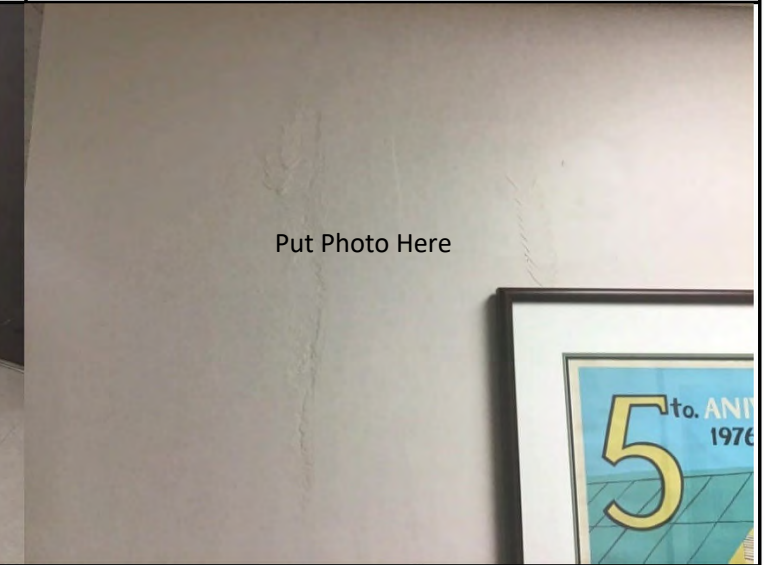
Damage Description:	Item #: 23	Damage Description:	Item #: 24
Wall, ¼ IN thick plaster on concrete, painted, discolored, caused by rainwater intrusion (Main Bldg., Floor 1, Hallway)		Wall, ¼ IN thick plaster on concrete, repair spalling, peeling paint, caused by rainwater intrusion (Main Bldg., Floor 1, Hallway)	
Additional Comments:		Additional Comments:

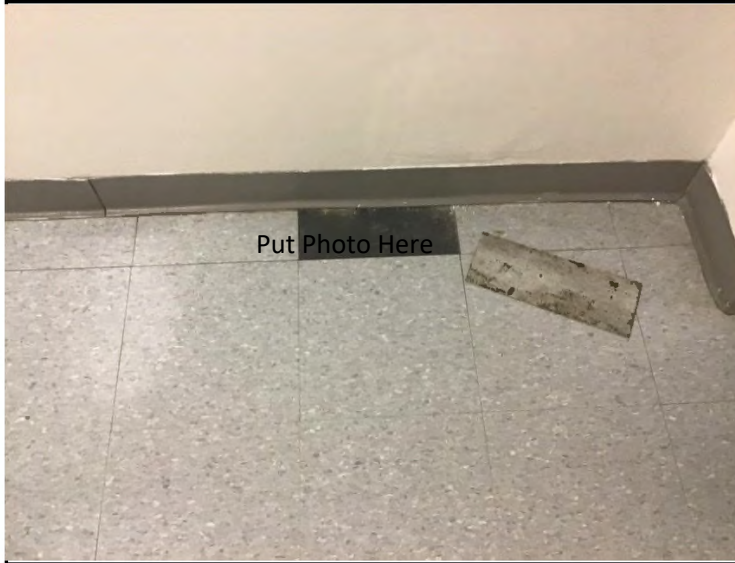
Damage Description:	Item #: 25
Floor, VCT, 12x12 IN, detached, caused by surface water flooding (Main Bldg., Floor 1, Hallway)	
Additional Comments:

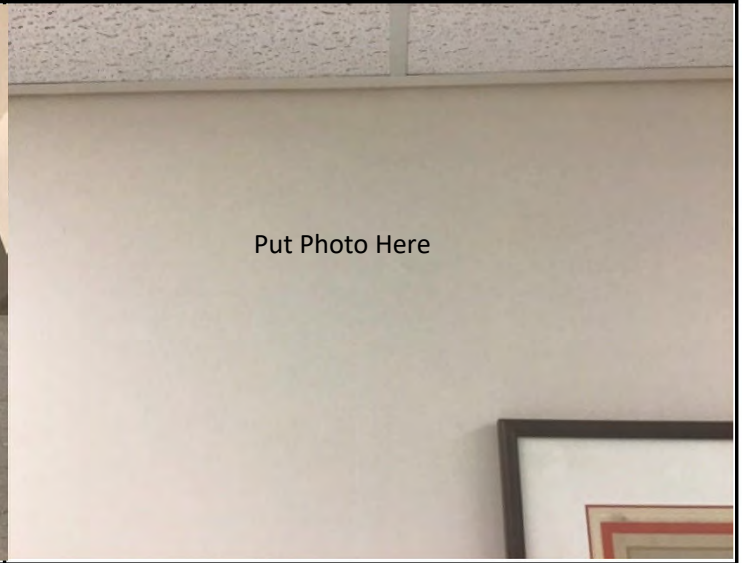
Damage Description:	Item #: 26
Wall, ¼ IN thick plaster on concrete, painted, discolored, caused by rainwater intrusion (Main Bldg., Floor 1, Hallway)	
Additional Comments:

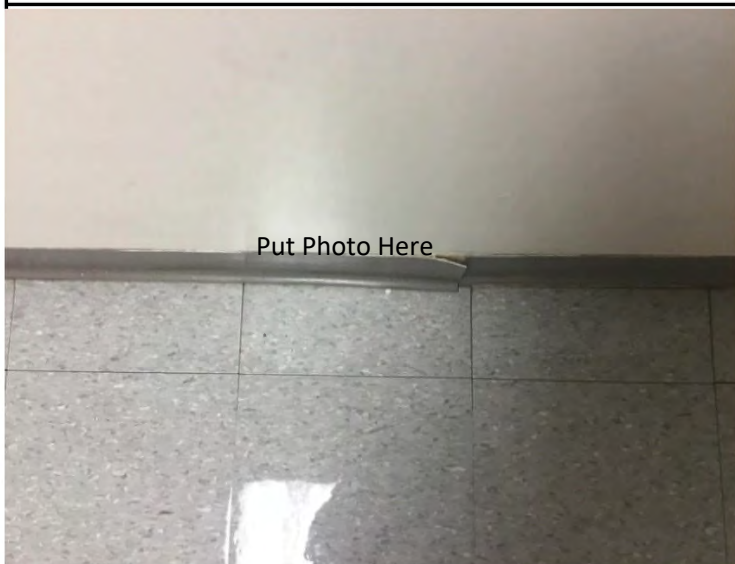
Damage Description:	Item #: 27
Base Lining, vinyl, 4 IN, detached, caused by surface water flooding (Main Bldg., Floor 1, Hallway)	
Additional Comments:

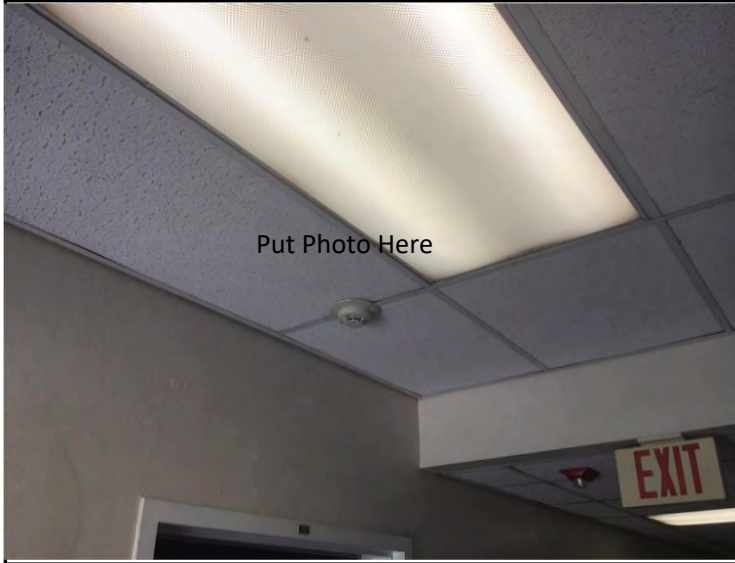
Damage Description:	Item #: 29
Ceiling, 2 FT x 4 FT acoustic tile, suspended, deformed, caused by rainwater intrusion (Main Bldg., Floor 1, Hallway Cargo Area)	
Additional Comments:

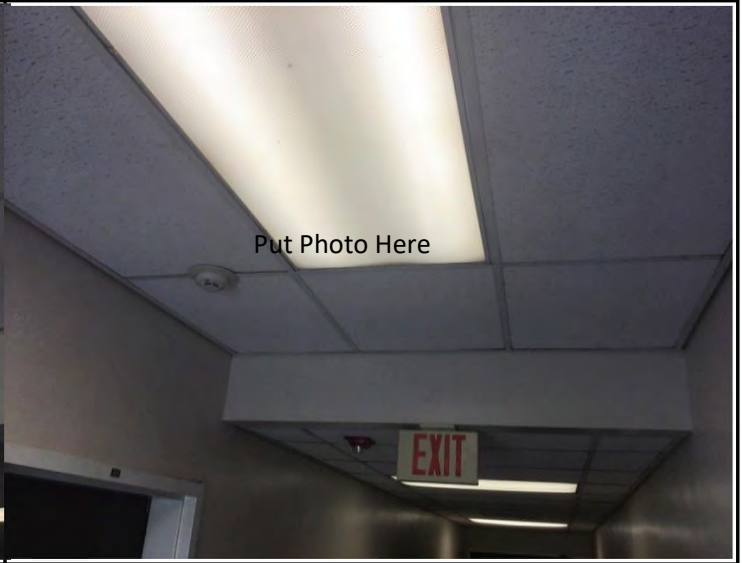
Damage Description:	Item #: 30
Light, florescent, recessed Troffer, electrical issues, caused by rainwater intrusion (Main Bldg., Floor 1, Hallway Cargo Area)	
Additional Comments:

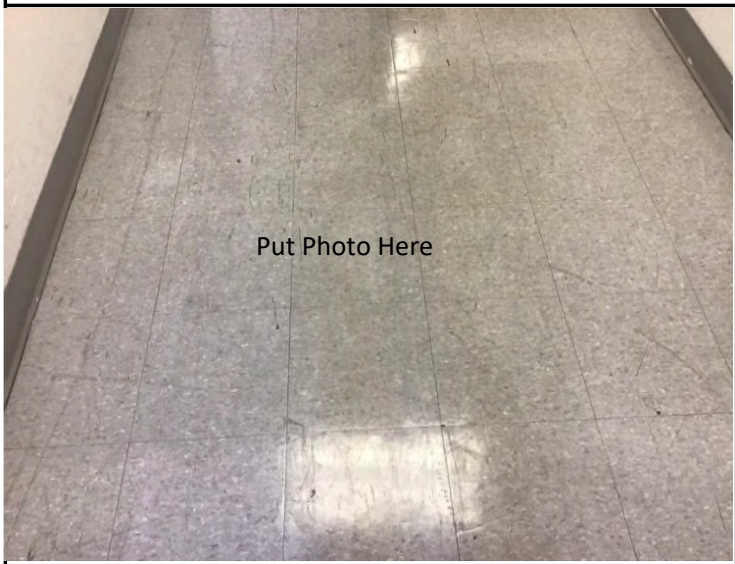
Damage Description:	Item #: 31
Floor, VCT, 12x12 IN, detached, caused by surface water flooding (Main Bldg., Floor 1, Hallway Cargo Area)	
Additional Comments:

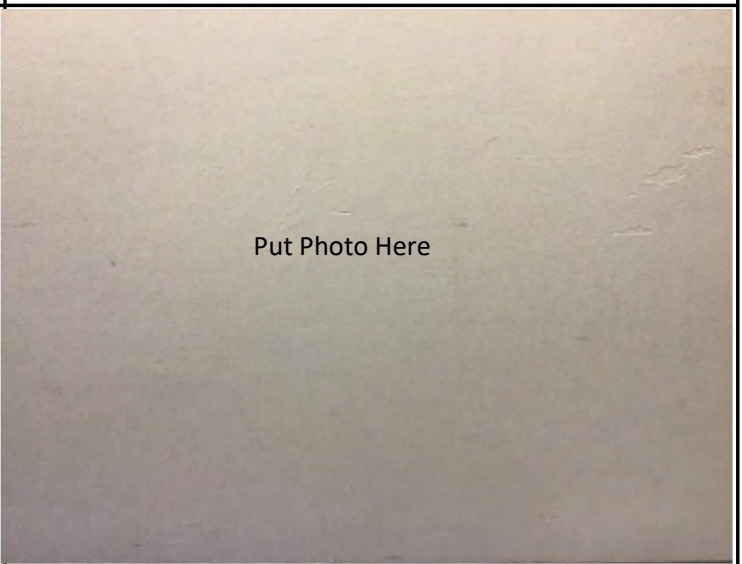
Damage Description:	Item #: 32
Wall, ¼ IN thick plaster on concrete, painted, discolored, caused by rainwater intrusion (Main Bldg., Floor 1, Hallway Cargo Area)	
Additional Comments:

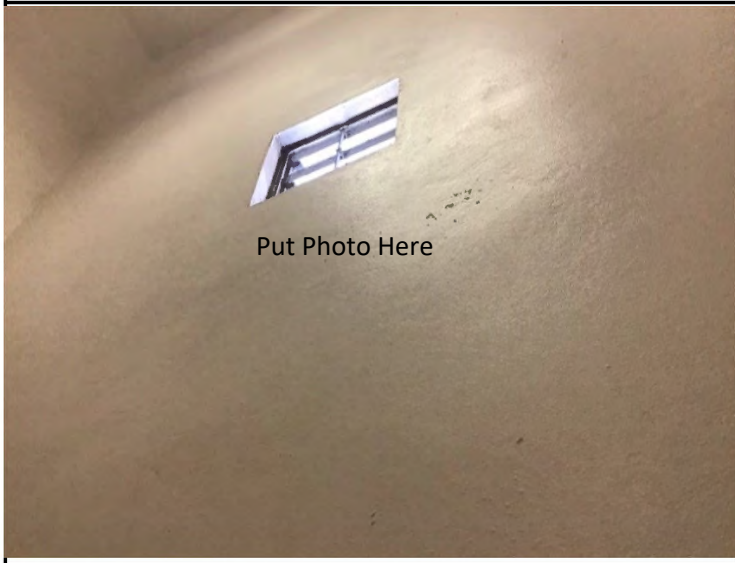
Damage Description:	Item #: 33
Wall, ¼ IN thick plaster on concrete, painted, discolored, caused by rainwater intrusion (Main Bldg., Floor 1, Stairway North)	
Additional Comments:

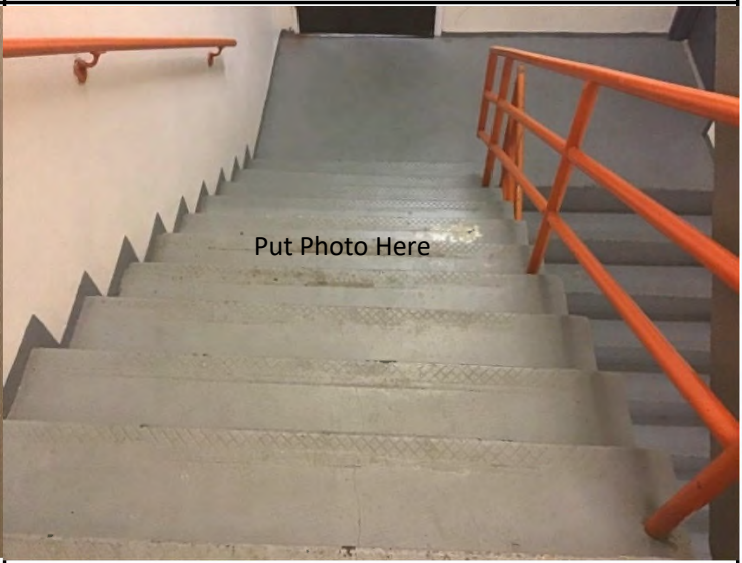
Damage Description:	Item #: 35
Floor, sealed concrete, painted, discolored, caused by surface water flooding (Main Bldg., Floor 1, Stairway North)	
Additional Comments:

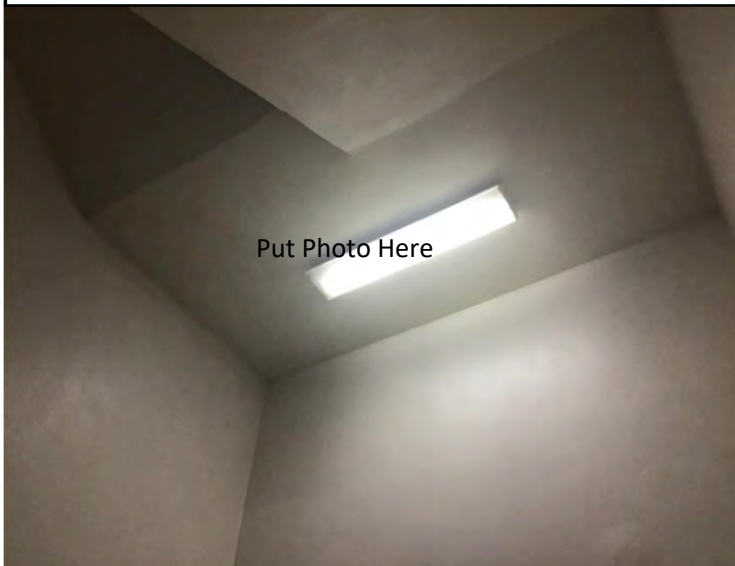
Damage Description:	Item #: 36
Light, fluorescent, surface-mounted, 1 FT x 4 FT light fixture, electrical issues, caused by rainwater intrusion (Main Bldg., Floor 1, Stairway North)	
Additional Comments:

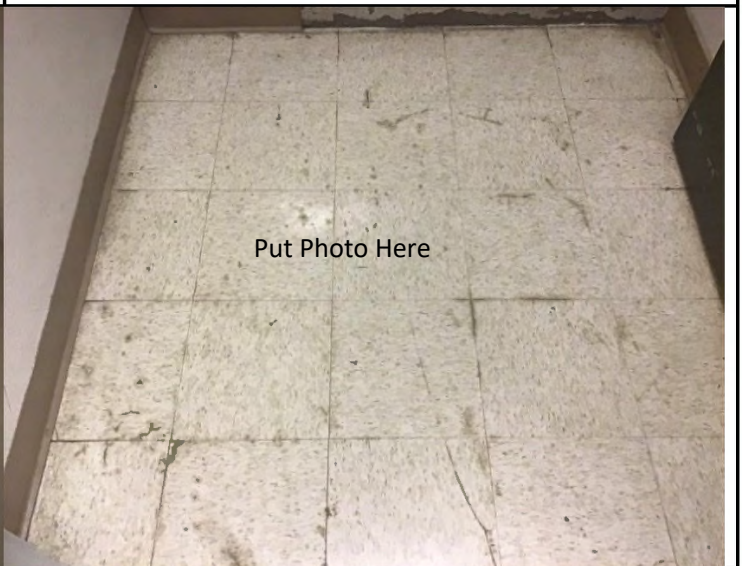
Damage Description:	Item #: 37
Floor, VCT, 12x12 IN, detached, caused by rainwater intrusion (Main Bldg., Basement, Stairway)	
Additional Comments:

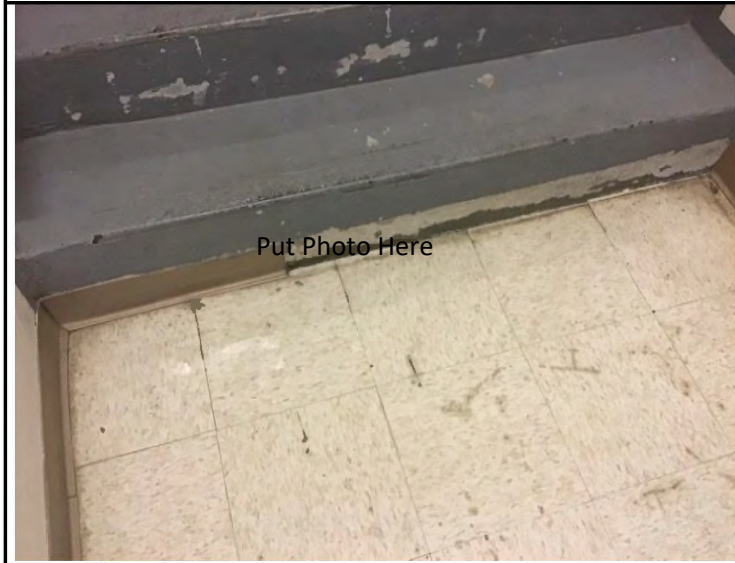
Damage Description:	Item #: 38
Base Lining, vinyl, 4 IN, detached, caused by surface water flooding (Main Bldg., Basement, Stairway)	
Additional Comments:

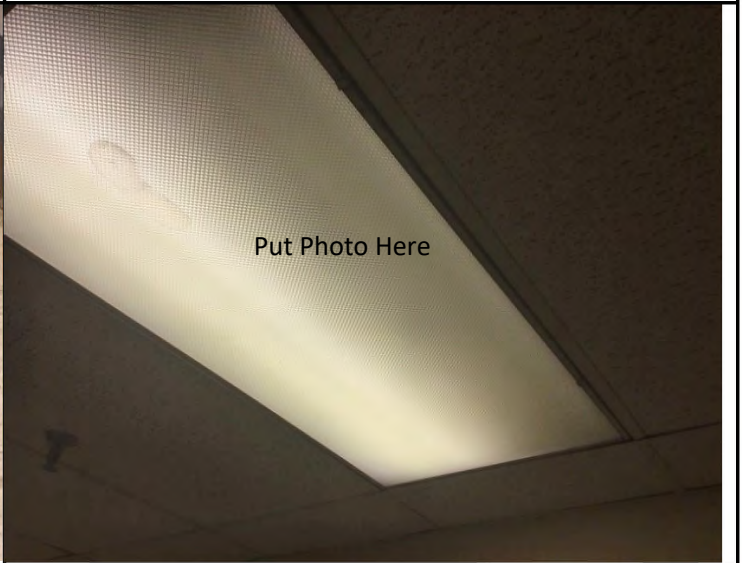
Damage Description:	Item #: 39
Light, florescent, recessed Troffer, electrical issues, caused by rainwater intrusion (Main Bldg., Basement, Hallway ARC)	
Additional Comments:

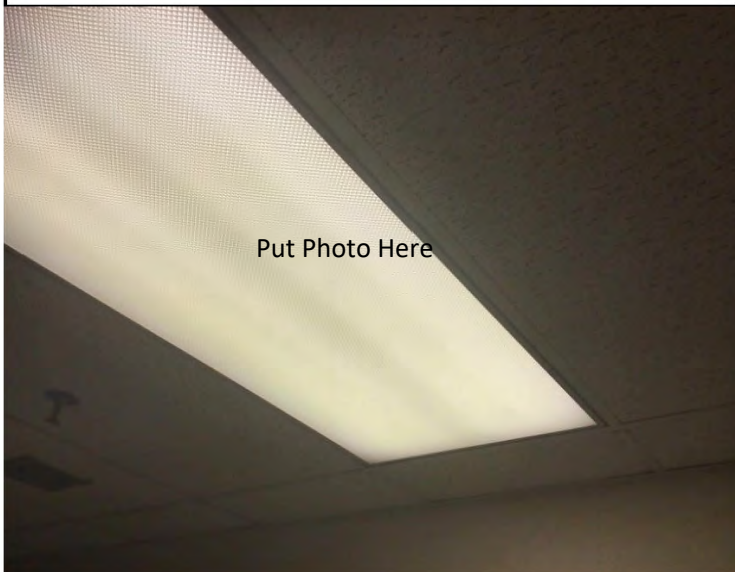
Damage Description:	Item #: 40
Light, florescent, recessed Troffer, acrylic prismatic lens only, discolored, caused by rainwater intrusion (Main Bldg., Basement, Hallway ARC)	
Additional Comments:

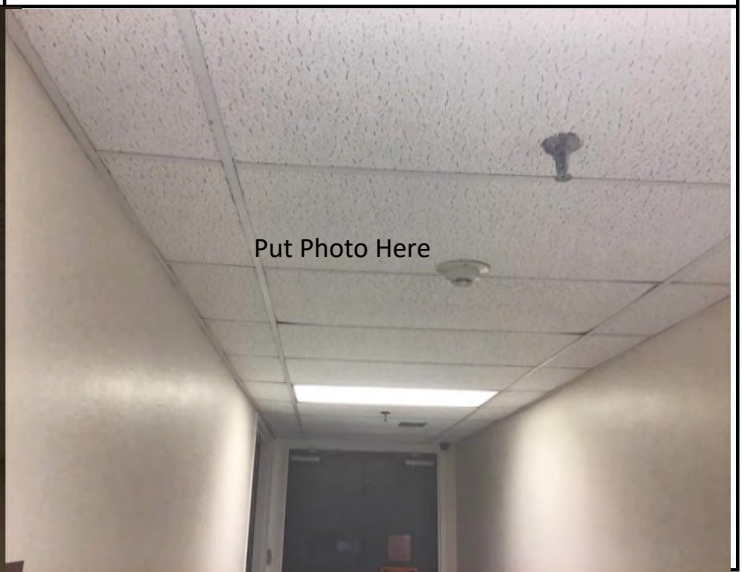
Damage Description:	Item #: 41
Ceiling, 2 FT x 4 FT acoustic tile, suspended, deformed, caused by rainwater intrusion (Main Bldg., Basement, Hallway ARC)	
Additional Comments:

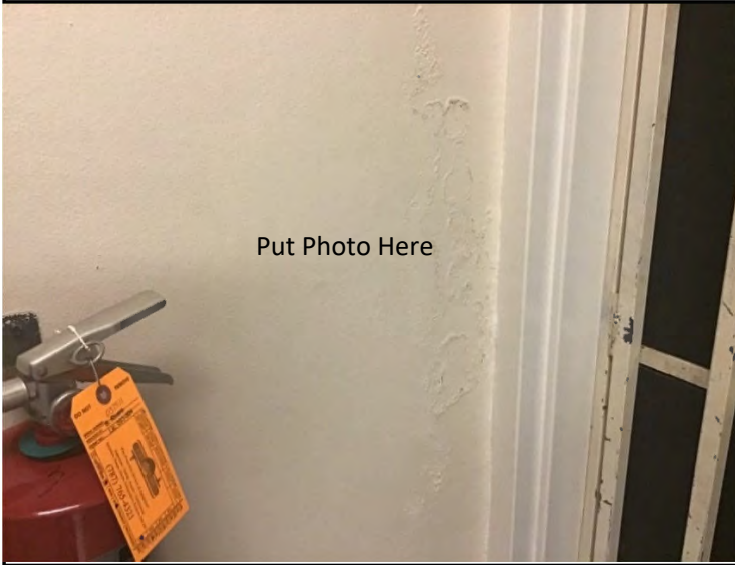
Damage Description:	Item #: 42
Wall, ¼ IN thick plaster on concrete, painted, discolored, caused by rainwater intrusion (Main Bldg., Basement, Hallway ARC)	
Additional Comments:

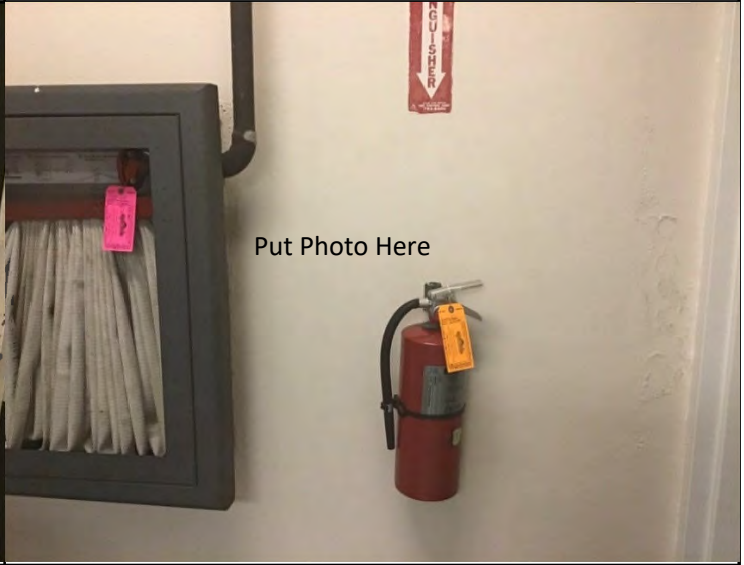
Damage Description:	Item #: 43
Wall, ¼ IN thick plaster on concrete, repair spalling, cracked, caused by rainwater intrusion (Main Bldg., Basement, Hallway ARC)	
Additional Comments:

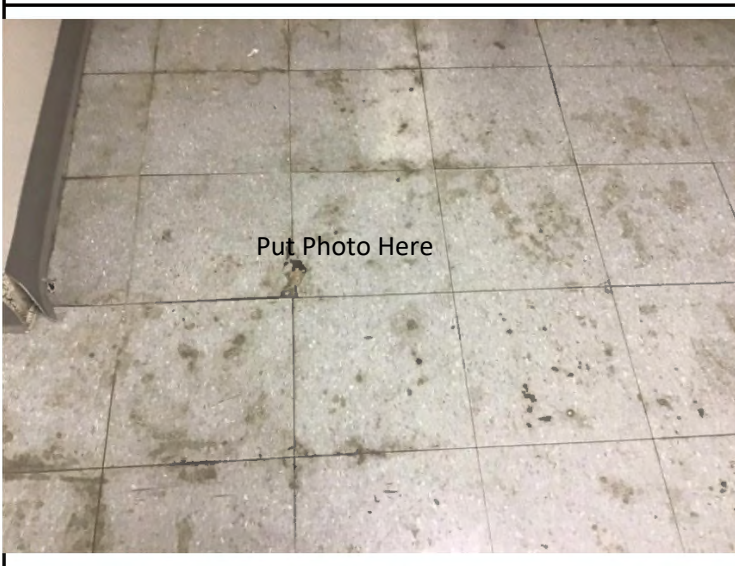
Damage Description:	Item #: 44
Floor, VCT, 12x12 IN, cracked, caused by surface water flooding (Main Bldg., Basement, Hallway ARC)	
Additional Comments:

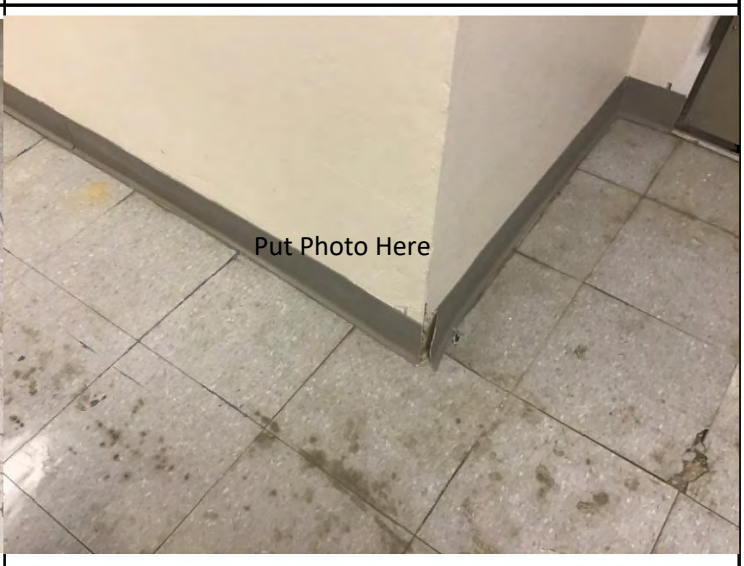
Damage Description:	Item #: 45
Base Lining, vinyl, 4 IN, detached, caused by surface water flooding (Main Bldg., Basement, Hallway ARC)	
Additional Comments:

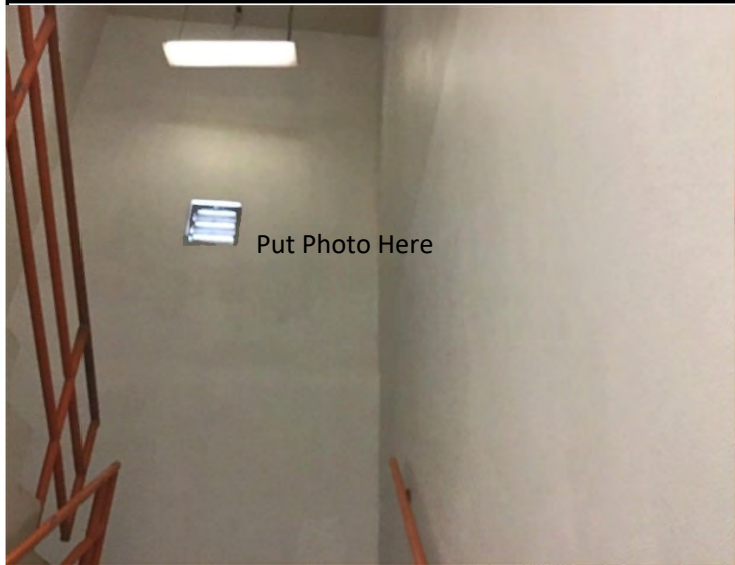
Damage Description:	Item #: 46
Wall, ¼ IN thick plaster on concrete, painted, discolored, caused by rainwater intrusion (Main Bldg., Floor 1, Stairway South)	
Additional Comments:

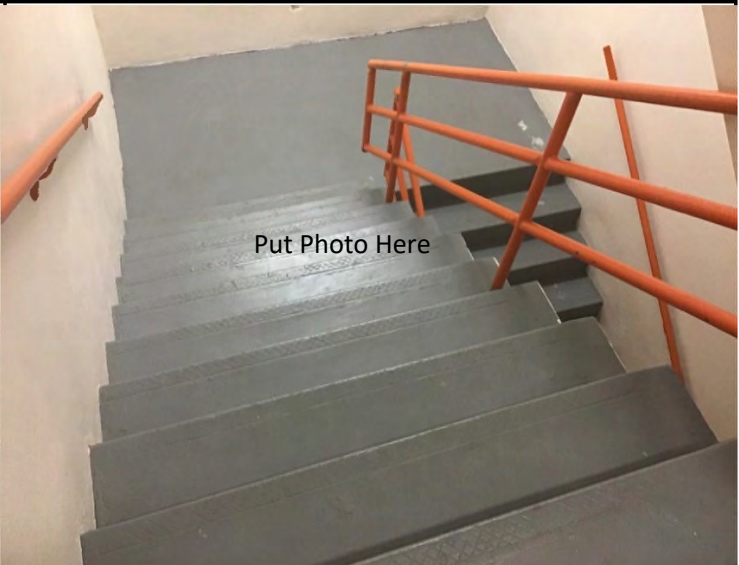
Damage Description:	Item #: 47
Floor, sealed concrete, painted, discolored, caused by rainwater intrusion (Main Bldg., Floor 1, Stairway South)	
Additional Comments:

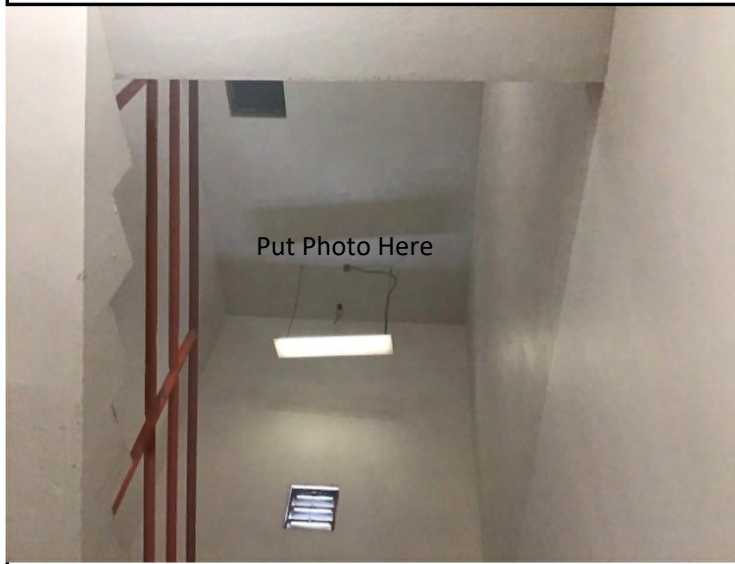
Damage Description:	Item #: 48
Ceiling, ¼ IN thick plaster on concrete, painted, discolored, caused by rainwater intrusion (Main Bldg., Floor 1, Stairway South)	
Additional Comments:

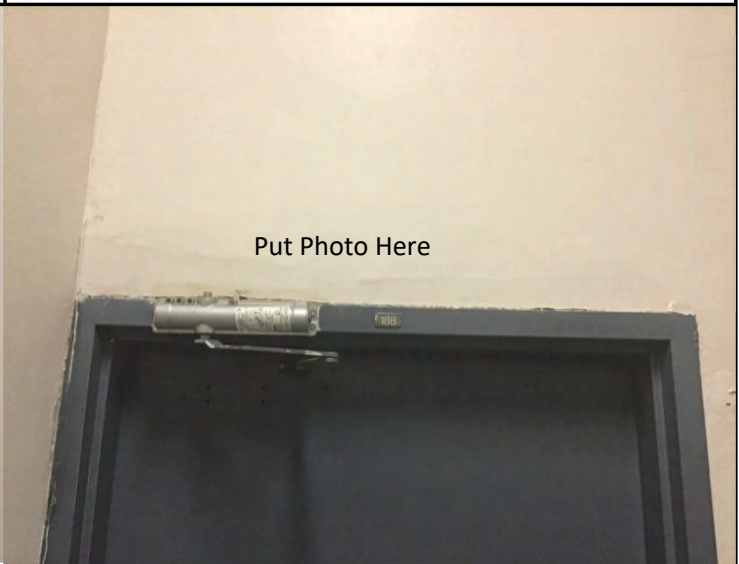
Damage Description:	Item #: 49
Wall, ¼ IN thick plaster on concrete, repair spalling and paint, cracked, caused by rainwater intrusion (Main Bldg., Floor 1, Stairway South)	
Additional Comments:

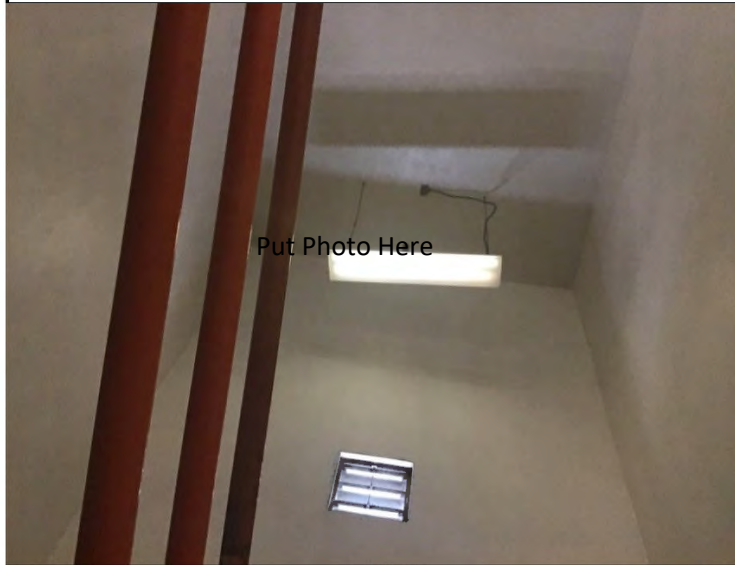
Damage Description:	Item #: 50
Light, fluorescent, suspended, 6 IN x 4 FT light fixture, electrical issues, caused by rainwater intrusion (Main Bldg., Floor 1, Stairway South)	
Additional Comments:

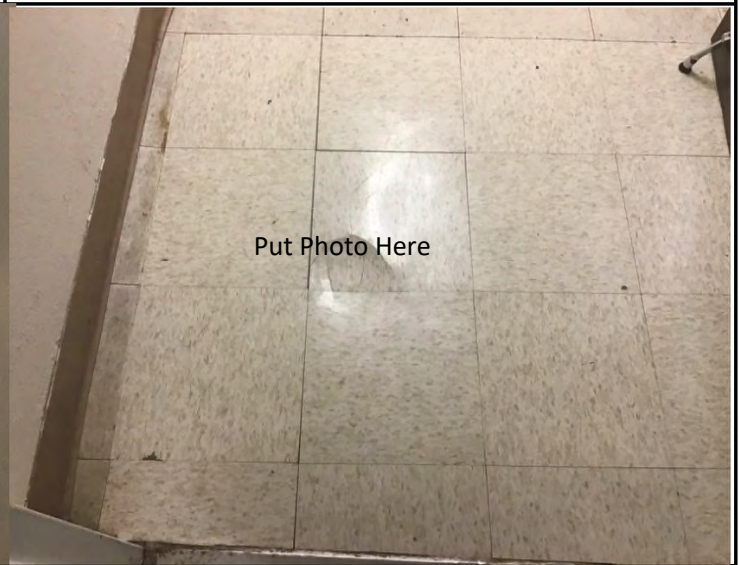
Damage Description:	Item #: 51
Floor, VCT, 12x12 IN, detached, caused by surface water flooding (Main Bldg., Basement, Hallway South)	
Additional Comments:

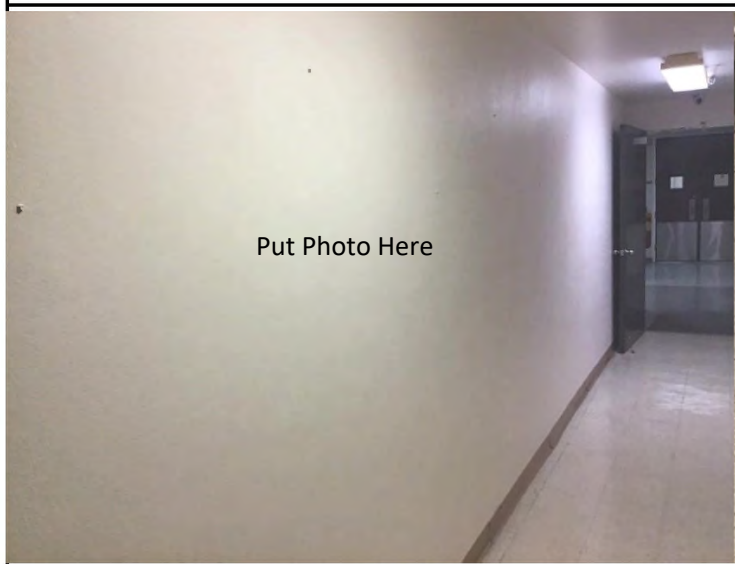
Damage Description:	Item #: 52
Wall, 1/4 IN thick plaster on concrete, painted, discolored, caused by rainwater intrusion (Main Bldg., Basement, Hallway South)	
Additional Comments:

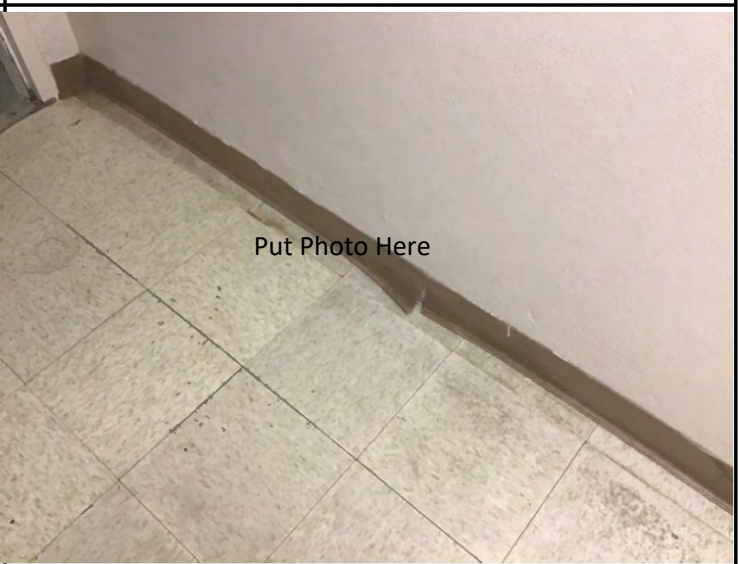
Damage Description:	Item #: 53
Base Lining, vinyl, 4 IN, detached, caused by surface water flooding (Main Bldg., Basement, Hallway South)	
Additional Comments:

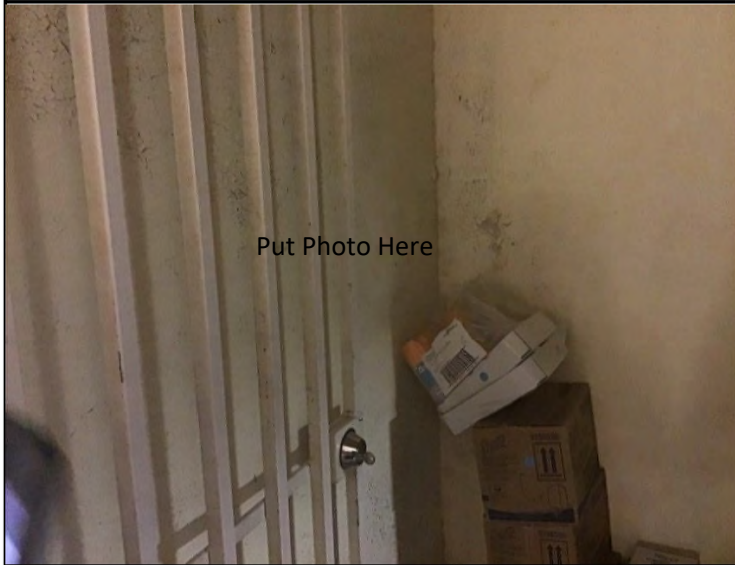
Damage Description:	Item #: 54
Wall, ¼ IN thick plaster on concrete, repair spalling, cracked, caused by rainwater intrusion (Main Bldg., Basement, Storage Room Under Stairway)	
Additional Comments:

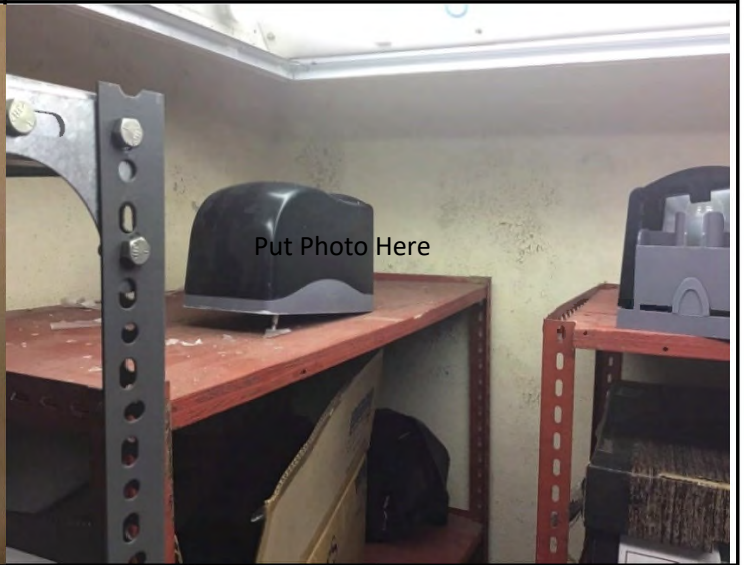
Damage Description:	Item #: 55
Wall, ¼ IN thick plaster on concrete, painted, dislodged, caused by rainwater intrusion (Main Bldg., Basement, Storage Room Under Stairway)	
Additional Comments:

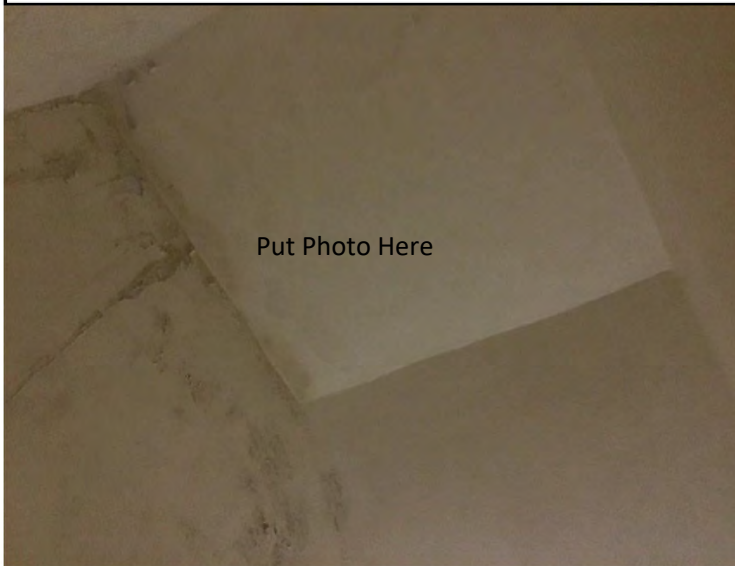
Damage Description:	Item #: 56
Ceiling, ¼ IN thick plaster on concrete, painted, discolored, caused by rainwater intrusion (Main Bldg., Basement, Storage Room Under Stairway)	
Additional Comments:

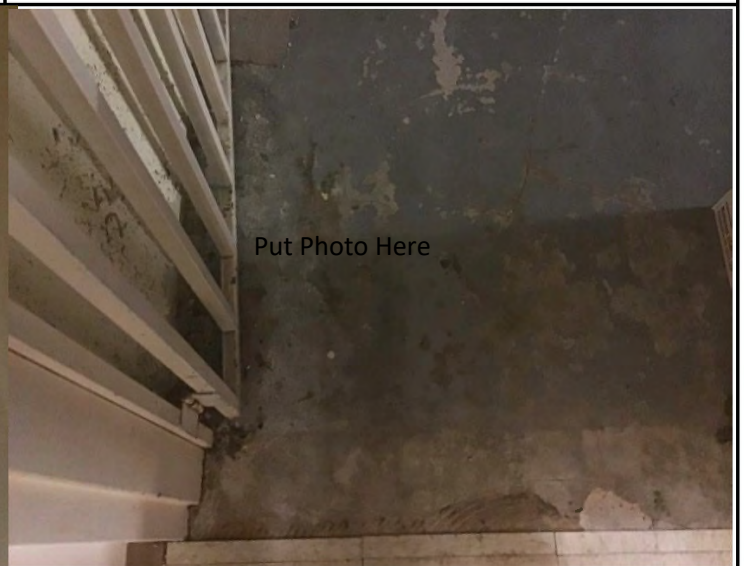
Damage Description:	Item #: 57
Floor, sealed concrete, repair spalling, cracked, caused by surface water flooding (Main Bldg., Basement, Storage Room Under Stairway)	
Additional Comments:

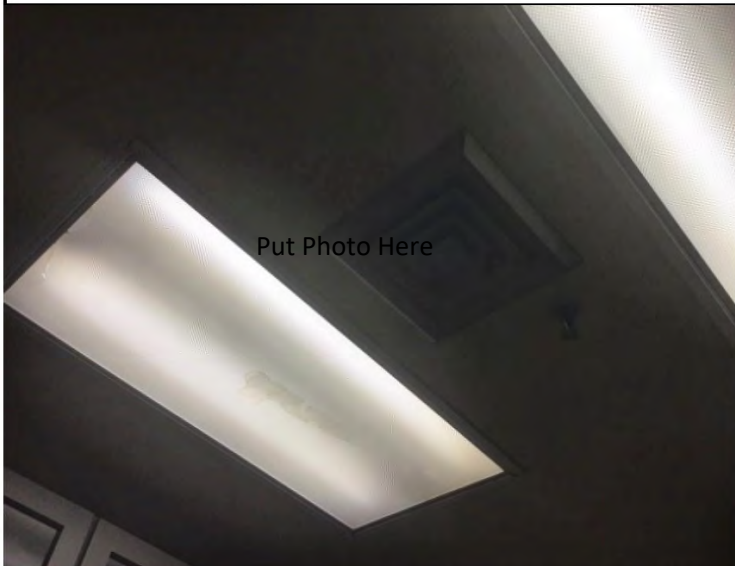
Damage Description:	Item #: 60
Light, fluorescent, recessed Troffer, acrylic prismatic lens only, discolored, caused by rainwater intrusion (Main Bldg., Basement, Laboratory R003)	
Additional Comments:

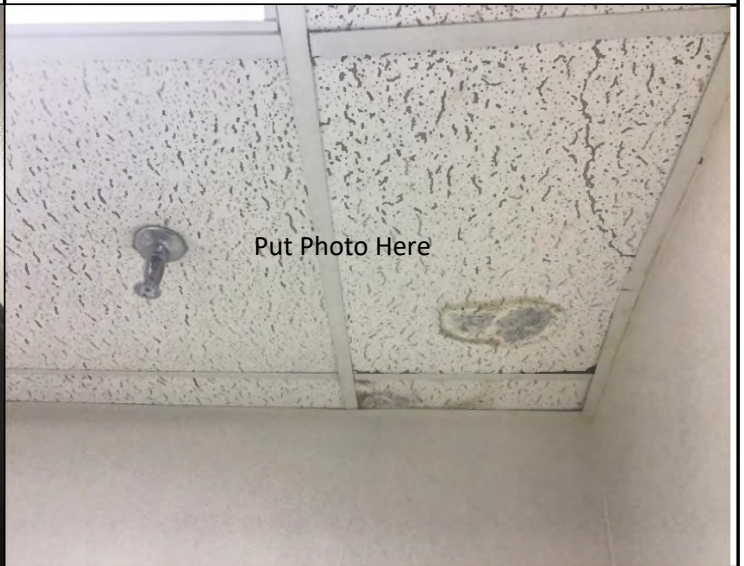
Damage Description:	Item #: 61
Ceiling, 2 FT x 4 FT acoustic tile, suspended, deformed, caused by rainwater intrusion (Main Bldg., Basement, Laboratory R004)	
Additional Comments:
