Applicant: Universidad Central Del Caribe, Inc.	Damage Inventory: 305240	Category: E
WO # 46525 FIPS# 021-UNUGB-00	Date: 09/04-17/2019 GPS: 18.365953, -66.153767	
Inspector: Gregory Sondergeld / Alexander Nieves	Damage Facility: Main Bldg.

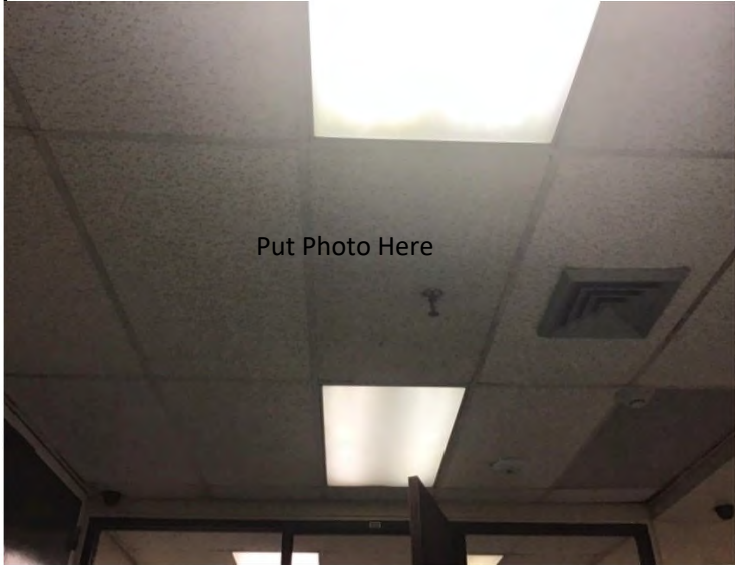
Damage Description:	Item #: 62
Ceiling, 2 FT x 4 FT acoustic tile, suspended, deformed, caused by rainwater intrusion (Main Bldg., Basement, Laboratory Reception Lobby)	
Additional Comments:

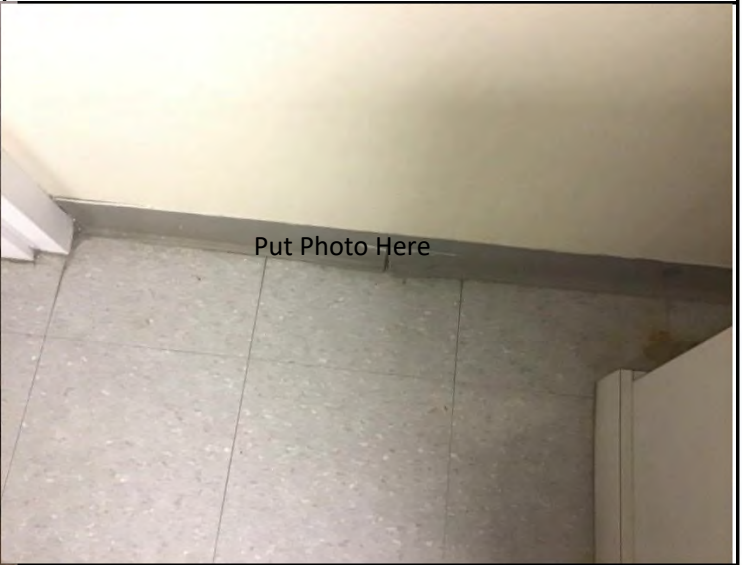
Damage Description:	Item #: 63
Base Lining, vinyl, 4 IN, detached, caused by rainwater intrusion (Main Bldg., Basement, Laboratory Reception Lobby)	
Additional Comments:

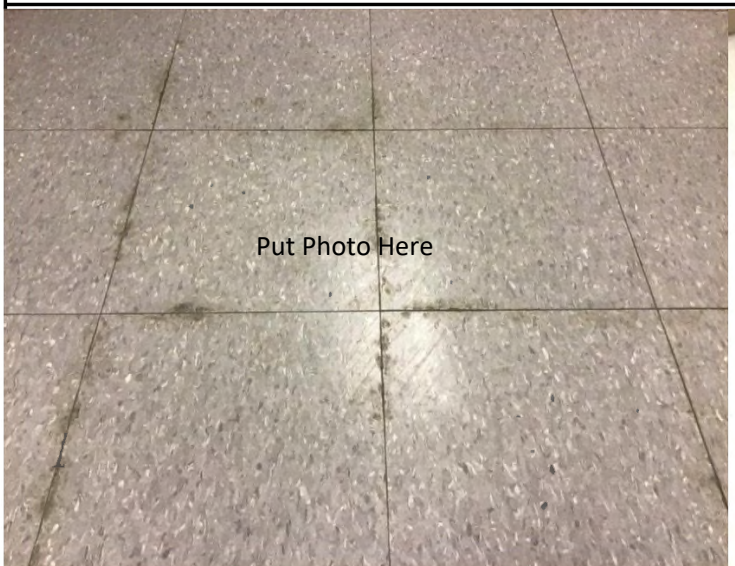
Damage Description:	Item #: 64
Floor, VCT, 12x12 IN, detached, caused by rainwater intrusion (Main Bldg., Basement, Laboratory Reception Lobby)	
Additional Comments:

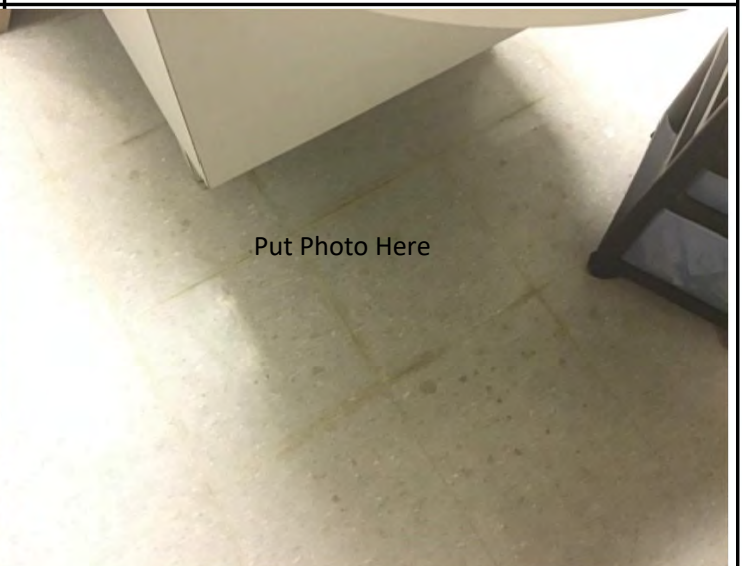
Damage Description:	Item #: 65
Floor, VCT, 12x12 IN, detached, caused by surface water flooding (Main Bldg., Basement, Laboratory R009)	
Additional Comments:

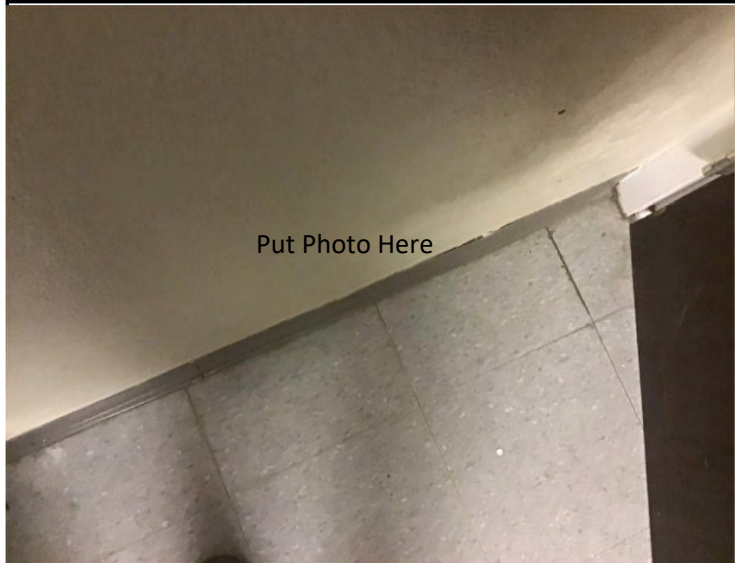
Damage Description:	Item #: 66
Base Lining, vinyl, 4 IN, detached, caused by surface water flooding (Main Bldg., Basement, Laboratory R009)	
Additional Comments:

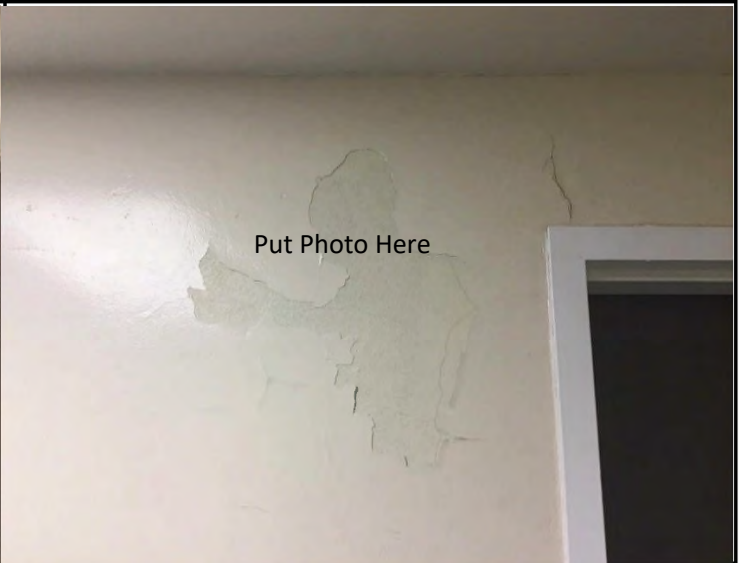
Damage Description:	Item #: 67
Wall, ¼ IN thick plaster on concrete, repair spalling, deformed, caused by rainwater intrusion (Main Bldg., Basement, Laboratory Hallway)	
Additional Comments:

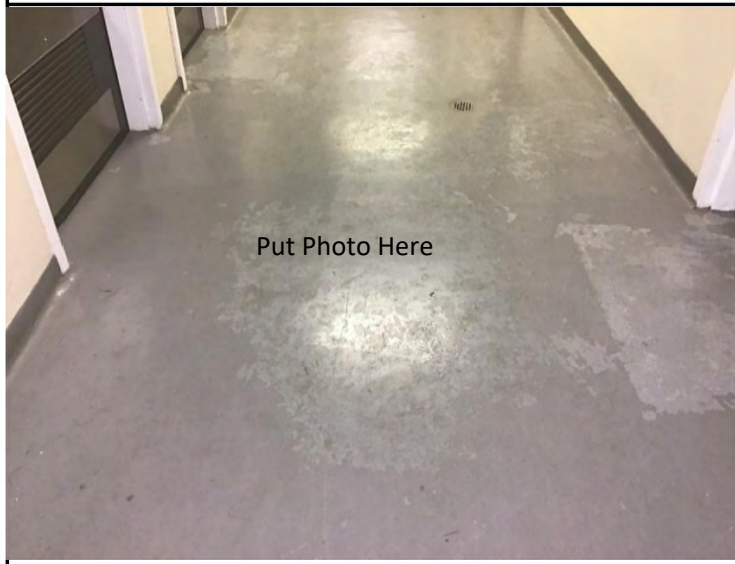
Damage Description:	Item #: 69
Floor, sealed concrete, epoxy painted, peeling paint, caused by surface water flooding (Main Bldg., Basement, Laboratory Interior Hallway)	
Additional Comments:

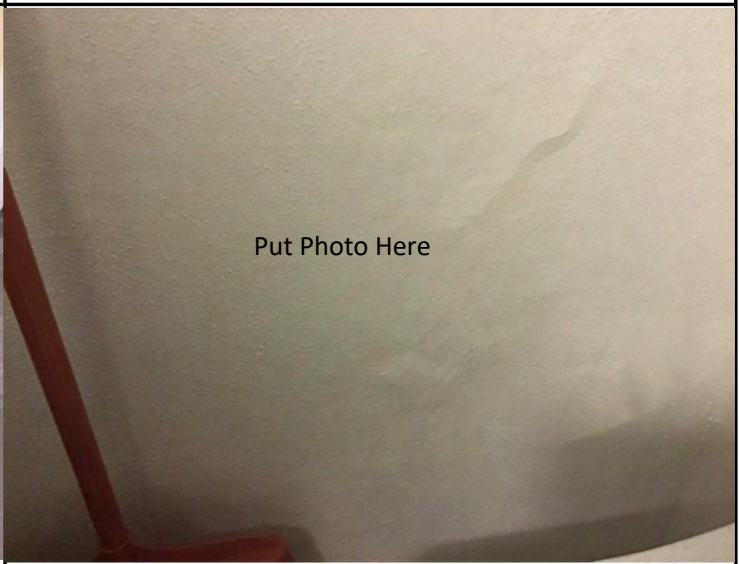
Damage Description:	Item #: 70
Wall, ¼ IN thick plaster on concrete, repair spalling, cracked, caused by rainwater intrusion (Main Bldg., Basement, Laboratory R032)	
Additional Comments:

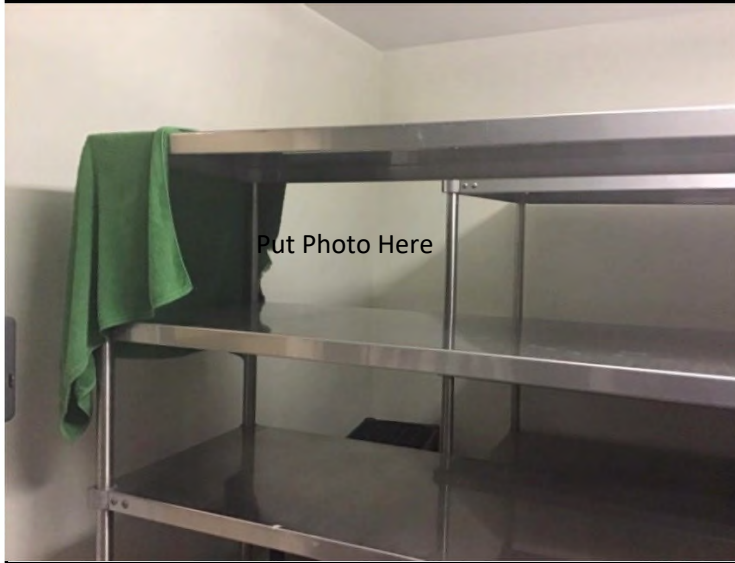
Damage Description:	Item #: 71
Wall, ¼ IN thick plaster on concrete, painted, discolored, caused by rainwater intrusion (Main Bldg., Basement, Laboratory R032)	
Additional Comments:

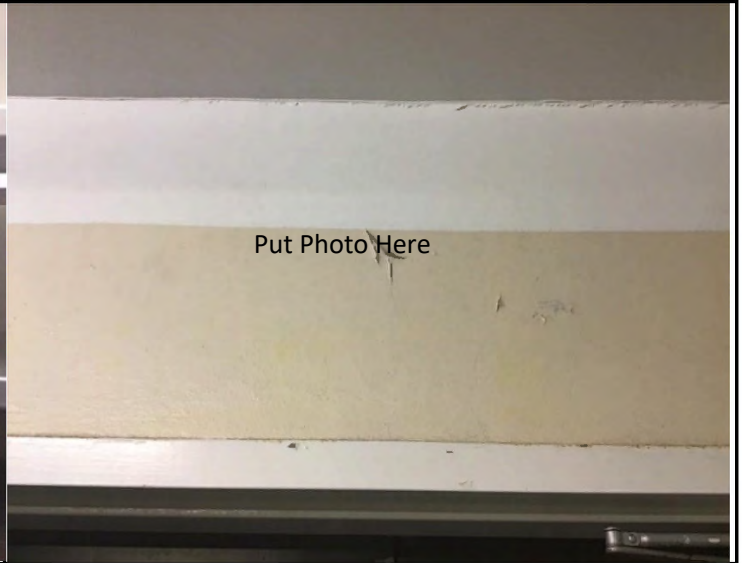
Damage Description:	Item #: 72
Wall, ¼ IN thick plaster on concrete, repair spalling, cracked, caused by rainwater intrusion (Main Bldg., Basement, Laboratory R027)	
Additional Comments:

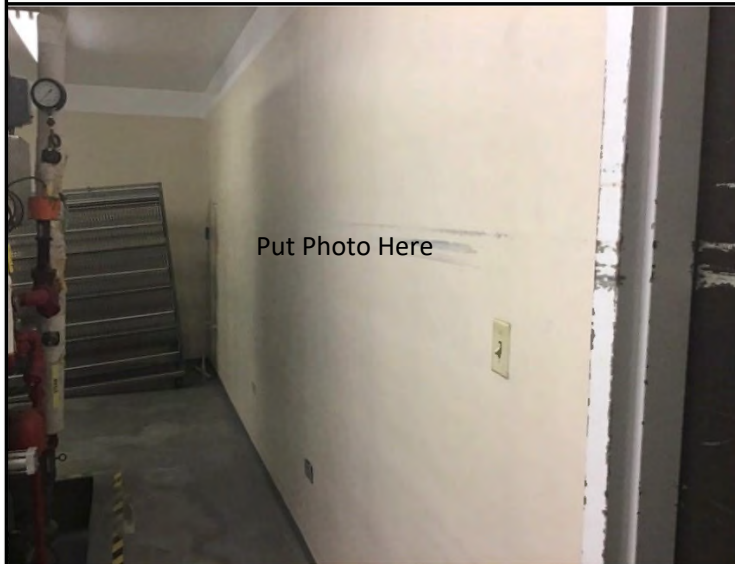
Damage Description:	Item #: 73
Wall, ¼ IN thick plaster on concrete, painted, discolored, caused by rainwater intrusion (Main Bldg., Basement, Laboratory R027)	
Additional Comments:

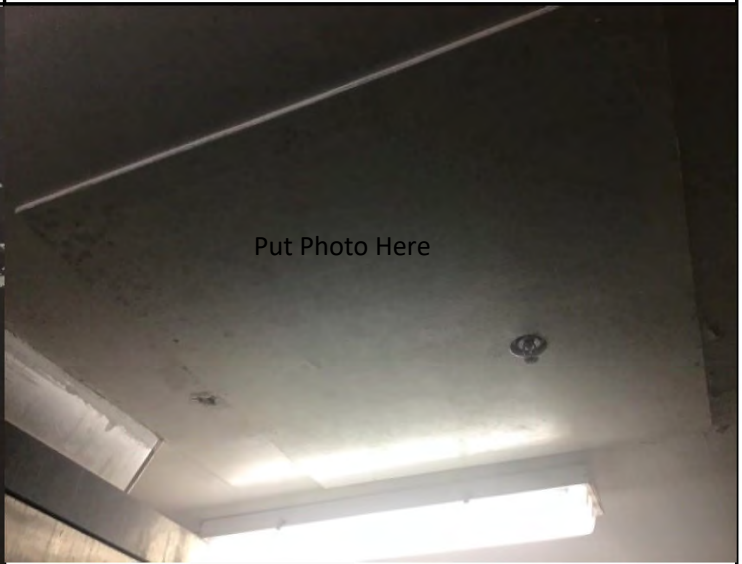
Damage Description:	Item #: 74
Ceiling, drywall, repair, cracked, caused by rainwater intrusion (Main Bldg., Basement, Laboratory R027)	
Additional Comments:

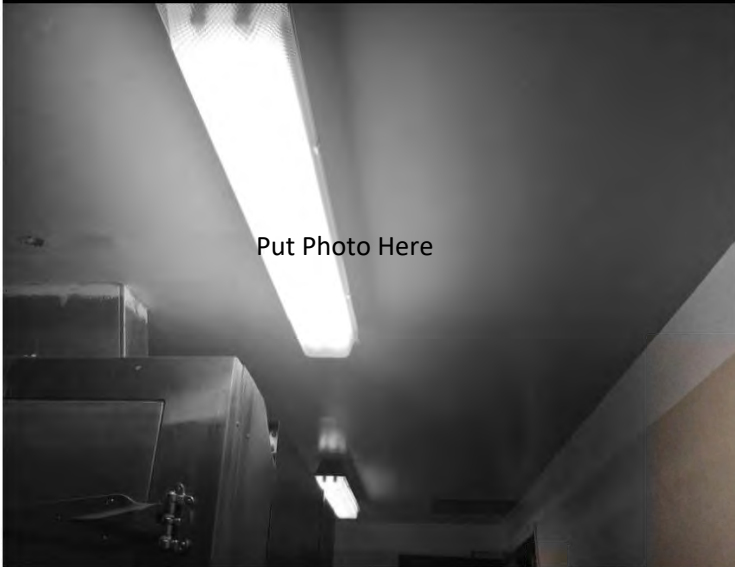
Damage Description:	Item #: 75
Ceiling, drywall, paint, discolored, caused by rainwater intrusion (Main Bldg., Basement, Laboratory R027)	
Additional Comments:

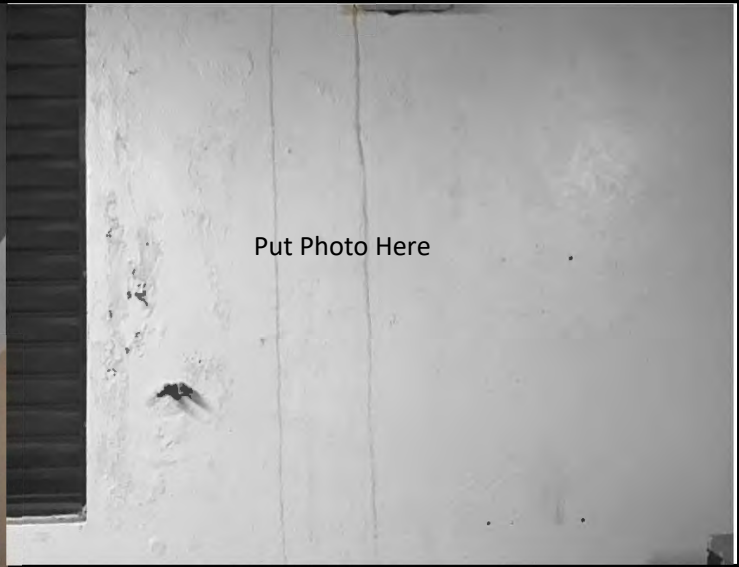
Damage Description:	Item #: 76
Wall, ¼ IN thick plaster on concrete, repair spalling, cracked, caused by rainwater intrusion (Main Bldg., Basement, Air Handler Unit R516)	
Additional Comments:

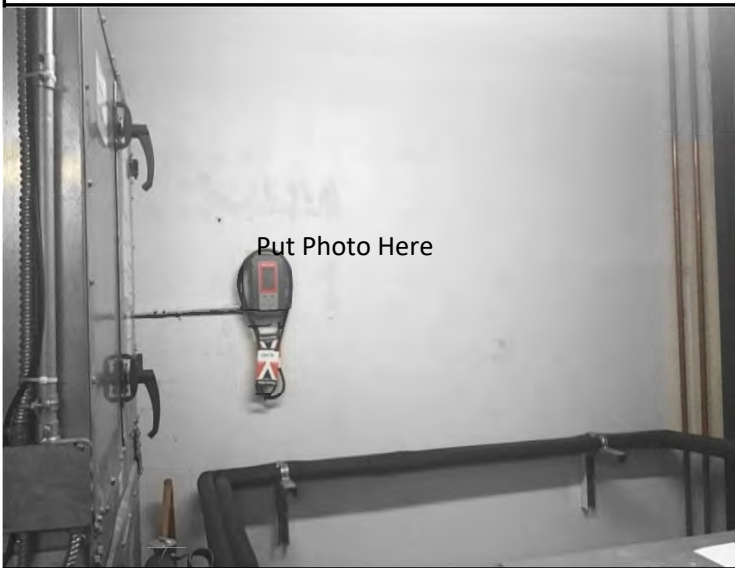
Damage Description:	Item #: 77
Wall, ¼ IN thick plaster on concrete, painted, peeling paint, caused by rainwater intrusion (Main Bldg., Basement, Air Handler Unit R516)	
Additional Comments:

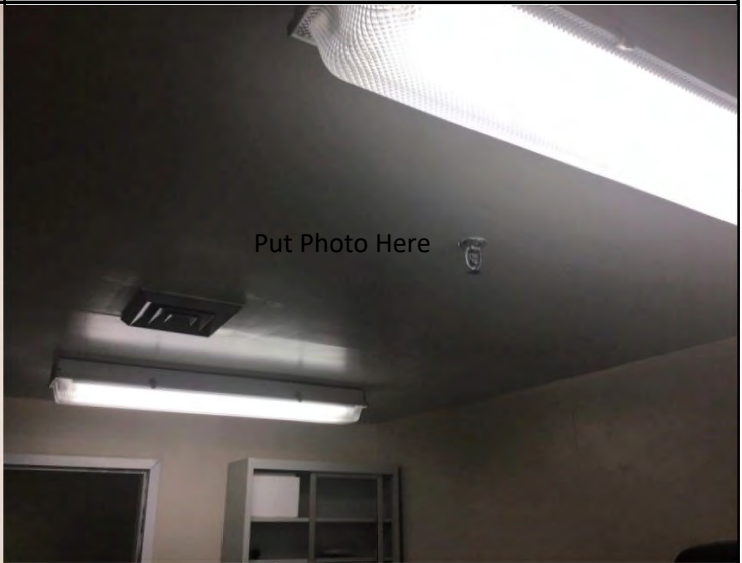
Damage Description:	Item #: 82
Ceiling, drywall, painted, cracked, caused by rainwater intrusion (Main Bldg., Basement, Laboratory R028 & 029)	
Additional Comments:

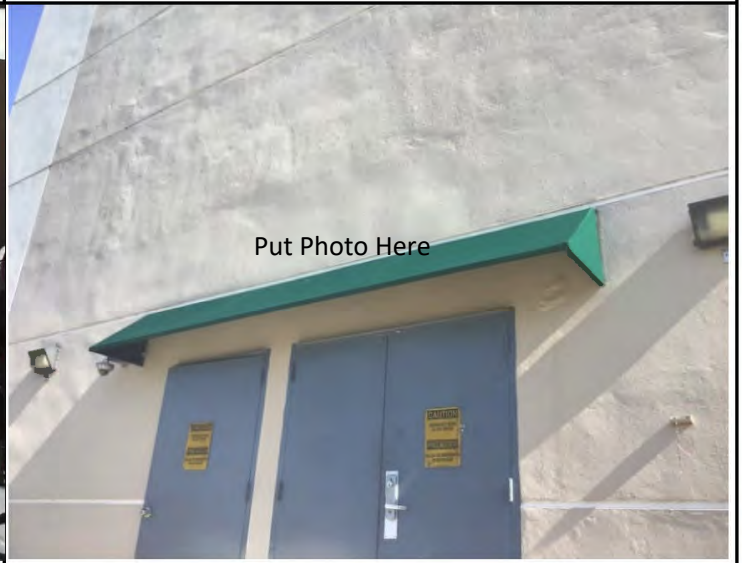
Damage Description:	Item #: 84
Entrance awning, aluminum-framed, fabric covered, broken components, caused by high winds (Main Bldg., Exterior, Loading Dock)	
Additional Comments:

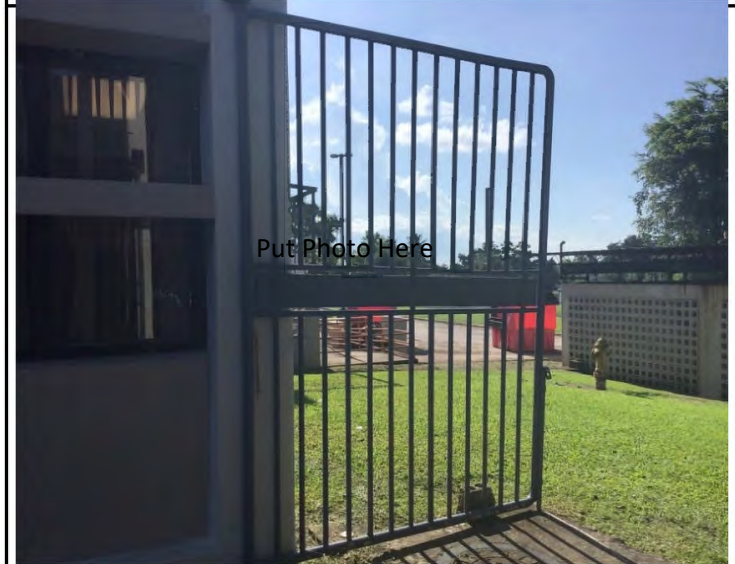
Damage Description:	Item #: 85
Security gate, galvanized tubular steel piping, 2 IN-dia. perimeter framing, 1.5 IN-dia. vertical framing, steel ball-bearing pin hinges, painted finish, broken components, caused by wind-blown debris (Main Bldg., Exterior, Loading Dock)	
Additional Comments:
