<b>Applicant:</b> Universidad Central Del Caribe, Inc.	<b>Damage Inventory:</b> 305240	<b>Category:</b> E
<b>WO #</b> 46525 <b>FIPS#</b> 021-UNUGB-00	<b>Date:</b> 09/04-17/2019 <b>GPS:</b> 18.365953, -66.153767	
<b>Inspector:</b> Gregory Sondergeld / Alexander Nieves	<b>Damage Facility:</b> Main Bldg.

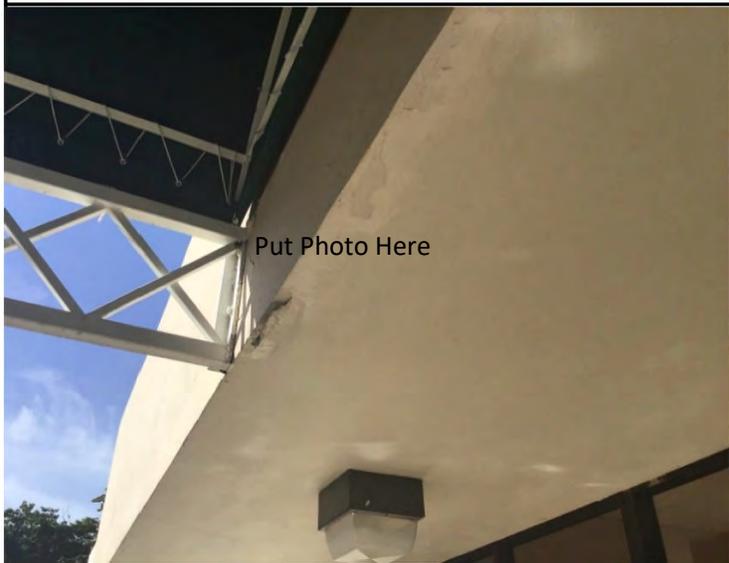
<b>Damage Description:</b>	<b>Item #:</b> 1
Ceiling, ¼ IN thick plaster on concrete, repair spalling and paint, cracked, caused by rain water intrusion (Main Bldg., Exterior, Main Entrance)	
<b>Additional Comments:</b>

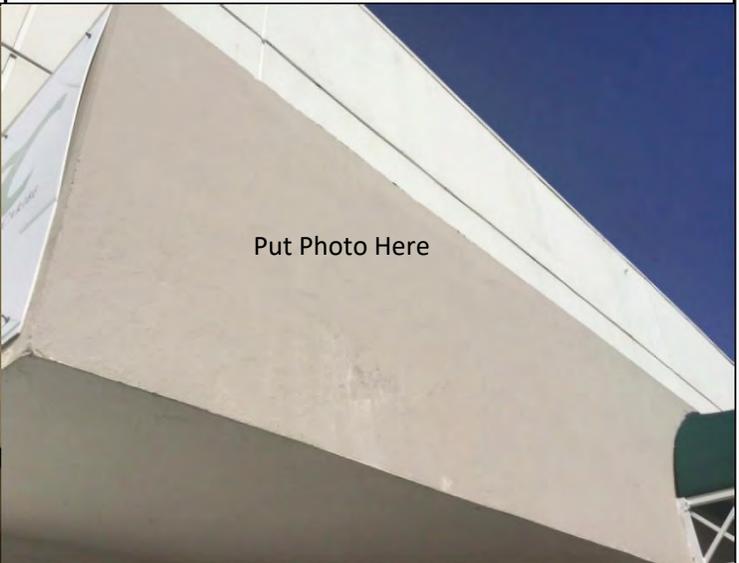
<b>Damage Description:</b>	<b>Item #:</b> 2
Wall, ¼ IN thick plaster on concrete, repair spalling and paint, discolored, caused by rainwater intrusion (Main Bldg., Exterior, Fascia East & West)	
<b>Additional Comments:</b>

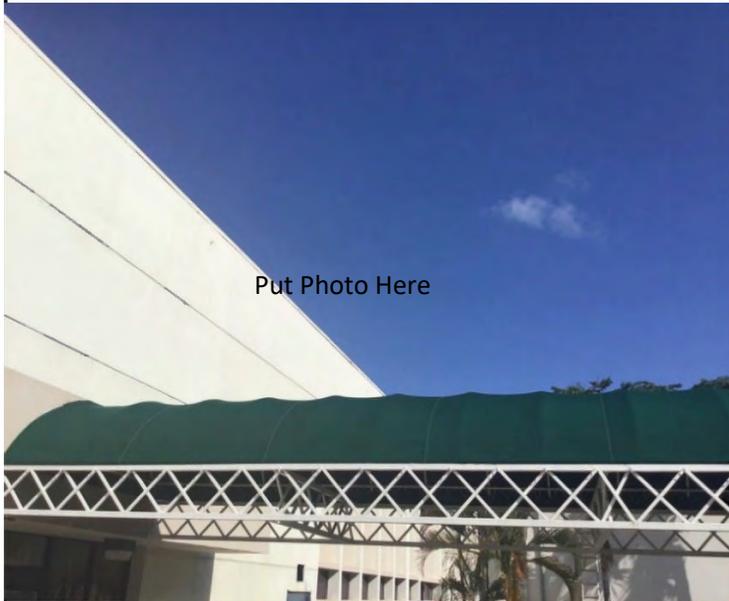
<b>Damage Description:</b>	<b>Item #:</b> 3
Entrance Canopy, steel-framed, barrel vault-shaped, fabric covering only, broken components, caused by high winds (Main Bldg., Exterior, Canopy)	
<b>Additional Comments:</b>

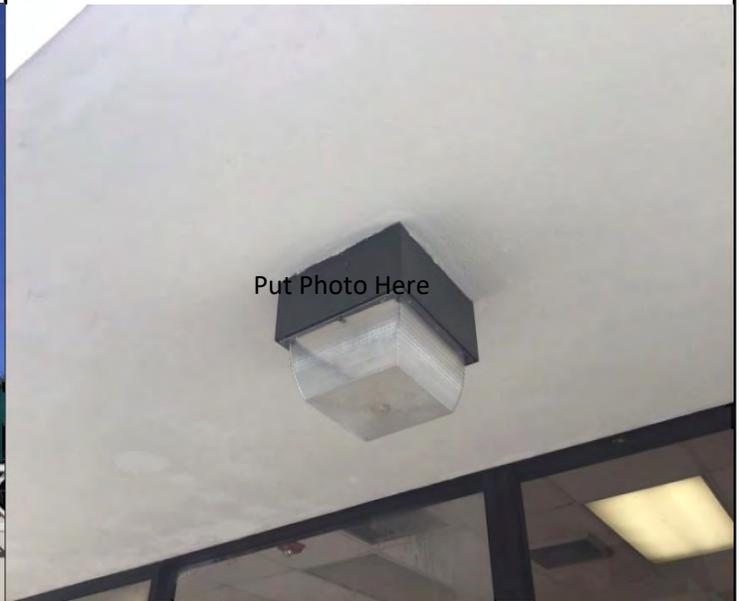
<b>Damage Description:</b>	<b>Item #:</b> 4
Light, Outdoor, surface-mounted, soffit fixture, 1 FT x 1 FT, clear acrylic lens cover only, cracked, caused by high winds (Main Bldg., Exterior, Entire Floor)	
<b>Additional Comments:</b>

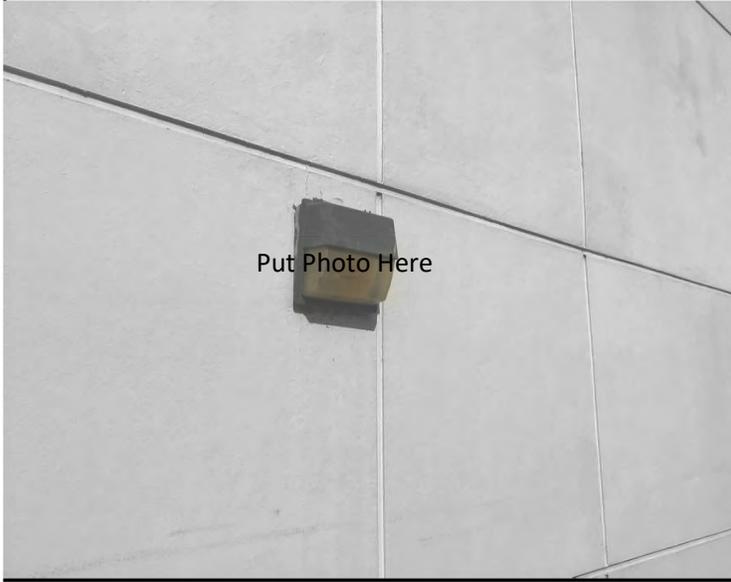
<b>Damage Description:</b>	<b>Item #:</b> 5
Light, Wall Pack luminaire, 110 Volt, 200-Watt, high-pressure sodium, cracked, caused by wind-blown debris (Main Bldg., Exterior, Entire Floor)	
<b>Additional Comments:</b>

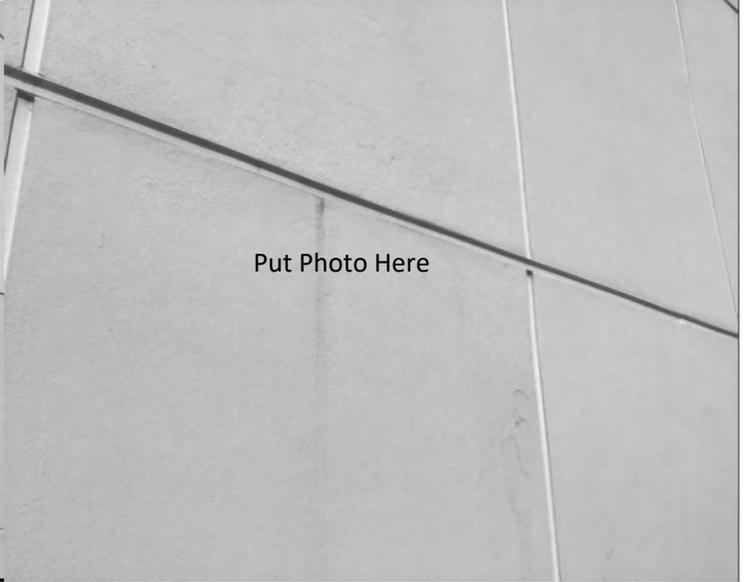
<b>Damage Description:</b>	<b>Item #:</b> 6
Wall, ¼ IN thick plaster on concrete, repair spalling, discolored, caused by rainwater intrusion (Main Bldg., Exterior, Entire Floor)	
<b>Additional Comments:</b>

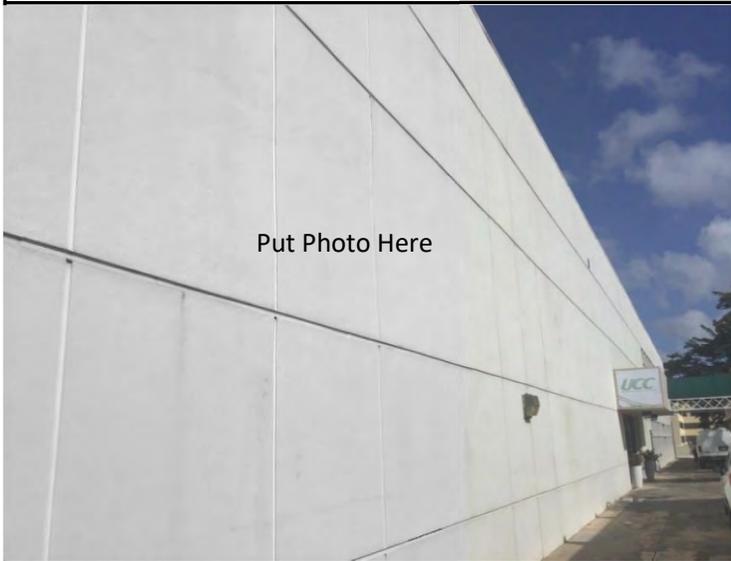
<b>Damage Description:</b>	<b>Item #:</b> 7
Wall, ¼ IN thick plaster on concrete, painted, discolored, caused by rainwater intrusion (Main Bldg., Exterior, Entire Floor)	
<b>Additional Comments:</b>

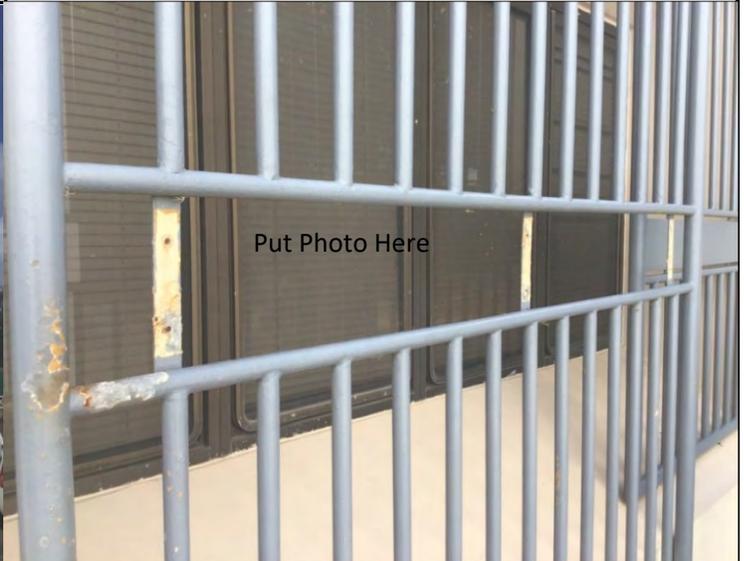
<b>Damage Description:</b>	<b>Item #:</b> 8
Tubular steel security gate, wooden insert only, 1 IN D x 8 IN W x 8 FT L, painted, broken components, caused by wind-blown debris (Main Bldg., Exterior, Steel Security Gate)	
<b>Additional Comments:</b>

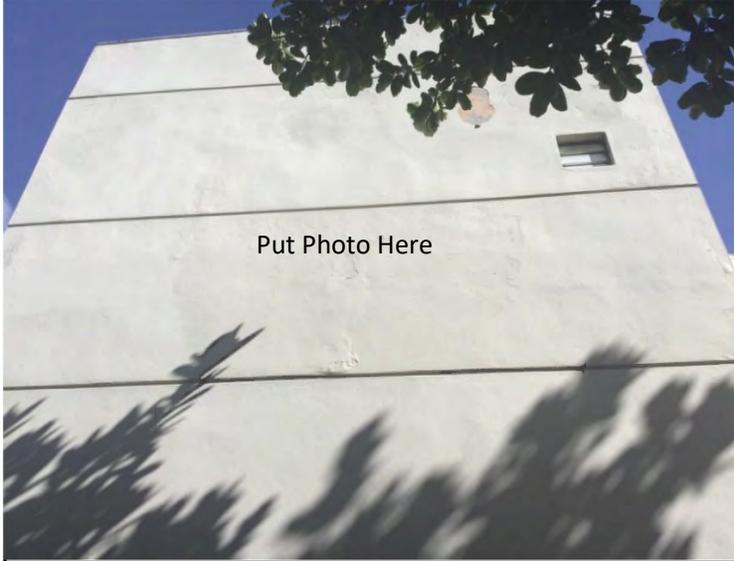
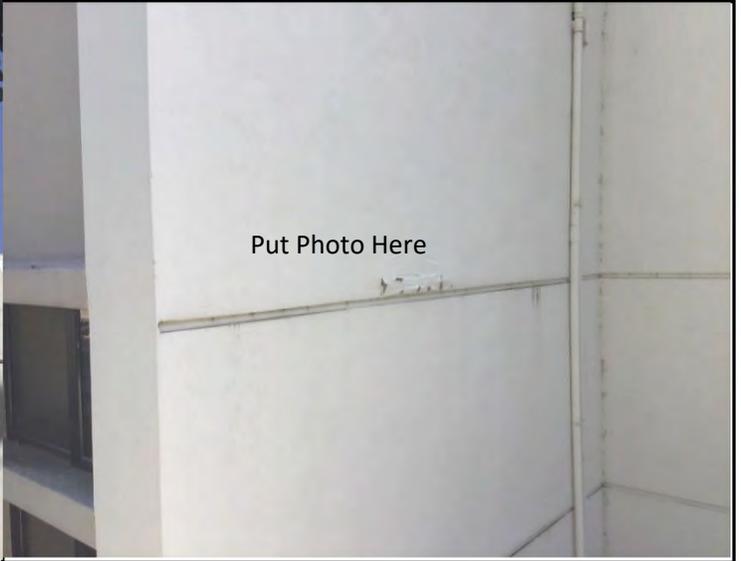
<b>Damage Description:</b>	<b>Item #:</b> 9	<b>Damage Description:</b>	<b>Item #:</b> 10 Wall,
Wall, ¼ IN thick plaster on concrete, repair spalling, peeling paint, caused by rainwater intrusion (Main Bldg., Exterior, Entire Floor)		¼ IN thick plaster on concrete, painted, peeling paint, caused by rainwater intrusion (Main Bldg., Exterior, Entire Floor)	
<b>Additional Comments:</b>		<b>Additional Comments:</b>

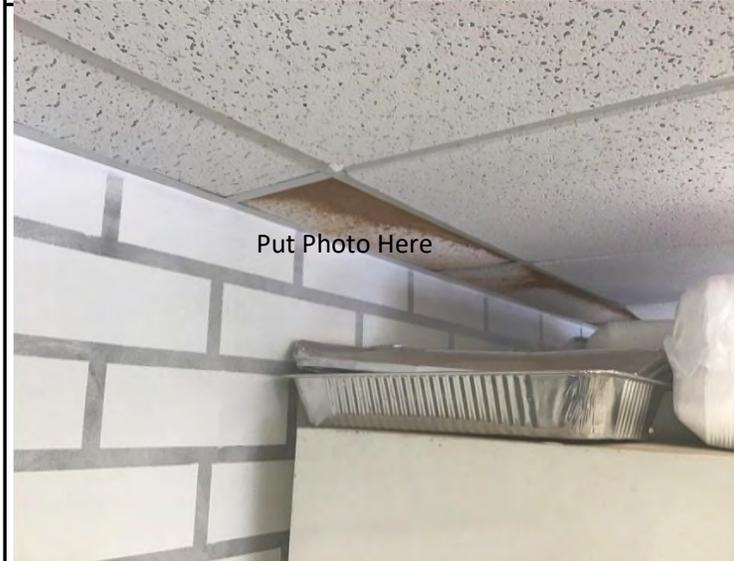
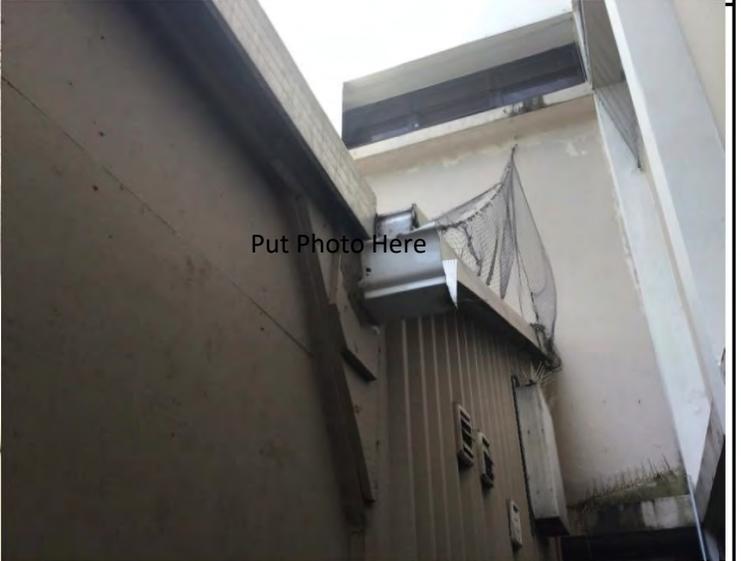
<b>Damage Description:</b>	<b>Item #:</b> 11	<b>Damage Description:</b>	<b>Item #:</b> 12
Ceiling, 2 FT x 2 FT acoustic tile, suspended, tegular, discolored, caused by rainwater intrusion (Main Bldg., Floor 1, Cafeteria)		Roof, Metal flashing, 26 gauge, 6 IN x 6 IN, deformed, caused by high winds (Main Bldg., Floor 1, Cafeteria)	
<b>Additional Comments:</b>		<b>Additional Comments:</b>

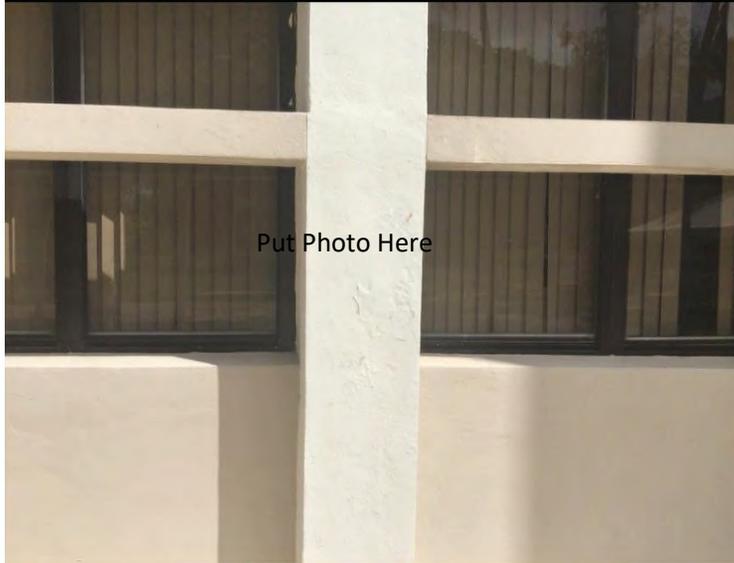
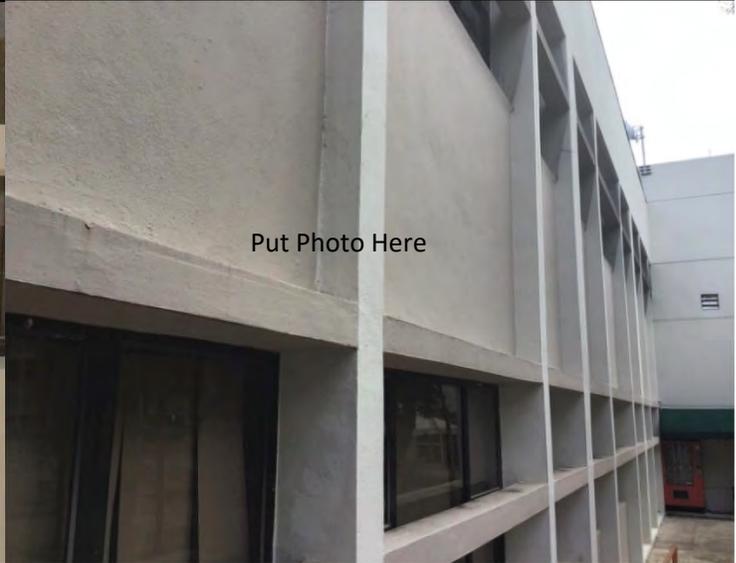
<b>Damage Description:</b>	<b>Item #:</b> 13	<b>Damage Description:</b>	<b>Item #:</b> 14
Wall, ¼ IN thick plaster on concrete, repair spalling, discolored, caused by rain water intrusion (Main Bldg., Exterior, Entire Floor)		Wall, ¼ IN thick plaster on concrete, painted, peeling paint, caused by rainwater intrusion (Main Bldg., Exterior, Entire Floor)	
<b>Additional Comments:</b>		<b>Additional Comments:</b>

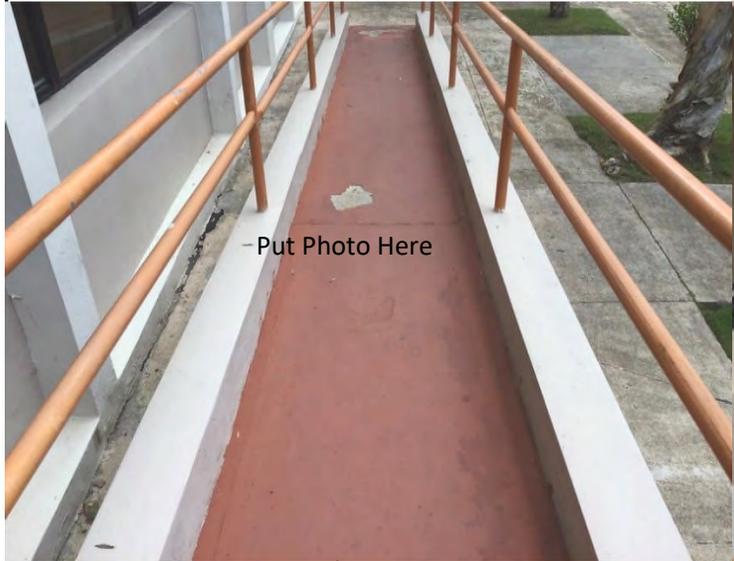
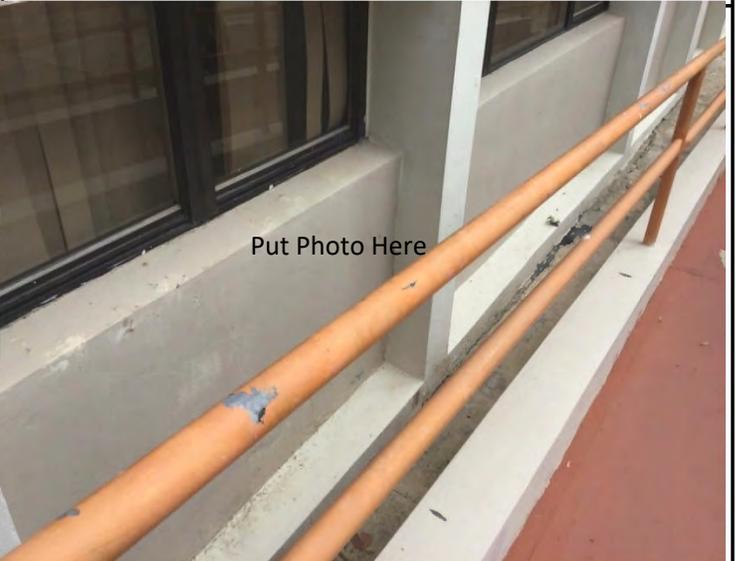
<b>Damage Description:</b>	<b>Item #:</b> 15	<b>Damage Description:</b>	<b>Item #:</b> 16
Floor, sealed concrete, epoxy-coated, peeling paint, caused by surface water flooding (Main Bldg., Exterior, Handicap-Access Ramp)		Hand Rail, Hand rail, galvanized steel piping, 2 IN-dia., double rail, painted finish, peeling paint, caused by wind-driven rain (Main Bldg., Exterior, Ramp)	
<b>Additional Comments:</b>		<b>Additional Comments:</b>

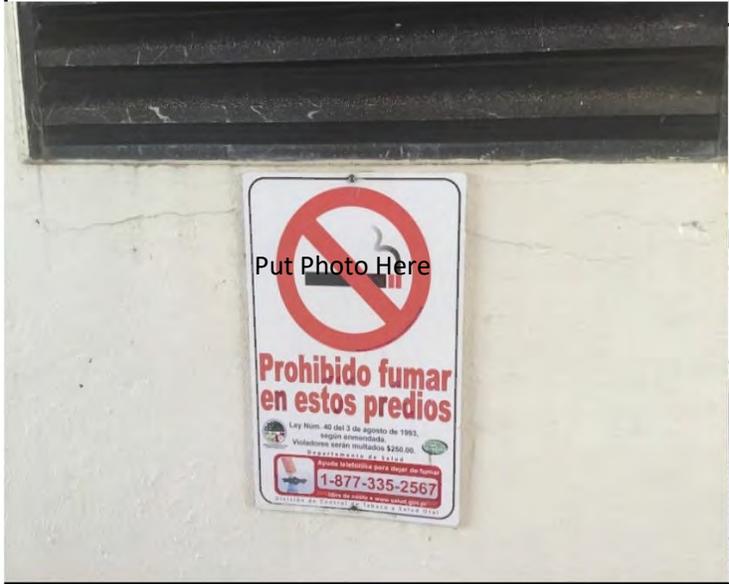
<b>Damage Description:</b>	<b>Item #:</b> 17
Wall, ¼ IN thick plaster on concrete, repair spalling, cracked, caused by rainwater intrusion (Main Bldg., Exterior, Entire Floor)	
<b>Additional Comments:</b>

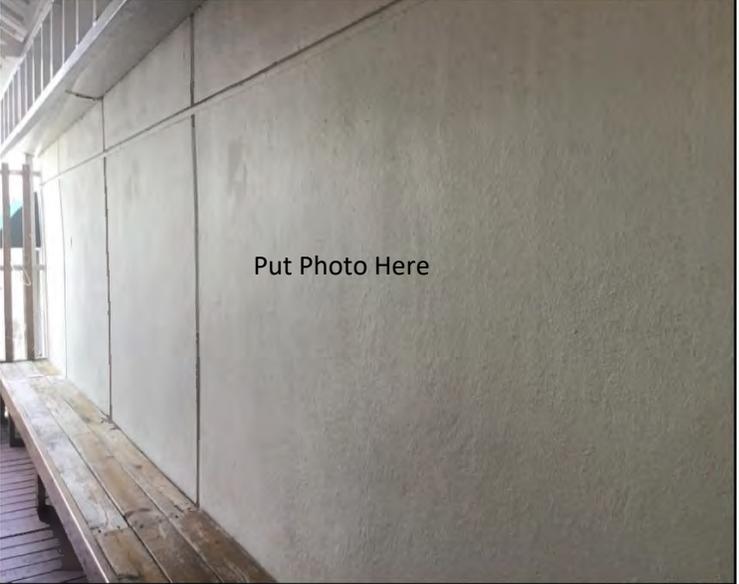
<b>Damage Description:</b>	<b>Item #:</b> 18
Wall, ¼ IN thick plaster on concrete, painted, discolored, caused by rainwater intrusion (Main Bldg., Exterior, Entire Floor)	
<b>Additional Comments:</b>

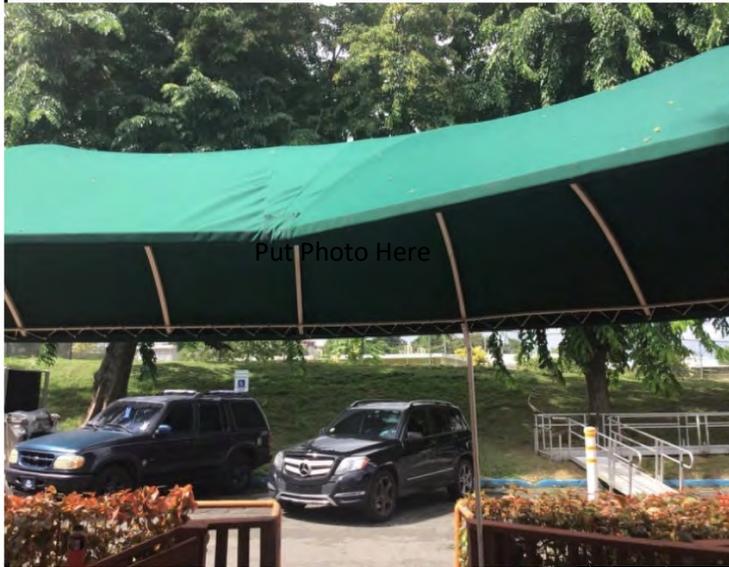
<b>Damage Description:</b>	<b>Item #:</b> 19
Entrance Canopy, metal-framed, arch-shaped, painted with fabric covering, broken components, caused by high winds (Main Bldg., Exterior, Wooden Patio Deck)	
<b>Additional Comments:</b>

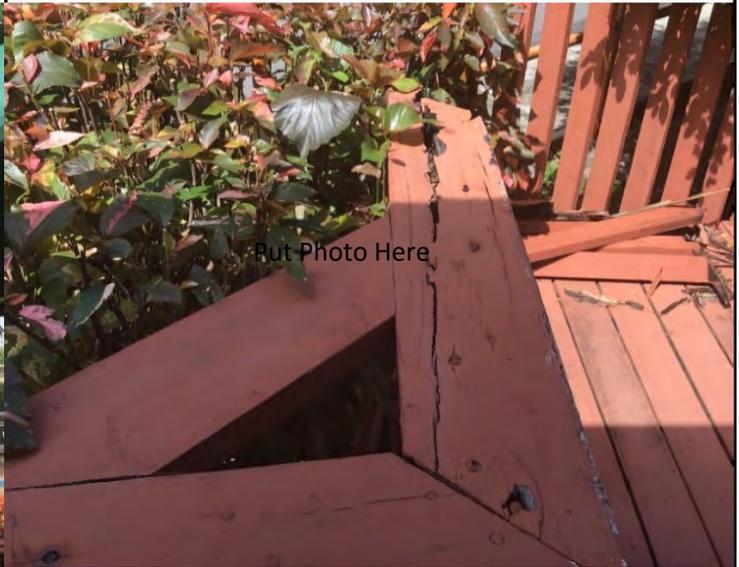
<b>Damage Description:</b>	<b>Item #:</b> 20
Wooden Deck Railing, 3 FT tall, with 2 IN x 4 IN top rail and angled balustrades spaced at 6 IN on-center, painted, broken components, caused by high winds (Main Bldg., Exterior, Wooden Patio Deck)	
<b>Additional Comments:</b>

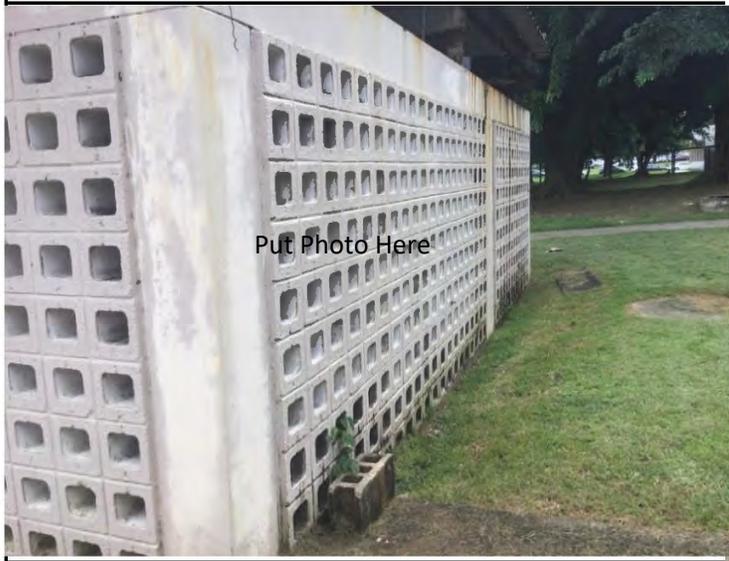
<b>Damage Description:</b>	<b>Item #:</b> 27
Wall, ¼ IN thick plaster on concrete, painted, peeling paint caused, by wind-driven rain (Main Bldg., Exterior, Generator Shed Area)	
<b>Additional Comments:</b>

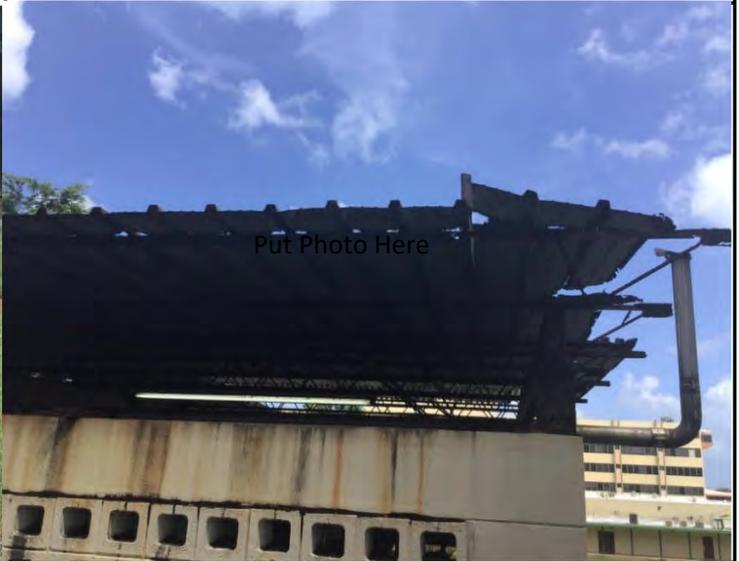
<b>Damage Description:</b>	<b>Item #:</b> 26
Roof, Ribbed metal roofing, 26-gauge, galvanized, broken components. caused by high winds (Main Bldg., Exterior, Generator Shed Area)	
<b>Additional Comments:</b>
