<b>Applicant:</b> Universidad Central Del Caribe, Inc.	<b>Damage Inventory:</b> 305240	<b>Category:</b> E
<b>WO #</b> 46525 <b>FIPS#</b> 021-UNUGB-00	<b>Date:</b> 09/04-17/2019 <b>GPS:</b> 18.365953, -66.153767	
<b>Inspector:</b> Gregory Sondergeld / Alexander Nieves	<b>Damage Facility:</b> Main Building

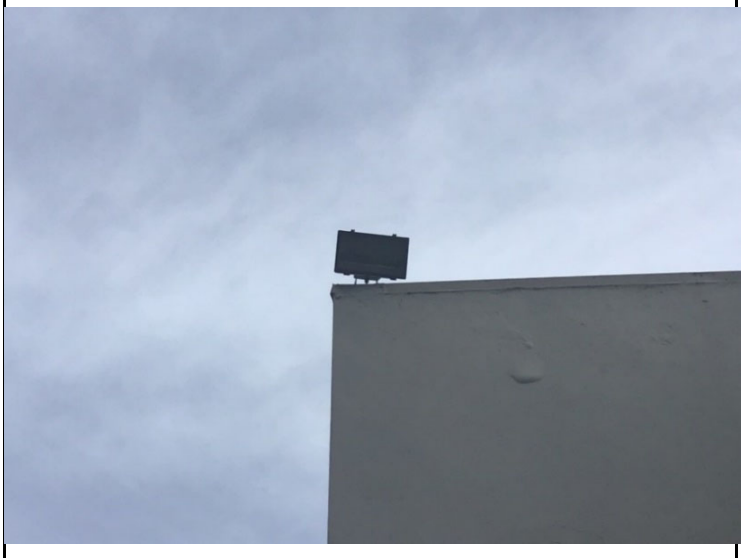
Damage Description:	Item #:	Damage Description:	Item #:
			10
<b>Additional Comments:</b>		Lighting, Parking lot luminaire, roof-mounted, single, 240/277-Volt, 400-Watt, metal halide bulbs, broken components caused by wind-blown debris (Main Bldg., Exterior, Wall)	
		<b>Additional Comments:</b>
