Applicant: Universidad Central Del Caribe, Inc.	Damage Inventory: 305240	Category: E
WO # 46525 FIPS# 021-UNUGB-00	Date: 09/04-17/2019 GPS: 18.365953, -66.153767	
Inspector: Gregory Sondergeld / Alexander Nieves	Damage Facility: Main Bldg.

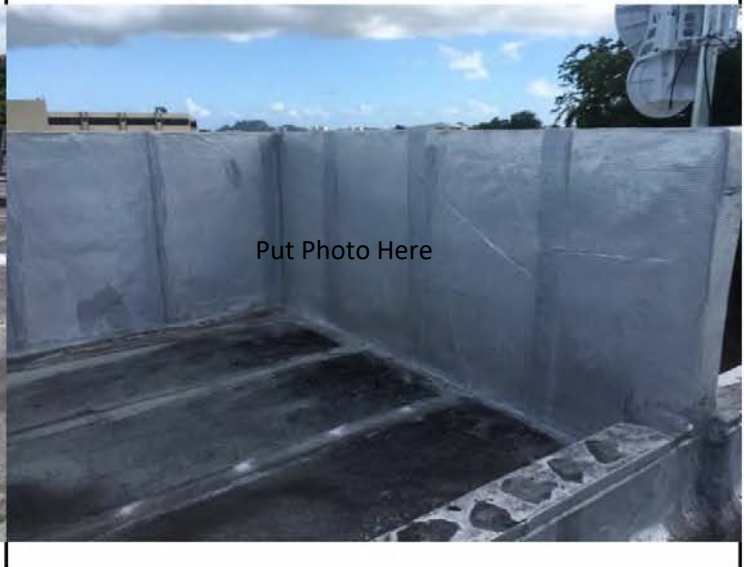
Damage Description:	Item #: 2
Roof, Flashing, Parapet North Wall, deformed, caused by wind-driven rain (Main Bldg., Roof)	
Additional Comments:

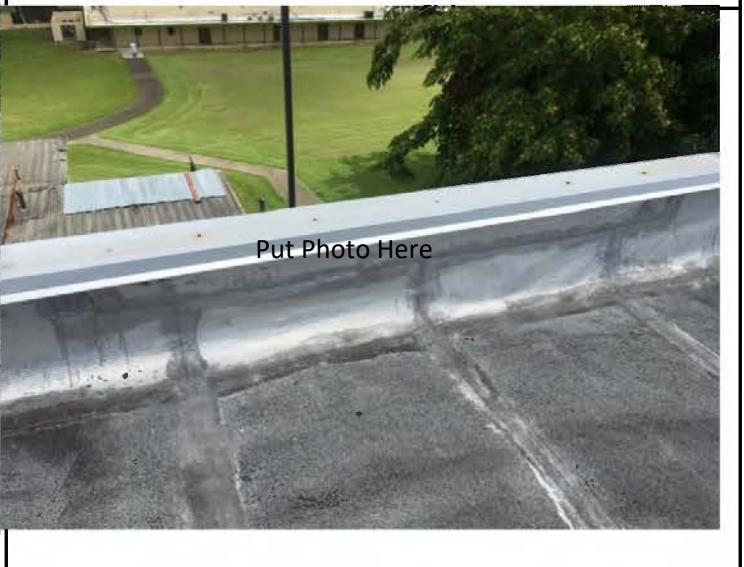
Damage Description:	Item #: 4
Roof, Flashing, Parapet Wall Cap, deformed, caused by wind-driven rain (Main Bldg., Roof)	
Additional Comments:

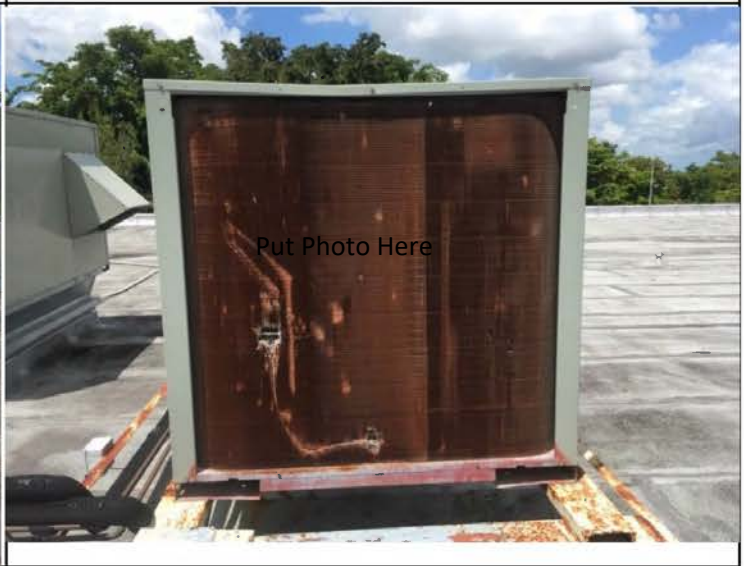
Damage Description:	Item #: 5	Damage Description:	Item #: 6
Air Conditioning, 15 Ton Package Unit, blown covers, caused by high winds (Main Bldg., Roof)		Air Conditioning, 15 Ton Package Unit, broken condenser fins, enclosure deformed, caused by wind-blown debris (Main Bldg., Roof)	
Additional Comments: Water infiltrated to the A/C ducts through the space created by blown covers Model # TCD180F400BA Serial # 120210113D		Additional Comments: Model # TTA180E400AA Serial # 14073LONTA

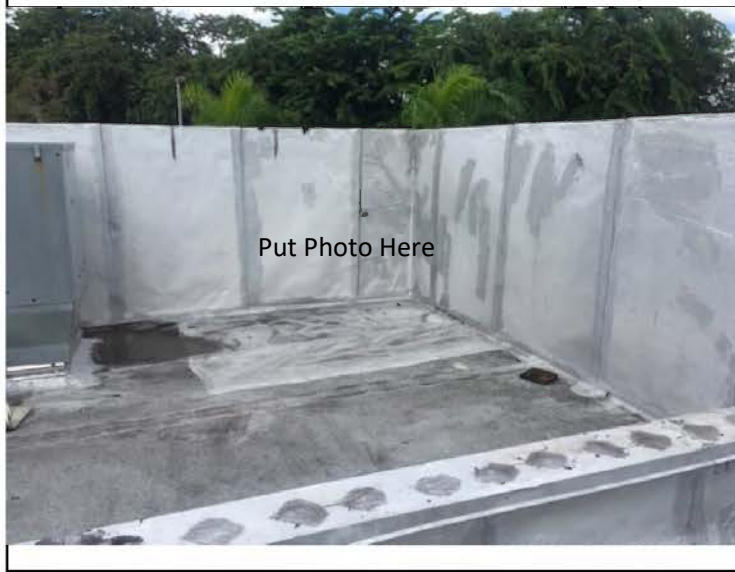
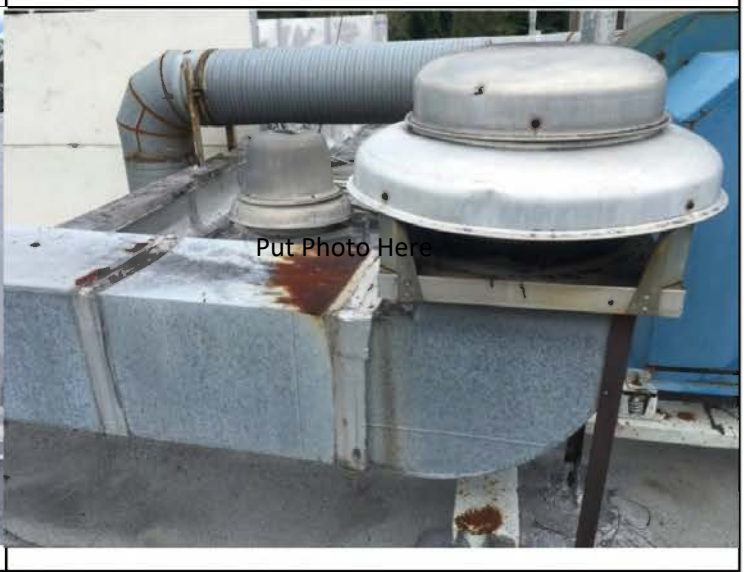
Damage Description:	Item #: 7 Roof,	Damage Description:	Item #: 8
Flashing, Parapet South Wall, deformed, caused by wind-driven rain (Main Bldg., Roof)		Exhaust Fan, 2 FT Dia, Kitchen Area, electrical issues, caused by high winds (Main Bldg., Roof)	
Additional Comments:		Additional Comments:

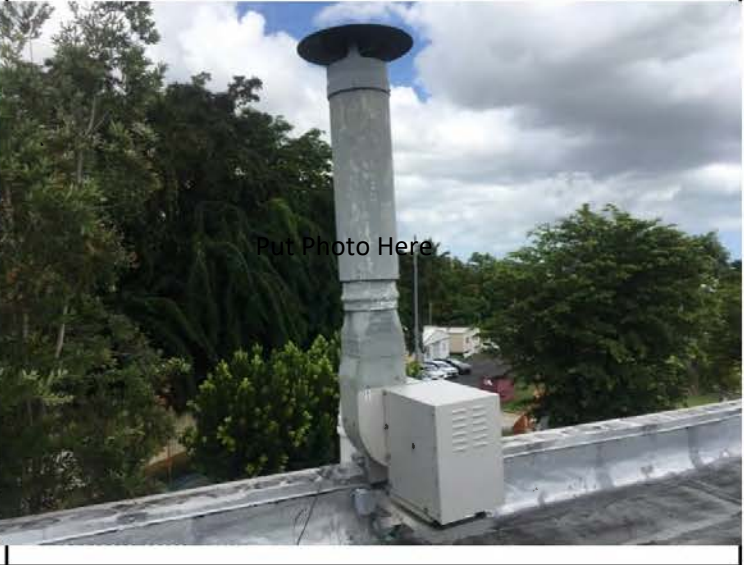
Damage Description:	Item #:	10
Exhaust Fan, 1 FT Dia. with Motor, Laboratory Area, broken components, caused by high winds (Main Bldg., Roof)		
Additional Comments:

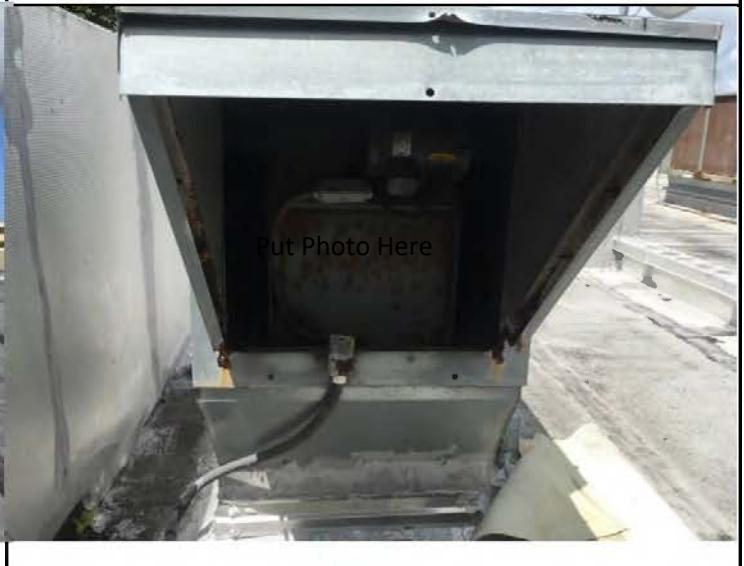
Damage Description:	Item #:	12
Air Extractor Grille, 24 IN x 36 IN, Stairs Area, broken components, caused by high winds (Main Bldg., Roof)		
Additional Comments:

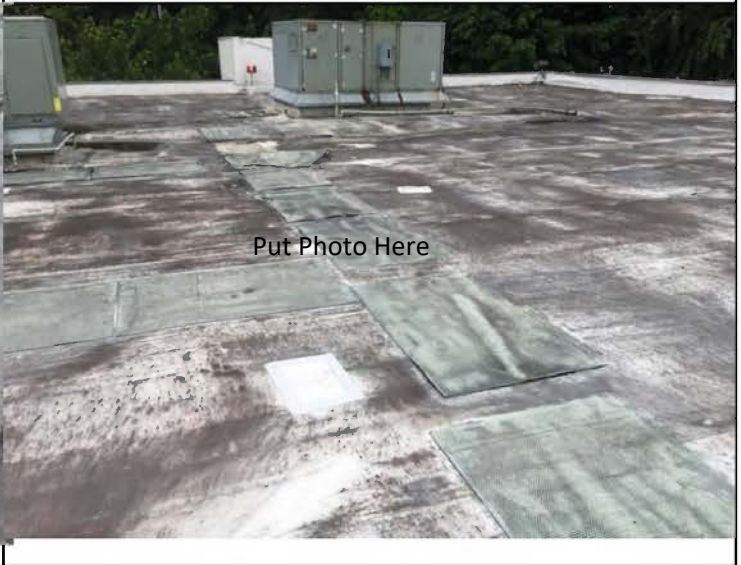
Damage Description:	Item #: 14
Roof, PVC roofing membrane, 2-ply, 45-mil, polyethylene thermoplastic elastomeric, hot-air seam welded with field-fasteners, deformed, caused by wind-driven rainwater intrusion (Main Bldg., Roof)	
Additional Comments:

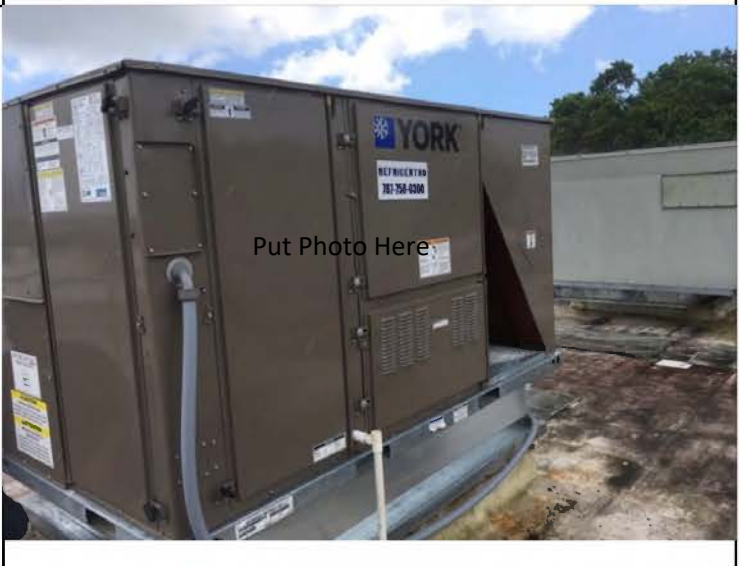
Damage Description:	Item #: 16
Conditioning, 10-Ton Package Unit, broken components, completely damaged, caused by high winds (Main Bldg., Roof)	
Additional Comments: Shown in the photo is the replaced unit Model XP120C00Y4A1BAA1A1 Serial # N1F9013862

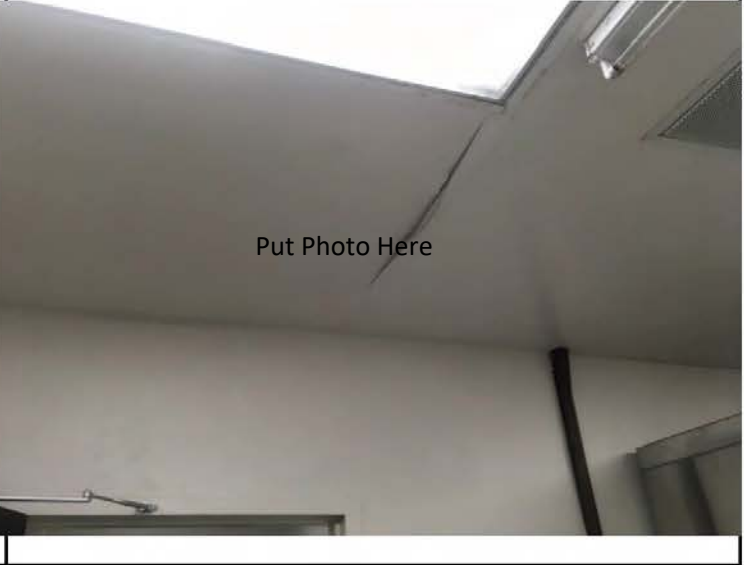
Damage Description:	Item #: 18
Ceiling, drywall, repair, cracked, caused by rainwater intrusion (Main Bldg., Floor 2, Laboratory R181)	
Additional Comments:

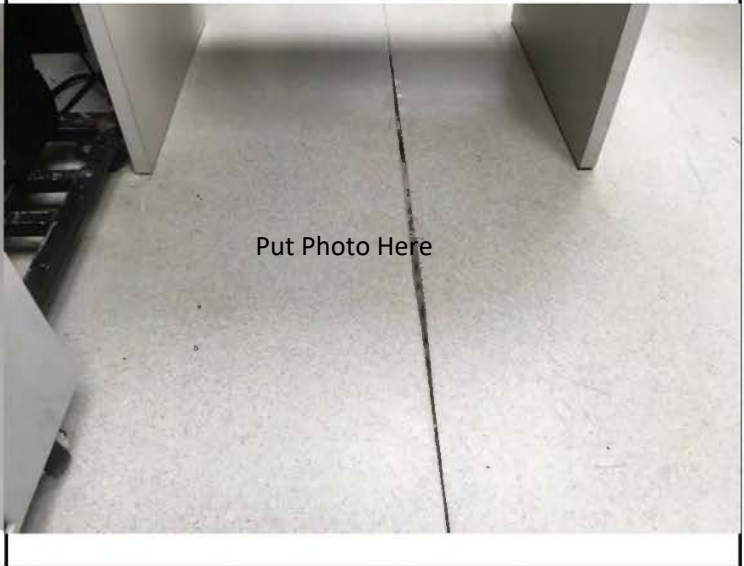
Damage Description:	Item #: 20
Floor, Linoleum, commercial-grade , dislodged, caused by rainwater intrusion (Main Bldg., Floor 2, Laboratory R181)	
Additional Comments:

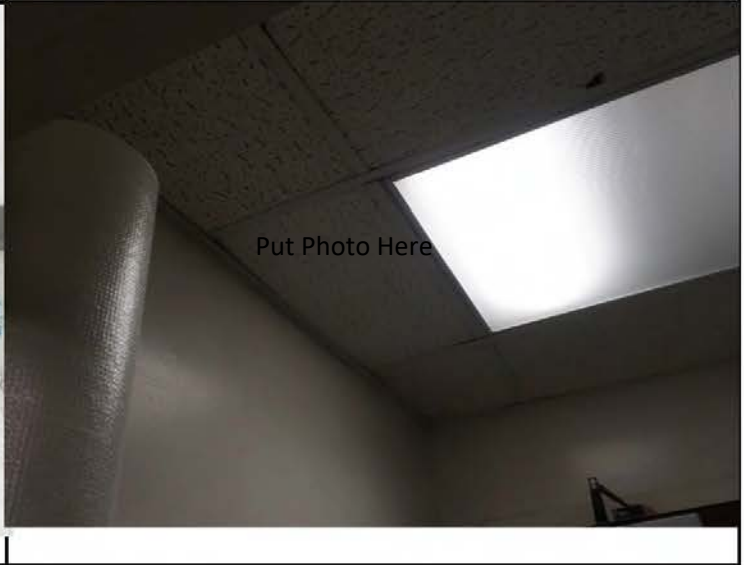
Damage Description:	Item #: 22
Ceiling, 2 FT x 2 FT acoustic tile, suspended, deformed, caused by rainwater intrusion (Main Bldg., Floor 2, Laboratory R133)	
Additional Comments:

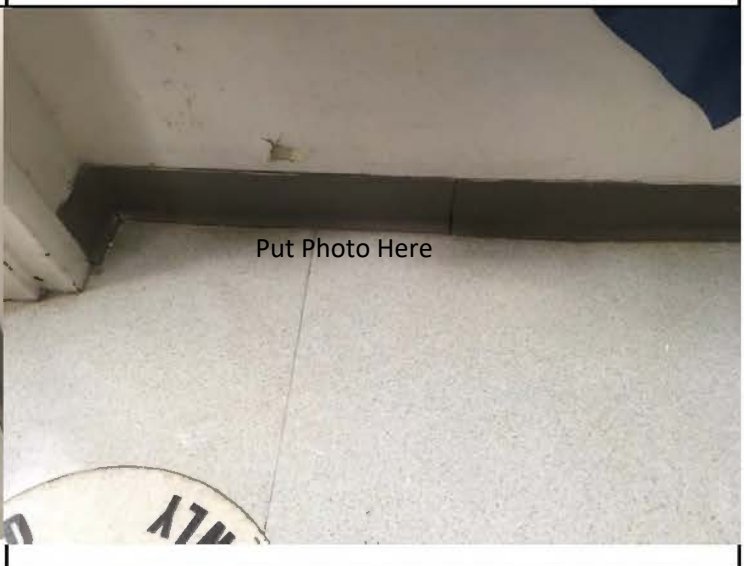
Damage Description:	Item #: 24
Base Lining, vinyl, 4 IN, deformed, caused by rainwater intrusion (Main Bldg., Floor 2, Laboratory R133)	
Additional Comments:

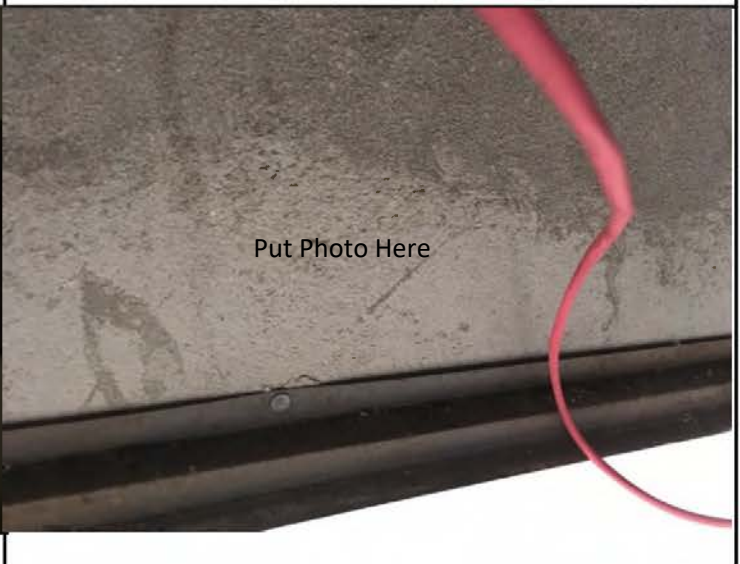
Damage Description:	Item #: 31	Damage Description:	Item #: 32
Window, Alum. window frames, perimeter caulking/sealing only, cracked, caused by rainwater intrusion (Main Bldg., Floor 2, Office R141)		Ceiling, 2 FT x 4 FT acoustic tile, suspended with grid, discolored, caused by rainwater intrusion (Main Bldg., Floor 2, Office)	
Additional Comments:		Additional Comments:

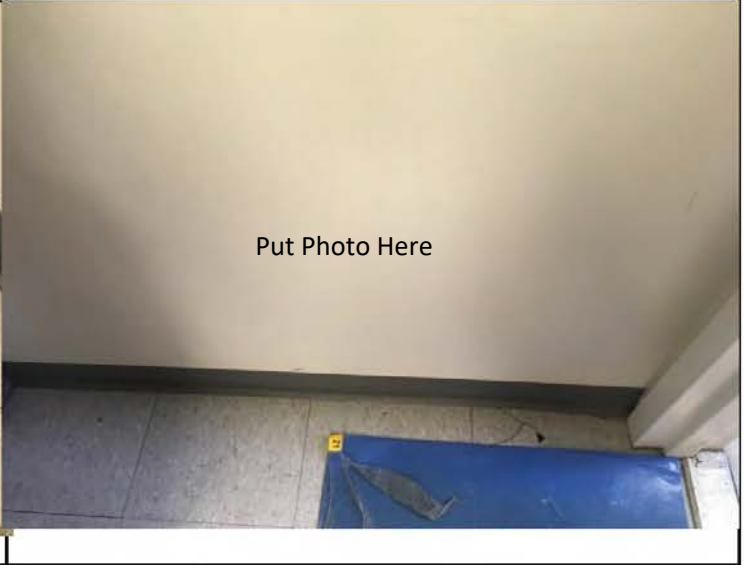
Damage Description:	Item #: 34
Base Lining, vinyl, 4 IN, detached, caused by surface water flooding (Main Bldg., Floor 2, Hallway R291)	
Additional Comments:

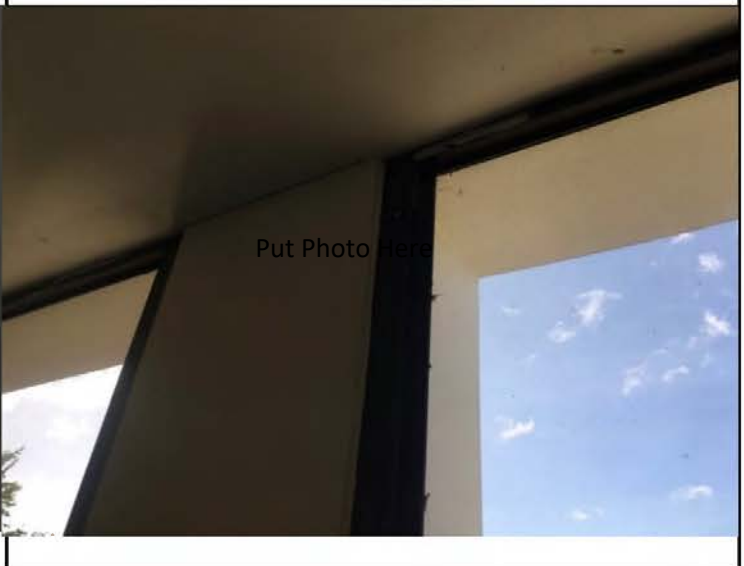
Damage Description:	Item #: 37
Window, Alum. window frames, perimeter caulking/sealing only, cracked, caused by wind-driven rain (Main Bldg., Floor 2, Laboratory R143)	
Additional Comments:

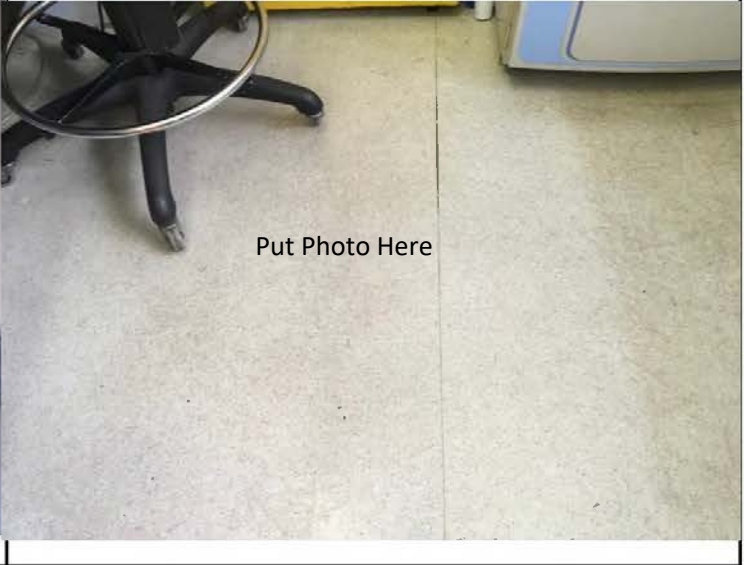
Damage Description:	Item #: 39
Floor, Linoleum, commercial-grade, detached, caused by surface water flooding (Main Bldg., Floor 2, Laboratory R143)	
Additional Comments:

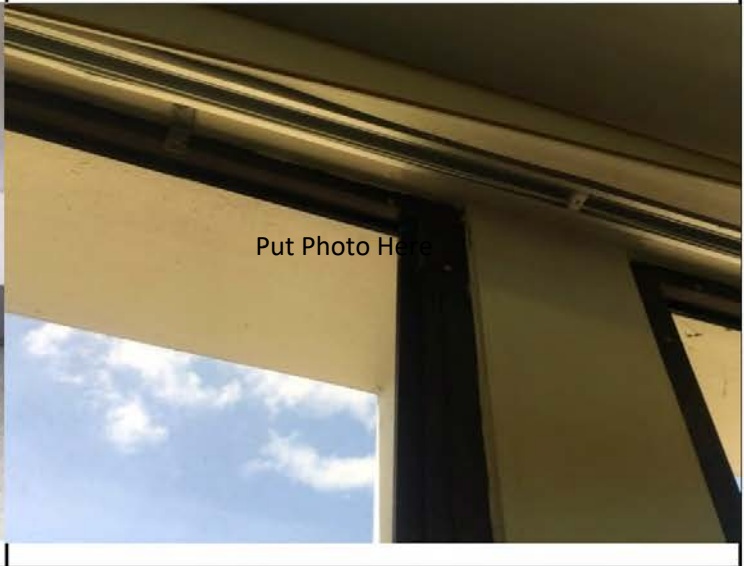
Damage Description:	Item #: 41
Window, Alum. window frames, perimeter caulking/sealing only, cracked, caused by wind-driven rain (Main Bldg., Floor 2, Laboratory R144)	
Additional Comments:

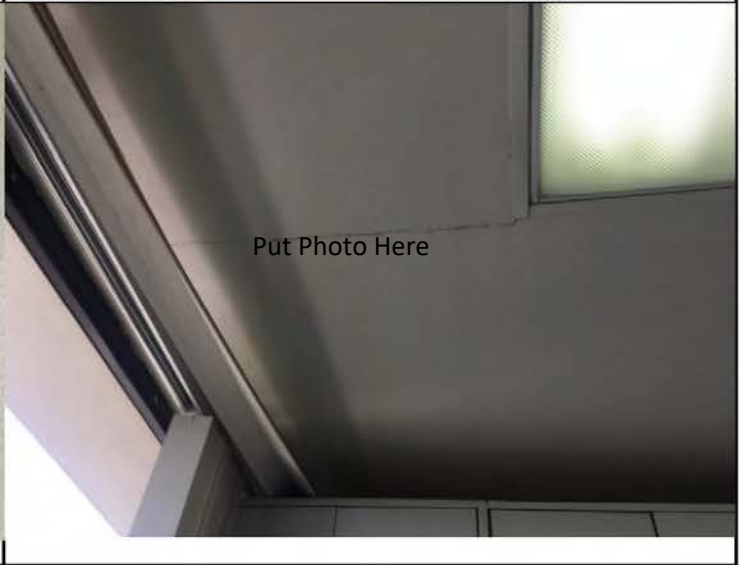
Damage Description:	Item #: 42	Damage Description:	Item #: 44
Floor, Linoleum, commercial-grade, detached, caused by rainwater intrusion (Main Bldg., Floor 2, Laboratory R144)		Ceiling, drywall, repair and paint, cracked, caused by rainwater intrusion (Main Bldg., Floor 2, Laboratory R144)	
Additional Comments:		Additional Comments:

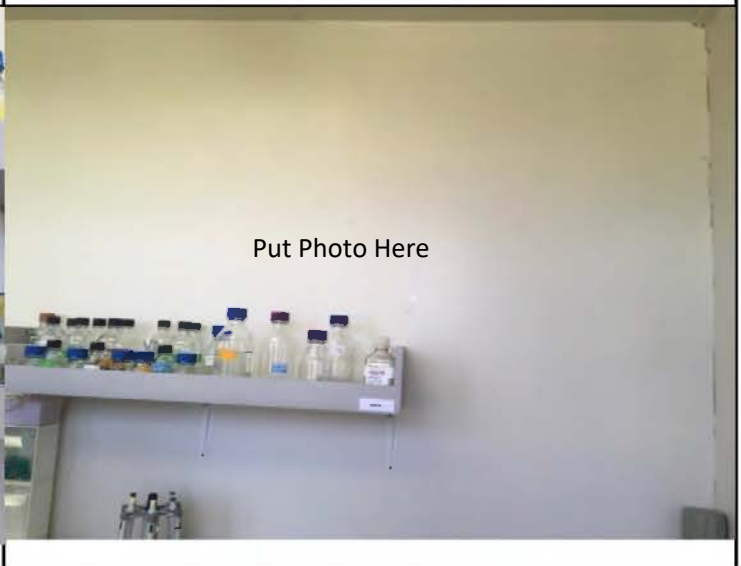
Damage Description:	Item #: 45	Damage Description:	Item #: 46
Wall, ¼ IN thick plaster on concrete, painted, with spalls, cracked, caused by rainwater intrusion (Main Bldg., Floor 2, Laboratory R144)		Wall, drywall, discolored, caused by rainwater intrusion (Main Bldg., Floor 2, Laboratory R144)	
Additional Comments:		Additional Comments:

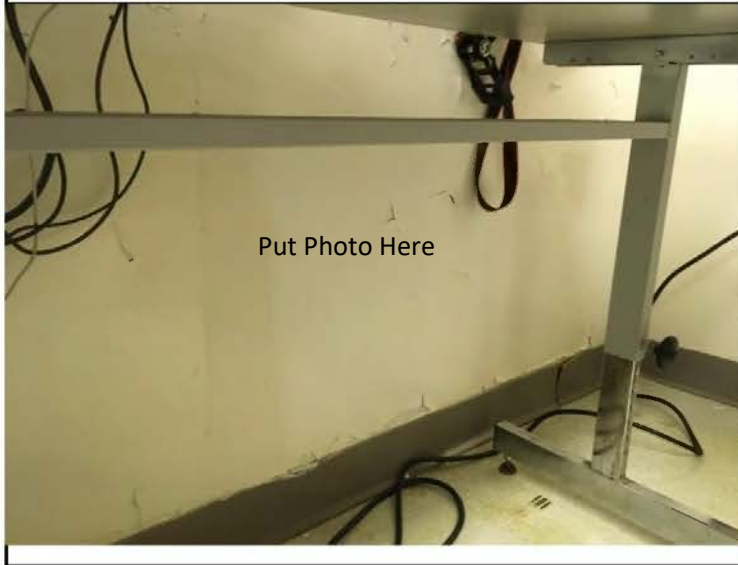
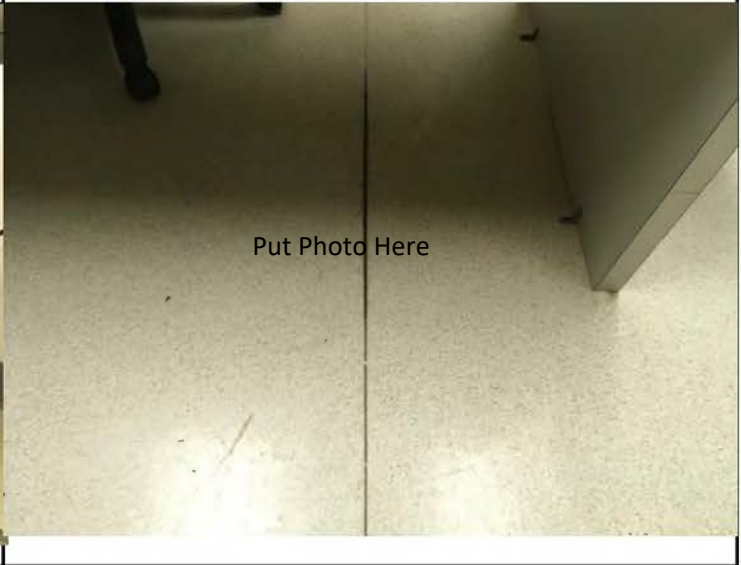
Damage Description:	Item #: 47	Damage Description:	Item #: 48
Wall, ¼ IN thick plaster on concrete, painted, with spalls, peeling paint, caused by rainwater intrusion (Main Bldg., Floor 2, Laboratory R541)		Floor, Linoleum, commercial-grade, detached, caused by rainwater intrusion (Main Bldg., Floor 2, Laboratory R541)	
Additional Comments:		Additional Comments:

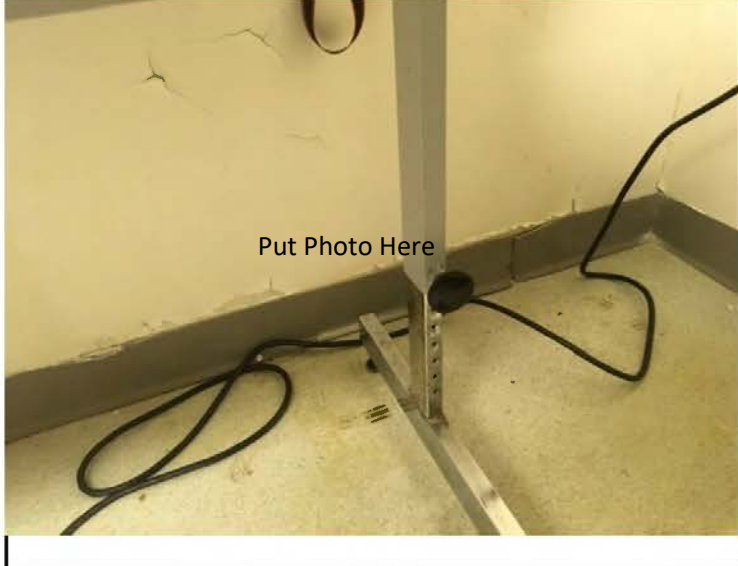
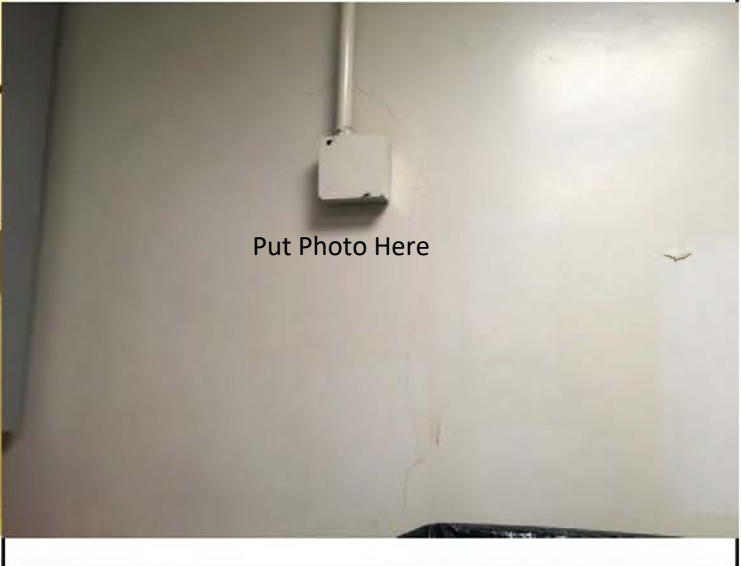
Damage Description:	Item #: 49	Damage Description:	Item #: 50
Base Lining, vinyl, 4 IN, detached, caused by rainwater intrusion (Main Bldg., Floor 2, Laboratory R541)		Wall, ¼ IN thick plaster on concrete, painted, with spalls, cracked, caused by rainwater intrusion (Main Bldg., Floor 2, Kitchen 145)	
Additional Comments:		Additional Comments:

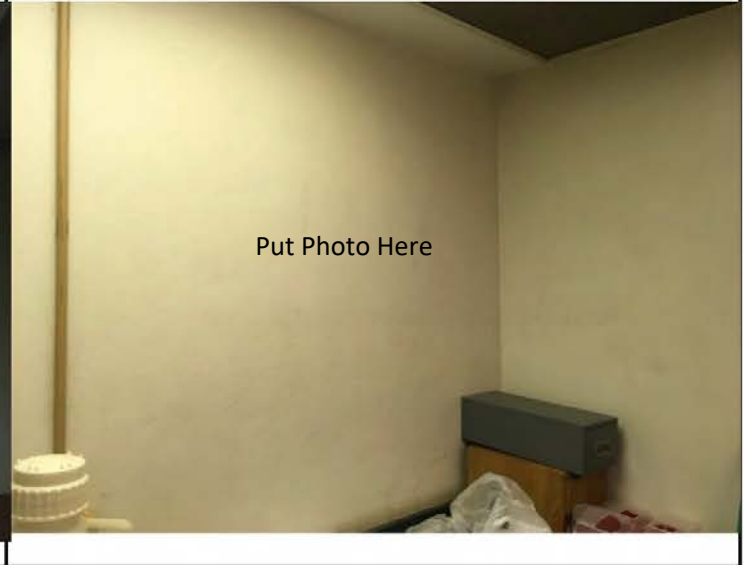
Damage Description:	Item #: 53
Wall, ¼ IN thick plaster on concrete, painted, discolored, caused by rainwater intrusion (Main Bldg., Floor 2, Office)	
Additional Comments:

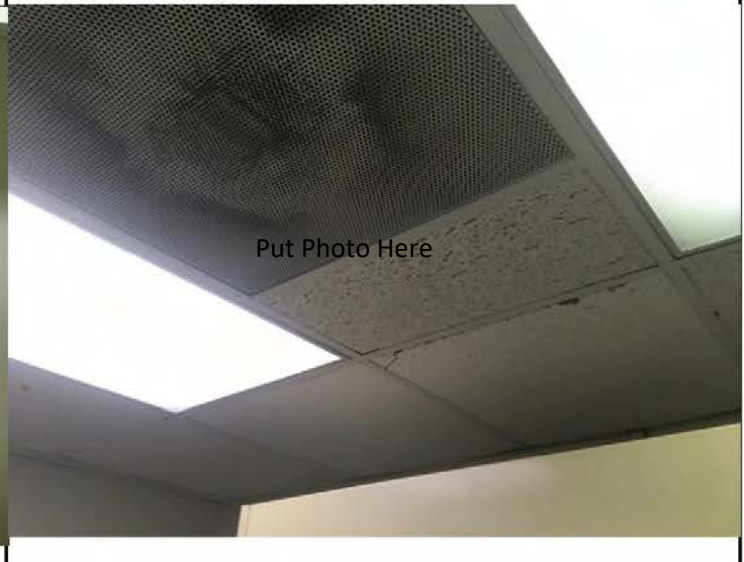
Damage Description:	Item #: 55
Ceiling, 2 FT x 2 FT acoustic tile, suspended with grid, deformed, caused by rainwater intrusion (Main Bldg., Floor 2, Laboratory R147)	
Additional Comments:

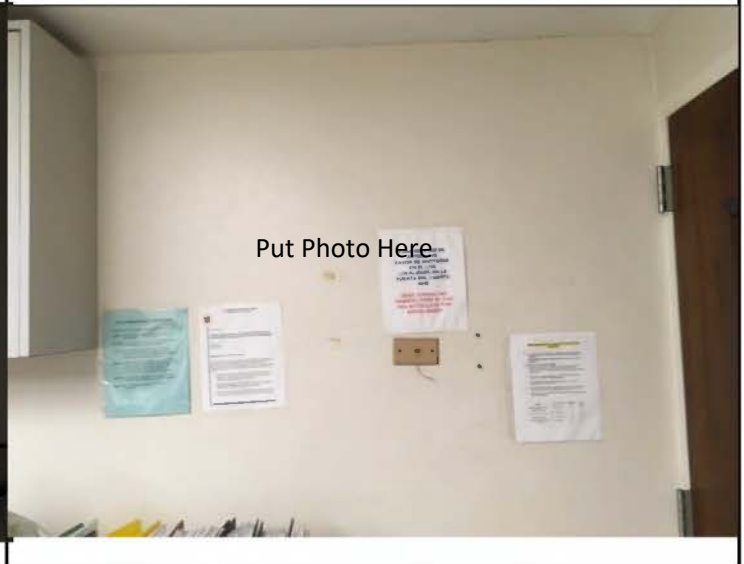
Damage Description:	Item #: 59
Wall, ¼ IN thick plaster on concrete, painted, discolored, caused by rainwater intrusion (Main Bldg., Floor 2, Laboratory R146)	
Additional Comments:

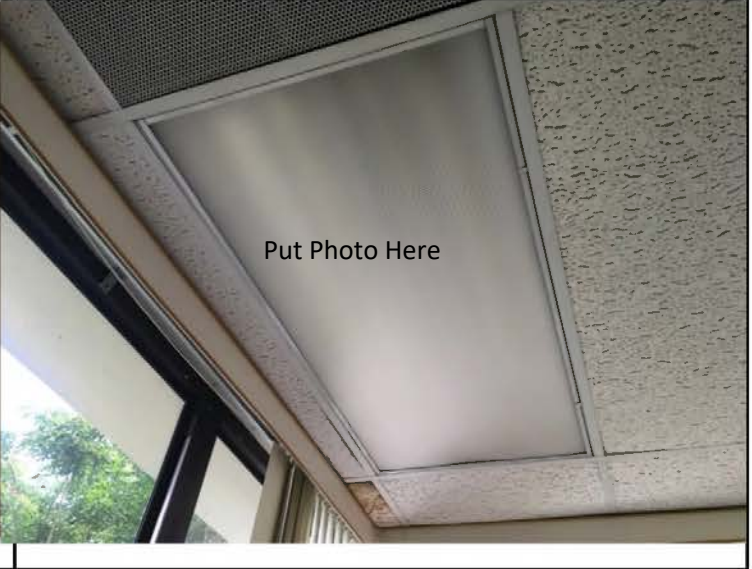
Damage Description:	Item #: 64	Damage Description:	Item #: 65
Ceiling, 2 FT x 4 FT acoustic tile, suspended, deformed, caused by rainwater intrusion (Main Bldg., Floor 2, Office R119)		Light, fluorescent, recessed Troffer, electrical issues, caused by rainwater intrusion (Main Bldg., Floor 2, Office R119)	
Additional Comments:		Additional Comments:

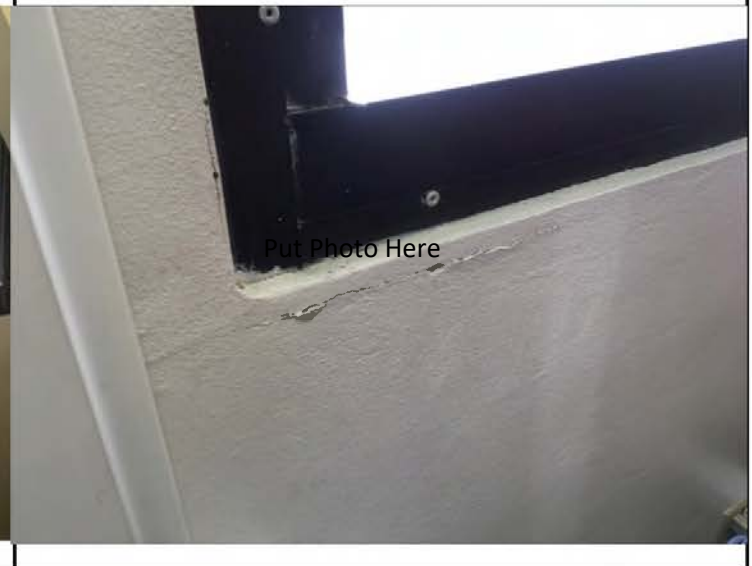
Damage Description:	Item #: 66	Damage Description:	Item #: 67
Window, Alum. window frames, perimeter caulking/sealing only, cracked, caused by rainwater intrusion (Main Bldg., Floor 2, Office R119)		Wall, ¼ IN thick plaster on concrete, painted, with spalls, cracked, caused by high winds (Main Bldg., Floor 2, Office R119)	
Additional Comments:		Additional Comments:

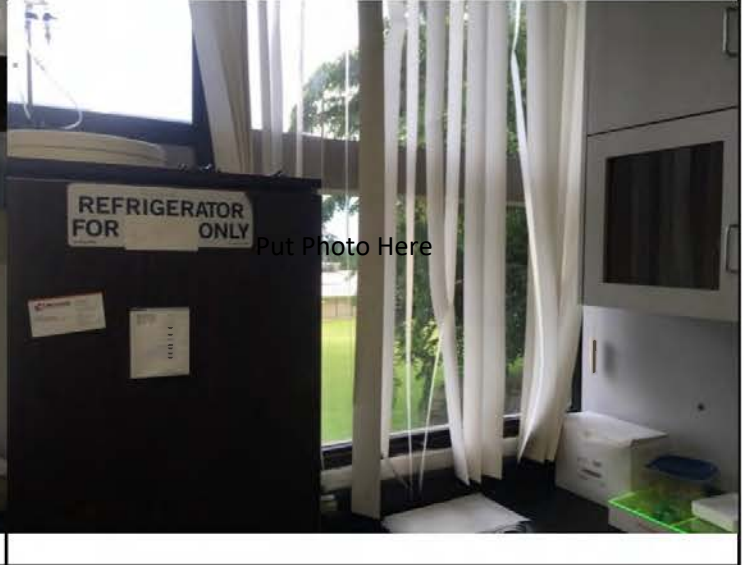
Damage Description:	Item #: 69
Window, Vertical Window Blind, 3.5 IN blades, deformed, caused by high winds (Main Bldg., Floor 2, Laboratory R122)	
Additional Comments:

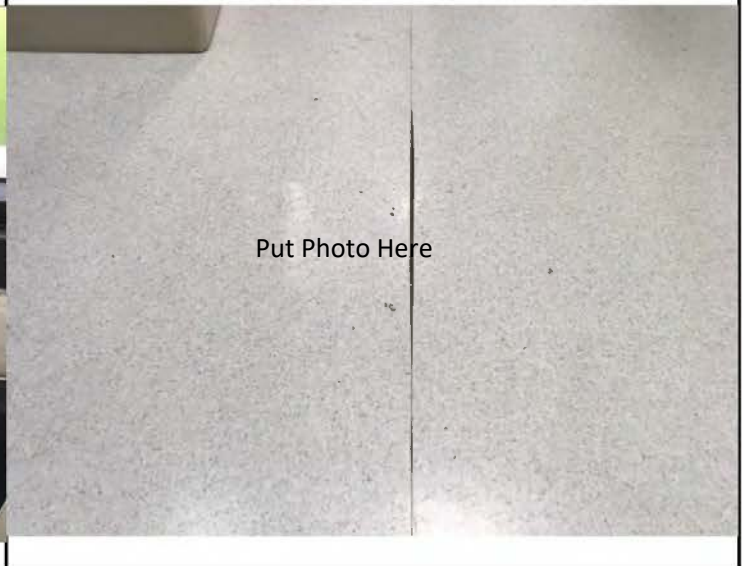
Damage Description:	Item #: 71
Floor, Linoleum, commercial-grade, dislodged, caused by surface water flooding (Main Bldg., Floor 2, Laboratory R122)	
Additional Comments:

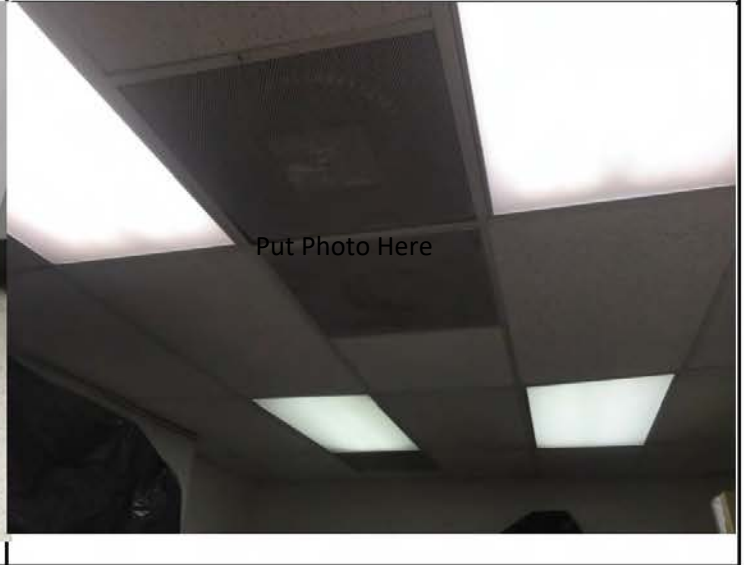
Damage Description:	Item #: 74
Ceiling, 2 FT x 4 FT acoustic tile, suspended, broken components, caused by rainwater intrusion (Main Bldg., Floor 2, Laboratory R120)	
Additional Comments:

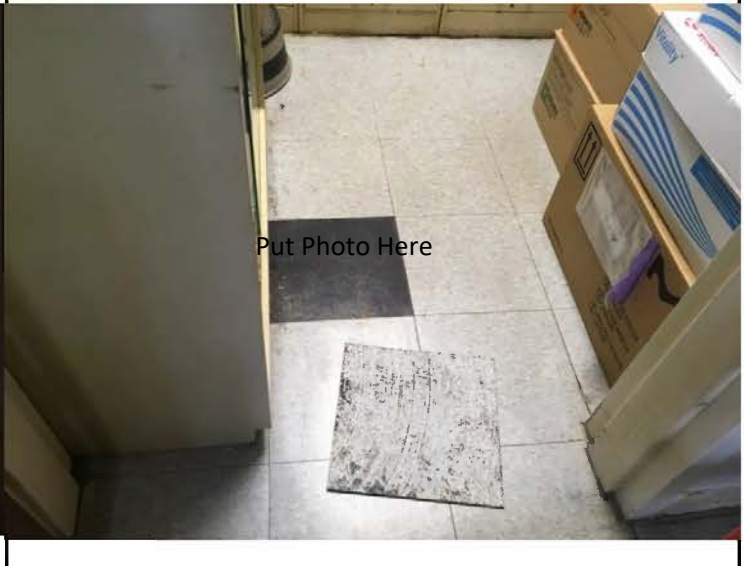
Damage Description:	Item #: 76
Floor, VCT, 12x12 IN, dislodged, caused by surface water flooding (Main Bldg., Floor 2, Hallway)	
Additional Comments:

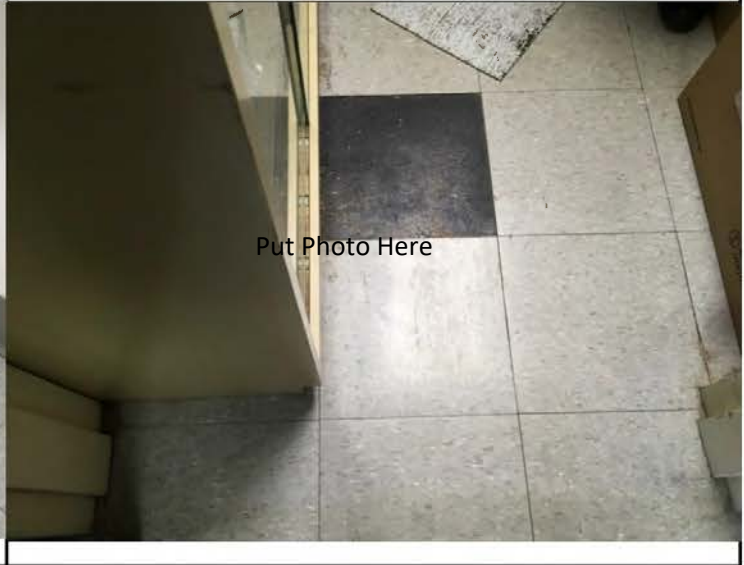
Damage Description:	Item #: 78
Floor, VCT, 12x12 IN, dislodged, caused by surface water flooding (Main Bldg., Floor 2, Storage Room R121)	
Additional Comments:

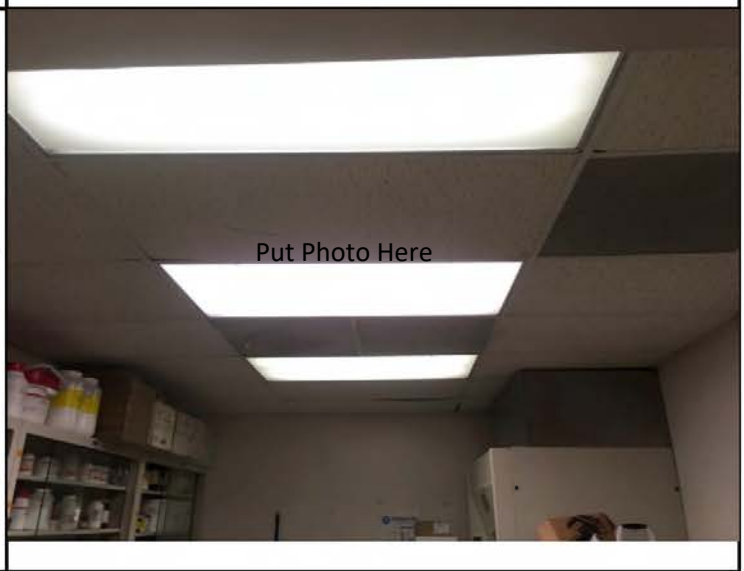
Damage Description:	Item #: 82
Ceiling, 2 FT x 4 FT acoustic tile, suspended with grid, broken components, caused by rainwater intrusion (Main Bldg., Floor 2, Laboratory R386)	
Additional Comments:

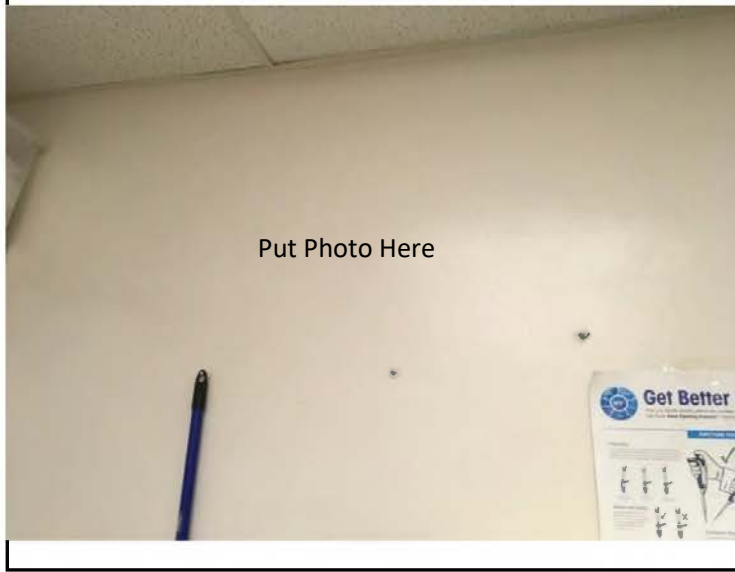
Damage Description:	Item #: 83
Wall, ¼ IN thick plaster on concrete, painted, discolored, caused by rainwater intrusion (Main Bldg., Floor 2, Laboratory R386)	
Additional Comments:

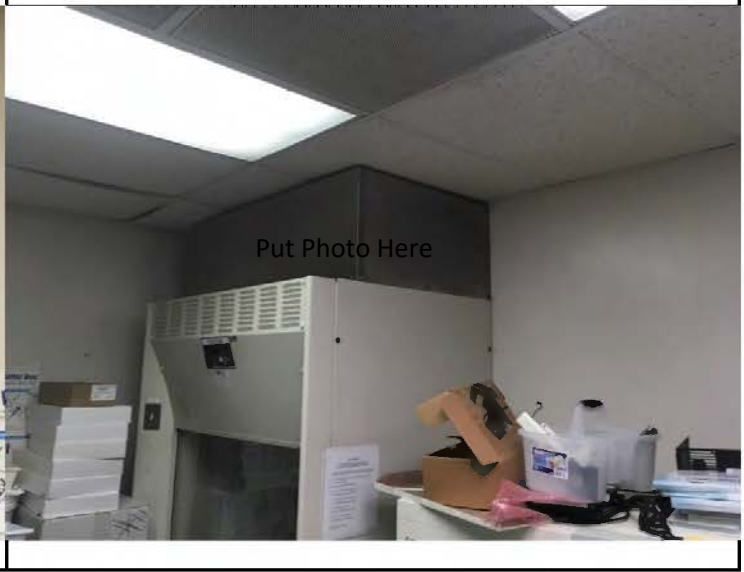
Damage Description:	Item #: 84
Fixed Laboratory Equipment, Metal Exhaust Fume Hood, electrical issues, caused by rainwater intrusion (Main Bldg., Floor 2, Laboratory R386)	
Additional Comments:

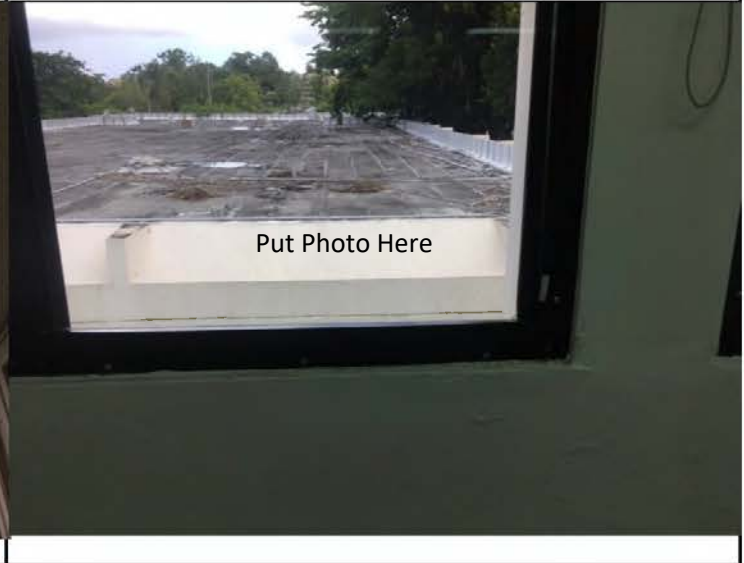
Damage Description:	Item #: 87	Damage Description:	Item #: 88
Ceiling, 2 FT x 4 FT acoustic tile, suspended, deformed, caused by rainwater intrusion (Main Bldg., Floor 2, Laboratory R386)		Window, Alum. window frames, perimeter caulking/sealing only, cracked, caused by wind-driven rain (Main Bldg., Floor 2, Laboratory R111)	
Additional Comments:		Additional Comments:

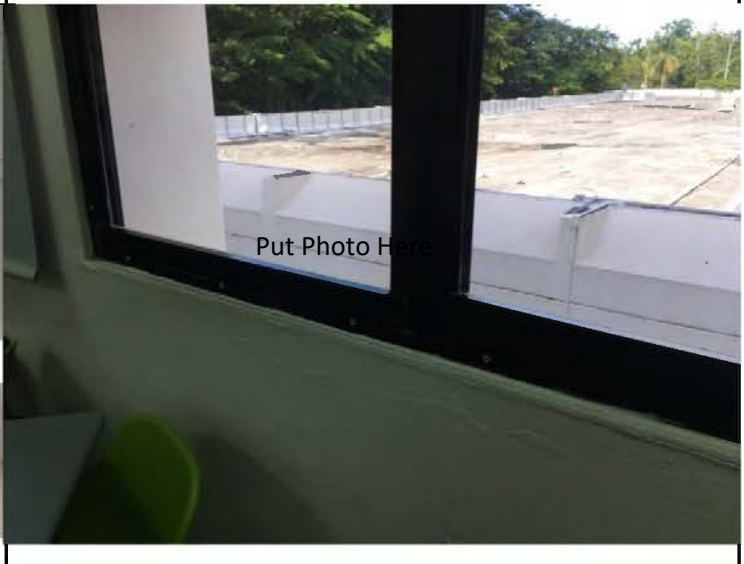
Damage Description:	Item #:	109	Damage Description:	Item #:	110
Ceiling, 2 FT x 4 FT acoustic tile, suspended, deformed, caused by rainwater intrusion (Main Bldg., Floor 2, Classroom R113)	Additional Comments:		Window, Alum. window frames, perimeter caulking/sealing only, cracked, caused by rainwater intrusion (Main Bldg., Floor 2, Classroom R113)	Additional Comments:

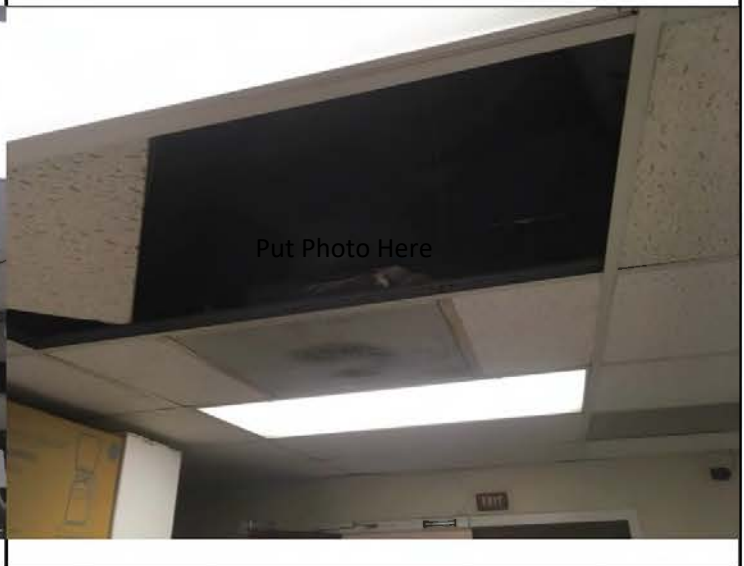
Damage Description:	Item #: 117	Damage Description:	Item #: 118
Ceiling, 2 FT x 4 FT acoustic tile, suspended, deformed, caused by rainwater intrusion (Main Bldg., Floor 2, Laboratory R167)		Ceiling, 2 FT x 4 FT acoustic tile, suspended, grid only, deformed, caused by rainwater intrusion (Main Bldg., Floor 2, Laboratory R167)	
Additional Comments:		Additional Comments:

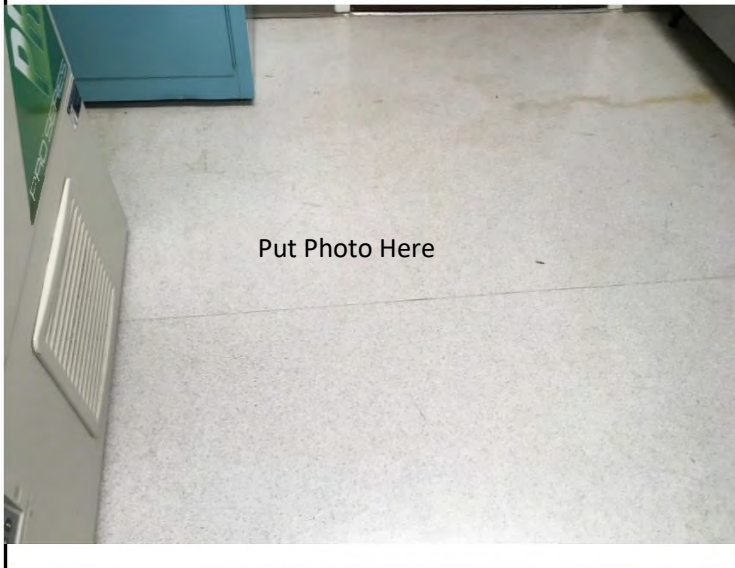
Damage Description:	Item #: 121
Floor, Linoleum, commercial-grade, dislodged, caused by surface water flooding (Main Bldg., Floor 2, Laboratory R167)	
Additional Comments:

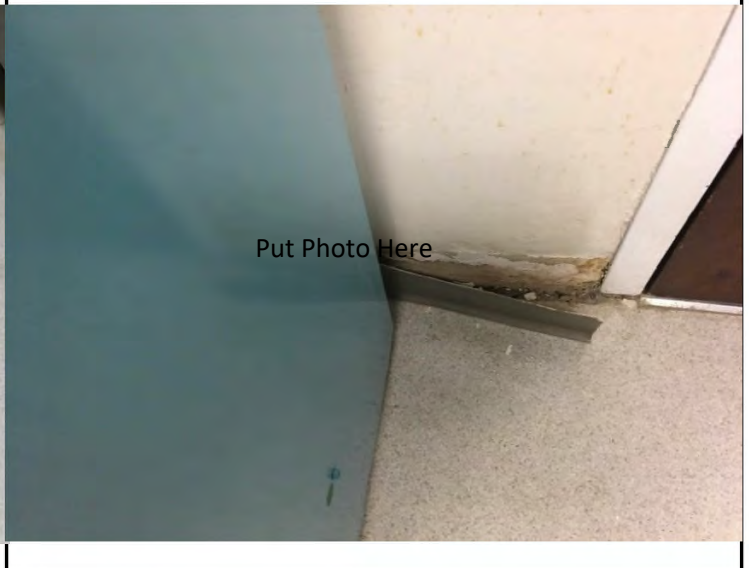
Damage Description:	Item #: 122
Base Lining, vinyl, 4 IN, dislodged, caused by surface water flooding (Main Bldg., Floor 2, Laboratory R167)	
Additional Comments:

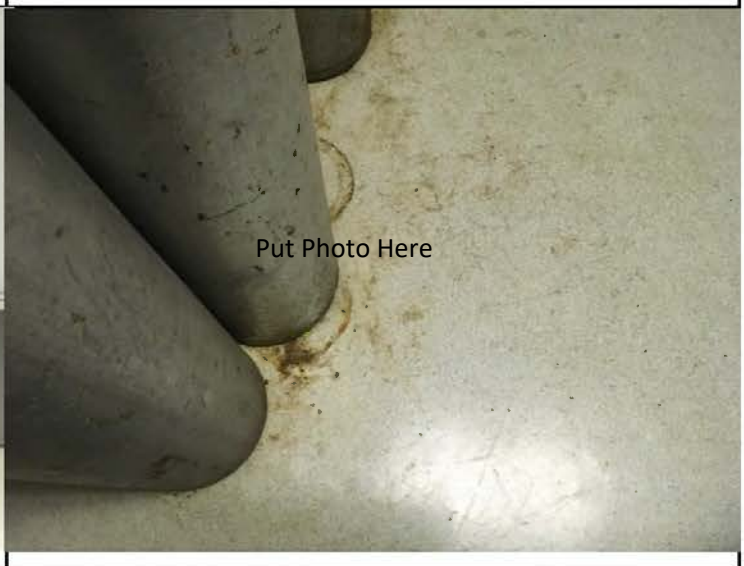
Damage Description:	Item #: 134	Damage Description:	Item #: 135
Ceiling, 2 FT x 4 FT acoustic tile, suspended, grid only, deformed, caused by rainwater intrusion (Main Bldg., Floor 2, Laboratory R168)		Floor, Linoleum, commercial-grade, dislodged, caused by surface water flooding (Main Bldg., Floor 2, Laboratory R168)	
Additional Comments:		Additional Comments:
