Applicant: Universidad Central Del Caribe, Inc.	Damage Inventory: 305240	Category: E
WO # 46525 FIPS# 021-UNUGB-00	Date: 09/04-17/2019 GPS: 18.365953, -66.153767	
Inspector: Gregory Sondergeld / Alexander Nieves	Damage Facility: Main Bldg.

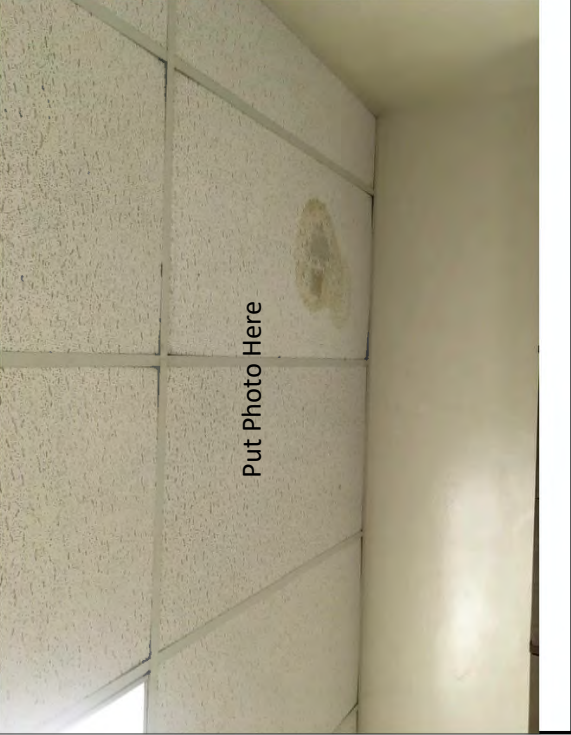
Damage Description:	Item #: 13
Ceiling, 2 FT x 4 FT acoustic tile, suspended, deformed, caused by rainwater intrusion (Main Bldg., Floor 2, Conference)	
Additional Comments:

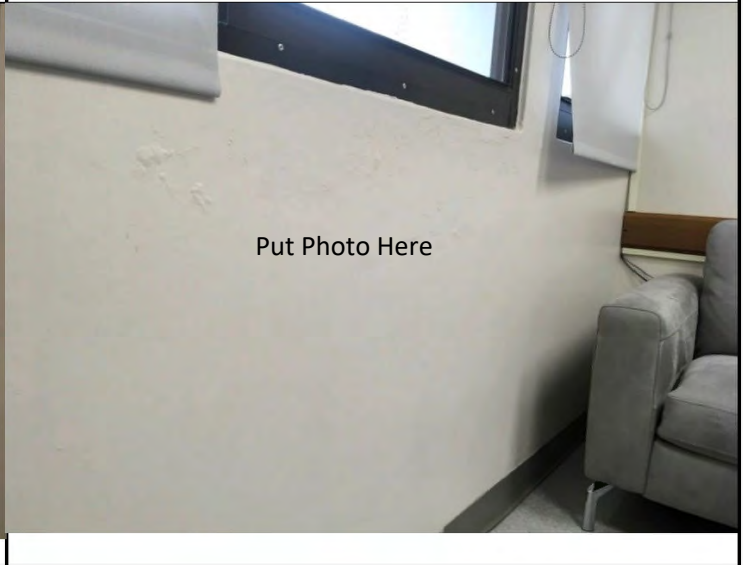
Damage Description:	Item #: 21
Wall, ¼ IN thick plaster on concrete, repair, cracked, caused by rainwater intrusion (Main Bldg., Floor 2, Office R223)	
Additional Comments:

Damage Description:	Item #: 22
Wall, ¼ IN thick plaster on concrete, painted, discolored, caused by rainwater intrusion (Main Bldg., Floor 2, Office R223)	
Additional Comments:

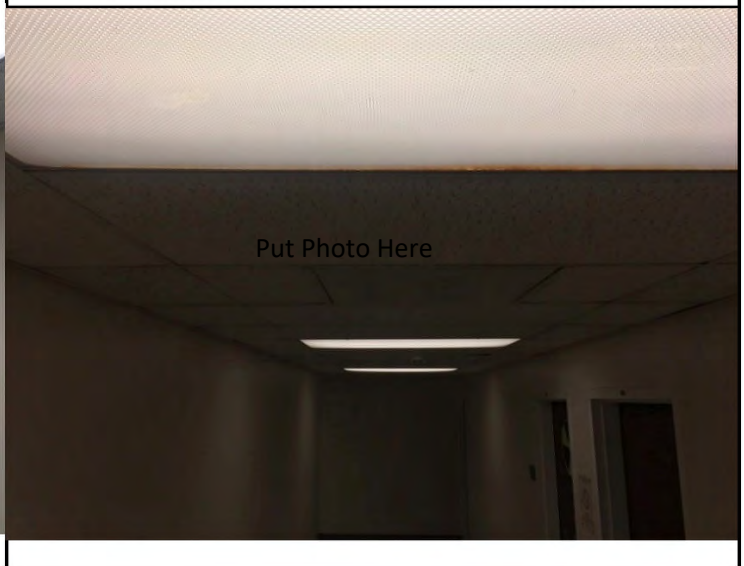
Damage Description:	Item #: 23
Ceiling, 2 FT x 4 FT acoustic tile, suspended, broken components, caused by rainwater intrusion (Main Bldg., Floor 2, Hallway)	
Additional Comments:

Damage Description:	Item #: 25
Light, fluorescent, recessed Troffer, electrical issues, caused by rainwater intrusion (Main Bldg., Floor 2, Hallway)	
Additional Comments:

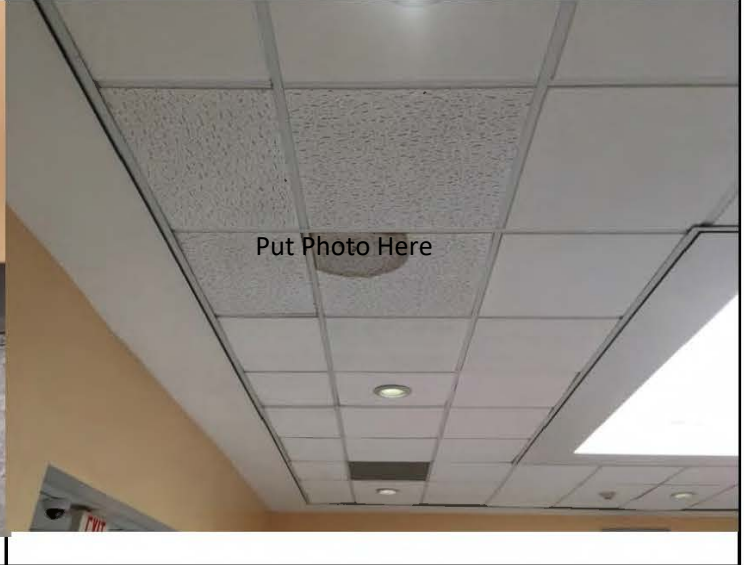
Damage Description:	Item #: 33
Base Lining, vinyl, 4 IN, dislodged, caused by surface water flooding (Main Bldg., Floor 2, Hallway Presidential Lobby)	
Additional Comments:

Damage Description:	Item #: 34
Ceiling, 2 FT x 2 FT acoustic tile, suspended, tegular, deformed, caused by rainwater intrusion (Main Bldg., Floor 2, Presidential Lobby)	
Additional Comments:

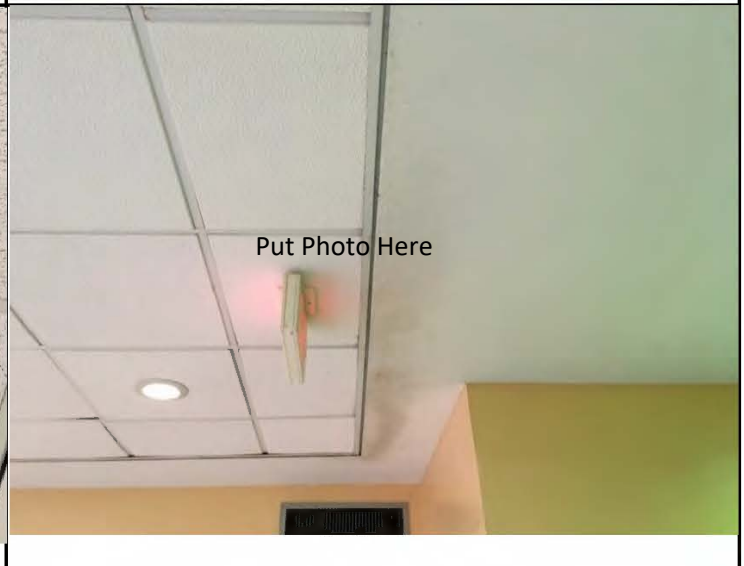
Damage Description:	Item #: 35
Ceiling, 2 FT x 2 FT acoustic tile, suspended, tegular, grid only, deformed, caused by rainwater intrusion (Main Bldg., Floor 2, Presidential Lobby)	
Additional Comments:

Damage Description:	Item #: 36
Ceiling, drywall, repair, discolored, caused by rainwater intrusion (Main Bldg., Floor 2, Presidential Lobby)	
Additional Comments:

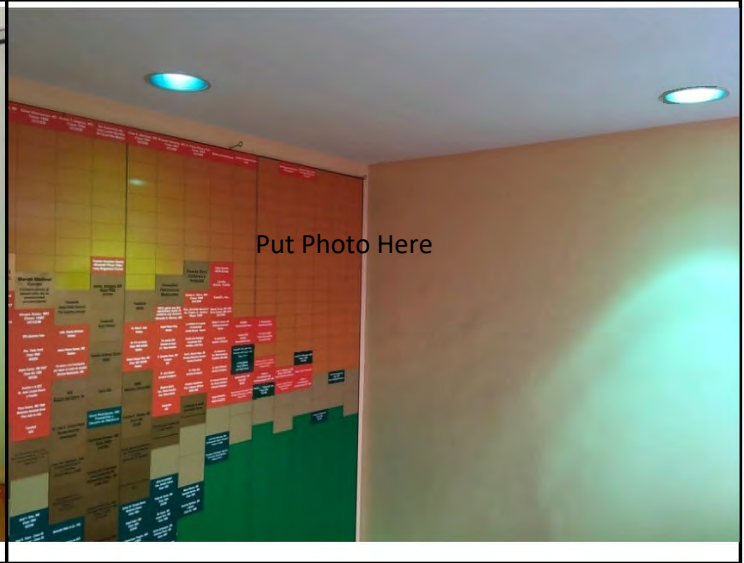
Damage Description:	Item #: 37	Damage Description:	Item #: 38
Ceiling, drywall, paint, discolored, caused by rainwater intrusion (Main Bldg., Floor 2, Presidential Lobby)		Wall, ¼ IN thick plaster on concrete, painted, discolored, caused by rainwater intrusion (Main Bldg., Floor 2, Stairway)	
Additional Comments:		Additional Comments:

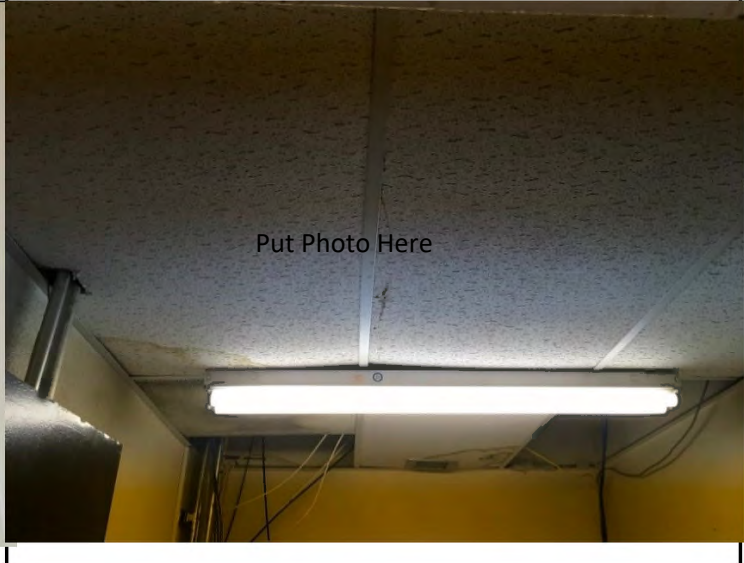
Damage Description:	Item #: 39	Damage Description:	Item #: 40
Wall, ¼ IN thick plaster on concrete, painted, discolored, caused by rainwater intrusion (Main Bldg., Floor 2, Presidential Lobby)		Ceiling, 2 FT x 4 FT acoustic tile, suspended, cracked, caused by rainwater intrusion (Main Bldg., Floor 2, Elevator Machine Room)	
Additional Comments:		Additional Comments:

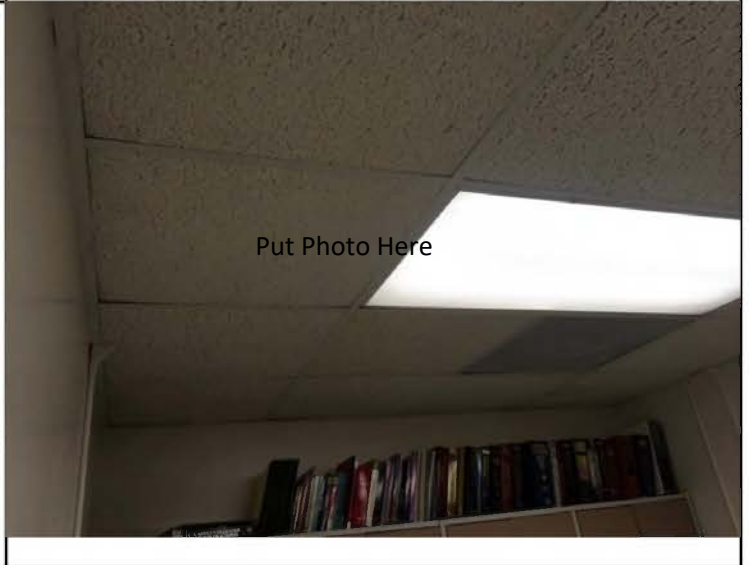
Damage Description: **Item #:** 41
 Building Interior, Elevator 340 at lobby, floor, 12 IN X 12 IN VCT, detached due to water infiltration (Main Bldg., Entire Building)

Damage Description: **Item #:** 42
 Ceiling, 2 FT x 4 FT acoustic tile, suspended, deformed, caused by rainwater intrusion (Main Bldg., Floor 2, Office R215)

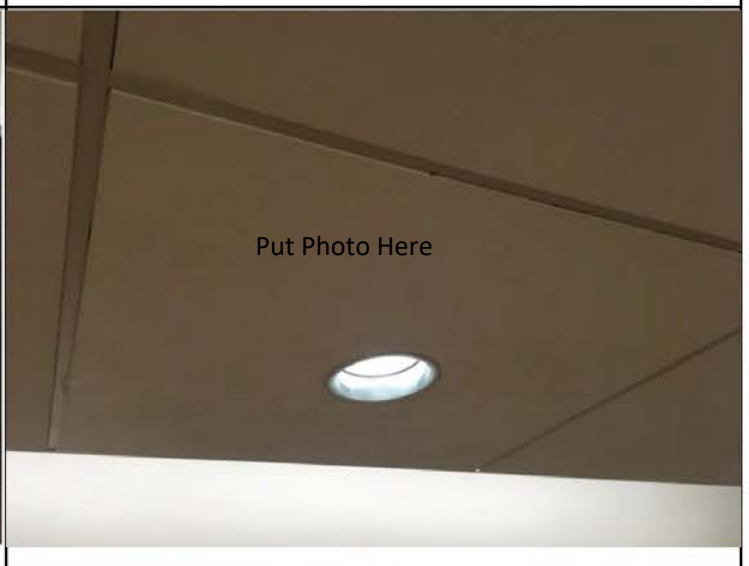
Damage Description: **Item #:** 43
 Wall, ¼ IN thick plaster on concrete, painted, discolored, caused by rainwater intrusion (Main Bldg., Floor 2, Office R215)

Damage Description: **Item #:** 44
 Ceiling, 4 FT x 4 FT acoustic tile, suspended, tegular, deformed, caused by rainwater intrusion (Main Bldg., Floor 2, Conference)

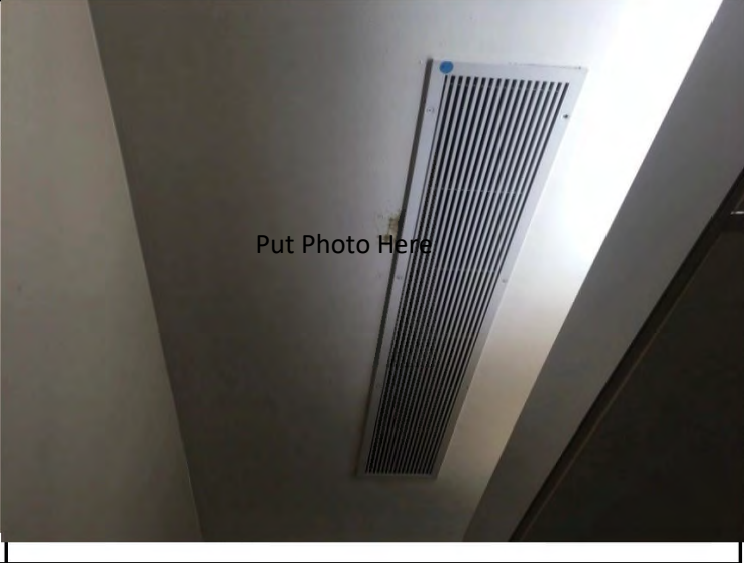
Damage Description:	Item #: 45	Damage Description:	Item #: 46
Wall, ¼ IN thick plaster on concrete, painted, discolored, caused by rainwater intrusion (Main Bldg., Floor 2, Conference)		Ceiling, drywall, repair and paint, dislodged, caused by rainwater intrusion (Main Bldg., Floor 2, Conference)	
Additional Comments:		Additional Comments:

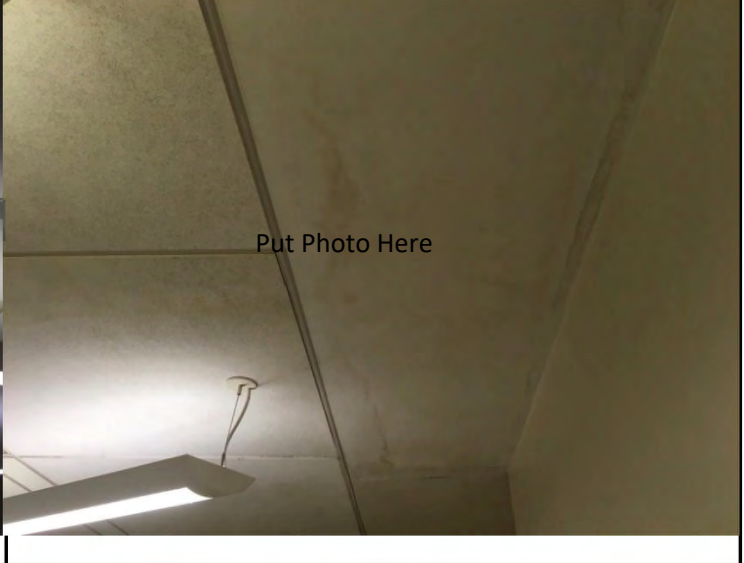
Damage Description:	Item #: 47	Damage Description:	Item #: 48
Ceiling, 4 FT x 4 FT acoustic tile, suspended, tegular, deformed, caused by rainwater intrusion (Main Bldg., Floor 2, Classroom R542)		Wall, drywall, repair, deformed, caused by rainwater intrusion (Main Bldg., Floor 2, Classroom R542)	
Additional Comments:		Additional Comments:

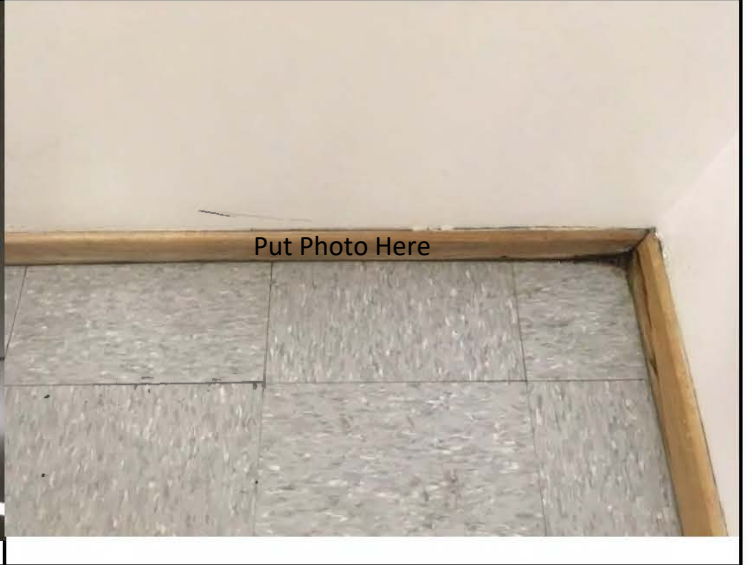
Damage Description:	Item #: 49	Damage Description:	Item #: 50
Ceiling, drywall, paint, discolored, caused by rainwater intrusion (Main Bldg., Floor 2, Classroom R542)		Base Lining, Base molding, wood, 2 5/8 IN x 1/2 IN, stained and urethane-finished, dislodged, caused by rainwater intrusion (Main Bldg., Floor 2, Classroom R542)	
Additional Comments:		Additional Comments:

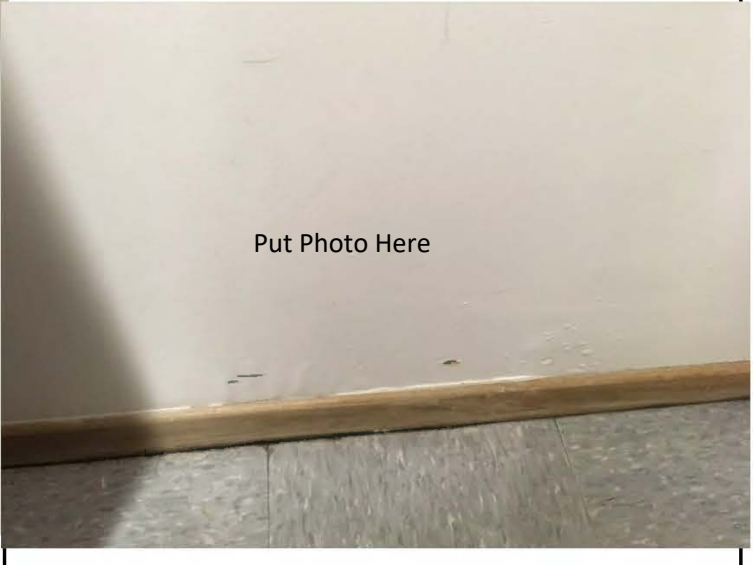
Damage Description:	Item #: 51	Damage Description:	Item #: 52
Wall, drywall, paint, discolored, caused by rainwater intrusion (Main Bldg., Floor 2, Classroom R542)		Wall, drywall, repair, deformed, caused by rainwater intrusion (Main Bldg., Floor 2, Classroom R542)	
Additional Comments:		Additional Comments:

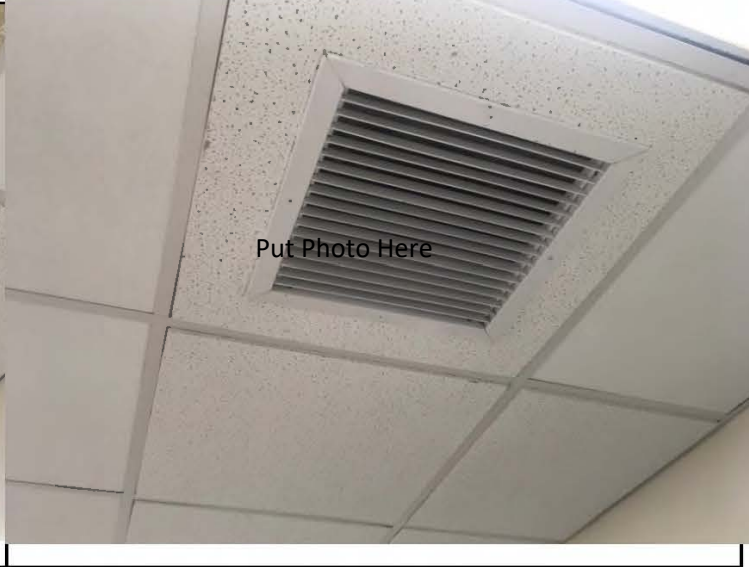
Damage Description:	Item #: 57
Light, fluorescent, recessed Troffer, electrical issues, caused by rainwater intrusion (Main Bldg., Floor 2, Office R544)	
Additional Comments:

Damage Description:	Item #: 58
HVAC return grill, ceiling-mounted, aluminum, bladed, 16 IN x 16 IN, dislodged, caused by rainwater intrusion (Main Bldg., Floor 2, Office R544)	
Additional Comments:

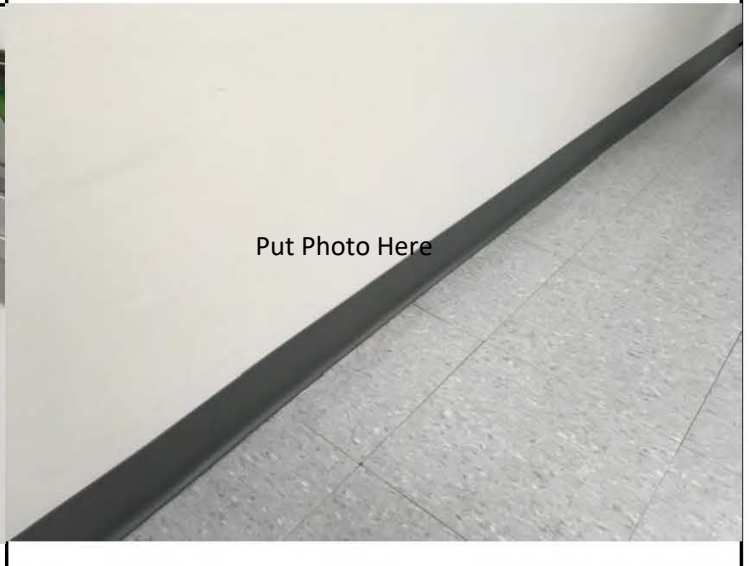
Damage Description:	Item #: 59 Wall,
drywall, painted, deformed, caused by rainwater intrusion (Main Bldg., Floor 1, Library R231)	
Additional Comments:

Damage Description:	Item #: 60
Base Lining, vinyl, 4 IN, deformed, caused by rainwater intrusion (Main Bldg., Floor 1, Library R231)	
Additional Comments:

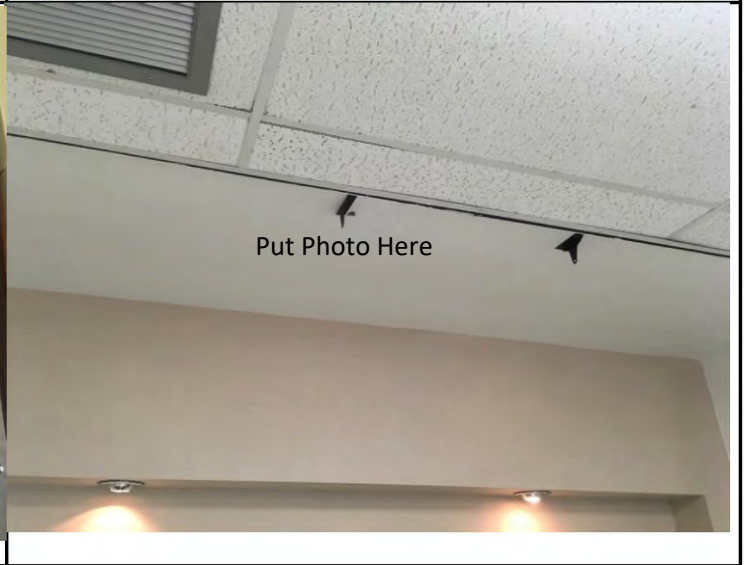
Damage Description:	Item #: 62
Floor, VCT, 12x12 IN, dislodged, caused by surface water flooding (Main Bldg., Floor 1, Library)	
Additional Comments:

Damage Description:	Item #: 63
Ceiling, drywall, painted , discolored, caused by rainwater intrusion (Main Bldg., Floor 1, Library Including Rooms 204 @ 206)	
Additional Comments:

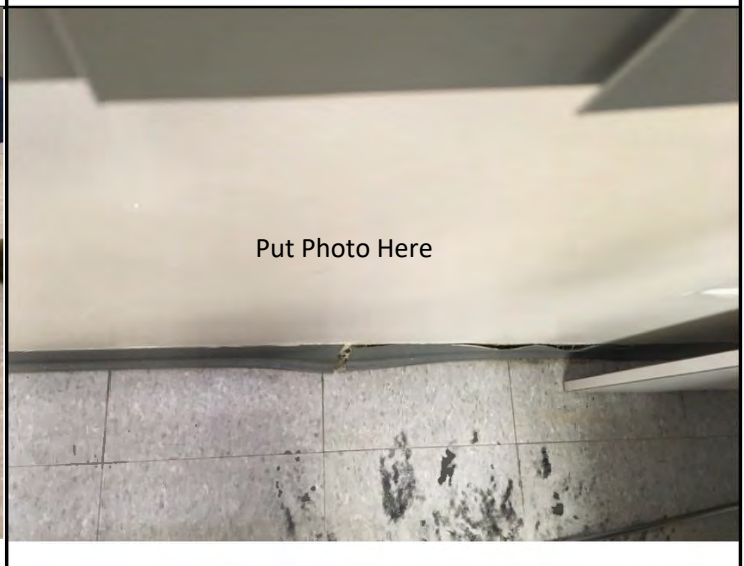
Damage Description:	Item #: 64
Floor, carpet, commercial-grade, including 12 LF of aluminum transition strip , discolored, caused by surface water flooding (Main Bldg., Floor 1, Library Including Rooms 204 @ 206)	
Additional Comments:

Damage Description:	Item #: 66
Base Lining, vinyl, 4 IN, dislodged, caused by surface water flooding (Main Bldg., Floor 1, Library)	
Additional Comments:

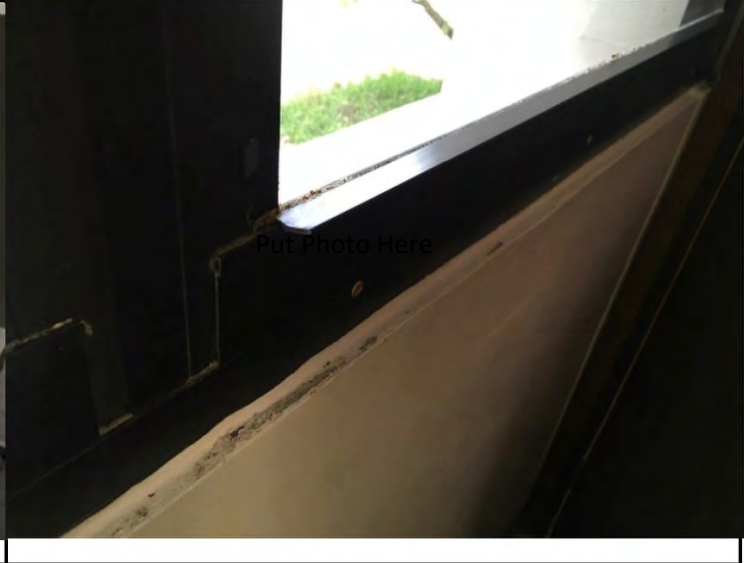
Damage Description:	Item #: 67
Wall, ¼ IN thick plaster on concrete, repair, cracked, caused by rainwater intrusion (Main Bldg., Floor 1, Library)	
Additional Comments:

Damage Description:	Item #: 68
Window, Alum. window frames, perimeter caulking/sealing only, cracked, caused by wind-driven rain (Main Bldg., Floor 1, Library)	
Additional Comments:

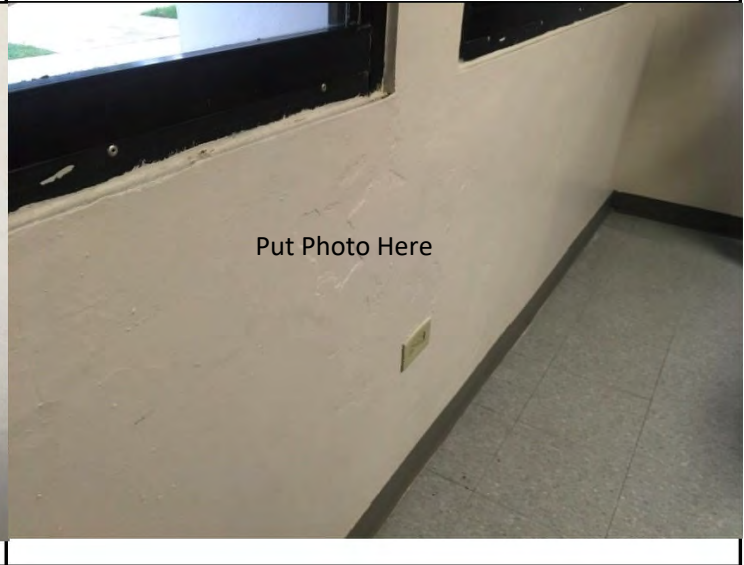
Damage Description:	Item #: 72
Wall, ¼ IN thick plaster on concrete, painted, repair spalling, cracked, caused by rainwater intrusion (Main Bldg., Floor 1, Classroom R357 & 356)	
Additional Comments:

Damage Description:	Item #: 73
Wall, ¼ IN thick plaster on concrete, painted, discolored, caused by rainwater intrusion (Main Bldg., Floor 1, Classroom R357 & 356)	
Additional Comments:

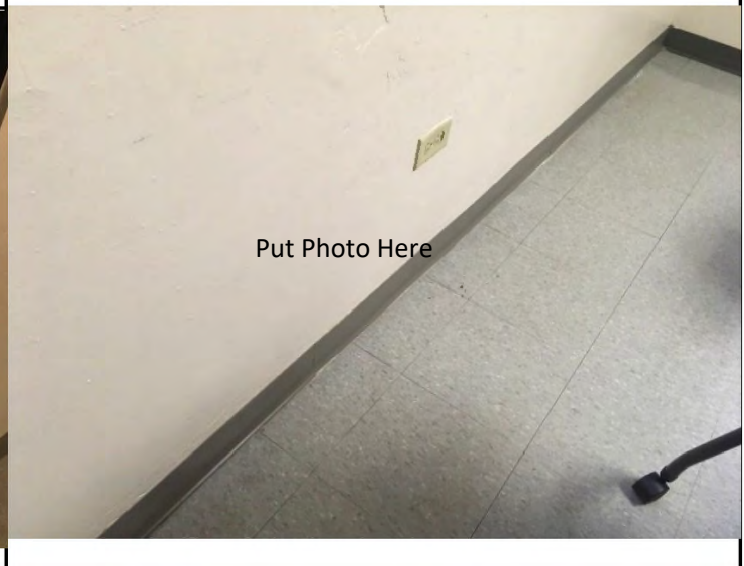
Damage Description:	Item #: 74
Window, Alum. window frames, perimeter caulking/sealing only, cracked, caused by rainwater intrusion (Main Bldg., Floor 1, Classroom R357 & 356)	
Additional Comments:

Damage Description:	Item #: 75
Base Lining, vinyl, 4 IN, deformed, caused by rainwater intrusion (Main Bldg., Floor 1, Classroom R357 & 356)	
Additional Comments:

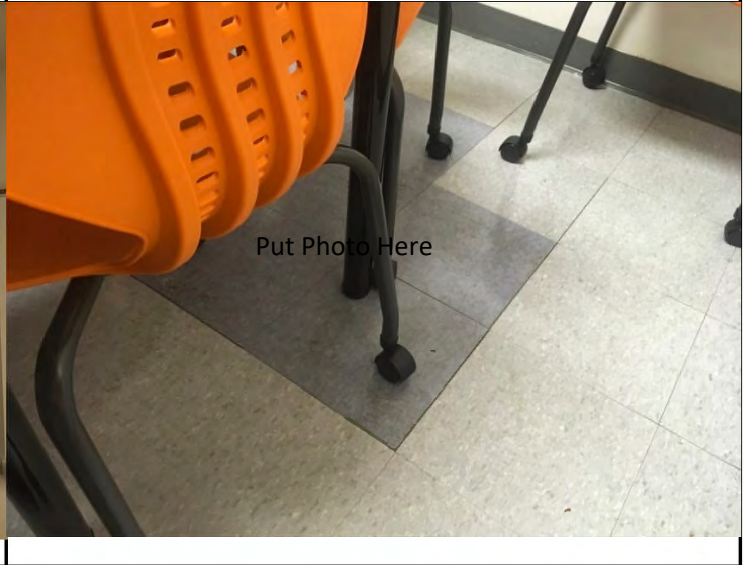
Damage Description:	Item #: 76
Vertical blinds, PVC, 3-IN blades, broken components, caused by rainwater intrusion (Main Bldg., Floor 1, Classroom R357 & R356)	
Additional Comments:

Damage Description:	Item #: 77
Floor, VCT, 12x12 IN, dislodged, caused by surface water flooding (Main Bldg., Floor 1, Classroom R360)	
Additional Comments:

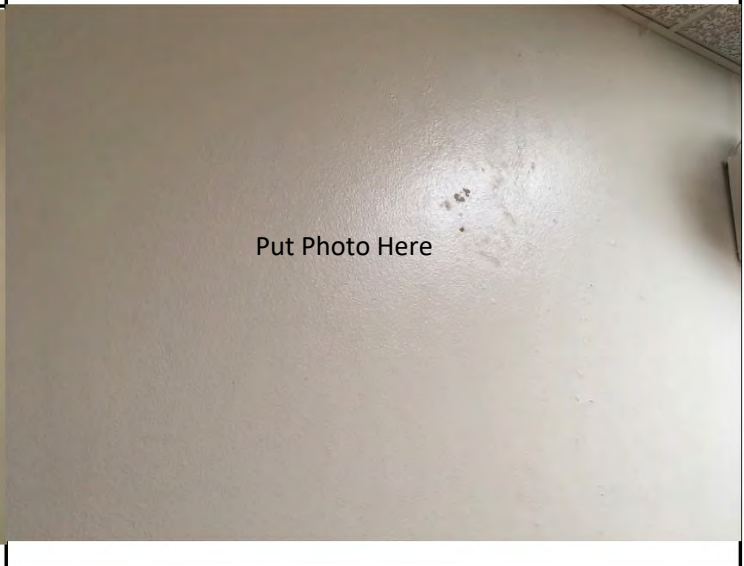
Damage Description:	Item #: 78
Base Lining, vinyl, 4 IN, deformed, caused by surface water flooding (Main Bldg., Floor 1, Classroom R360)	
Additional Comments:

Damage Description:	Item #: 79
Wall, ¼ IN thick plaster on concrete, repair, cracked, caused by rainwater intrusion (Main Bldg., Floor 1, Classroom R360)	
Additional Comments:

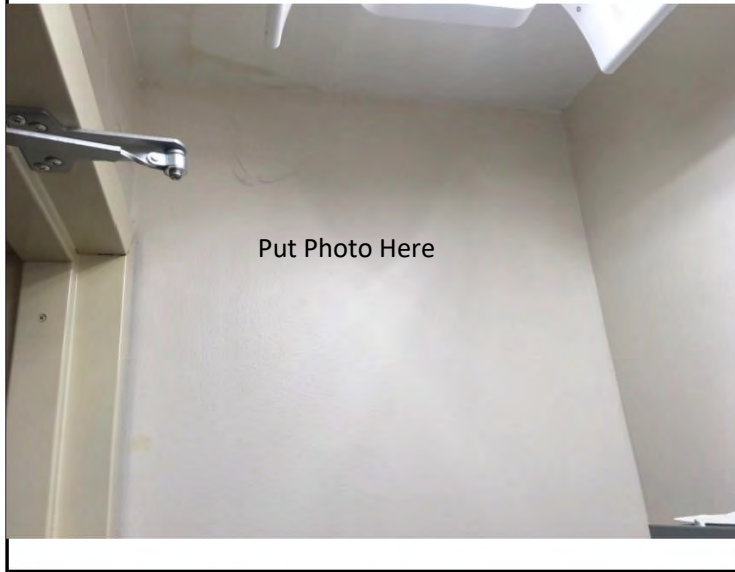
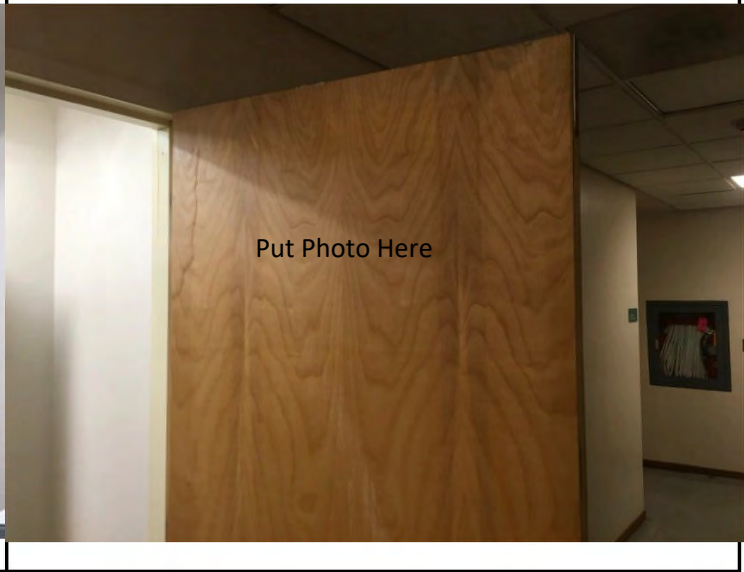
Damage Description:	Item #: 98	Damage Description:	Item #: 99
Wall, drywall, paint, discolored, caused by rainwater intrusion (Main Bldg., Floor 2, Electrical Room)		Door, Wood, solid-core with standard hardware, deformed, caused by rainwater intrusion (Main Bldg., Floor 2, Electrical Room)	
Additional Comments:		Additional Comments:

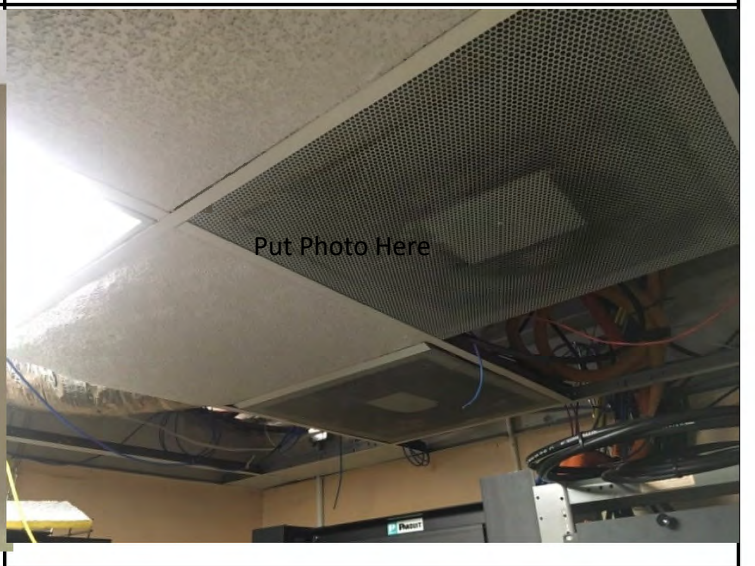
Damage Description:	Item #: 116	Damage Description:	Item #: 117
Ceiling, drywall, painted, discolored, caused by rainwater intrusion (Main Bldg., Floor 2, Stairway Library)		Ceiling, 2 FT x 4 FT acoustic tile, suspended, 15/16 IN thick, fiberglass-faced, with grid, broken components, caused by rainwater intrusion (Main Bldg., Floor 1, Server Room)	
Additional Comments:		Additional Comments:

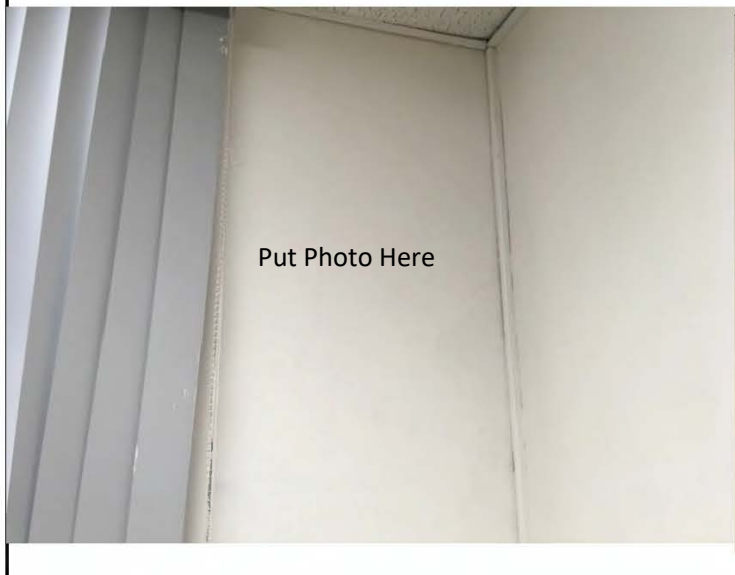
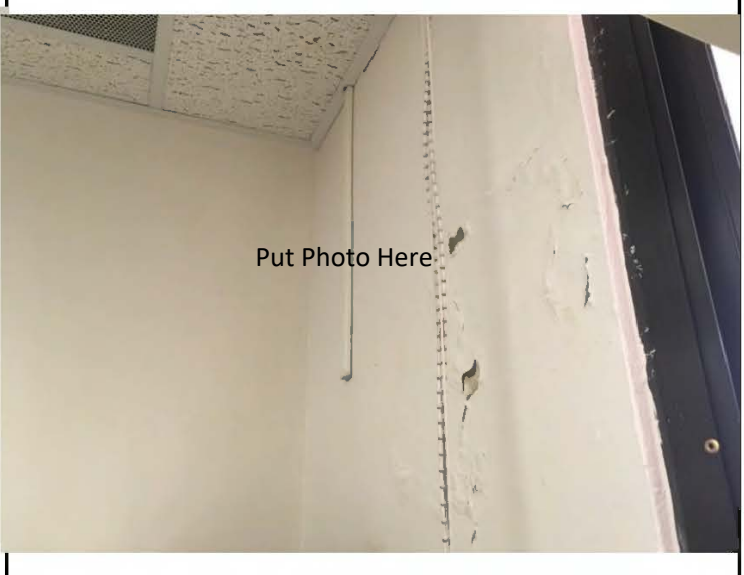
Damage Description:	Item #: 136	Damage Description:	Item #: 137
Wall, ¼ IN thick plaster on concrete, painted, discolored ,caused by rainwater intrusion (Main Bldg., Floor 1, Office R197)		Wall, ¼ IN thick plaster on concrete, painted, repair spalling, cracked, caused by rainwater intrusion (Main Bldg., Floor 1, Office R195)	
Additional Comments:		Additional Comments:
