Applicant: Universidad Central Del Caribe, Inc.	Damage Inventory: 305240	Category: E
WO # 46525 FIPS# 021-UNUGB-00	Date: 09/04-17/2019 GPS: 18.365953, -66.153767	
Inspector: Gregory Sondergeld / Alexander Nieves	Damage Facility: Main Bldg.

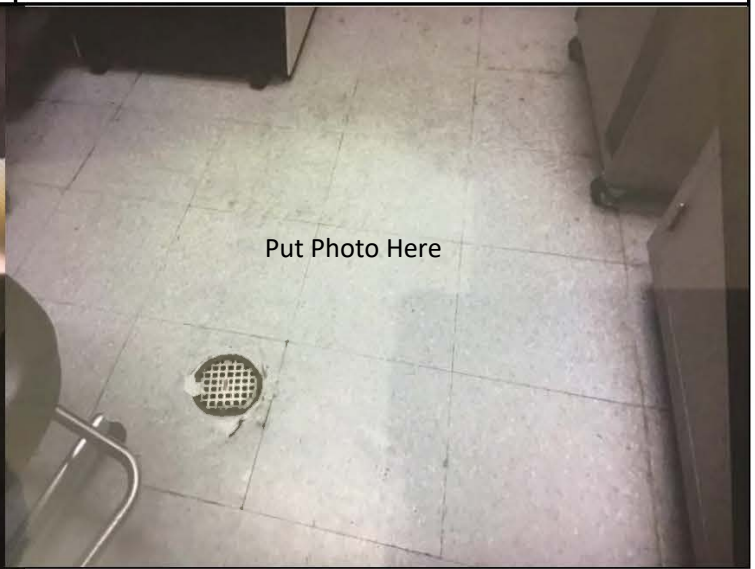
Damage Description:	Item #: 1	Damage Description:	Item #: 2
Light, fluorescent, recessed Troffer, acrylic prismatic lens only, discolored, caused by rainwater intrusion (Main Bldg., Basement, Laboratory ARC 010)		Floor, VCT, 12x12 IN, detached, caused by surface water flooding (Main Bldg., Basement, Laboratory ARC 010)	
Additional Comments:		Additional Comments:

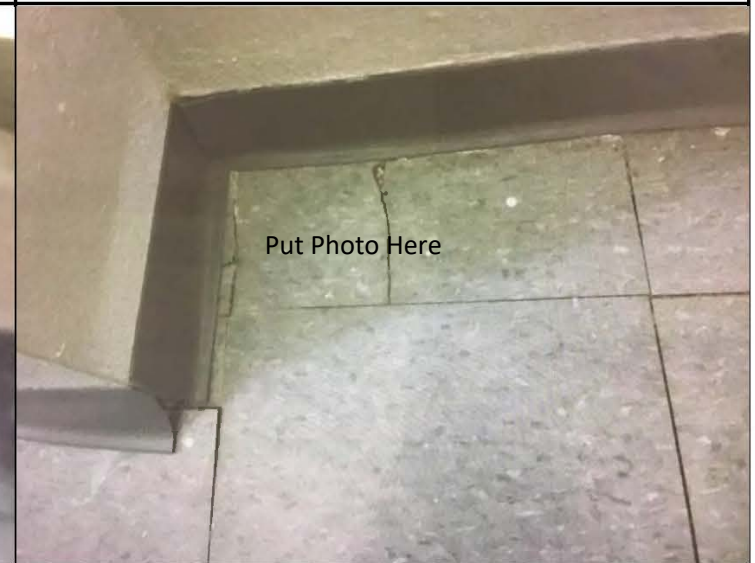
Damage Description:	Item #: 3	Damage Description:	Item #: 4
Base Lining, vinyl, 4 IN, detached, caused by surface water flooding (Main Bldg., Basement, Laboratory ARC 010)		Floor, VCT, 12x12 IN, detached, caused by surface water flooding (Main Bldg., Basement, Laboratory ARC 014)	
Additional Comments:		Additional Comments:

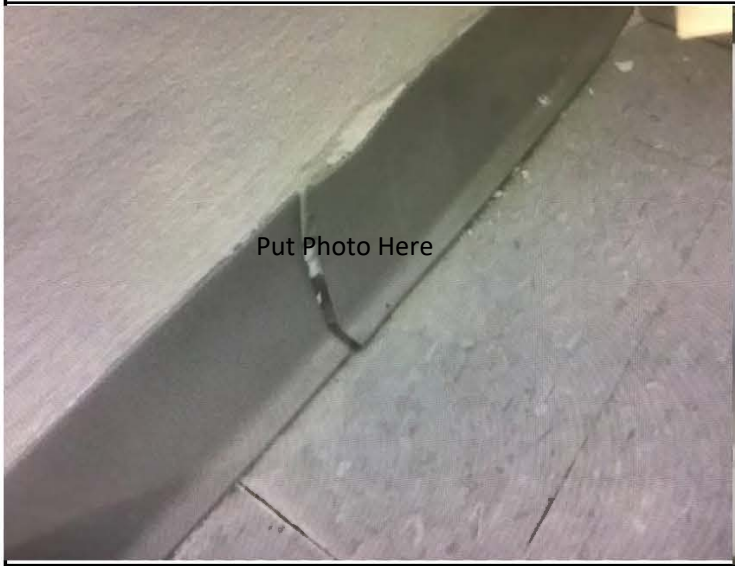
Damage Description:	Item #: 5
Base Lining, vinyl, 4 IN, detached, caused by surface water flooding (Main Bldg., Basement, Laboratory ARC 014)	
Additional Comments:

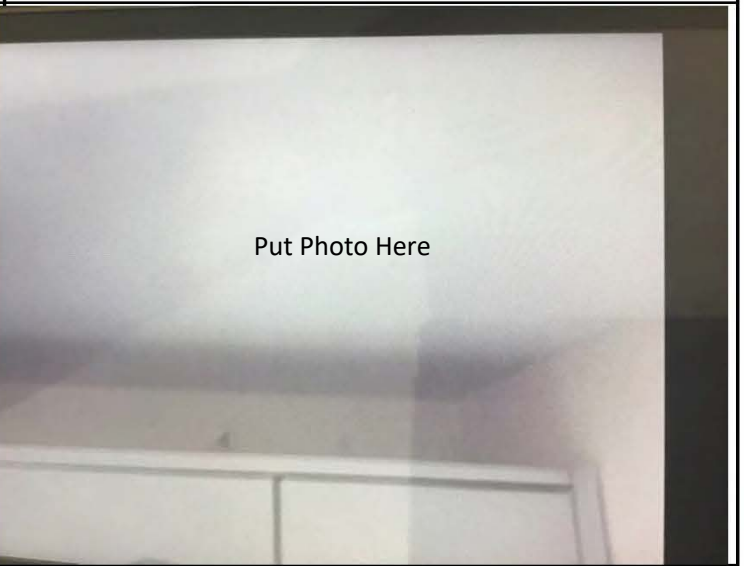
Damage Description:	Item #: 6
Wall, ¼ IN thick plaster on concrete, repair spalling and paint, cracked, caused by rainwater intrusion (Main Bldg., Basement, Laboratory ARC 015)	
Additional Comments:

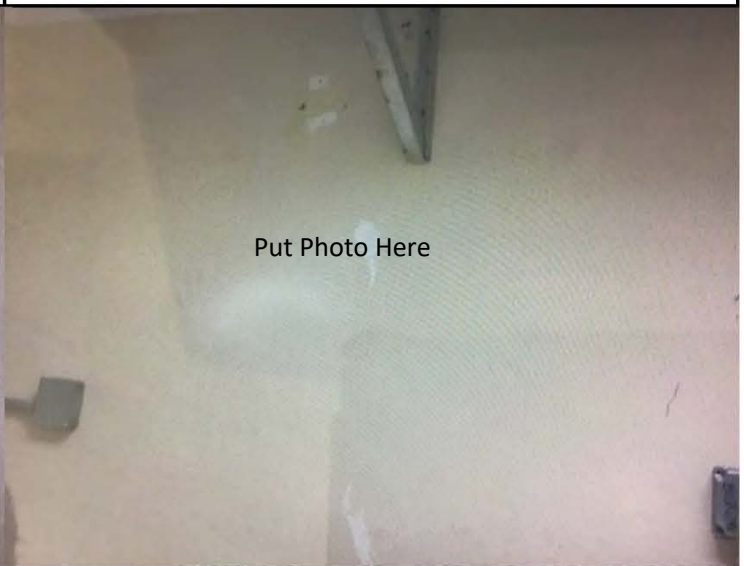
Damage Description:	Item #: 8 Wall,
¼ IN thick plaster on concrete, painted, peeling paint, caused by rainwater intrusion (Main Bldg., Basement, Laboratory ARC 017)	
Additional Comments:

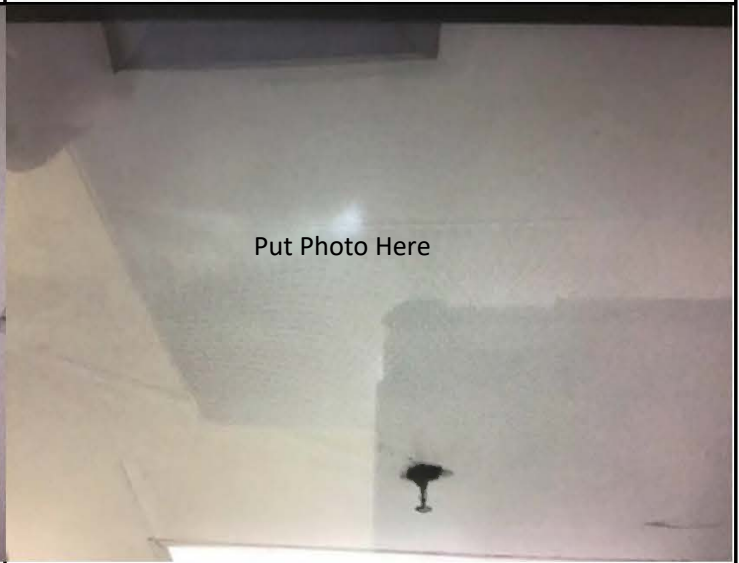
Damage Description:	Item #: 10
Ceiling, drywall, paint, discolored, caused by rainwater intrusion (Main Bldg., Basement, Laboratory ARC 017)	
Additional Comments:

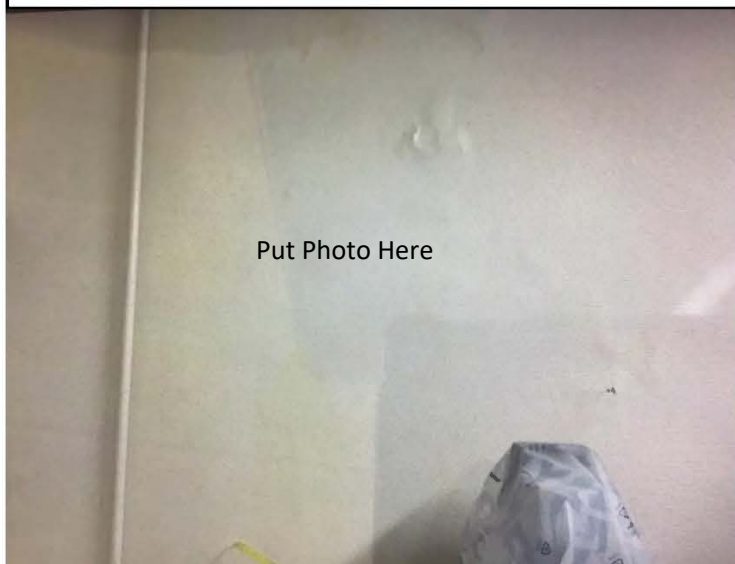
Damage Description:	Item #: 11
Wall, ¼ IN thick plaster on concrete, repair spalling and paint, cracked, caused by rainwater intrusion (Main Bldg., Basement, Laboratory ARC 023)	
Additional Comments:

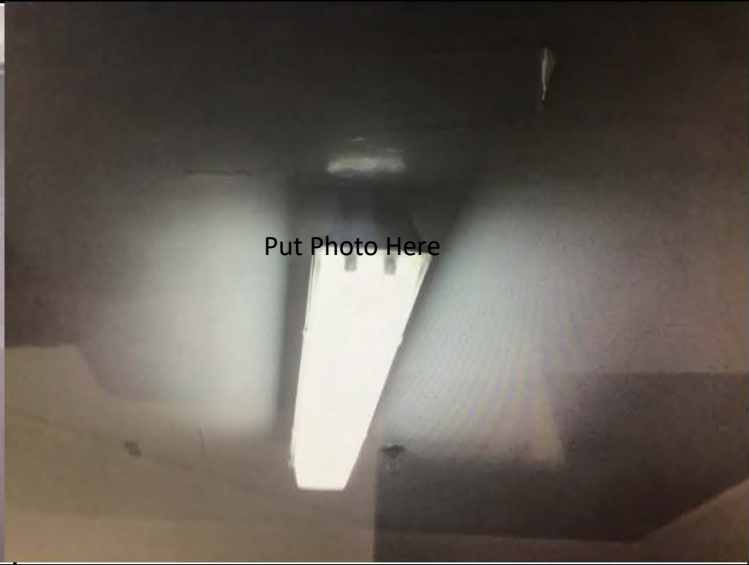
Damage Description:	Item #: 13	Damage Description:	Item #: 14
Ceiling, drywall, repair, detached, caused by rainwater intrusion (Main Bldg., Basement, Laboratory ARC 024)		Wall, ¼ IN thick plaster on concrete, painted, discolored, caused by rainwater intrusion (Main Bldg., Basement, Laboratory ARC 024)	
Additional Comments:		Additional Comments:

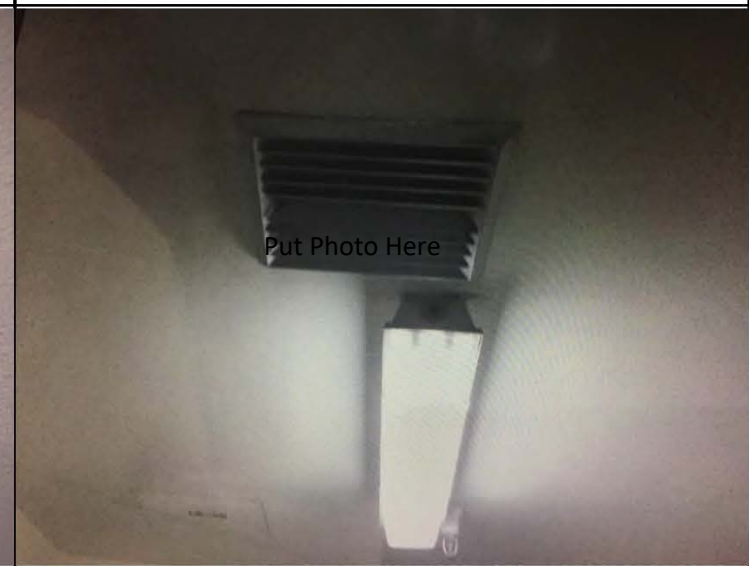
Damage Description:	Item #: 15	Damage Description:	Item #: 16
Wall, ¼ IN thick plaster on concrete, repair spalling and paint, cracked, caused by rainwater intrusion (Main Bldg., Basement, Laboratory ARC 025)		Light, fluorescent, surface-mounted, vapor-resistant, 6 IN x 48 IN, acrylic lens cover only, discolored, caused by rainwater intrusion (Main Bldg., Basement, Laboratory ARC 025)	
Additional Comments:		Additional Comments:

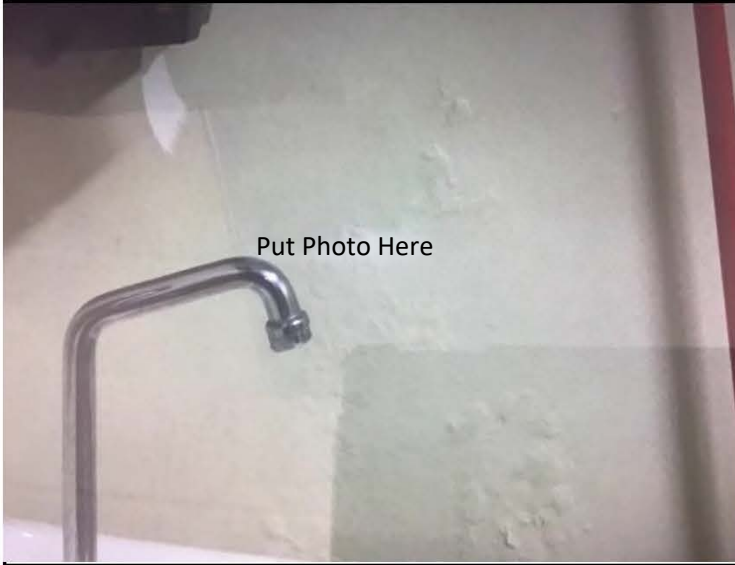
Damage Description:	Item #: 17
Wall, ¼ IN thick plaster on concrete, repair spalling and paint, cracked, caused by rainwater intrusion (Main Bldg., Basement, Laboratory ARC 026)	
Additional Comments:

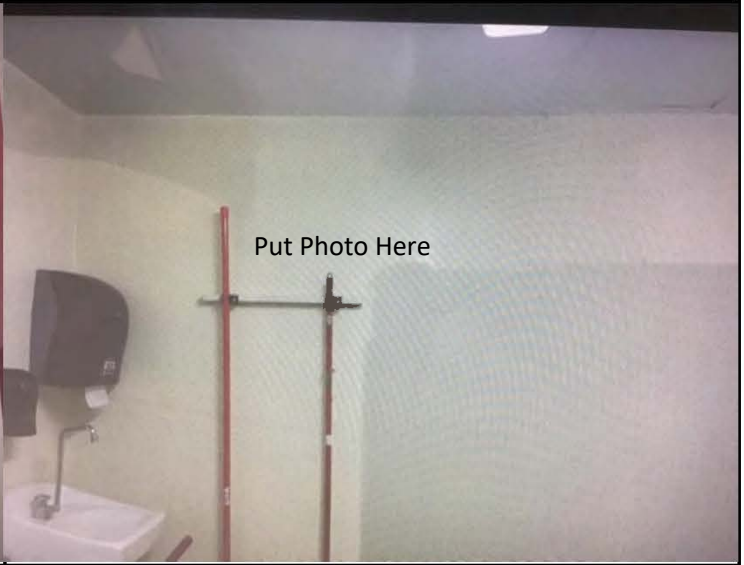
Damage Description:	Item #: 18
Wall, ¼ IN thick plaster on concrete, painted, discolored, caused by rainwater intrusion (Main Bldg., Basement, Laboratory ARC 026)	
Additional Comments:

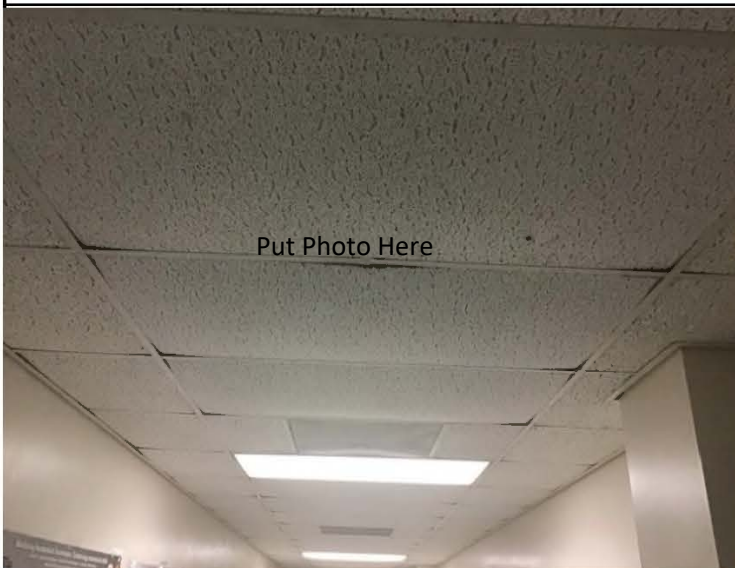
Damage Description:	Item #: 19
Ceiling, 2 FT x 4 FT acoustic tile, suspended, deformed, caused by rainwater intrusion (Main Bldg., Floor 1, Hallway)	
Additional Comments:

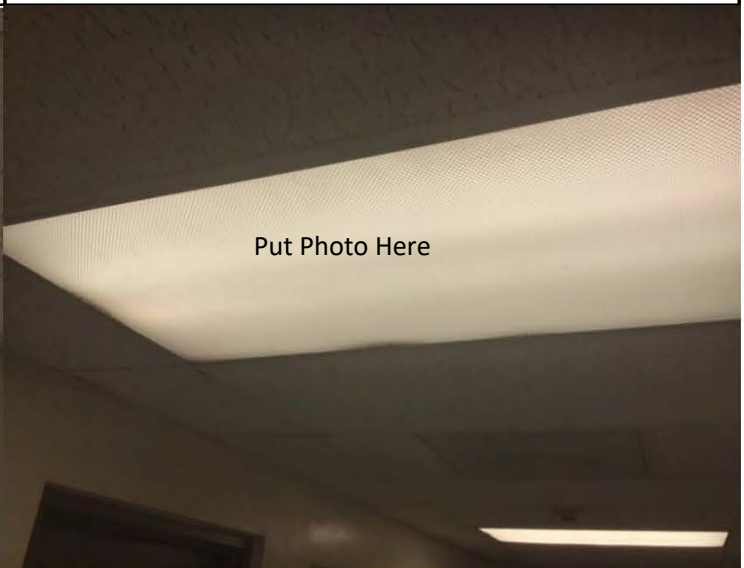
Damage Description:	Item #: 20
Light, fluorescent, recessed Troffer, acrylic prismatic lens only, deformed, caused by rainwater intrusion (Main Bldg., Floor 1, Hallway)	
Additional Comments:

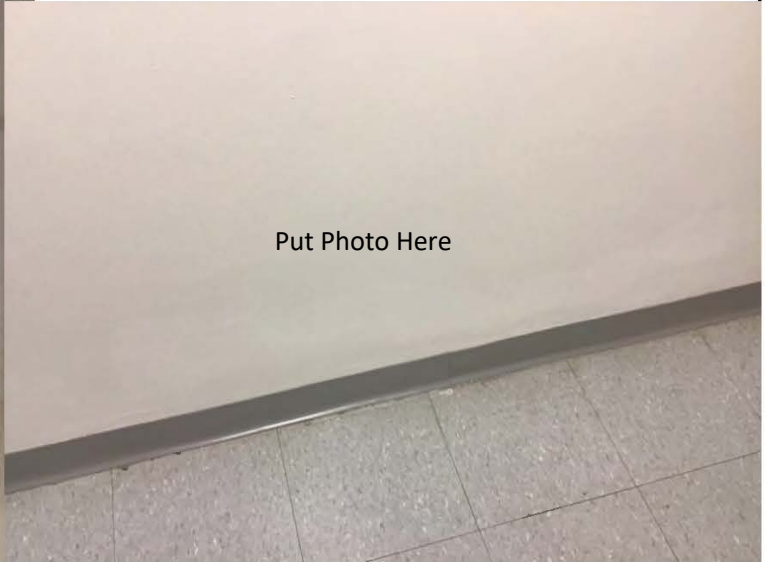
Damage Description:	Item #: 21	Damage Description:	Item #: 22
Ceiling, drywall, soffit, paint, discolored, caused by rainwater intrusion (Main Bldg., Floor 1, Hallway)		Wall, ¼ IN thick plaster on concrete, repair spalling, cracked, caused by rainwater intrusion (Main Bldg., Floor 1, Hallway)	
Additional Comments:		Additional Comments:

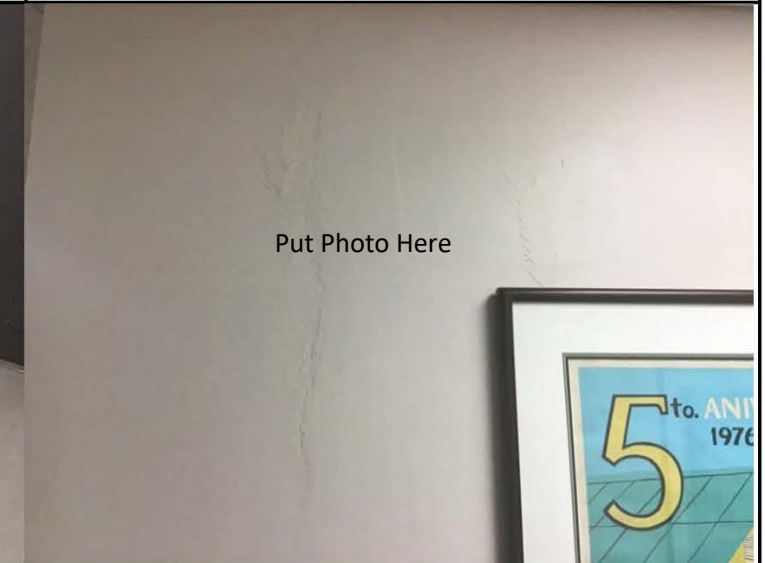
Damage Description:	Item #: 23	Damage Description:	Item #: 24
Wall, ¼ IN thick plaster on concrete, painted, discolored, caused by rainwater intrusion (Main Bldg., Floor 1, Hallway)		Wall, ¼ IN thick plaster on concrete, repair spalling, peeling paint, caused by rainwater intrusion (Main Bldg., Floor 1, Hallway)	
Additional Comments:		Additional Comments:

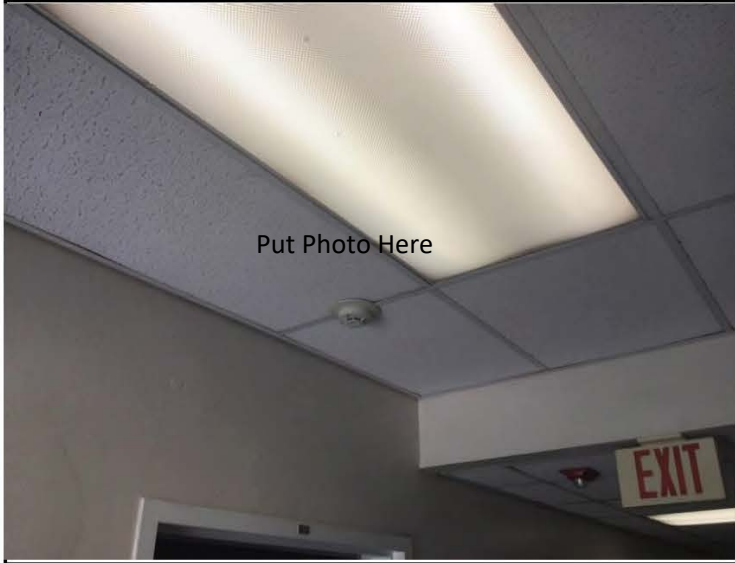
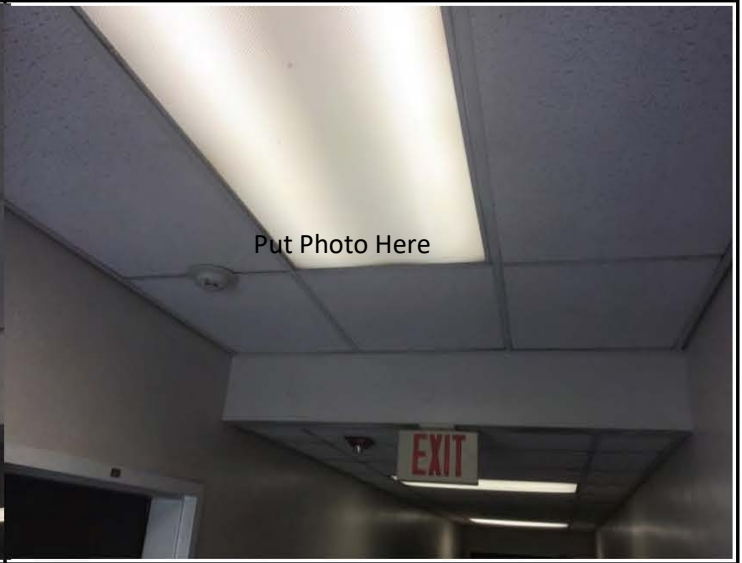
Damage Description:	Item #: 29	Damage Description:	Item #: 30
Ceiling, 2 FT x 4 FT acoustic tile, suspended, deformed, caused by rainwater intrusion (Main Bldg., Floor 1, Hallway Cargo Area)		Light, fluorescent, recessed Troffer, electrical issues, caused by rainwater intrusion (Main Bldg., Floor 1, Hallway Cargo Area)	
Additional Comments:		Additional Comments:

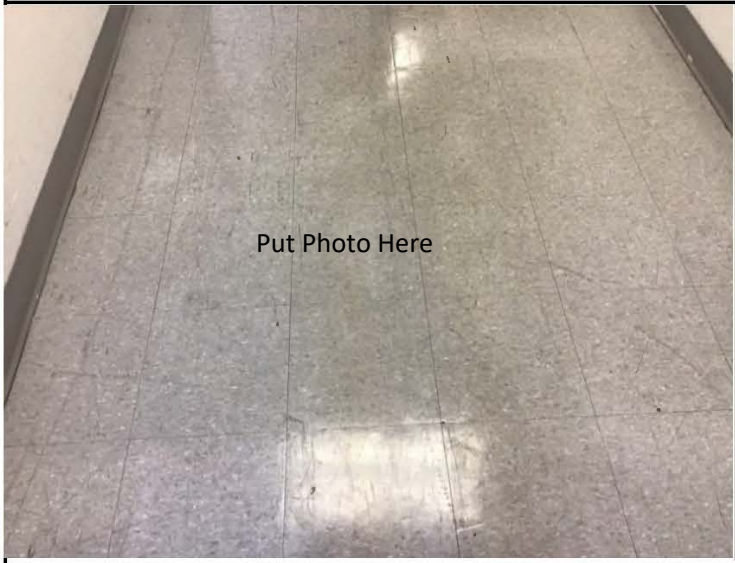
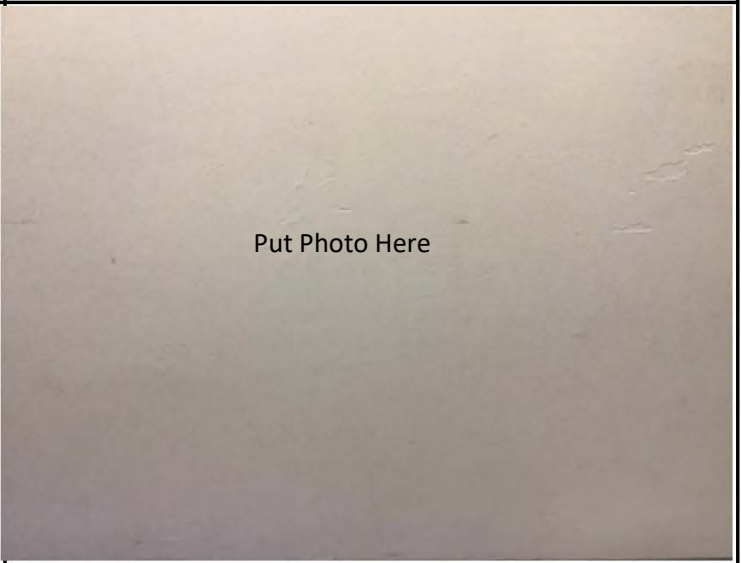
Damage Description:	Item #: 31	Damage Description:	Item #: 32
Floor, VCT, 12x12 IN, detached, caused by surface water flooding (Main Bldg., Floor 1, Hallway Cargo Area)		Wall, ¼ IN thick plaster on concrete, painted, discolored, caused by rainwater intrusion (Main Bldg., Floor 1, Hallway Cargo Area)	
Additional Comments:		Additional Comments:

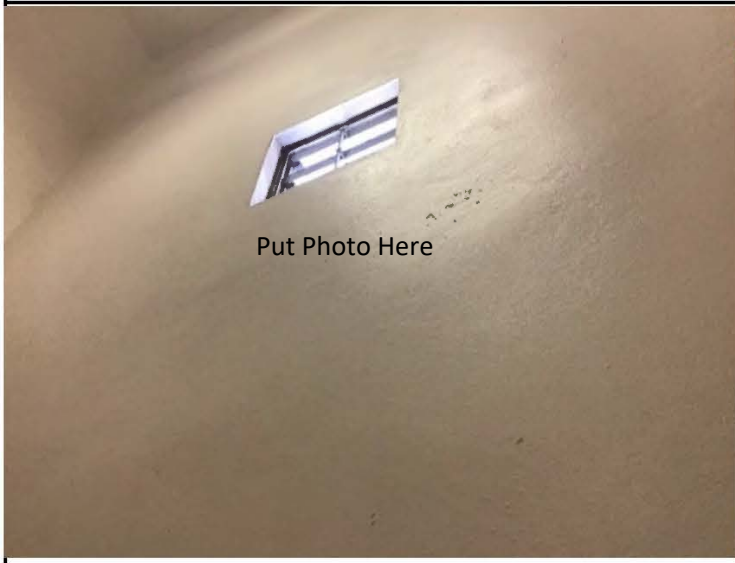
Damage Description:	Item #: 33
Wall, ¼ IN thick plaster on concrete, painted, discolored, caused by rainwater intrusion (Main Bldg., Floor 1, Stairway North)	
Additional Comments:

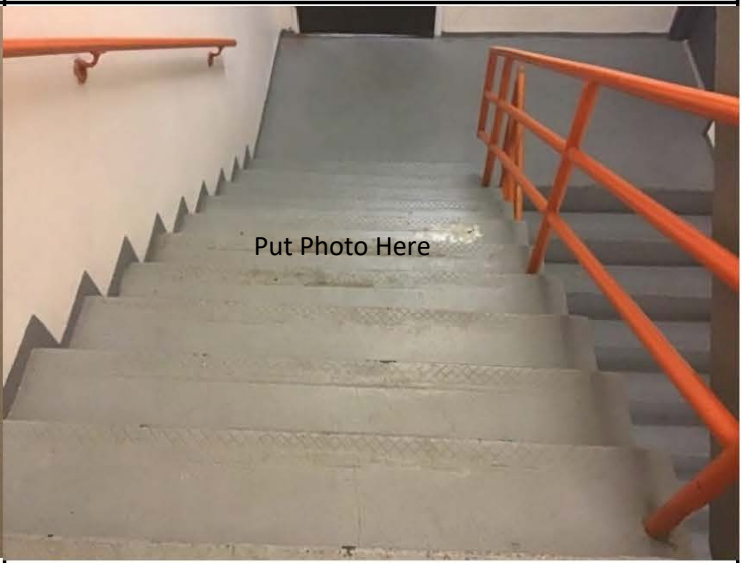
Damage Description:	Item #: 35
Floor, sealed concrete, painted, discolored, caused by surface water flooding (Main Bldg., Floor 1, Stairway North)	
Additional Comments:

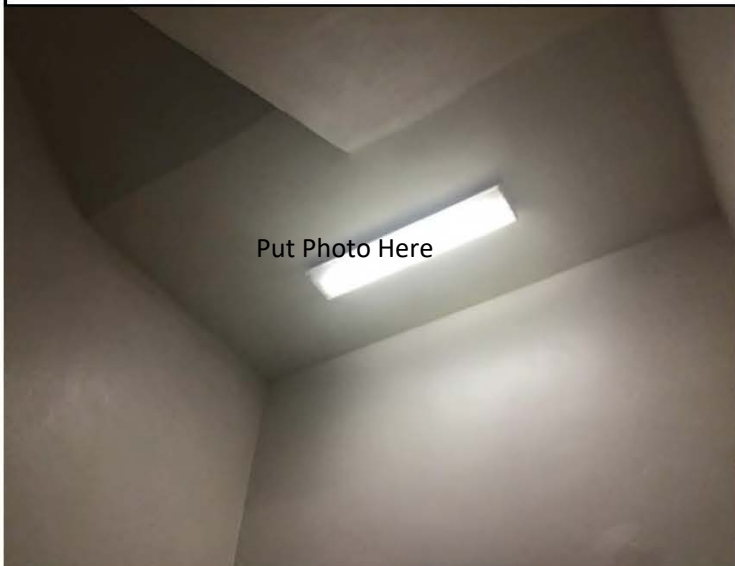
Damage Description:	Item #: 36
Light, fluorescent, surface-mounted, 1 FT x 4 FT light fixture, electrical issues, caused by rainwater intrusion (Main Bldg., Floor 1, Stairway North)	
Additional Comments:

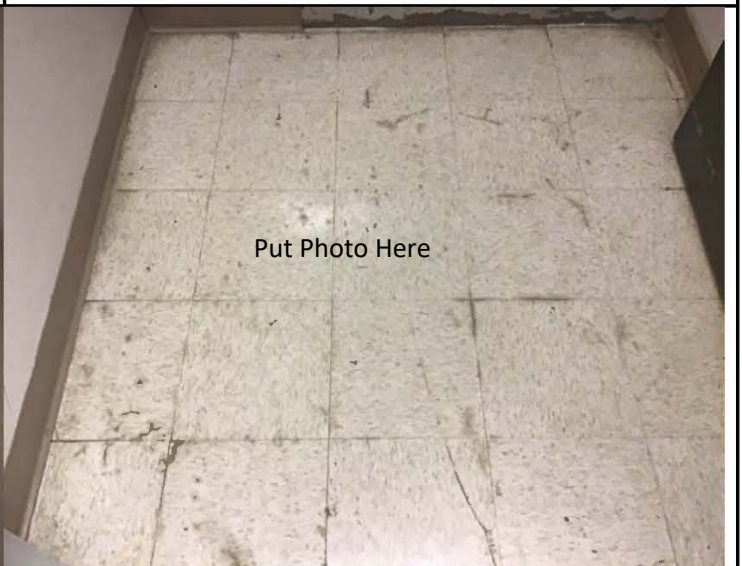
Damage Description:	Item #: 37
Floor, VCT, 12x12 IN, detached, caused by rainwater intrusion (Main Bldg., Basement, Stairway)	
Additional Comments:

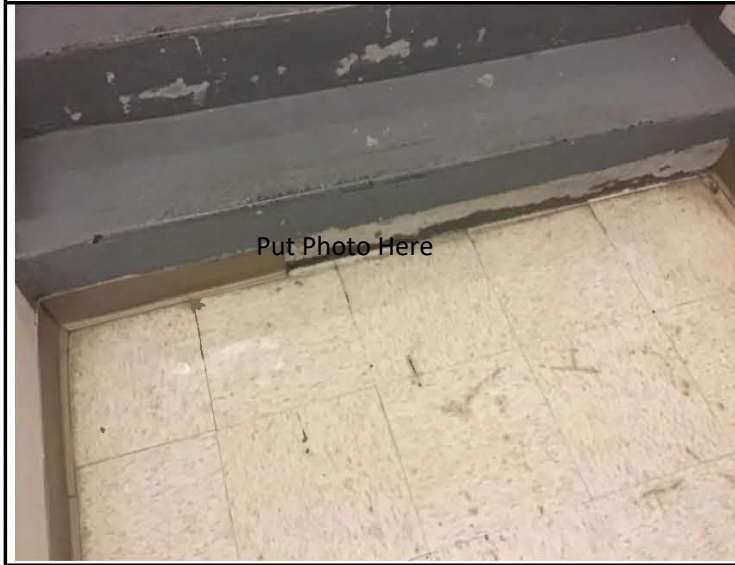
Damage Description:	Item #: 38
Base Lining, vinyl, 4 IN, detached, caused by surface water flooding (Main Bldg., Basement, Stairway)	
Additional Comments:

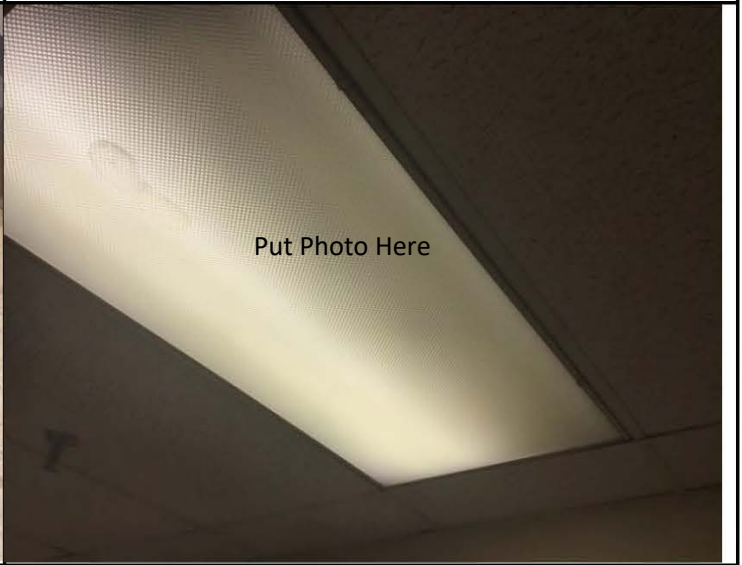
Damage Description:	Item #: 39
Light, florescent, recessed Troffer, electrical issues, caused by rainwater intrusion (Main Bldg., Basement, Hallway ARC)	
Additional Comments:

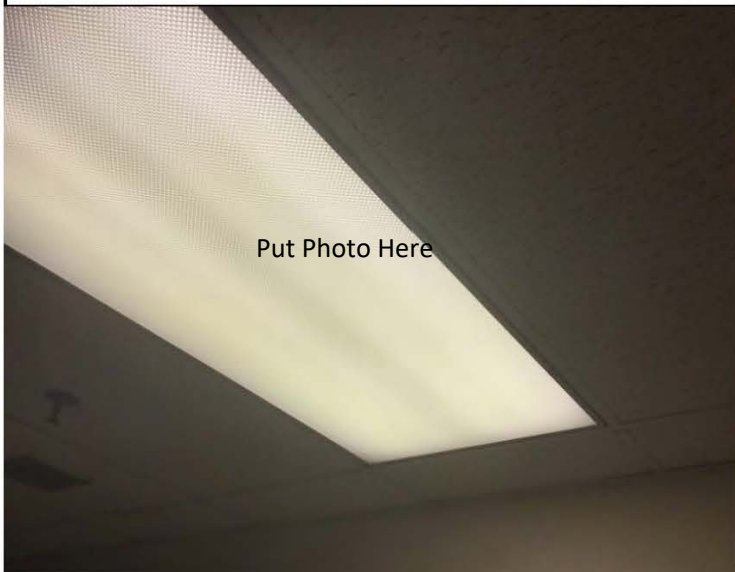
Damage Description:	Item #: 40
Light, florescent, recessed Troffer, acrylic prismatic lens only, discolored, caused by rainwater intrusion (Main Bldg., Basement, Hallway ARC)	
Additional Comments:

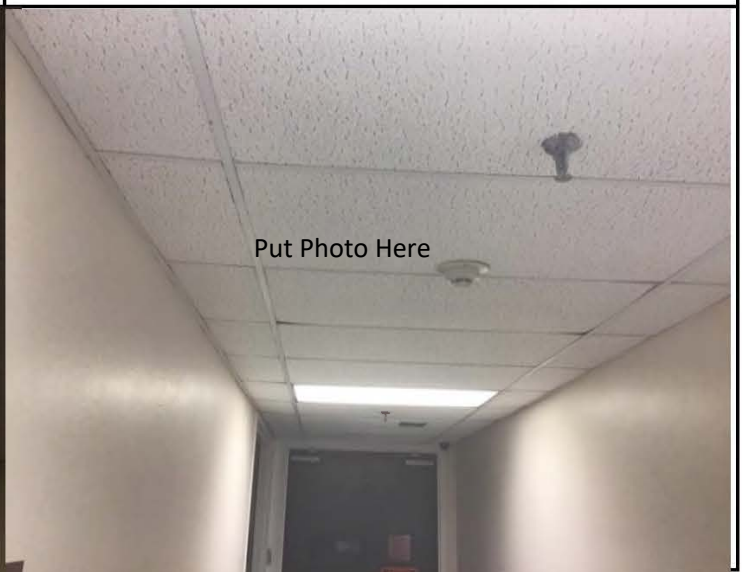
Damage Description:	Item #: 41
Ceiling, 2 FT x 4 FT acoustic tile, suspended, deformed, caused by rainwater intrusion (Main Bldg., Basement, Hallway ARC)	
Additional Comments:

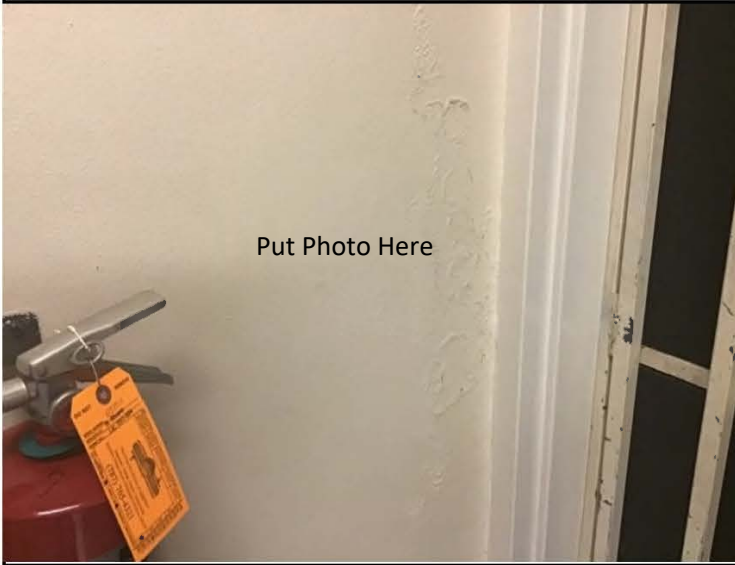
Damage Description:	Item #: 42
Wall, ¼ IN thick plaster on concrete, painted, discolored, caused by rainwater intrusion (Main Bldg., Basement, Hallway ARC)	
Additional Comments:

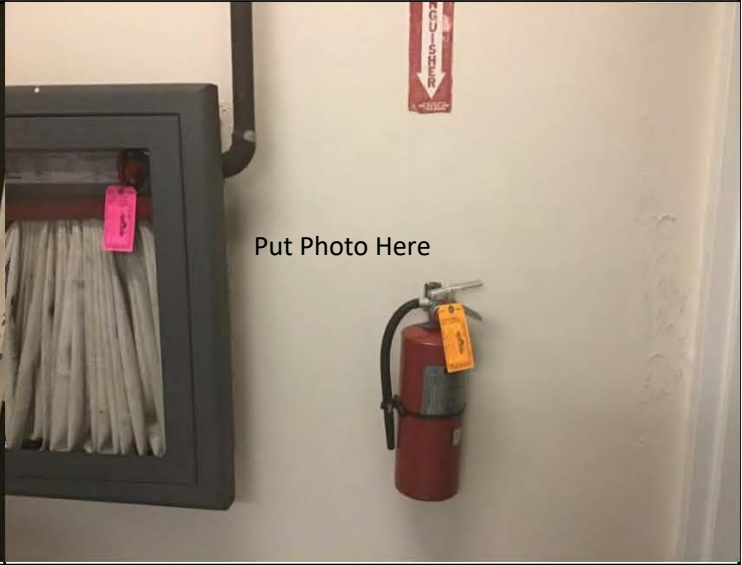
Damage Description:	Item #: 43
Wall, ¼ IN thick plaster on concrete, repair spalling, cracked, caused by rainwater intrusion (Main Bldg., Basement, Hallway ARC)	
Additional Comments:

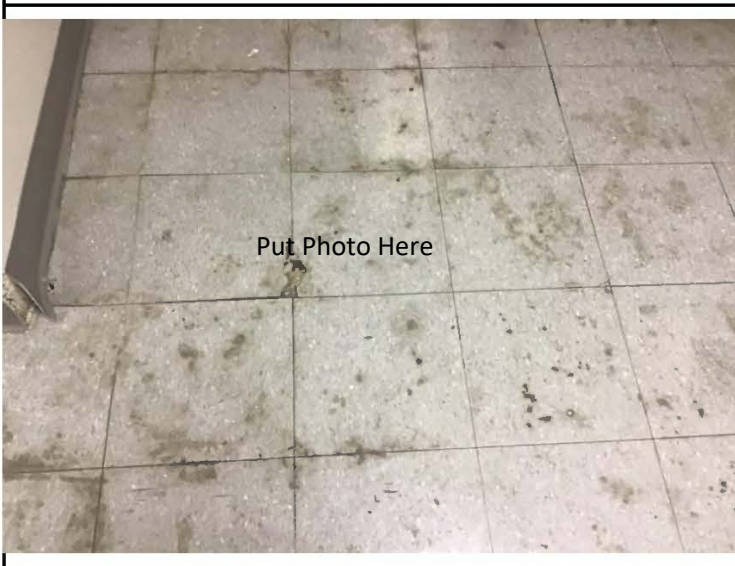
Damage Description:	Item #: 44
Floor, VCT, 12x12 IN, cracked, caused by surface water flooding (Main Bldg., Basement, Hallway ARC)	
Additional Comments:

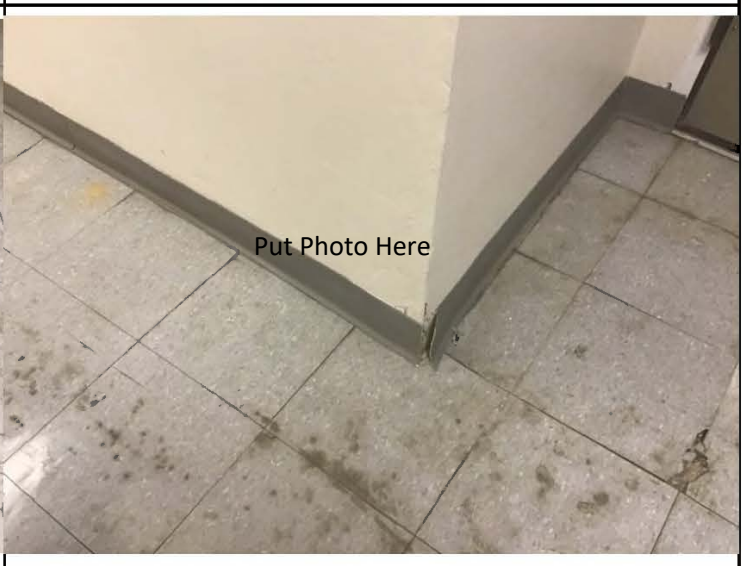
Damage Description:	Item #: 45
Base Lining, vinyl, 4 IN, detached, caused by surface water flooding (Main Bldg., Basement, Hallway ARC)	
Additional Comments:

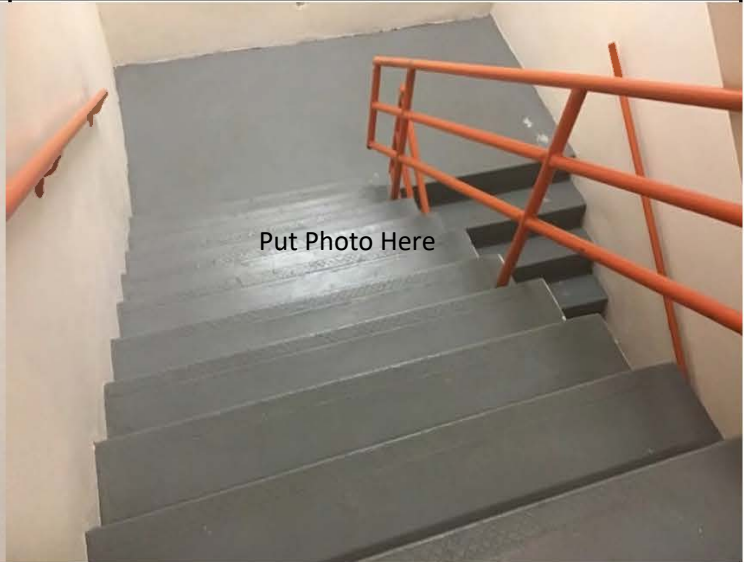
Damage Description:	Item #: 46	Damage Description:	Item #: 47
Wall, ¼ IN thick plaster on concrete, painted, discolored, caused by rainwater intrusion (Main Bldg., Floor 1, Stairway South)		Floor, sealed concrete, painted, discolored, caused by rainwater intrusion (Main Bldg., Floor 1, Stairway South)	
Additional Comments:		Additional Comments:

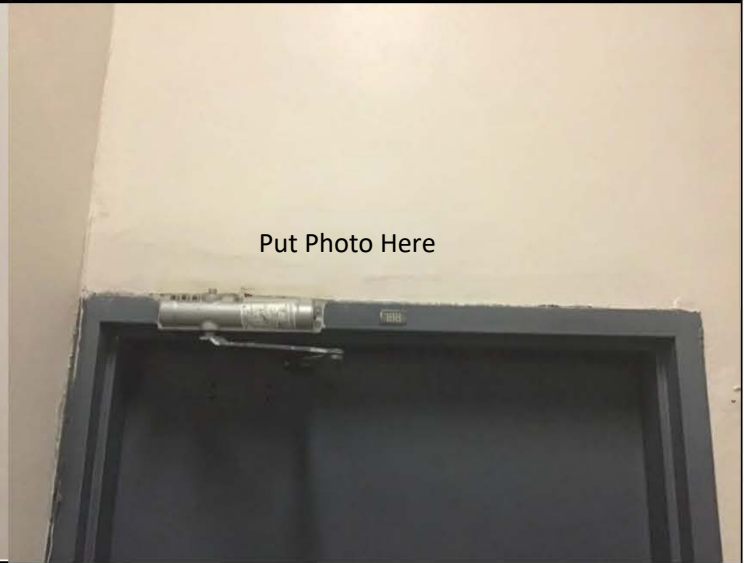
Damage Description:	Item #: 48	Damage Description:	Item #: 49
Ceiling, ¼ IN thick plaster on concrete, painted, discolored, caused by rainwater intrusion (Main Bldg., Floor 1, Stairway South)		Wall, ¼ IN thick plaster on concrete, repair spalling and paint, cracked, caused by rainwater intrusion (Main Bldg., Floor 1, Stairway South)	
Additional Comments:		Additional Comments:

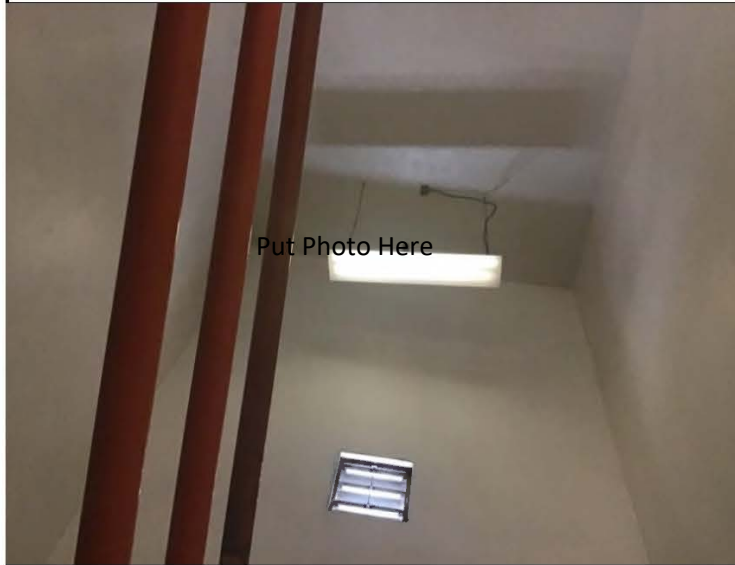
Damage Description:	Item #: 50
Light, fluorescent, suspended, 6 IN x 4 FT light fixture, electrical issues, caused by rainwater intrusion (Main Bldg., Floor 1, Stairway South)	
Additional Comments:

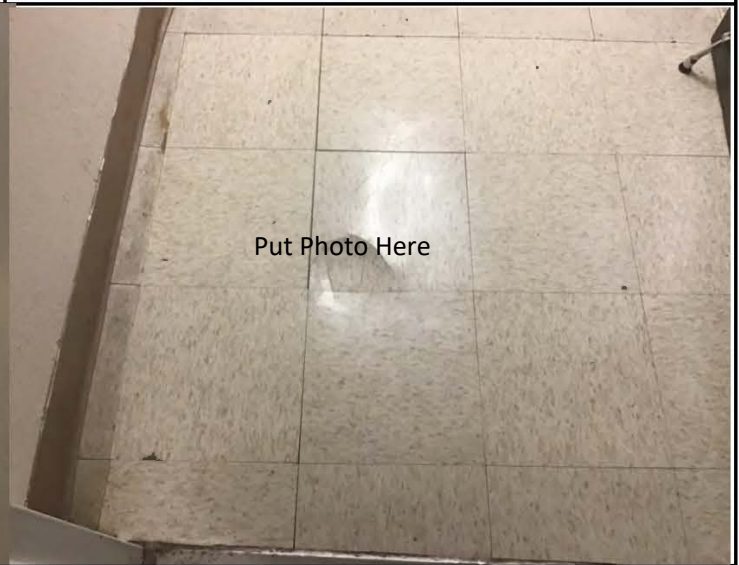
Damage Description:	Item #: 51
Floor, VCT, 12x12 IN, detached, caused by surface water flooding (Main Bldg., Basement, Hallway South)	
Additional Comments:

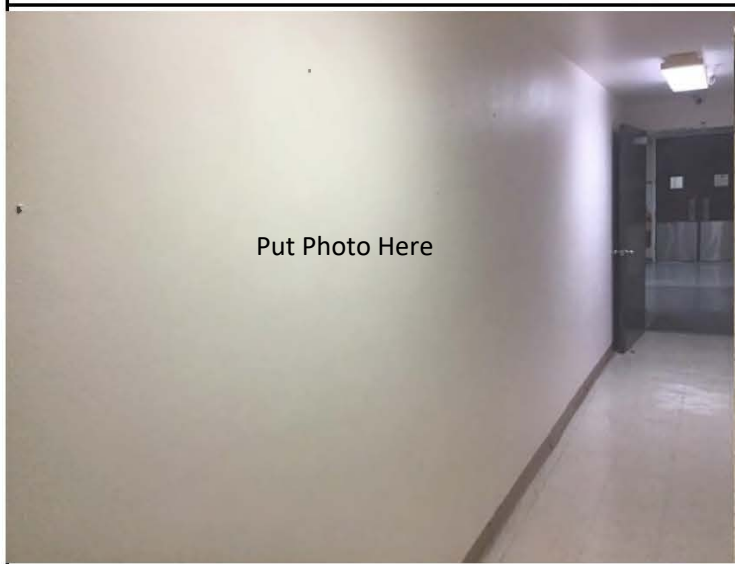
Damage Description:	Item #: 52
Wall, ¼ IN thick plaster on concrete, painted, discolored, caused by rainwater intrusion (Main Bldg., Basement, Hallway South)	
Additional Comments:

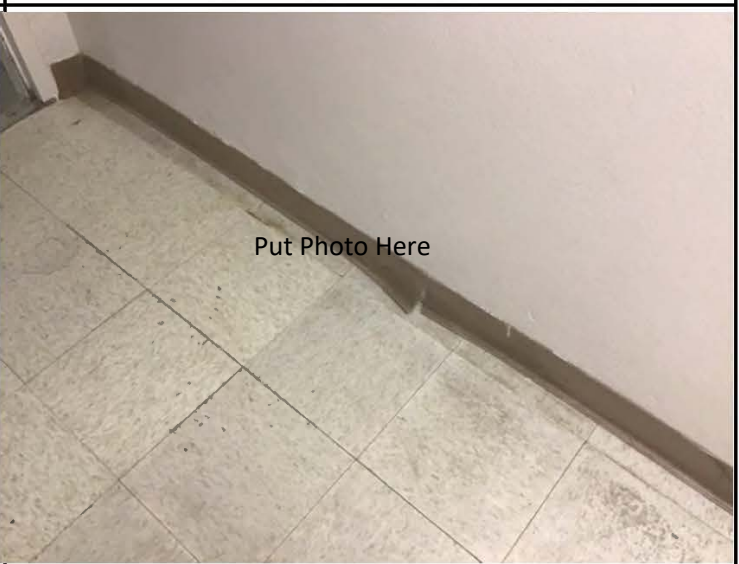
Damage Description:	Item #: 53
Base Lining, vinyl, 4 IN, detached, caused by surface water flooding (Main Bldg., Basement, Hallway South)	
Additional Comments:

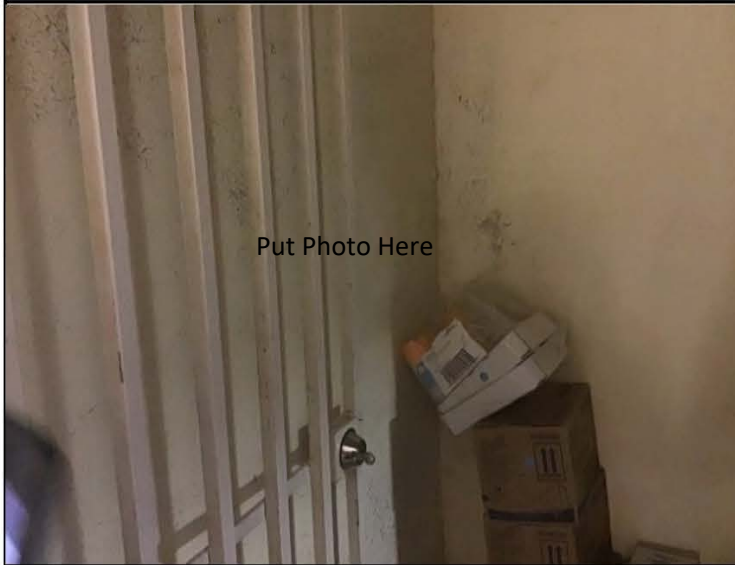
Damage Description:	Item #: 54
Wall, ¼ IN thick plaster on concrete, repair spalling, cracked, caused by rainwater intrusion (Main Bldg., Basement, Storage Room Under Stairway)	
Additional Comments:

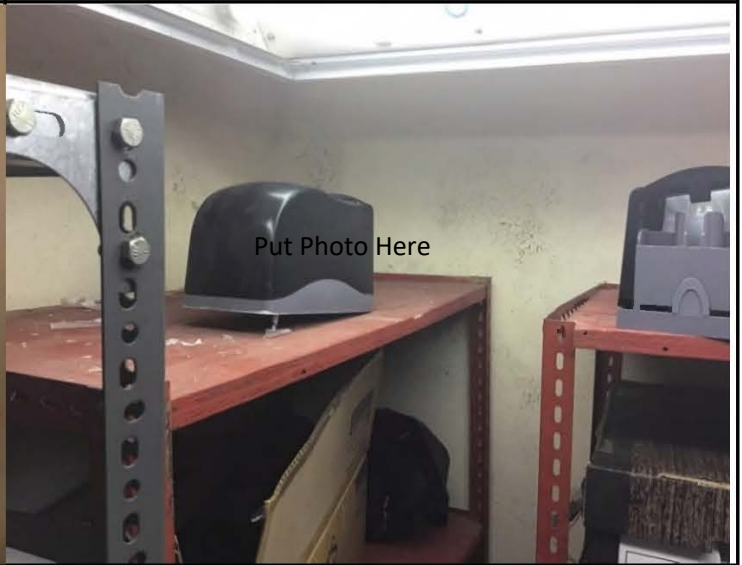
Damage Description:	Item #: 55
Wall, ¼ IN thick plaster on concrete, painted, dislodged, caused by rainwater intrusion (Main Bldg., Basement, Storage Room Under Stairway)	
Additional Comments:

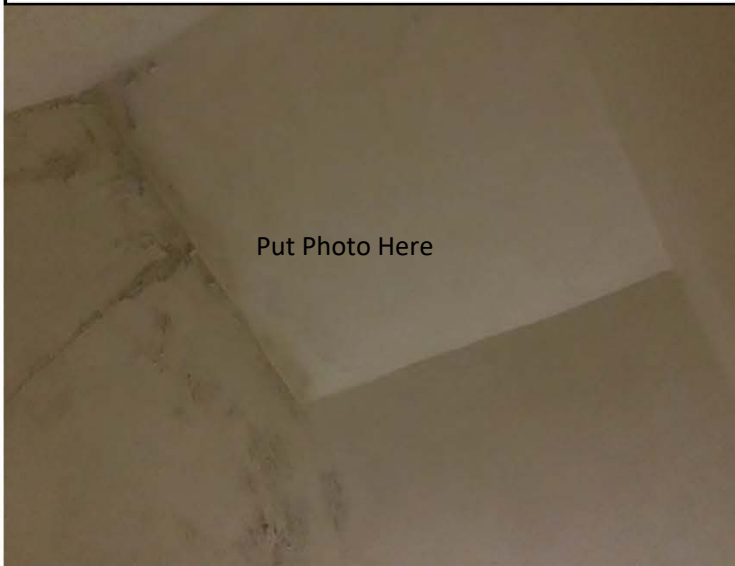
Damage Description:	Item #: 56
Ceiling, ¼ IN thick plaster on concrete, painted, discolored, caused by rainwater intrusion (Main Bldg., Basement, Storage Room Under Stairway)	
Additional Comments:

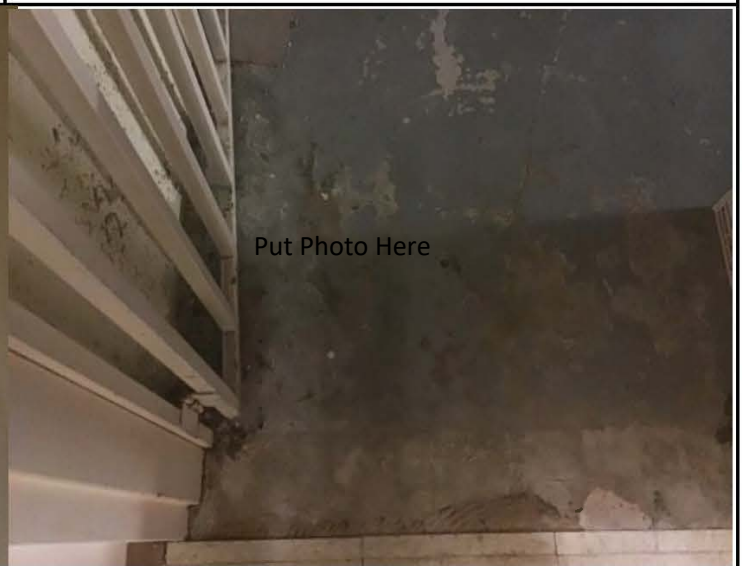
Damage Description:	Item #: 57
Floor, sealed concrete, repair spalling, cracked, caused by surface water flooding (Main Bldg., Basement, Storage Room Under Stairway)	
Additional Comments:

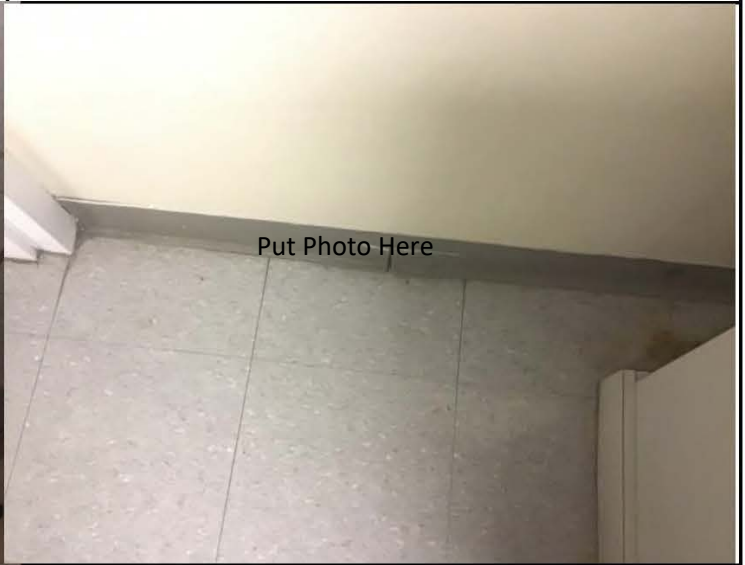
Damage Description:	Item #: 62
Ceiling, 2 FT x 4 FT acoustic tile, suspended, deformed, caused by rainwater intrusion (Main Bldg., Basement, Laboratory Reception Lobby)	
Additional Comments:

Damage Description:	Item #: 63
Base Lining, vinyl, 4 IN, detached, caused by rainwater intrusion (Main Bldg., Basement, Laboratory Reception Lobby)	
Additional Comments:

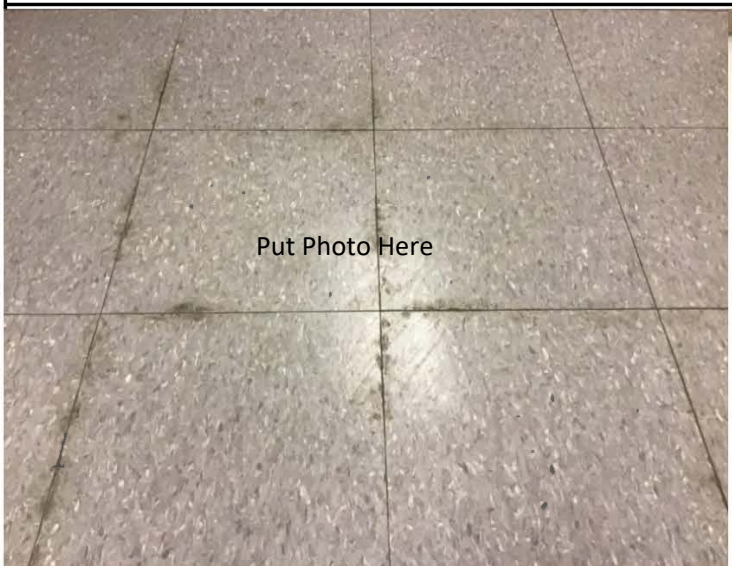
Damage Description:	Item #: 64
Floor, VCT, 12x12 IN, detached, caused by rainwater intrusion (Main Bldg., Basement, Laboratory Reception Lobby)	
Additional Comments:

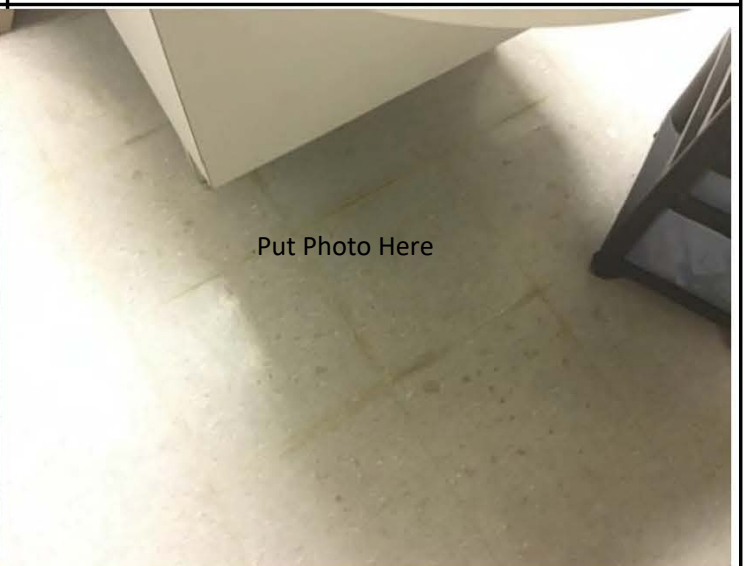
Damage Description:	Item #: 65
Floor, VCT, 12x12 IN, detached, caused by surface water flooding (Main Bldg., Basement, Laboratory R009)	
Additional Comments:

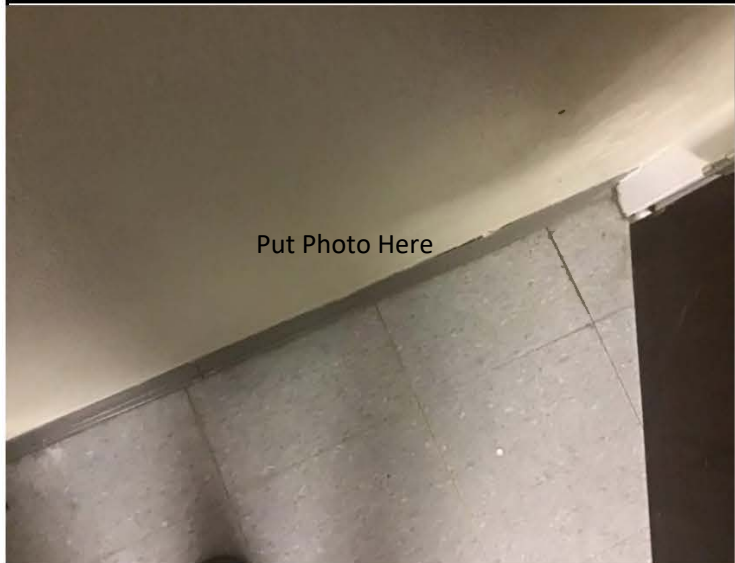
Damage Description:	Item #: 66
Base Lining, vinyl, 4 IN, detached, caused by surface water flooding (Main Bldg., Basement, Laboratory R009)	
Additional Comments:

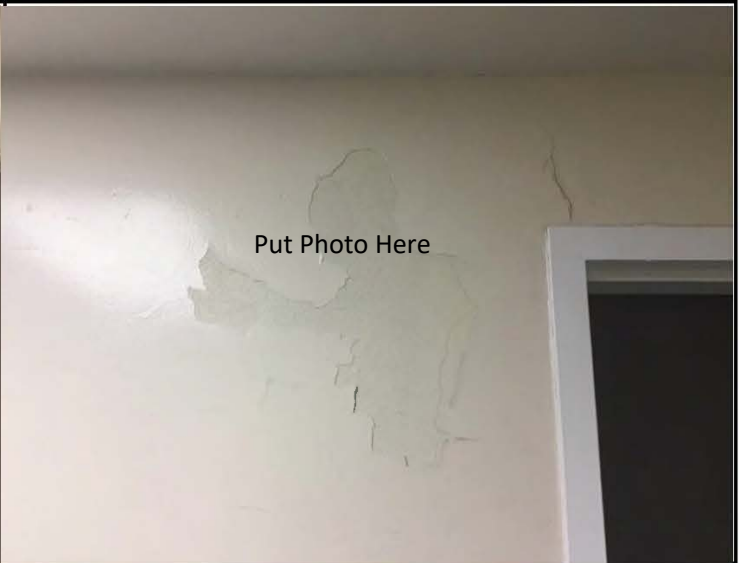
Damage Description:	Item #: 67
Wall, ¼ IN thick plaster on concrete, repair spalling, deformed, caused by rainwater intrusion (Main Bldg., Basement, Laboratory Hallway)	
Additional Comments:

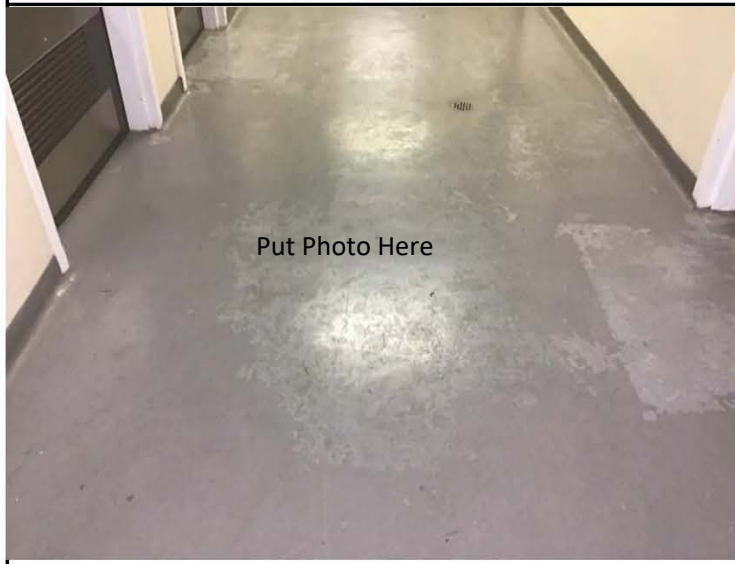
Damage Description:	Item #: 69
Floor, sealed concrete, epoxy painted, peeling paint, caused by surface water flooding (Main Bldg., Basement, Laboratory Interior Hallway)	
Additional Comments:

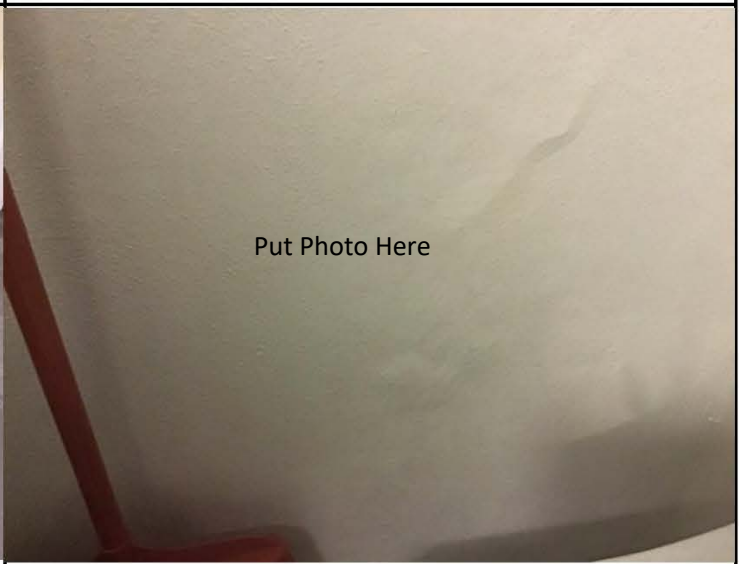
Damage Description:	Item #: 70
Wall, ¼ IN thick plaster on concrete, repair spalling, cracked, caused by rainwater intrusion (Main Bldg., Basement, Laboratory R032)	
Additional Comments:
