Applicant: Universidad Central Del Caribe, Inc.	Damage Inventory: 305240	Category: E
WO # 46525 FIPS# 021-UNUGB-00	Date: 09/04-17/2019 GPS: 18.365953, -66.153767	
Inspector: Gregory Sondergeld / Alexander Nieves	Damage Facility: Main Bldg.

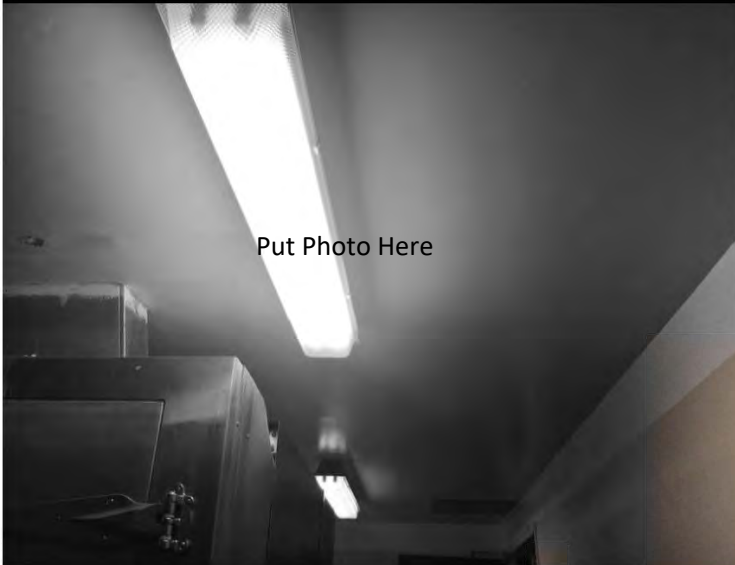
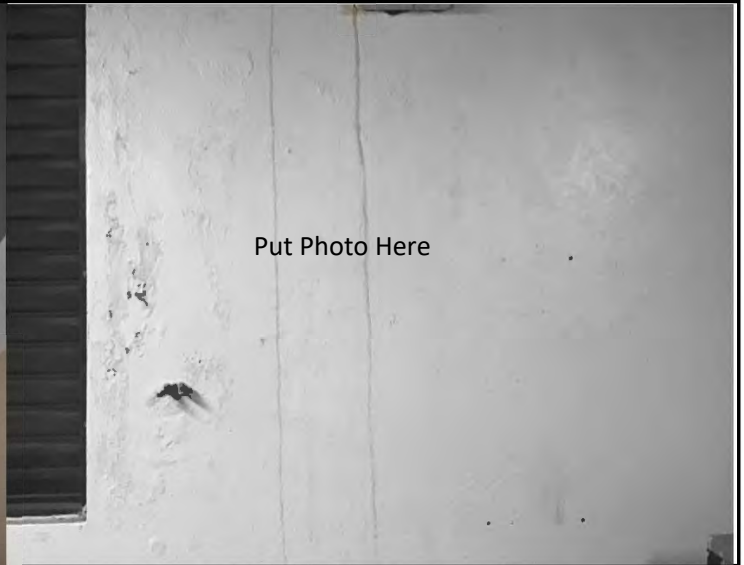
Damage Description:	Item #: 75	Damage Description:	Item #: 76
Ceiling, drywall, paint, discolored, caused by rainwater intrusion (Main Bldg., Basement, Laboratory R027)		Wall, ¼ IN thick plaster on concrete, repair spalling, cracked, caused by rainwater intrusion (Main Bldg., Basement, Air Handler Unit R516)	
Additional Comments:		Additional Comments:

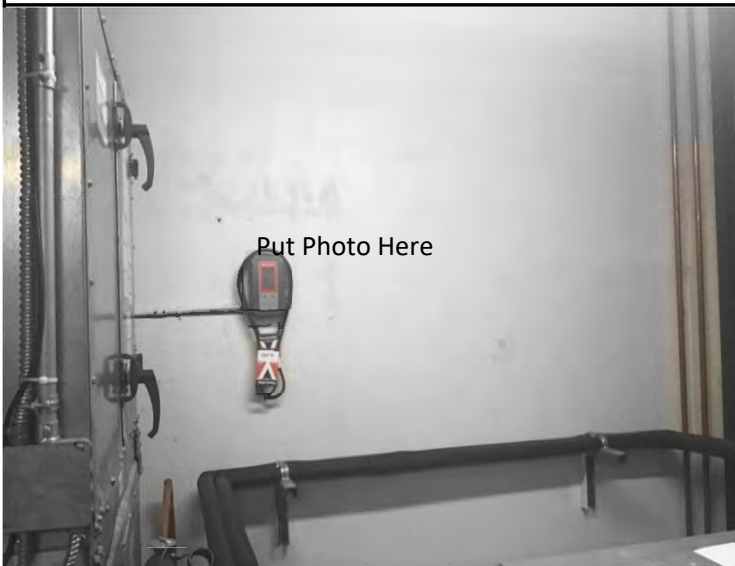
Damage Description:	Item #: 77	Damage Description:	Item #: 78
Wall, ¼ IN thick plaster on concrete, painted, peeling paint, caused by rainwater intrusion (Main Bldg., Basement, Air Handler Unit R516)		NOT USE	
Additional Comments:		Additional Comments:

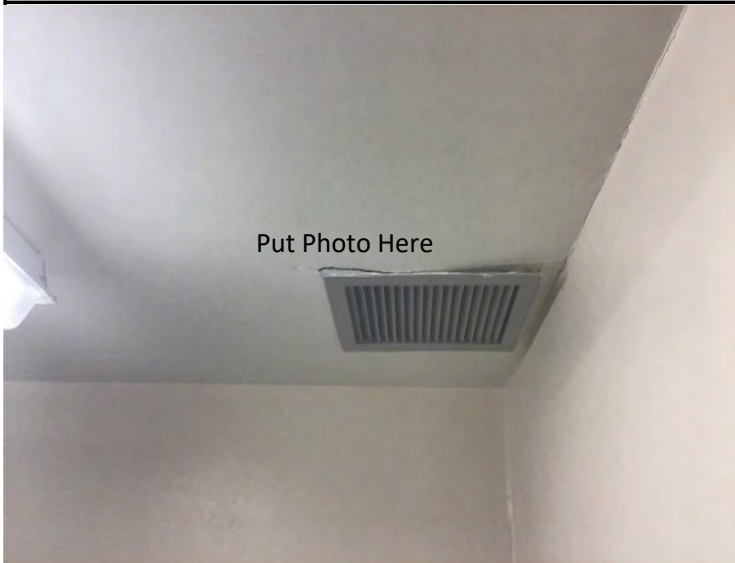
Damage Description:	Item #: 81
Wall, drywall, repair, cracked, caused by rainwater intrusion (Main Bldg., Basement, Laboratory R029 & 028)	
Additional Comments:

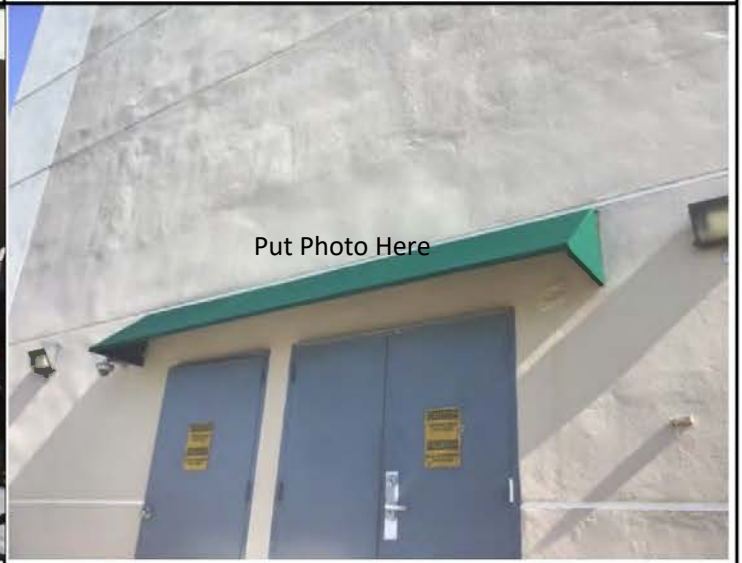
Damage Description:	Item #: 83
Hand Rail, Guard rail, galvanized steel piping, 1 1/2-IN dia., triple rail, painted finish, broken components, caused by wind-blown debris (Main Bldg., Exterior, Ramp)	
Additional Comments:

Damage Description:	Item #: 84
Entrance awning, aluminum-framed, fabric covered, broken components, caused by high winds (Main Bldg., Exterior, Loading Dock)	
Additional Comments:

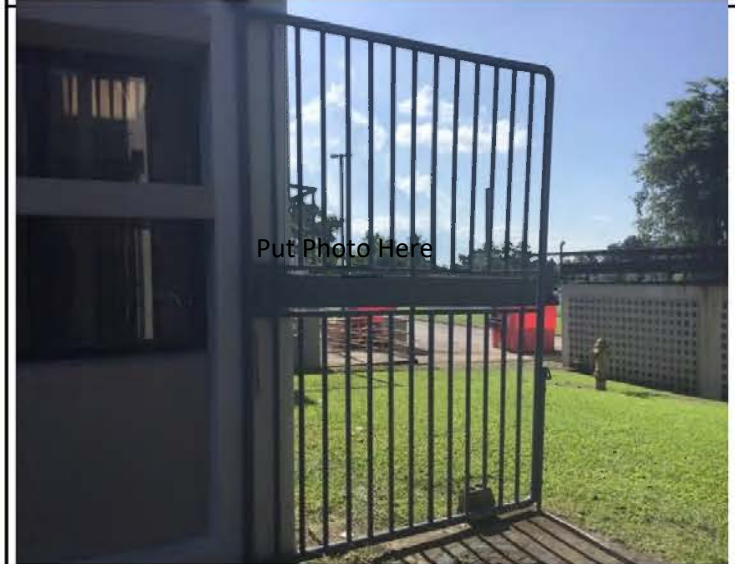
Damage Description:	Item #: 85
Security gate, galvanized tubular steel piping, 2 IN-dia. perimeter framing, 1.5 IN-dia. vertical framing, steel ball-bearing pin hinges, painted finish, broken components, caused by wind-blown debris (Main Bldg., Exterior, Loading Dock)	
Additional Comments:
