Applicant: Universidad Central Del Caribe, Inc.	Damage Inventory: 305240	Category: E
WO # 46525 FIPS# 021-UNUGB-00	Date: 09/04-17/2019 GPS: 18.365953, -66.153767	
Inspector: Gregory Sondergeld / Alexander Nieves	Damage Facility: Main Bldg.

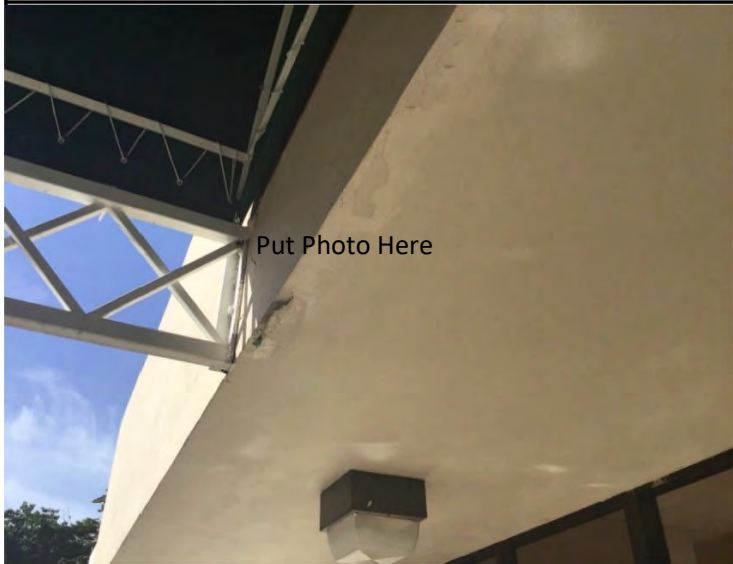
Damage Description:	Item #: 1
Ceiling, ¼ IN thick plaster on concrete, repair spalling and paint, cracked, caused by rain water intrusion (Main Bldg., Exterior, Main Entrance)	
Additional Comments:

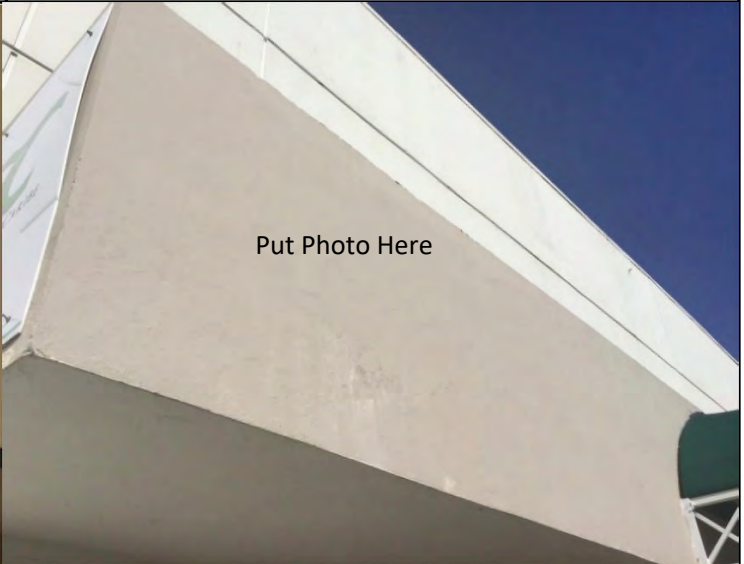
Damage Description:	Item #: 2
Wall, ¼ IN thick plaster on concrete, repair spalling and paint, discolored, caused by rainwater intrusion (Main Bldg., Exterior, Fascia East & West)	
Additional Comments:

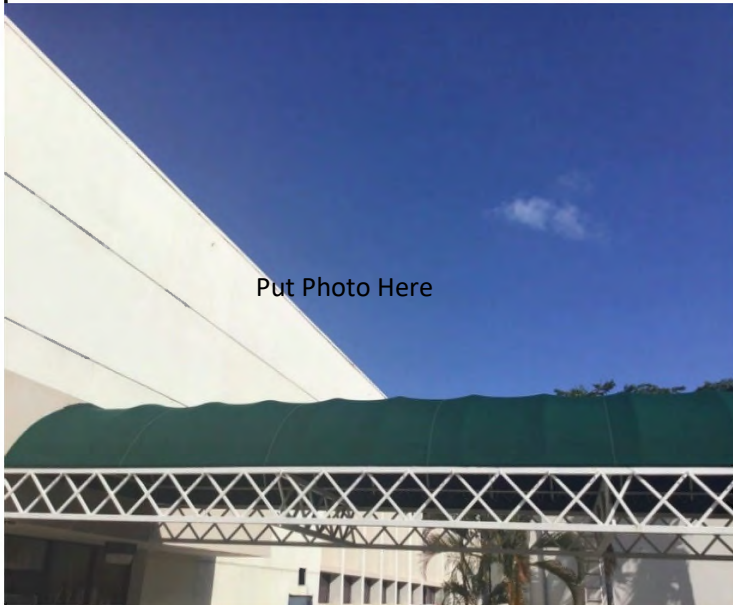
Damage Description:	Item #: 3
Entrance Canopy, steel-framed, barrel vault-shaped, fabric covering only, broken components, caused by high winds (Main Bldg., Exterior, Canopy)	
Additional Comments:

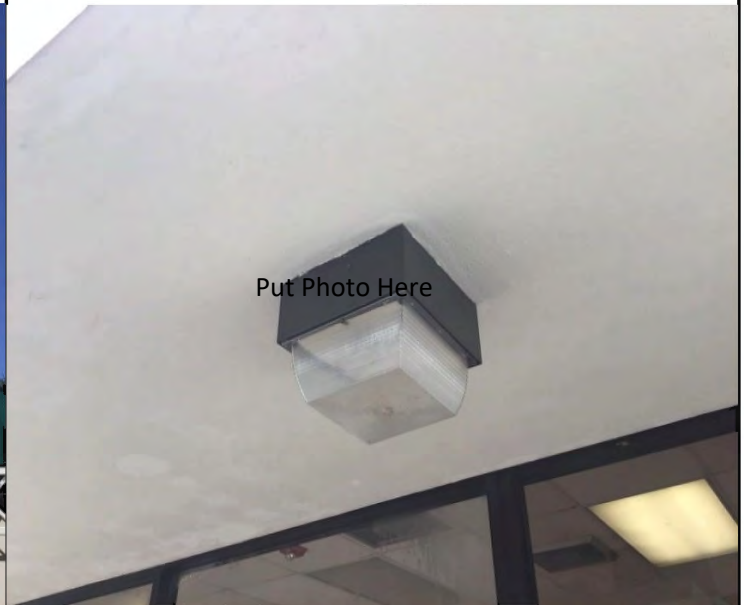
Damage Description:	Item #: 4
Light, Outdoor, surface-mounted, soffit fixture, 1 FT x 1 FT, clear acrylic lens cover only, cracked, caused by high winds (Main Bldg., Exterior, Entire Floor)	
Additional Comments:

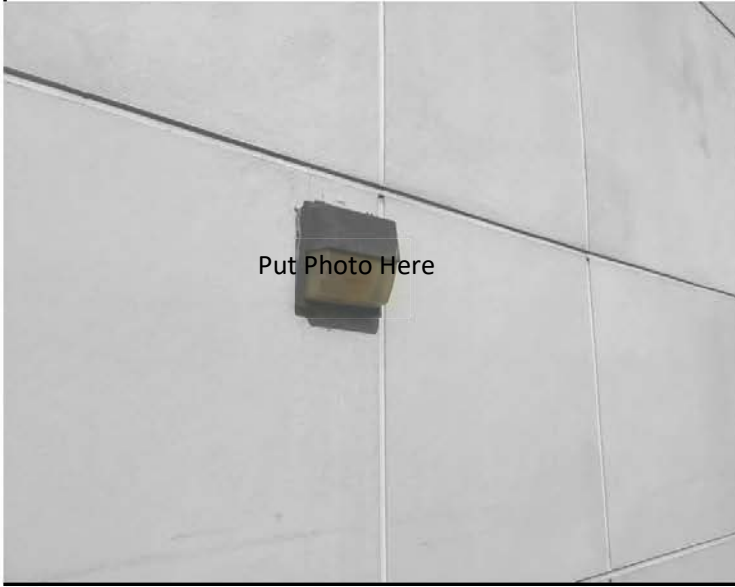
Damage Description:	Item #: 5
Light, Wall Pack luminaire, 110 Volt, 200-Watt, high-pressure sodium, cracked, caused by wind-blown debris (Main Bldg., Exterior, Entire Floor)	
Additional Comments:

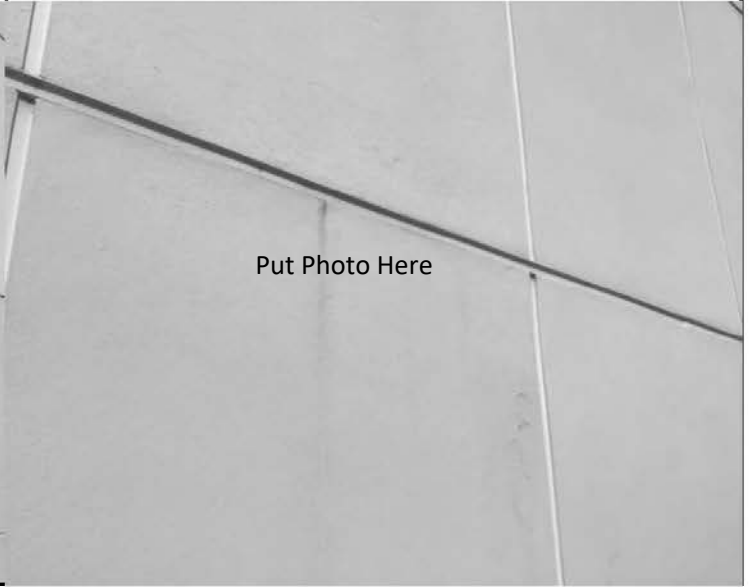
Damage Description:	Item #: 6
Wall, ¼ IN thick plaster on concrete, repair spalling, discolored, caused by rainwater intrusion (Main Bldg., Exterior, Entire Floor)	
Additional Comments:

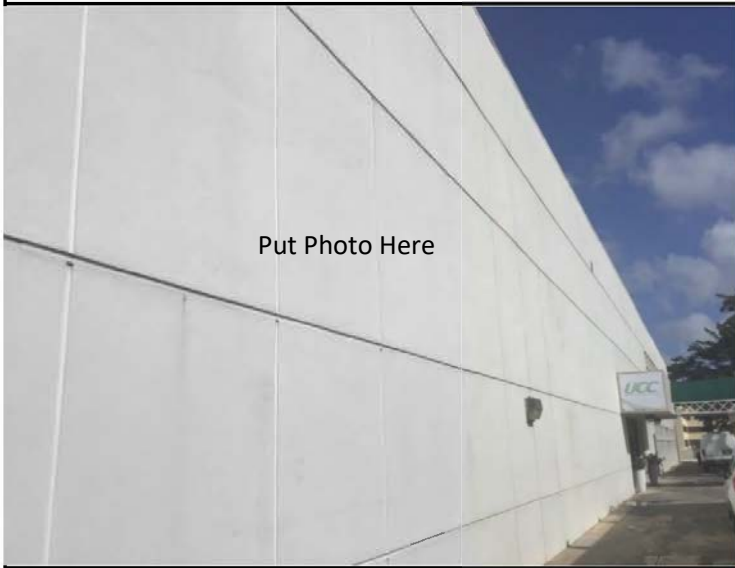
Damage Description:	Item #: 7
Wall, ¼ IN thick plaster on concrete, painted, discolored, caused by rainwater intrusion (Main Bldg., Exterior, Entire Floor)	
Additional Comments:

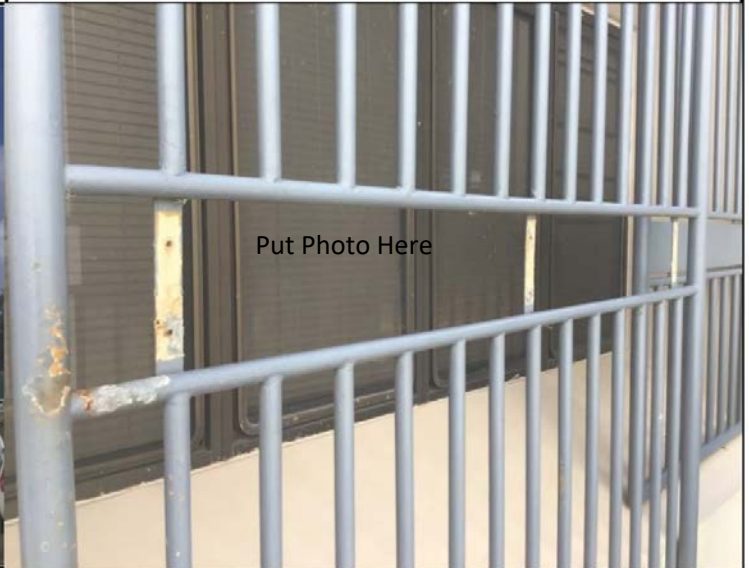
Damage Description:	Item #: 8
Tubular steel security gate, wooden insert only, 1 IN D x 8 IN W x 8 FT L, painted, broken components, caused by wind-blown debris (Main Bldg., Exterior, Steel Security Gate)	
Additional Comments:

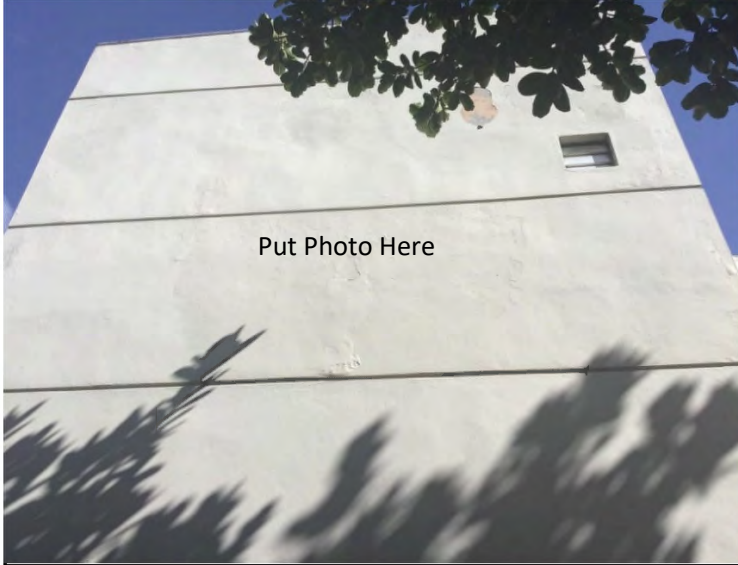
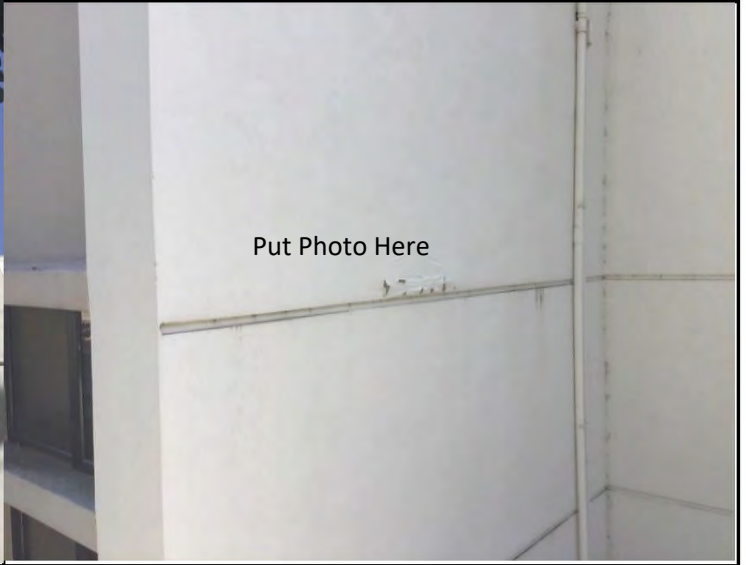
Damage Description:	Item #: 9	Damage Description:	Item #: 10 Wall,
Wall, ¼ IN thick plaster on concrete, repair spalling, peeling paint, caused by rainwater intrusion (Main Bldg., Exterior, Entire Floor)		¼ IN thick plaster on concrete, painted, peeling paint, caused by rainwater intrusion (Main Bldg., Exterior, Entire Floor)	
Additional Comments:		Additional Comments:

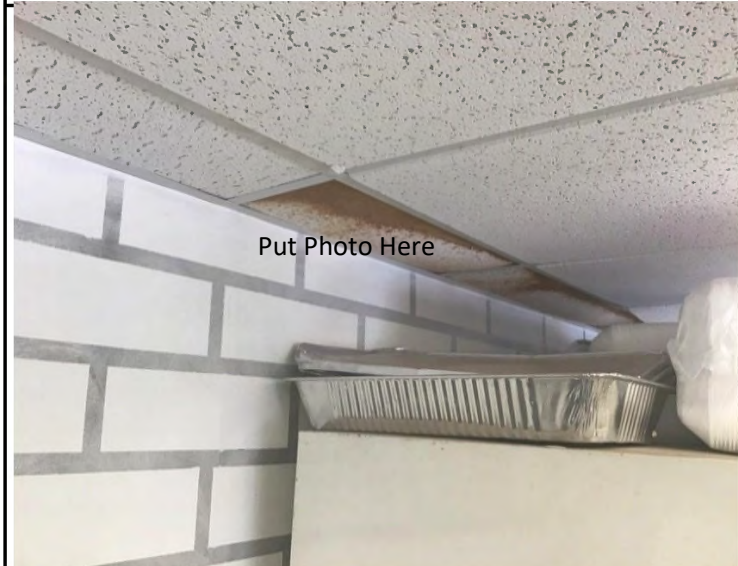
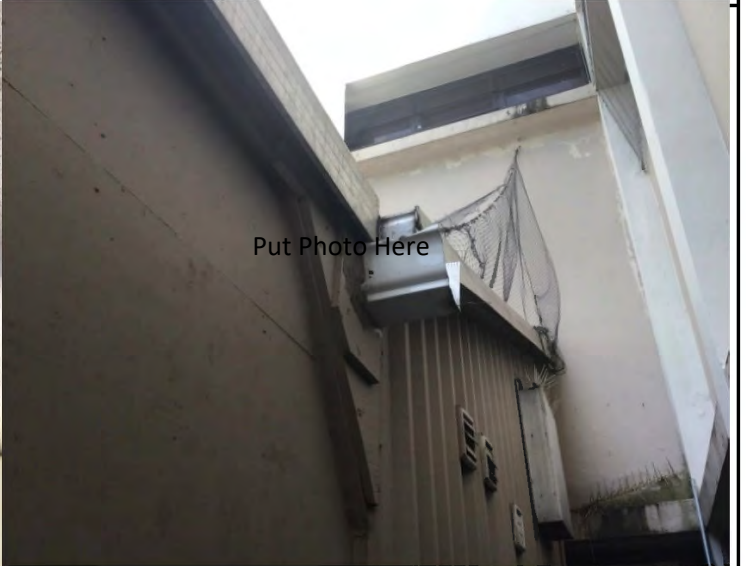
Damage Description:	Item #: 11	Damage Description:	Item #: 12
Ceiling, 2 FT x 2 FT acoustic tile, suspended, tegular, discolored, caused by rainwater intrusion (Main Bldg., Floor 1, Cafeteria)		Roof, Metal flashing, 26 gauge, 6 IN x 6 IN, deformed, caused by high winds (Main Bldg., Floor 1, Cafeteria)	
Additional Comments:		Additional Comments:

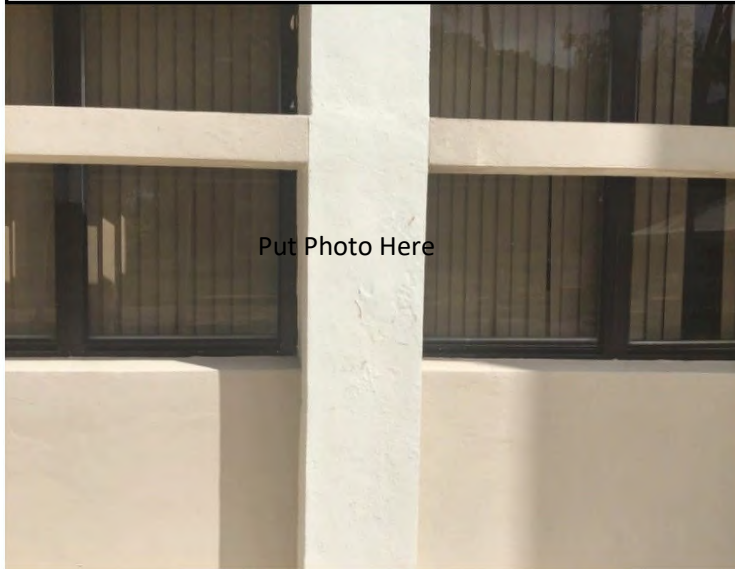
Damage Description:	Item #: 13
Wall, ¼ IN thick plaster on concrete, repair spalling, discolored, caused by rain water intrusion (Main Bldg., Exterior, Entire Floor)	
Additional Comments:

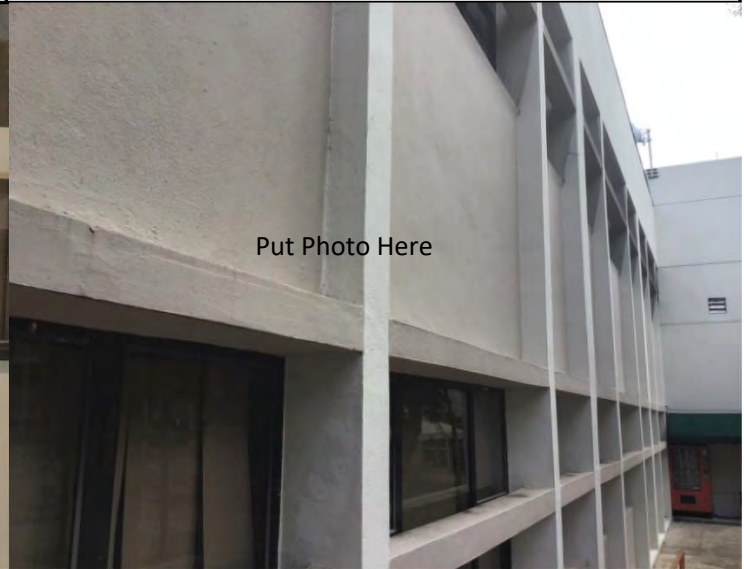
Damage Description:	Item #: 14
Wall, ¼ IN thick plaster on concrete, painted, peeling paint, caused by rainwater intrusion (Main Bldg., Exterior, Entire Floor)	
Additional Comments:

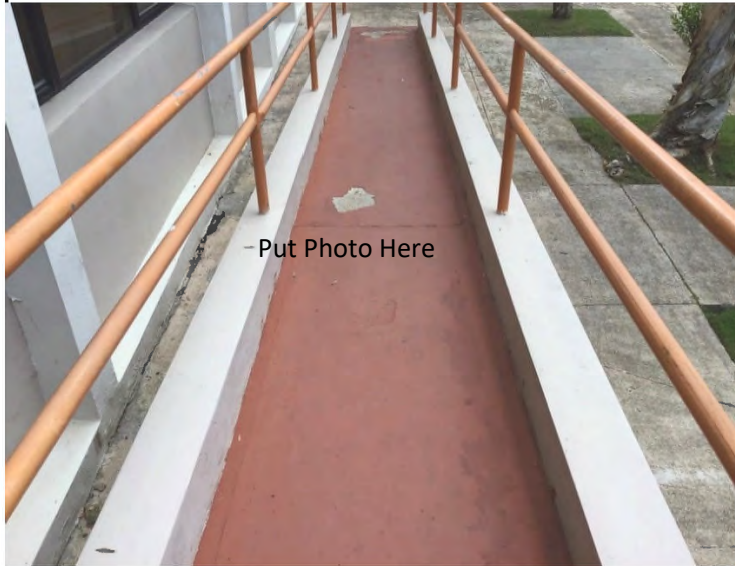
Damage Description:	Item #: 15
Floor, sealed concrete, epoxy-coated, peeling paint, caused by surface water flooding (Main Bldg., Exterior, Handicap-Access Ramp)	
Additional Comments:

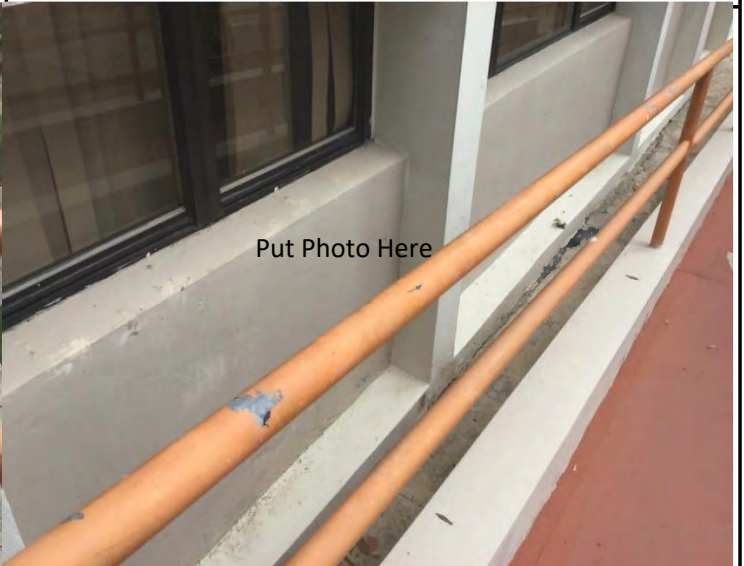
Damage Description:	Item #: 16
Hand Rail, Hand rail, galvanized steel piping, 2 IN-dia., double rail, painted finish, peeling paint, caused by wind-driven rain (Main Bldg., Exterior, Ramp)	
Additional Comments:

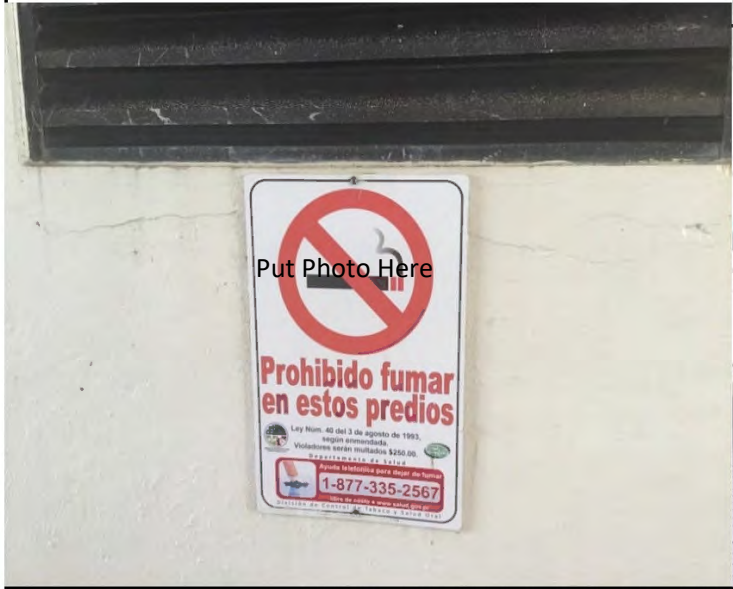
Damage Description:	Item #:	17
Wall, ¼ IN thick plaster on concrete, repair spalling, cracked, caused by rainwater intrusion (Main Bldg., Exterior, Entire Floor)		
Additional Comments:

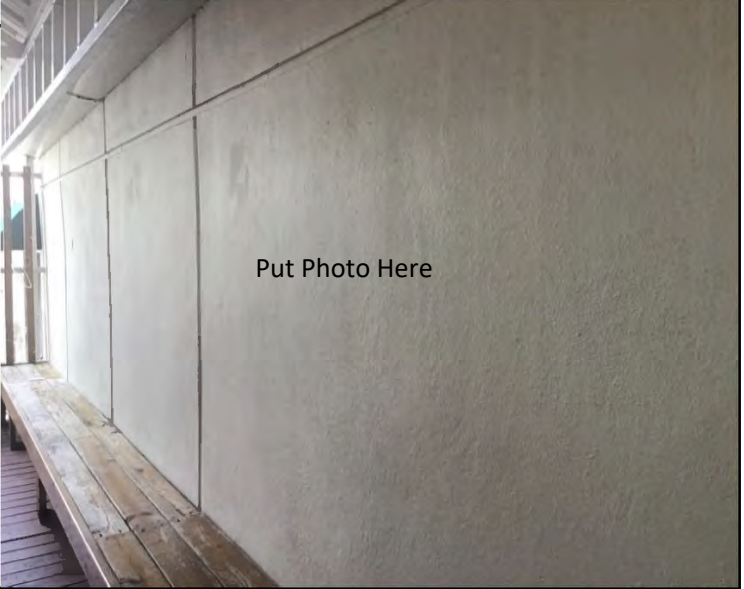
Damage Description:	Item #:	18
Wall, ¼ IN thick plaster on concrete, painted, discolored, caused by rainwater intrusion (Main Bldg., Exterior, Entire Floor)		
Additional Comments:

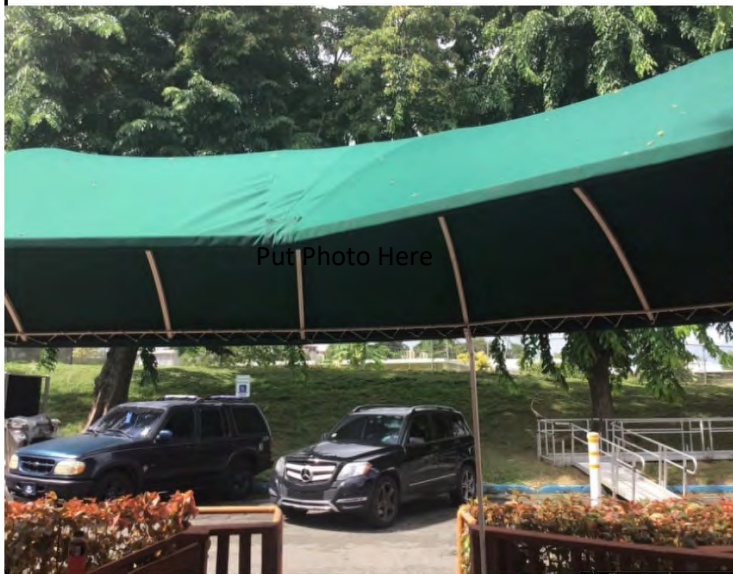
Damage Description:	Item #:	19
Entrance Canopy, metal-framed, arch-shaped, painted with fabric covering, broken components, caused by high winds (Main Bldg., Exterior, Wooden Patio Deck)		
Additional Comments:

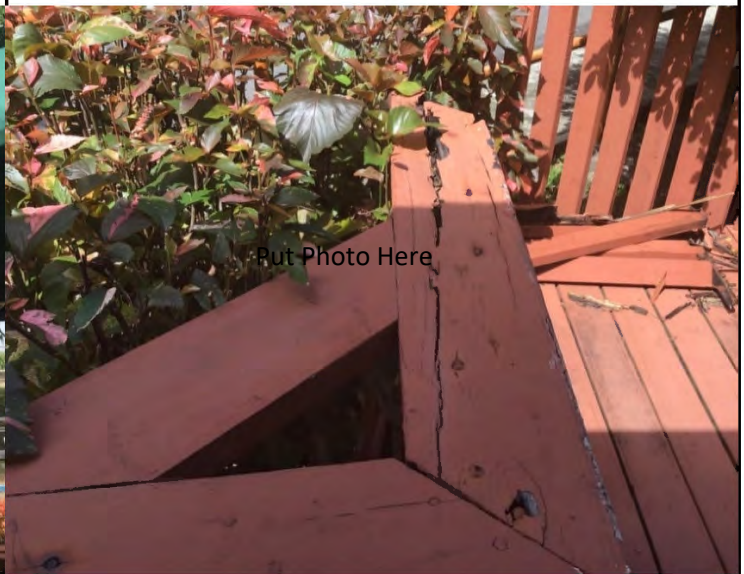
Damage Description:	Item #:	20
Wooden Deck Railing, 3 FT tall, with 2 IN x 4 IN top rail and angled balustrades spaced at 6 IN on-center, painted, broken components, caused by high winds (Main Bldg., Exterior, Wooden Patio Deck)		
Additional Comments:

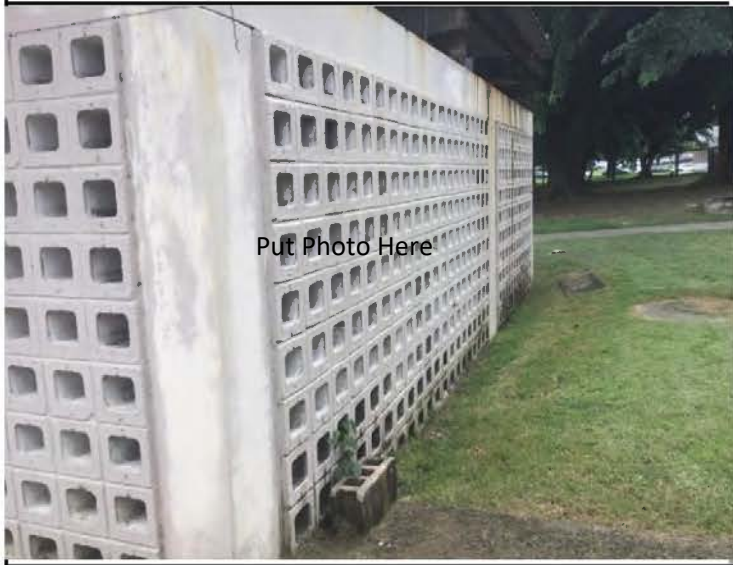
Damage Description:	Item #: 27
Wall, ¼ IN thick plaster on concrete, painted, peeling paint caused, by wind-driven rain (Main Bldg., Exterior, Generator Shed Area)	
Additional Comments:

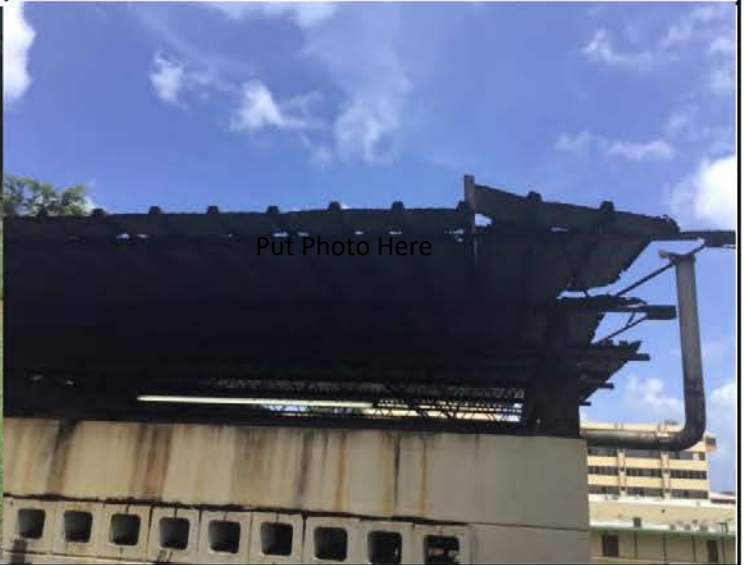
Damage Description:	Item #: 26
Roof, Ribbed metal roofing, 26-gauge, galvanized, broken components. caused by high winds (Main Bldg., Exterior, Generator Shed Area)	
Additional Comments:
