Applicant: Universidad Central Del Caribe, Inc.	Damage Inventory: 305244	Category: E
WO # 46525 FIPS# 021-UNUGB-00	Date: 09/04-17/2019 GPS: 18.366101, -66.154301	
Inspector: Gregory Sondergeld / Alexander Nieves	Damage Facility: Main Bldg. Annex

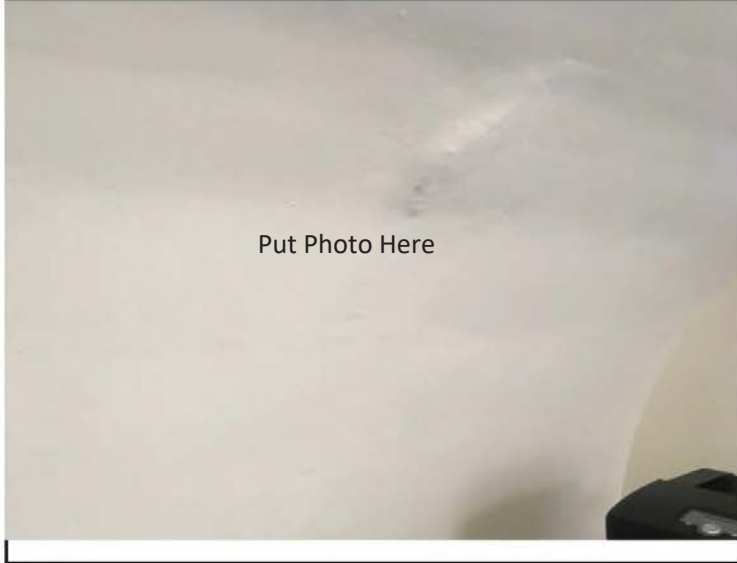
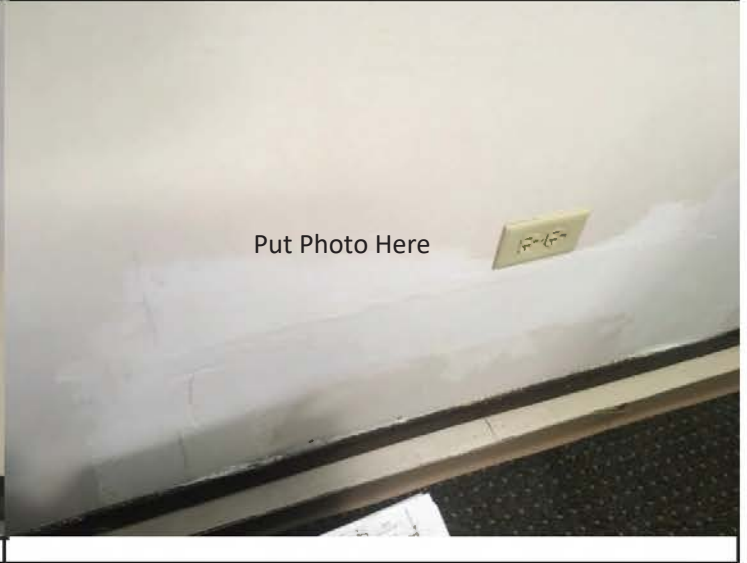
Damage Description:	Item #: 93	Damage Description:	Item #: 93
Wall, drywall, repair, deformed, caused by rain water intrusion (Main Bldg. Annex, Floor 2, Office R484)		Wall, drywall, repair, deformed, caused by rain water intrusion (Main Bldg. Annex, Floor 2, Office R484)	
Additional Comments:		Additional Comments:

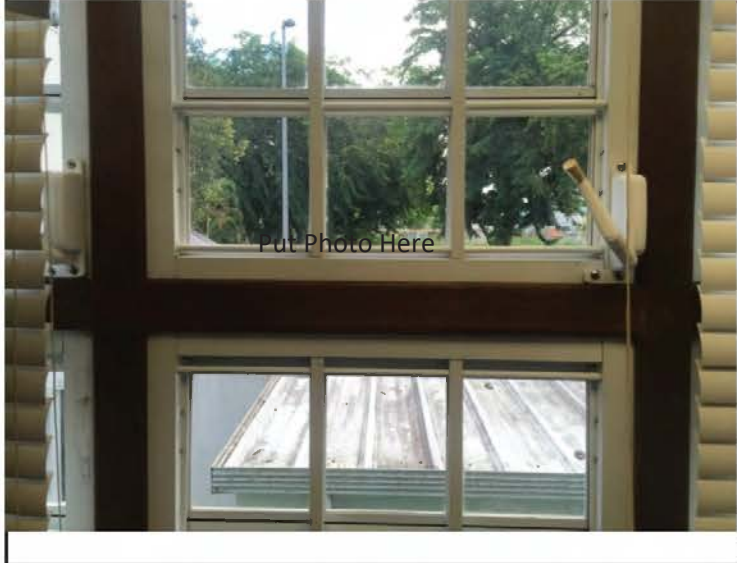
Damage Description:	Item #: 95	Damage Description:	Item #: 96
Window, Wood Trim, 1/2 IN x 3 IN, discolored, caused by rain water intrusion (Main Bldg. Annex, Floor 2, Office R484)		Window, Alum. window frames, perimeter caulking/sealing only, cracked, caused by rain water intrusion (Main Bldg. Annex, Floor 2, Office R484)	
Additional Comments:		Additional Comments:

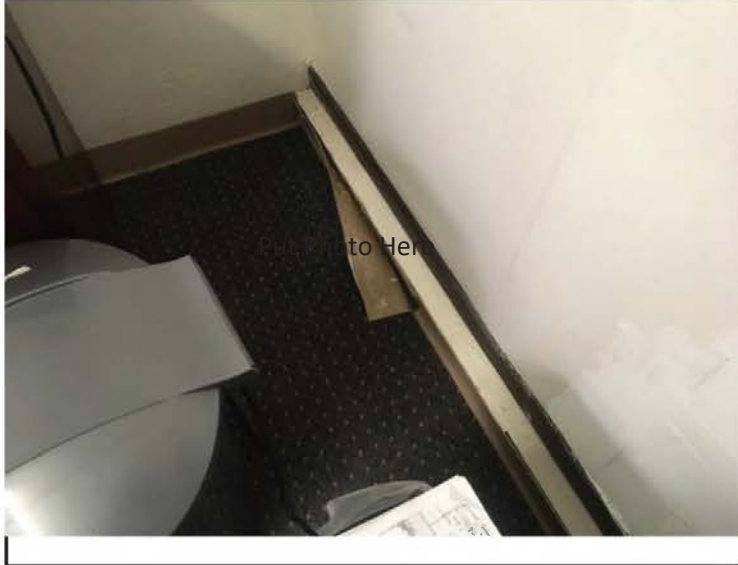
Damage Description:	Item #: 97	Damage Description:	Item #: 99
Base Lining, vinyl, 4 IN, deformed, caused by rain water intrusion (Main Bldg. Annex, Floor 2, Office R484)		Wall, drywall, repair, cracked, caused by rain water intrusion (Main Bldg. Annex, Floor 2, Office R485)	
Additional Comments:		Additional Comments:

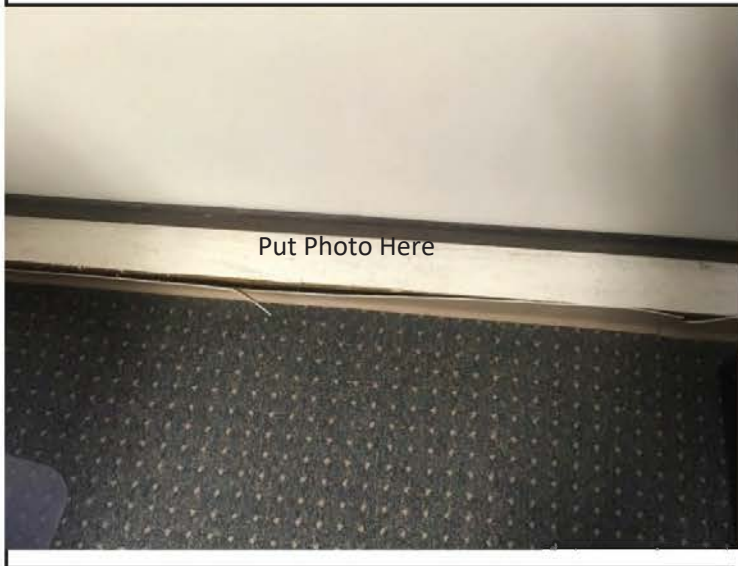
Damage Description:	Item #: 101	Damage Description:	Item #: 102
Base Lining, vinyl, 4 IN, deformed, caused by rain water intrusion (Main Bldg. Annex, Floor 2, Office R485)		Ceiling, drywall, repair, discolored, caused by rain water intrusion (Main Bldg. Annex, Floor 2, Office R483)	
Additional Comments:		Additional Comments:

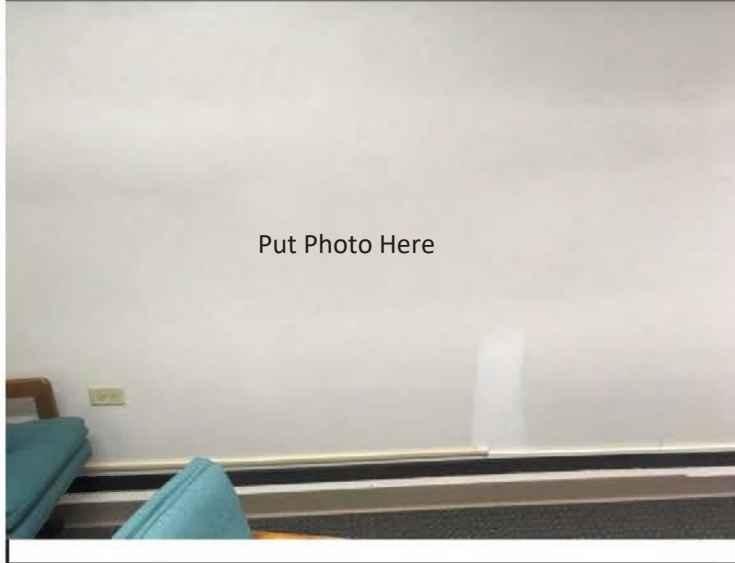
Damage Description:	Item #: 103
Wall, drywall, painted, discolored, caused by rain water intrusion (Main Bldg. Annex, Floor 2, Office R483)	
Additional Comments:

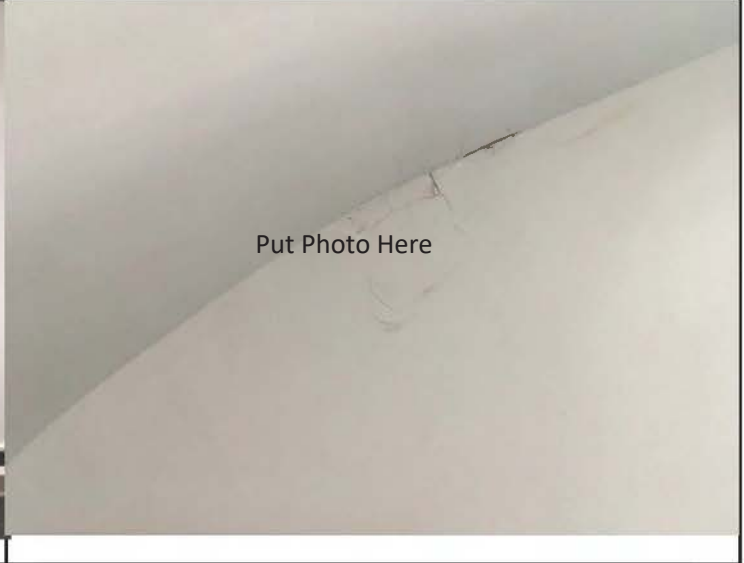
Damage Description:	Item #: 104
Wall, drywall, repair, cracked, caused by rain water intrusion (Main Bldg. Annex, Floor 2, Classroom R480)	
Additional Comments:

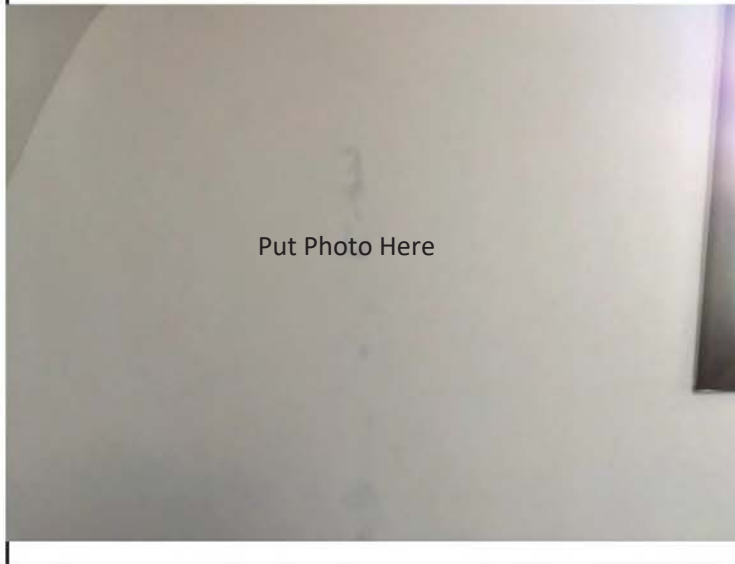
Damage Description:	Item #: 105
Wall, drywall, painted, cracked, caused by rain water intrusion (Main Bldg. Annex, Floor 2, Classroom R480)	
Additional Comments:

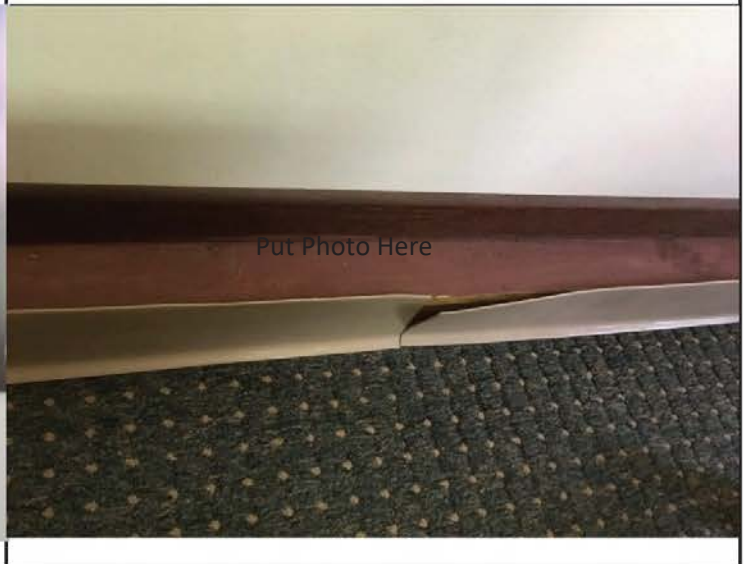
Damage Description:	Item #: 106
Base Lining, vinyl, 4 IN, dislodged, caused by rain water intrusion (Main Bldg. Annex, Floor 2, Dining Room R480)	
Additional Comments:

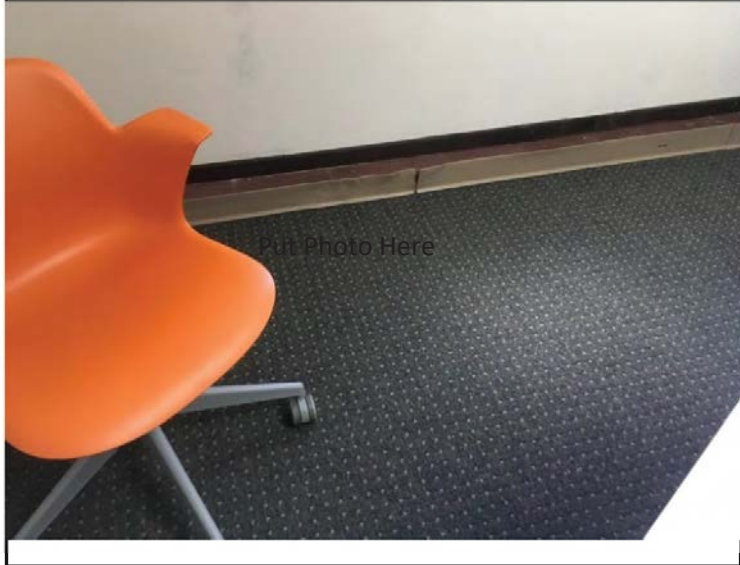
Damage Description:	Item #: 107	Damage Description:	Item #:
Floor, carpet, commercial-grade, discolored, caused by rain water intrusion (Main Bldg. Annex, Floor 2, Dining Room R480)			
Additional Comments:		Additional Comments:
