Applicant: Universidad Central del Caribe	Damage Inventory # 305244	Category E
Work Order # 62056 FIPS # 021-UNUGB-00	Date: July 17, 2020	GPS 18.36610, -66.15430
Site Inspector: Edwin G. Rosario	Damage Facility: Main Building Annex

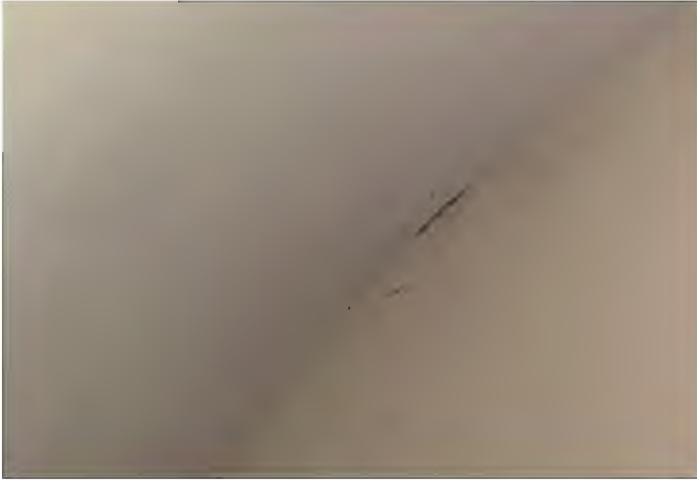
Applicant: Universidad Central del Caribe		Damage Inventory # 305244		Category E	
Work Order # 62056		FIPS # 021-UNUGB-00		Date: July 17, 2020	
				GPS 18.36610, -66.15430	
Site Inspector: Edwin G. Rosario		Damage Facility: Main Building Annex			
		Photo# 9		Photo# 10	
Interior, Room # 480, Wall, drywall cracked caused by rain water intrusion		Interior, Room # 480, Wall, drywall painted, discolored, caused by rain water intrusion

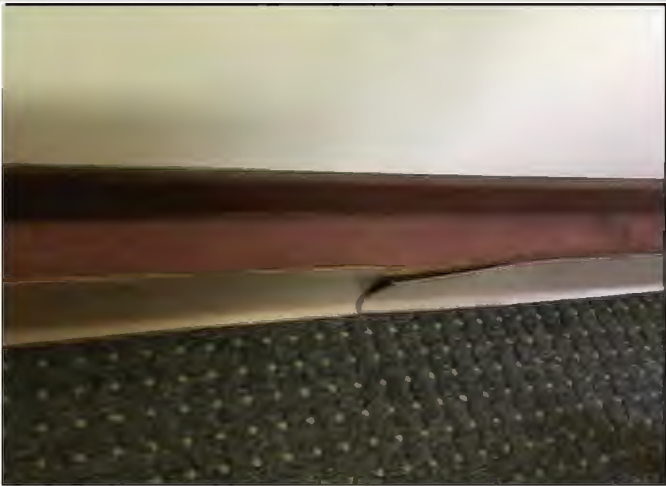
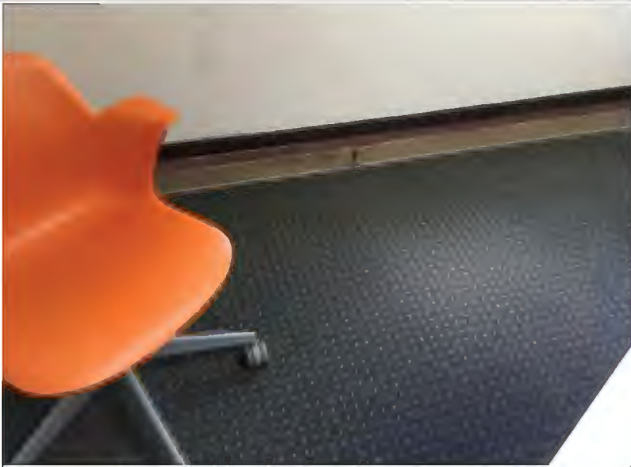
Damage Description:		Photo# 11		Photo# 12	
Interior, Room # 580, Base molding, vinyl, 4 IN, dislodged, caused by rain water intrusion		Interior, Room # 580, Carpet, Commercial grade, discolored, caused by rain water intrusion

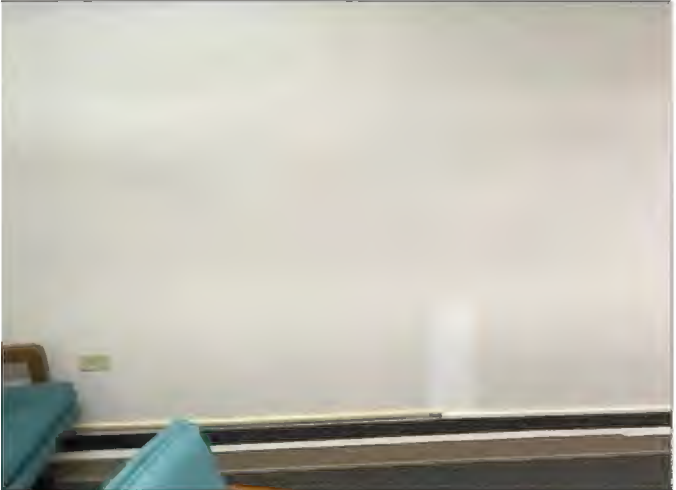
Damage Description:	Photo# 13
Interior, Hallway, Aluminum window, broken components, caused by high winds

Damage Description	Photo# 14
Interior, Room # 483, Wall, drywall painted, discolored, caused by rain water intrusion

Damage Description:	Photo# 15
Interior, Room # 483, Wall, drywall, painted, discolored caused by rain water intrusion

Damage Description	Photo# 16
Interior, Room # 484, Wall, drywall, deformed caused by rain water intrusion

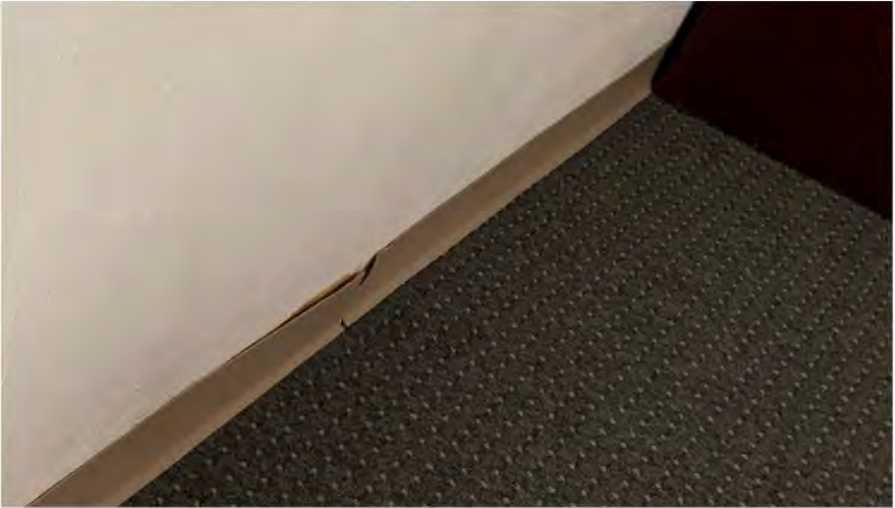
Damage Description:	Photo# 17
Interior, Room # 484, Wall, drywall, peeling paint, caused by rain water intrusion

Damage Description	Photo# 18
Interior, Room # 484, Window, wooden casing trim, pine, discolored, caused by rain water intrusion

Damage Description:	Photo# 19
Interior, Room # 484, Window, aluminum frame, caulking sealing, cracked, caused by rain water intrusion

Damage Description	Photo# 20
Interior, Room # 484, Base molding, vinyl, deformed caused by rain water intrusion

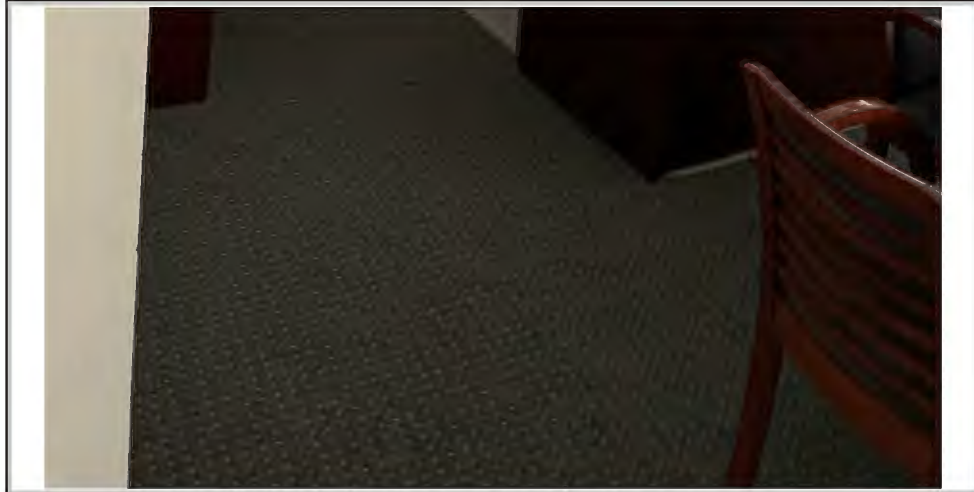
Photo# 21

Damage Description: Interior, Room # 484, Floor, Carpet, commercial grade, discolored, caused by rain water intrusion (Photo shows already replaced carpet)

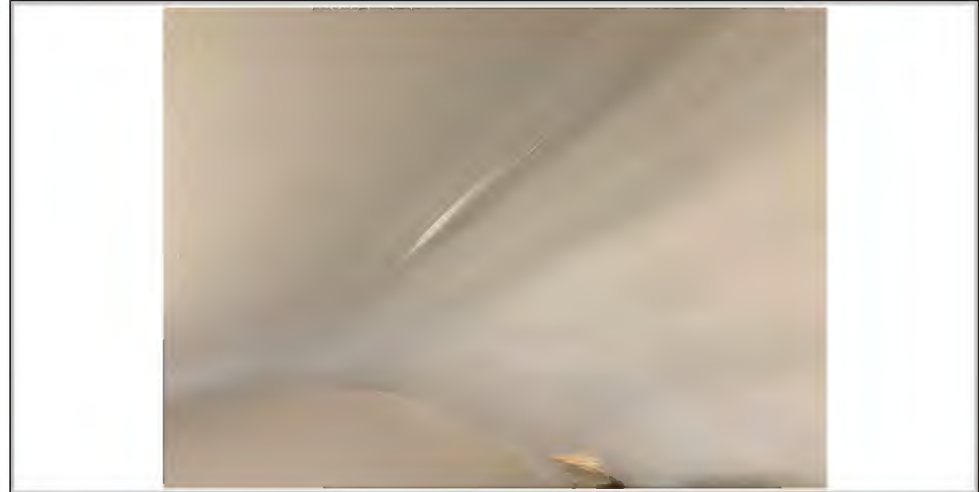
Photo# 22

Damage Description Interior, Room # 485, Wall, drywall, cracked, caused by rain water intrusion

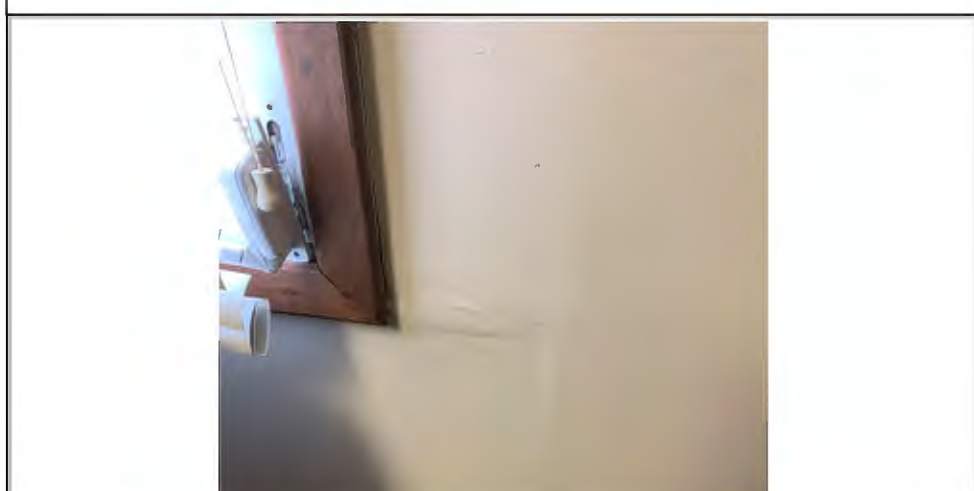
Photo# 23

Damage Description: Interior, Room # 485, Wall, drywall, painted, discolored, caused by rain water intrusion

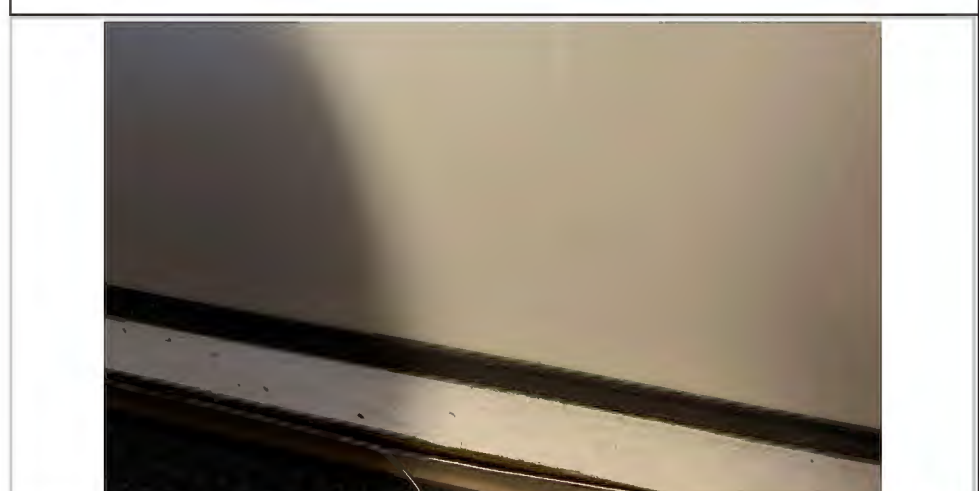
Photo# 24

Damage Description Interior, Room # 485, Base molding, vinyl, deformed, caused by rain water intrusion
