Applicant: Universidad Central Del Caribe, Inc.	Damage Inventory: 305310	Category: G
WO # 46525 FIPS# 021-UNUGB-00	Date: 09/04-17/2019 GPS: 18.36519, -66.152814	
Inspector: Gregory Sondergeld / Alexander Nieves	Damage Facility: Site 1

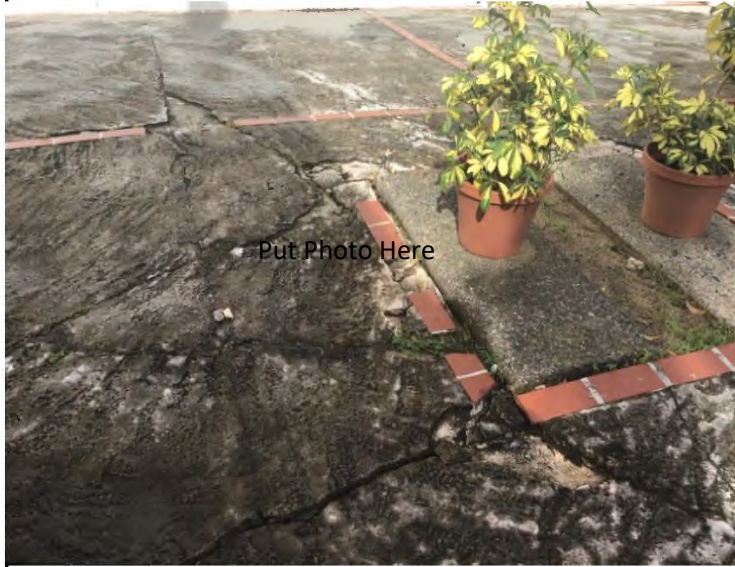
Damage Description:	Item #: 1	Damage Description:	Item #: 2
Concrete sidewalk, panels, 4 IN Thick, cracked, caused by other (Site 1)		Sidewalk trim tiles, Terracotta clay, 4 IN x 8 IN, cracked, caused by other (Site 1)	
Additional Comments:		Additional Comments:

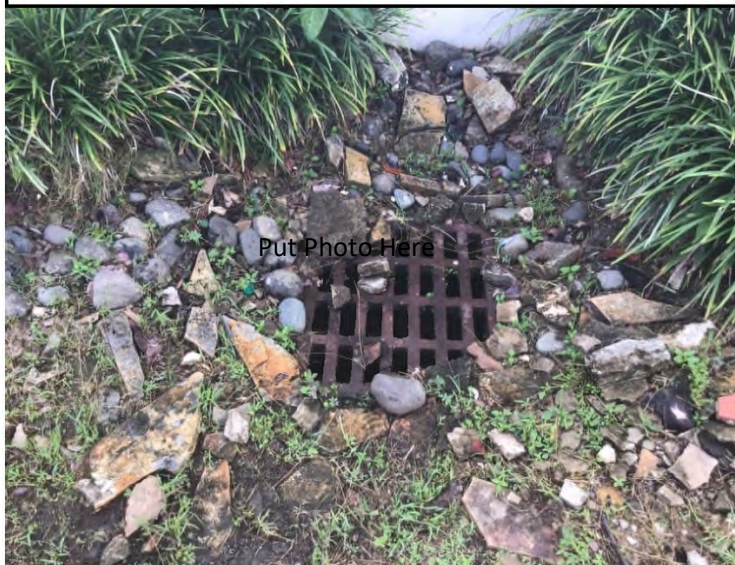
Damage Description:	Item #: 3 Storm	Damage Description:	Item #: 4
drainage system, Casa Salud Courtyard area, clogged, caused by surface water flooding (Site 1)		Aggregate concrete bench, 48 IN L x 18 IN W x 3 IN D, cracked, caused by wind-blown debris (Site 1)	
Additional Comments:		Additional Comments:

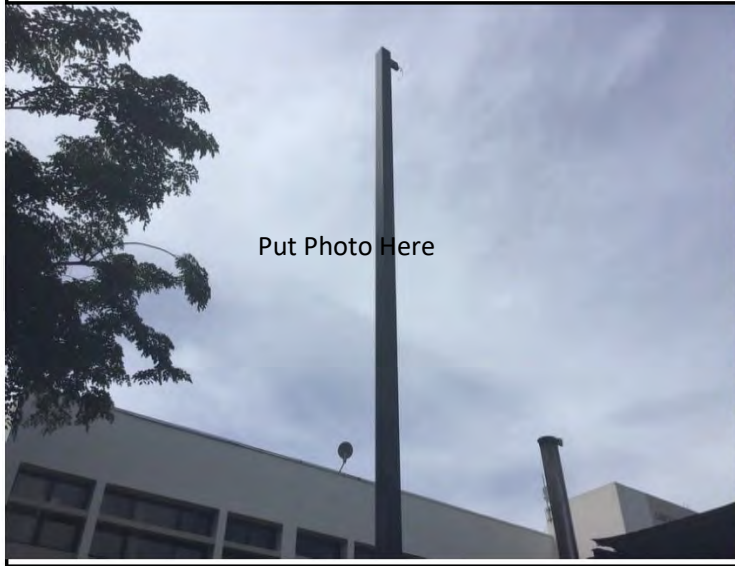
Damage Description:	Item #:	5
Generator Shed luminaire, single, 110-Volt, 80-Watt, high-pressure sodium bulb, including rewiring from pole-to-fixture only, mounted onto existing 25-FT tapered, aluminum light pole, missing components, caused by high winds (Site 1)		
Additional Comments:

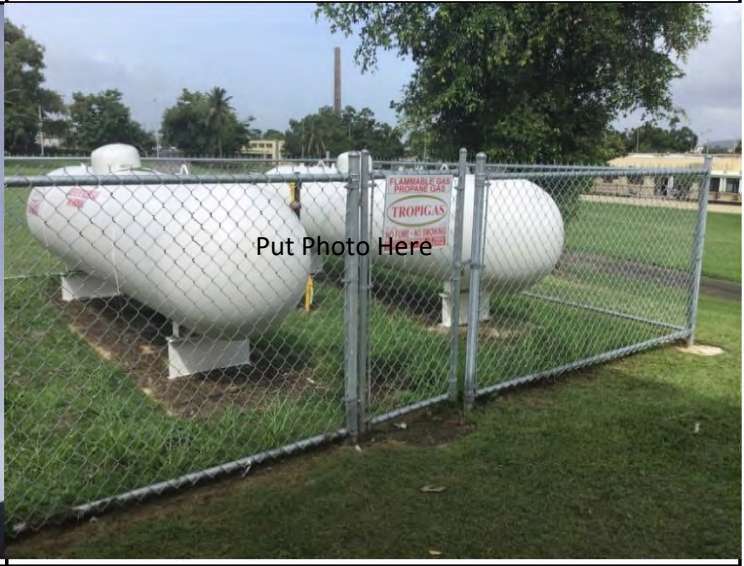
Damage Description:	Item #:	6
Security fencing, commercial-grade, chain link, 9-gauge, 4 FT tall, located around perimeter of propane tanks at Generator Shed, deformed, caused by wind-blown debris (Site 1)		
Additional Comments:

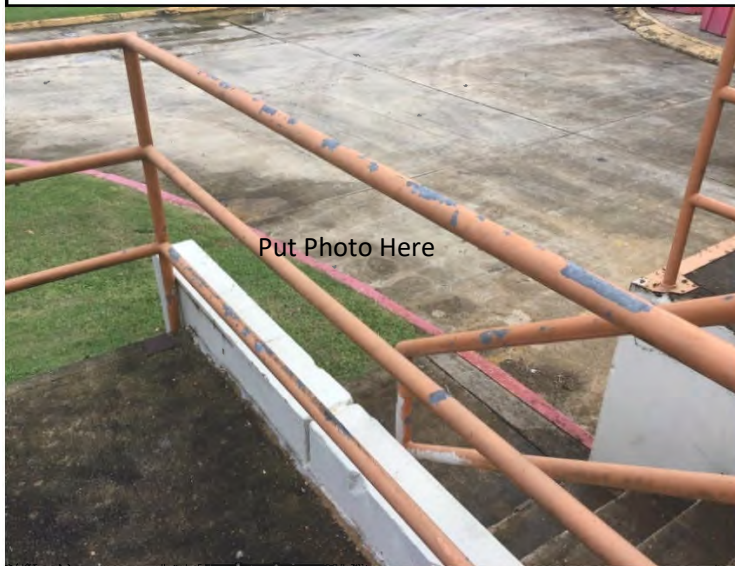
Damage Description:	Item #:	7
Guard rail, galvanized steel piping, 1 1/2 IN dia., triple rail, painted finish, peeling paint, caused by wind-driven rain (Site 1)		
Additional Comments:

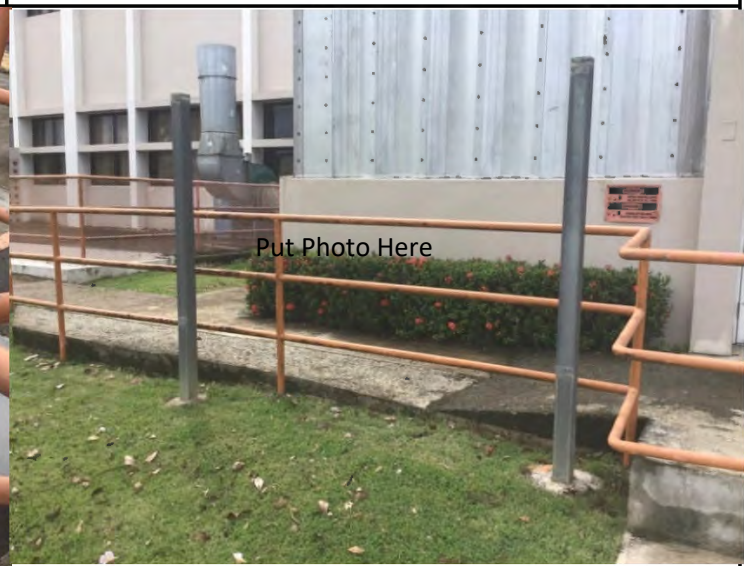
Damage Description:	Item #:	8
Facility identification sign, aluminum, 3 FT x 6 FT, missing components, caused by high winds (Site 1)		
Additional Comments:

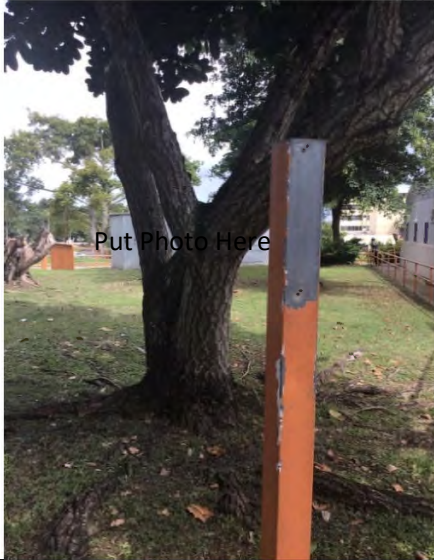
Damage Description:	Item #: 9	Damage Description:	Item #: 10
One-way travel sign, aluminum, 12 IN x 18 IN, missing components, caused by wind blow debris (Site 1)		Lighting, Parking lot luminaire, roof-mounted, single, 240/277-Volt, 400-Watt, metal halide bulbs, broken components, caused by wind-blown debris (Main Bldg. , Exterior, Wall)	
Additional Comments:		Additional Comments:

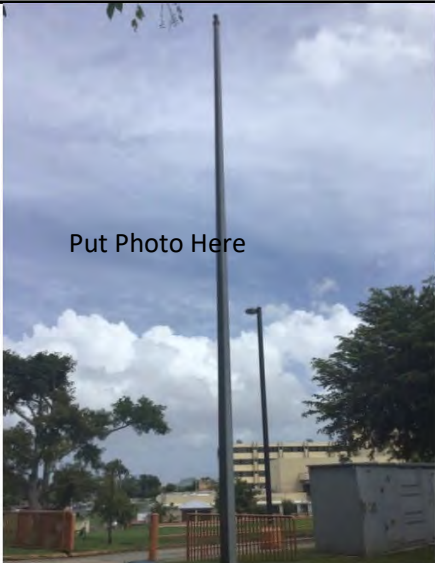
Damage Description:	Item #: 11	Damage Description:	Item #: 12
Parking lot luminaire, single, 240/277-Volt, 400-Watt, metal halide bulbs, including pole-to-fixture rewiring only, mounted on existing 35 FT steel light pole, missing components, caused by wind-blown debris		Facility identification sign, aluminum, 2 FT x 4 FT, missing components, caused by wind-blown debris (Site 1)	
Additional Comments:		Additional Comments:

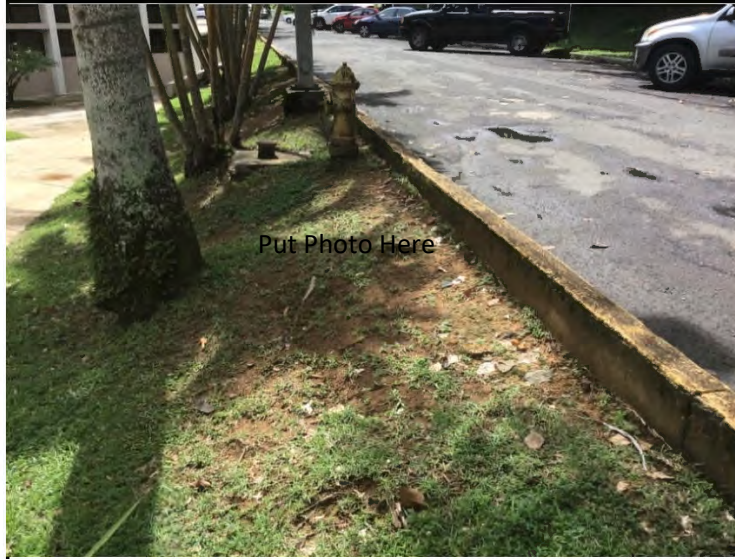
Damage Description:	Item #: 13
Engineered embankment, slope erosion, soil renourishment and repair, erosion, caused by wind-driven rain and surface flooding (Site 1)	
Additional Comments:

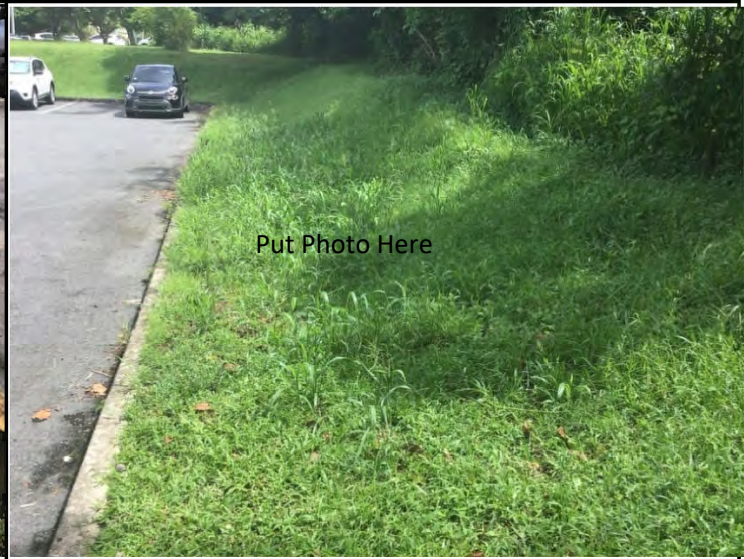
Damage Description:	Item #: 15
Engineered embankment, slope erosion, soil renourishment and repair, cracked, caused by surface water flooding (Site 1)	
Additional Comments:

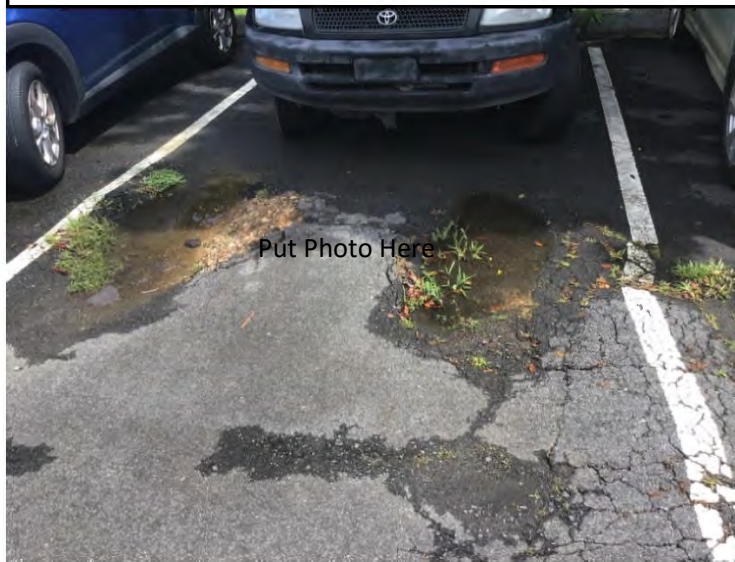
Damage Description:	Item #: 14
Asphalt parking lot, cracked, caused by surface water flooding (Site 1)	
Additional Comments:

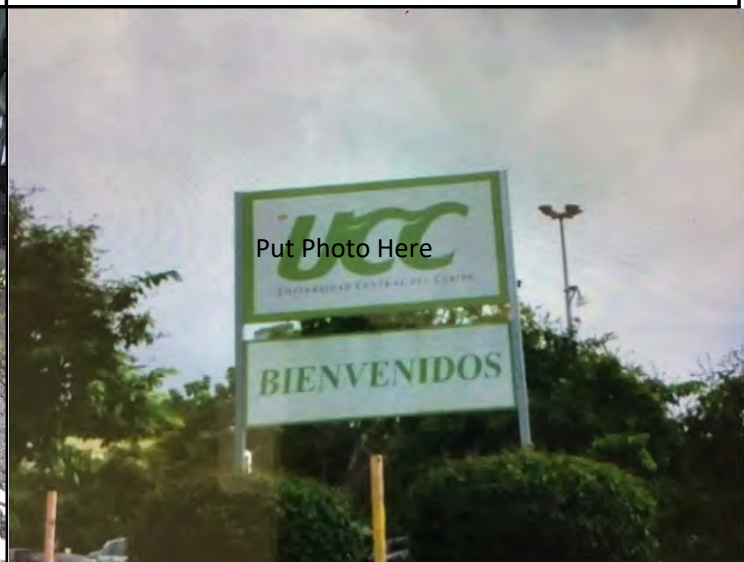
Damage Description:	Item #: 21
Facility identification sign, aluminum, 2-section, 5 FT W x 6 FT H, broken components, caused by high winds (Site 1)	
Additional Comments:
