Asbestos Containing Building Materials Inspection Report

Neuroscience Building Located at
Universidad Central del Caribe,
Laurel Avenue, 2U-6 Ext. Lomas Verdes,
Bayamón, Puerto Rico

ZEM-25262
August 2025

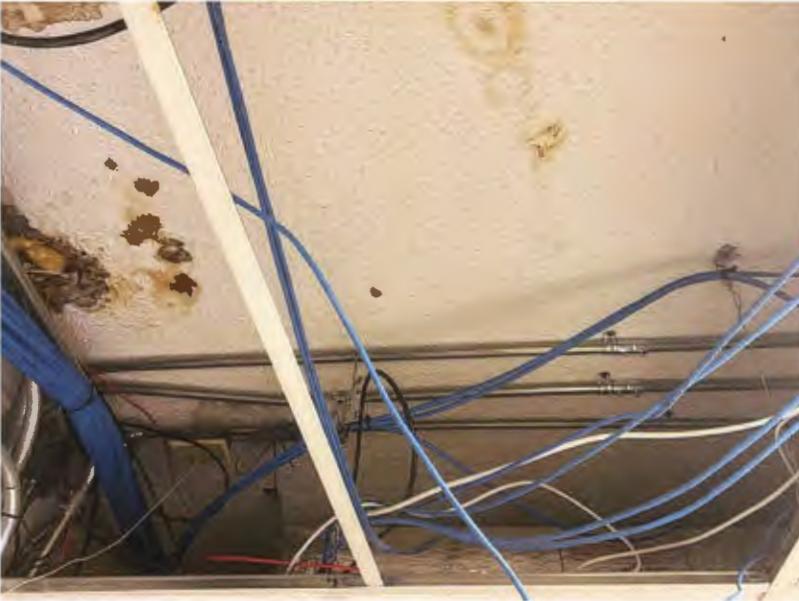
Photo No. 2108	Date: 08/13/2025

1. Popcorn Ceiling Sample: 25262-02

These materials are in a non-friable condition, and the analytical result range is 3% Chrysotile asbestos.

If these materials are to be removed, they should be managed and disposed of by a licensed asbestos contractor and disposed of as contaminated waste in an approved asbestos landfill site.

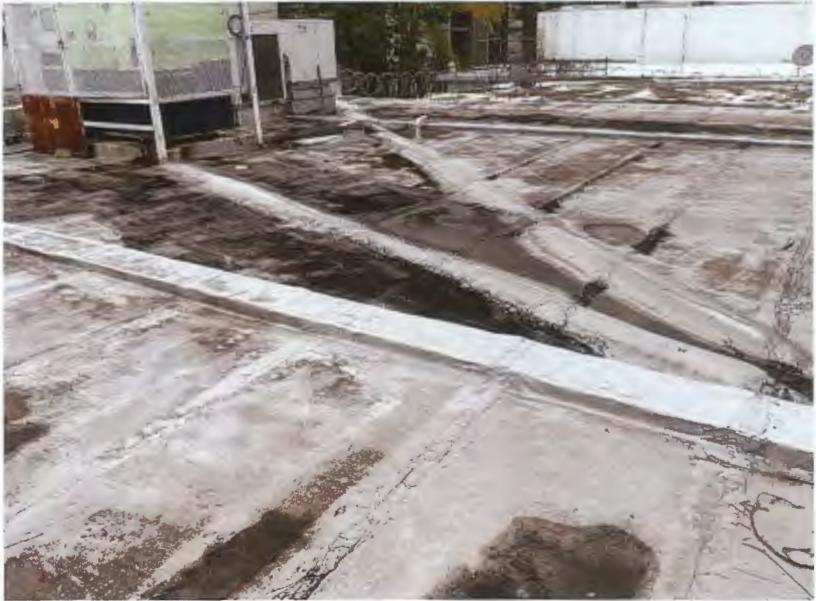
Photo No.	Date:	
2110	08/13/2025	
Description:

2. Roofing Material Sample: 25262-04

These materials are in a non-friable condition, and the analytical result range is 3% Chrysotile asbestos.

Roof #1 Asbestos-containing roofing material.

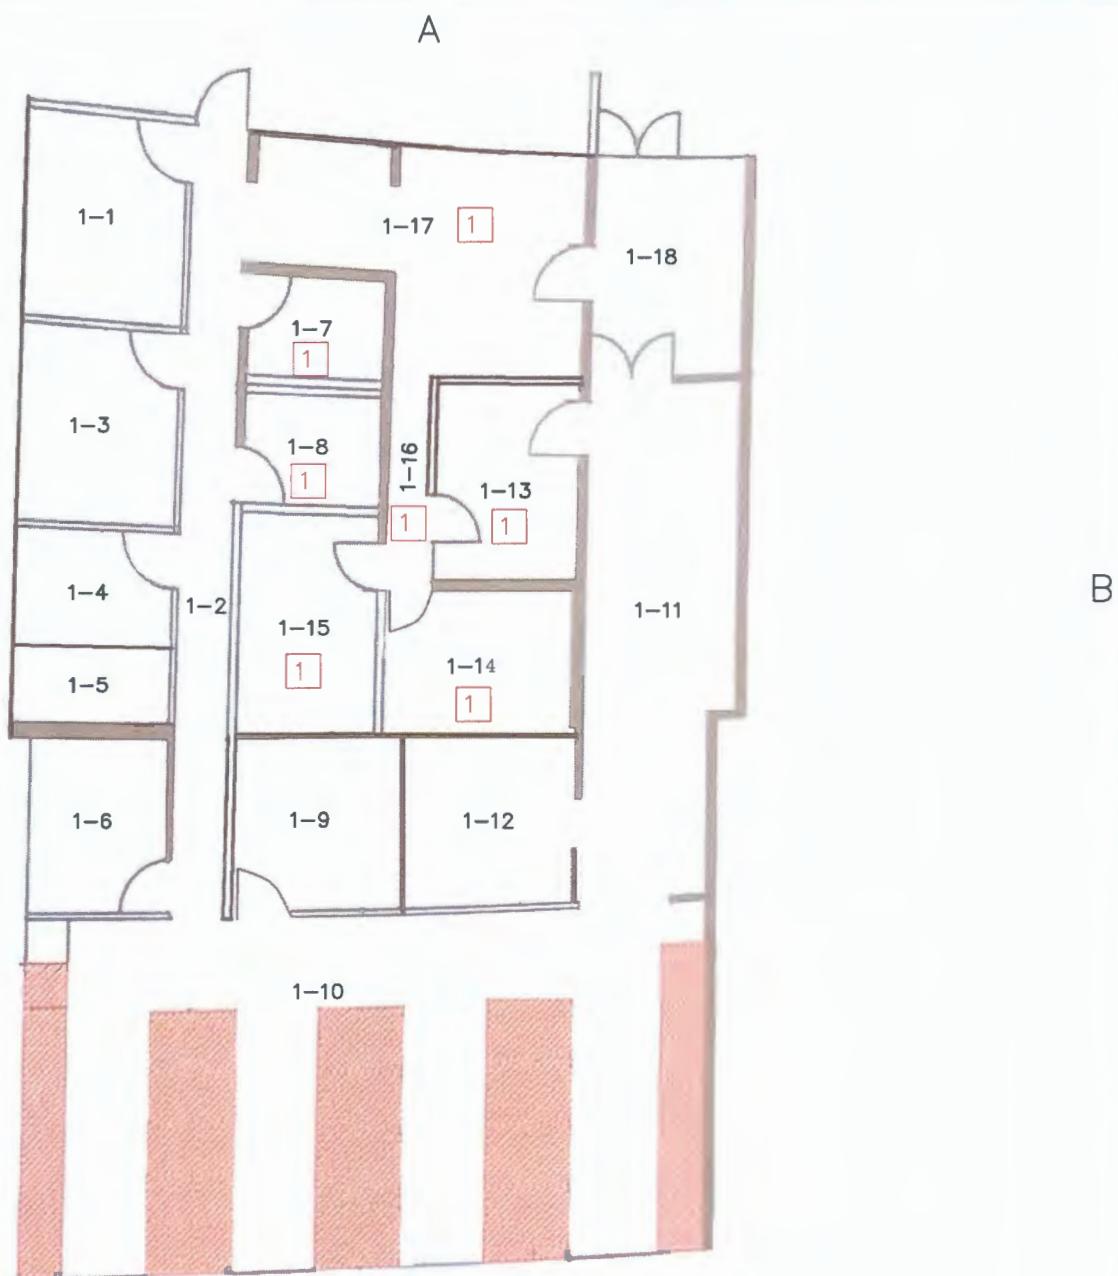
FLOOR PLAN

Area	Component	Approximate Amount
1-7, 1-8, 1-13, 1-14, 1-15, 1-16 & 1-17	Popcorn Ceiling	620 Ft ²
Roof #1	Roofing Material	1,620 Ft ²
