Lead-Based Paint Inspection Report

Neuroscience Building Located at
Universidad Central del Caribe,
Laurel Avenue, 2U-6 Ext. Lomas Verdes,
Bayamón, Puerto Rico

ZEM-25262

August 2025

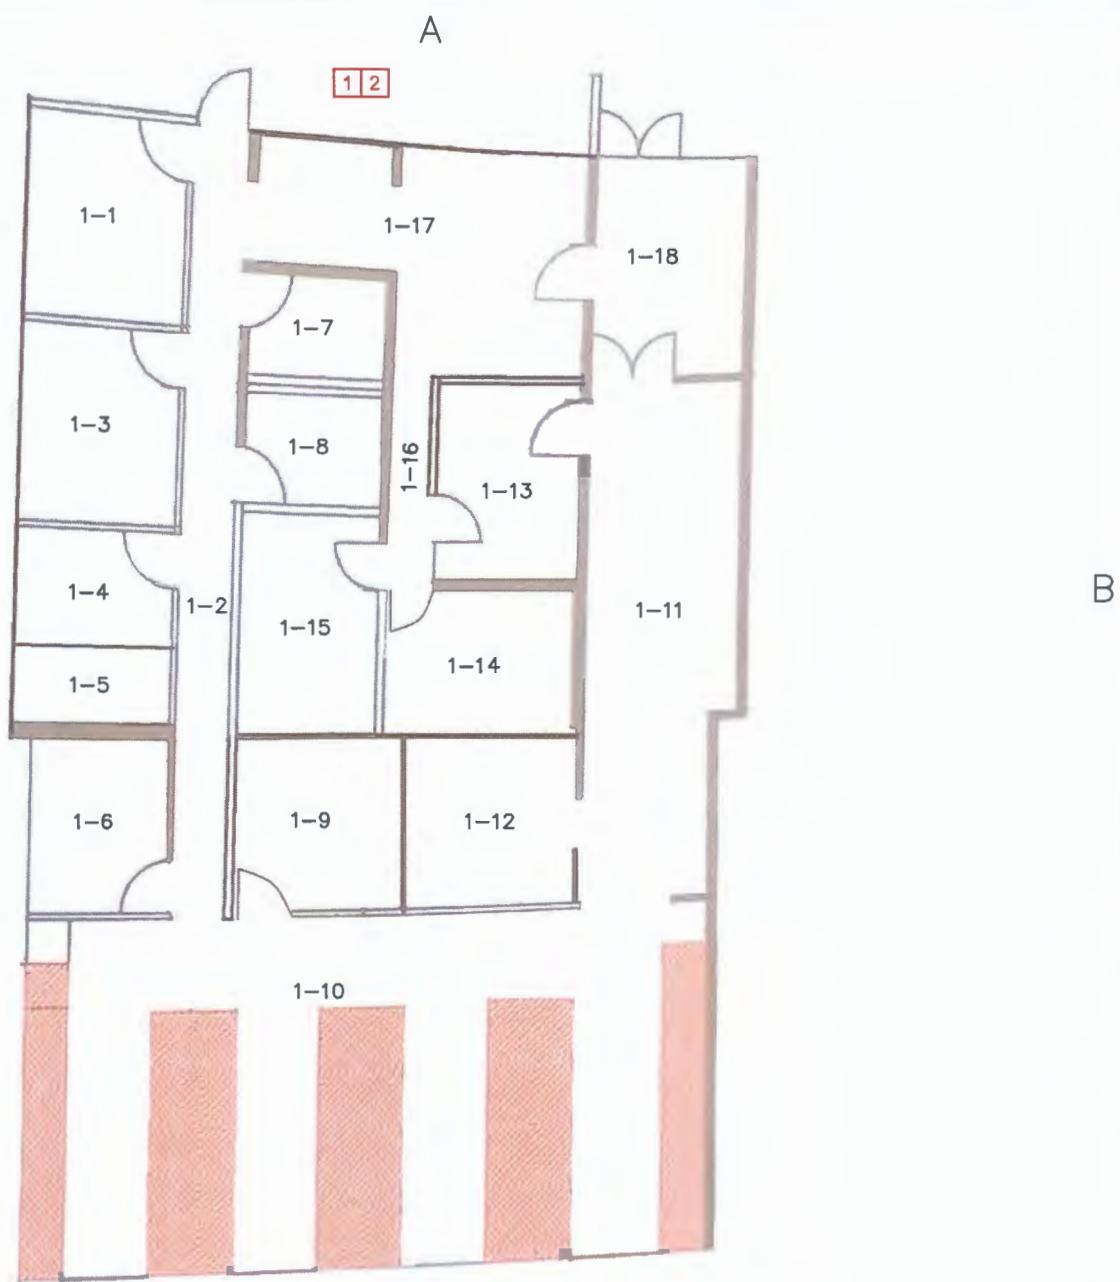
FLOOR PLAN

Area	Component	Color	Substrate	Approximate Amount
Exterior Areas	Floor Lines	Yellow	Concrete	50 Ln Ft
	Wheel Stops	Yellow	Concrete	3 Units
