Applicant: Universidad Central Del Caribe, Inc.	Damage Inventory: 305290	Category: E
WO # 46525	FIPS# 021-UNUGB-00	Date: 09/04/17/2019 GPS: 18.371576, -66.153119
Inspector: Gregory Sondergeld / Alexander Nieves	Damage Facility: Neuroscience Bldg.

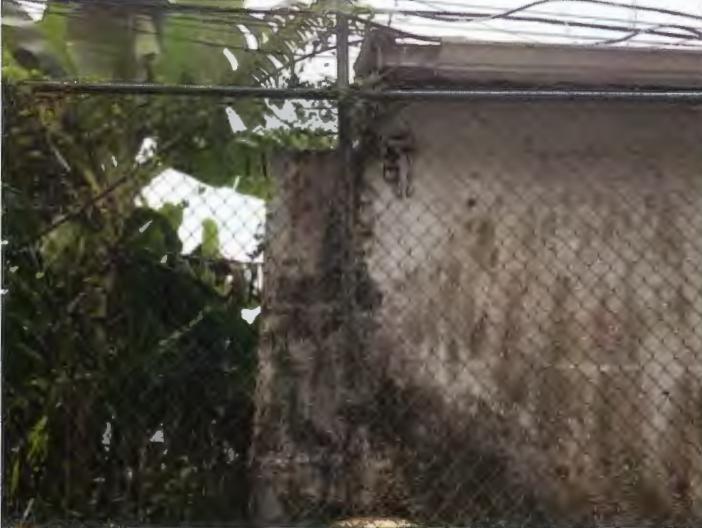
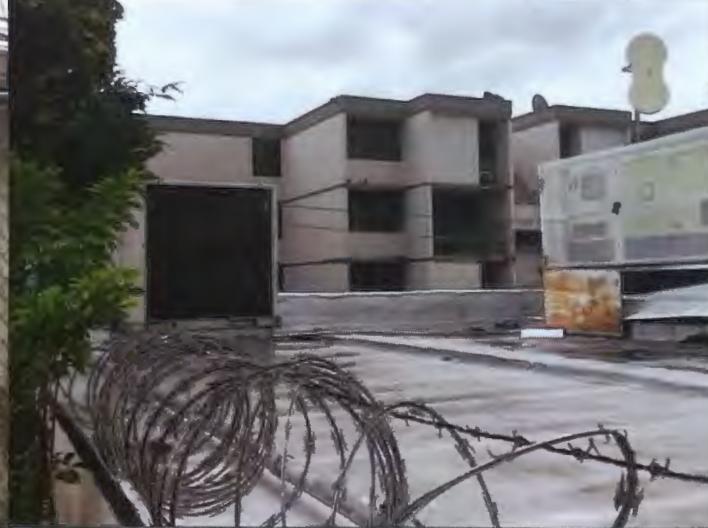
Damage Description: Downspout, commercial-grade, seamless, aluminum, 5 IN, missing components, caused by high winds (Neuroscience Bldg., Roof)	Item #: 17	Damage Description: Wall, 1/4 IN thick plaster on concrete, painted, discolored, caused by wind driven rain (Neuroscience Bldg., Floor 1, Exterior Rear)	Item #: 18
Additional Comments:		Additional Comments:

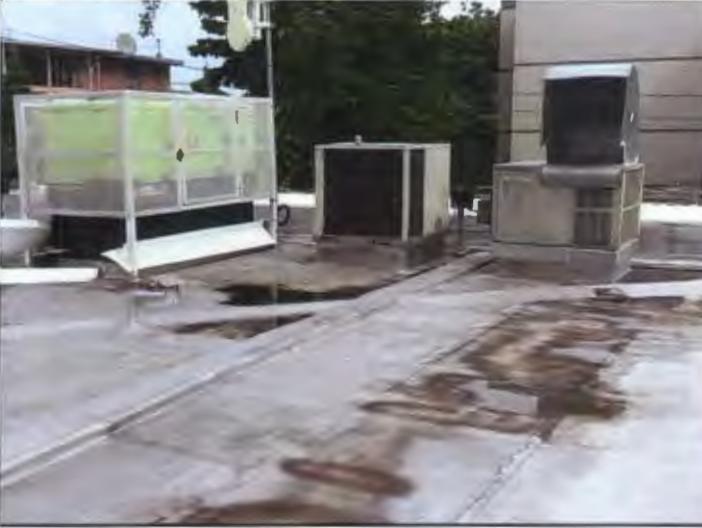
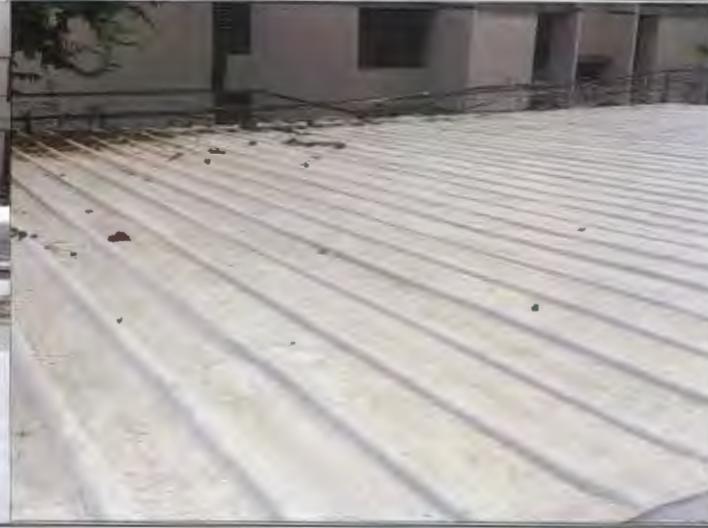
Damage Description: Roof, BUR membrane, 4-ply, with protective silver oxide coating, cracked, caused by rain water intrusion (Neuroscience Bldg., Roof)	Item #: 19	Damage Description: Roof, Metal roof, ribbed, with sprayed polyurethane foam (SPF) insulation overlay and protective aliphatic acrylic polyurethane seal coating, deformed, caused by high winds (Neuroscience Bldg., Roof)	Item #: 20
Additional Comments:		Additional Comments:

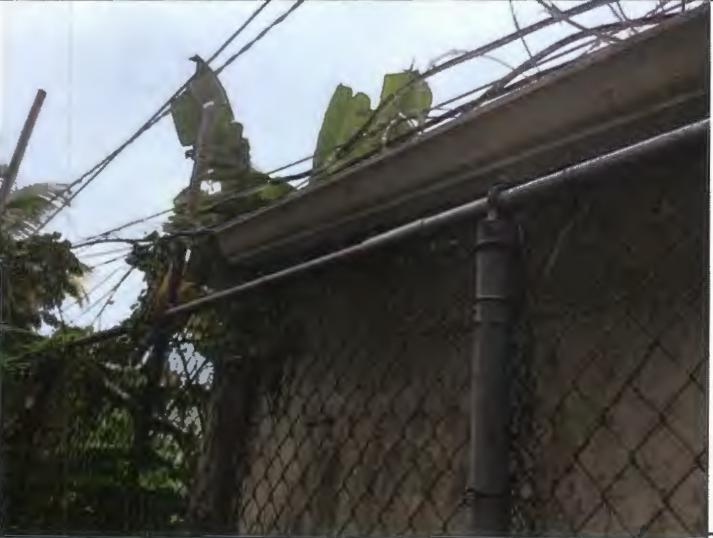
Damage Description: <input type="text"/> Item #: <input type="text"/> 16	Damage Description: <input type="text"/> Item #: <input type="text"/> Enter #
Gutter, commercial-grade, seamless, aluminum, 5 IN, broken components, caused by high winds (Neuroscience Bldg., Roof)	
Additional Comments:

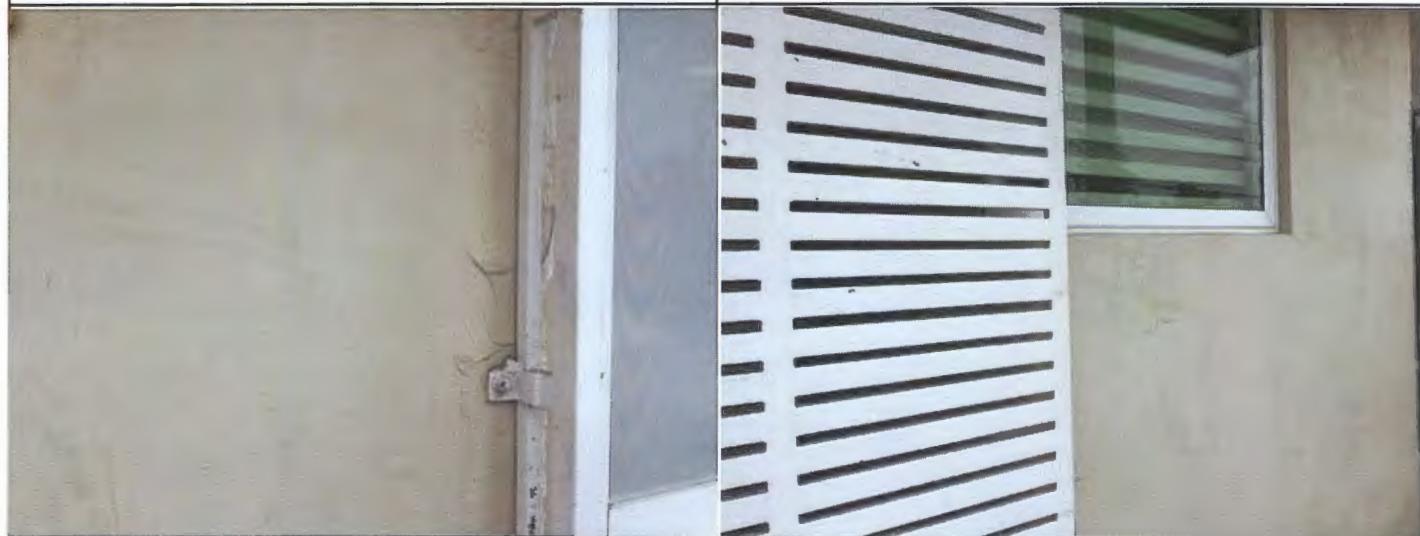
Damage Description: Wall, 1/4 IN thick plaster on concrete, repair spalling, cracked, caused by wind driven rain (Neuroscience Bldg., Entire Building)	Item #: 49	Damage Description: 1/4 IN thick plaster on concrete, painted, peeling paint, caused by wind driven rain (Neuroscience Bldg., Entire Building)	Item #: 50 Wall,
Additional Comments:	Additional Comments:

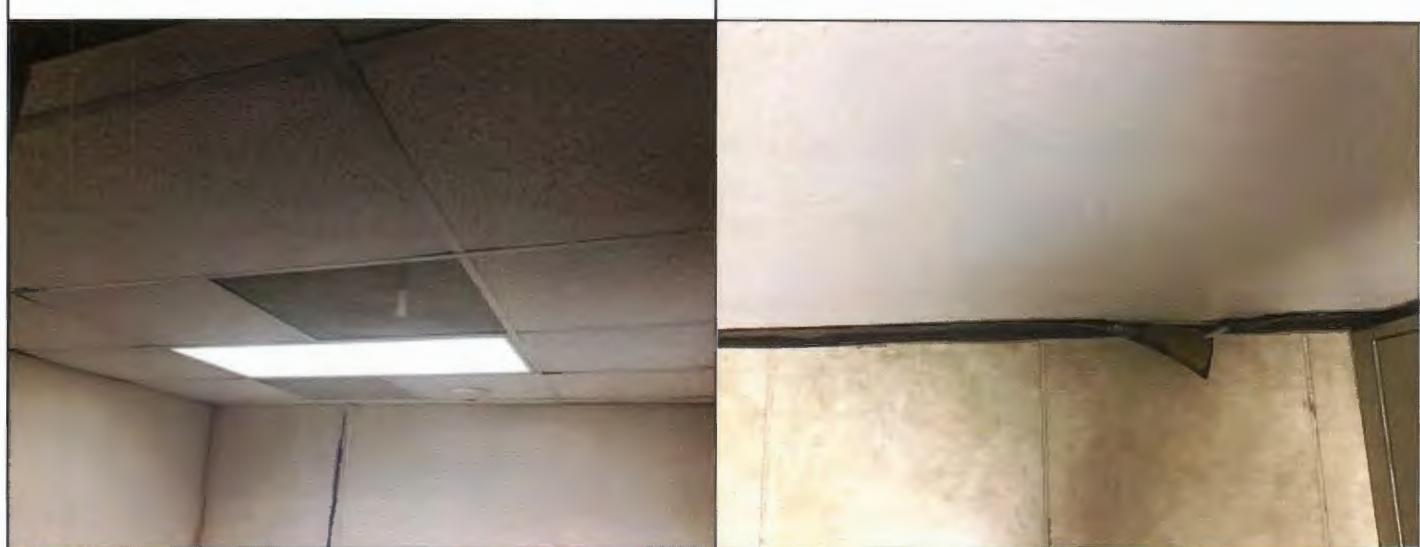
Damage Description: Ceiling, 2 FT x 4 FT acoustic tile, suspended, deformed, caused by rain water intrusion (Neuroscience Bldg., Floor 1, Office R514)	Item #: 51	Damage Description: Base Lining, vinyl, 4 IN, detached, caused by rain water intrusion (Neuroscience Bldg., Floor 1, Office)	Item #: 52
Additional Comments:	Additional Comments:

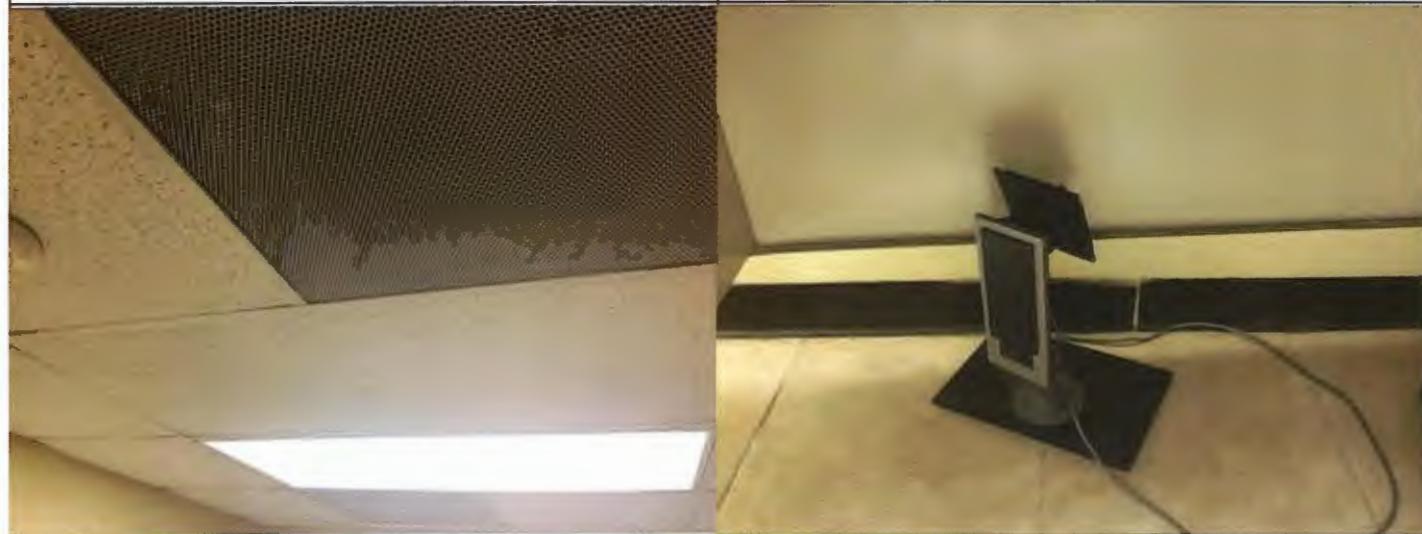
Damage Description: Ceiling, 2 FT x 4 FT acoustic tile, suspended, deformed, caused by rain water intrusion (Neuroscience Bldg., Floor 1, Office R516)	Item #: 53	Damage Description: Base Lining, vinyl, 4 IN, detached, caused by rain water intrusion (Neuroscience Bldg., Floor 1, Office R516)	Item #: 54
Additional Comments:	Additional Comments:

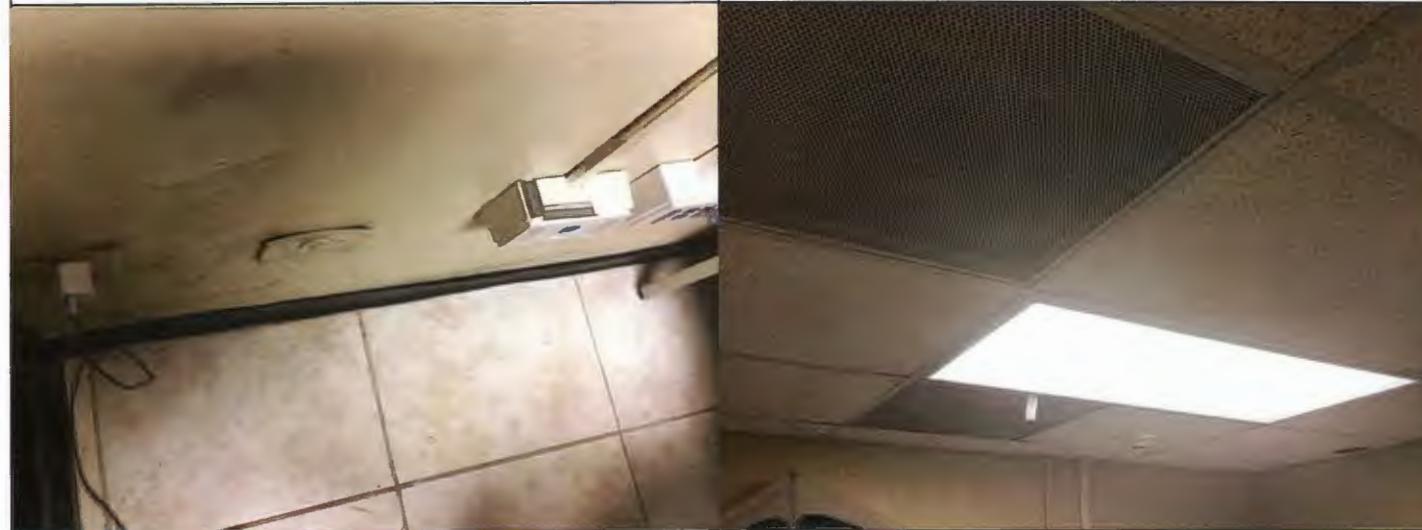
Damage Description: Base Lining, vinyl, 4 IN, detached, caused by rain water intrusion (Neuroscience Bldg., Floor 1, Office)	Item #: 55	Damage Description: Ceiling, 2 FT x 4 FT acoustic tile, suspended, deformed, caused by rain water intrusion (Neuroscience Bldg., Floor 1, Office R518)	Item #: 56
Additional Comments:	Additional Comments:

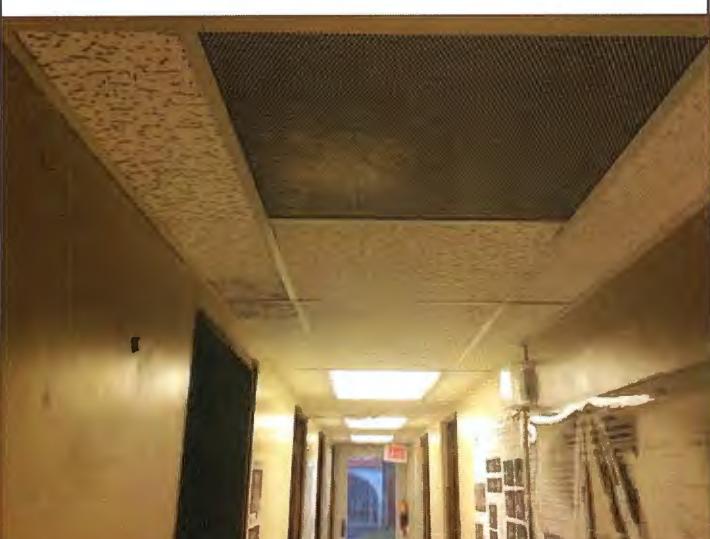
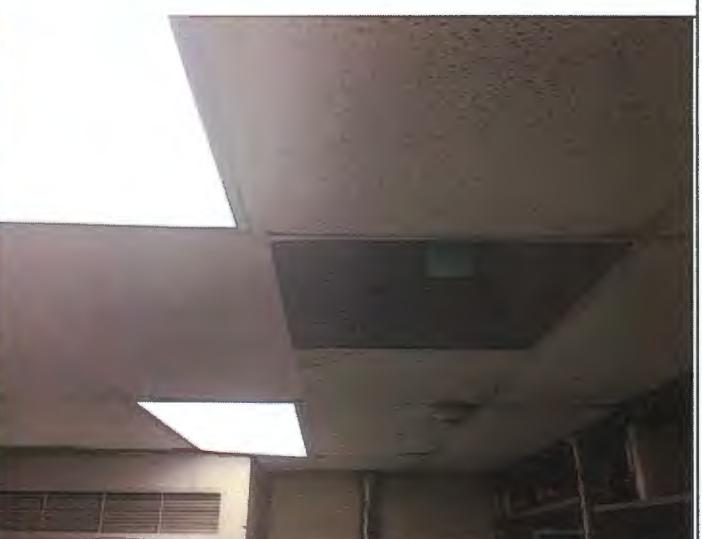
Damage Description: Ceiling, 2 FT x 4 FT acoustic tile, suspended, deformed, caused by rain water intrusion (Neuroscience Bldg., Floor 1, Hallway)	Item #: 57	Damage Description: Ceiling, 2 FT x 4 FT acoustic tile, suspended, deformed, caused by rain water intrusion (Neuroscience Bldg., Floor 1, Laboratory)	Item #: 58
Additional Comments:		Additional Comments:

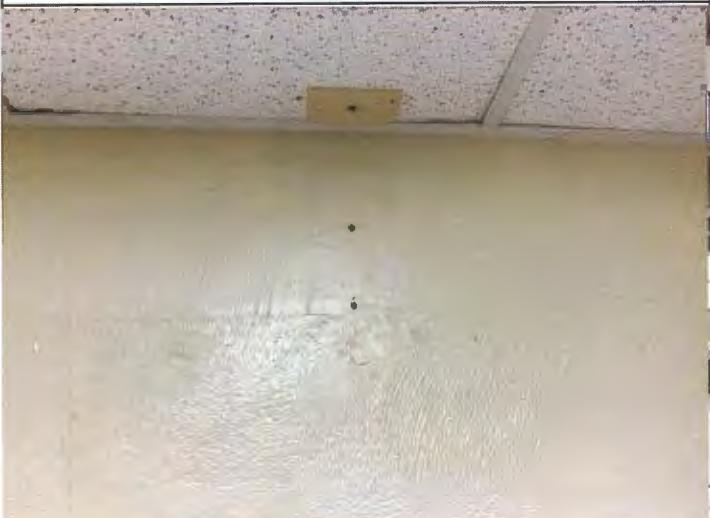
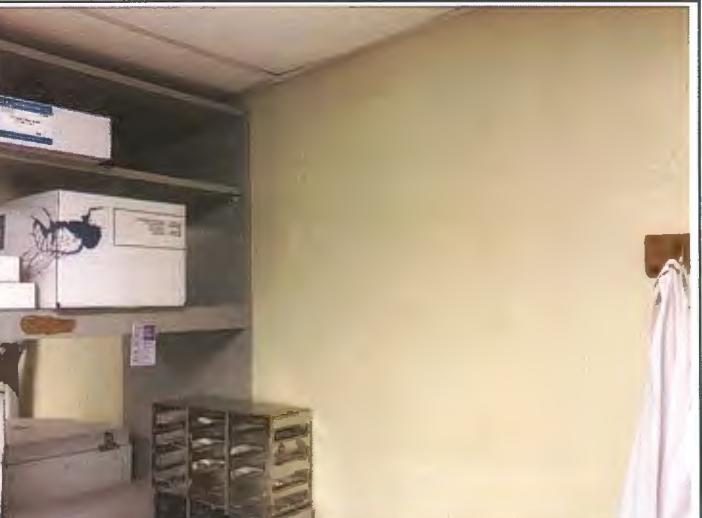
Damage Description: Wall, 1/4 IN thick plaster on concrete, repair spalling, cracked, caused by rain water intrusion (Neuroscience Bldg., Floor 1, Laboratory)	Item #: 59	Damage Description: Wall, 1/4 IN thick plaster on concrete, painted, discolored, caused by rain water intrusion (Neuroscience Bldg., Floor 1, Laboratory)	Item #: 60
Additional Comments:		Additional Comments:

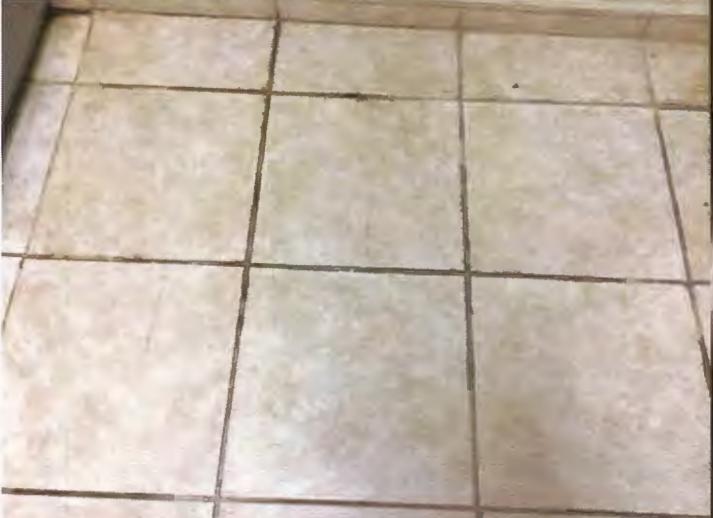
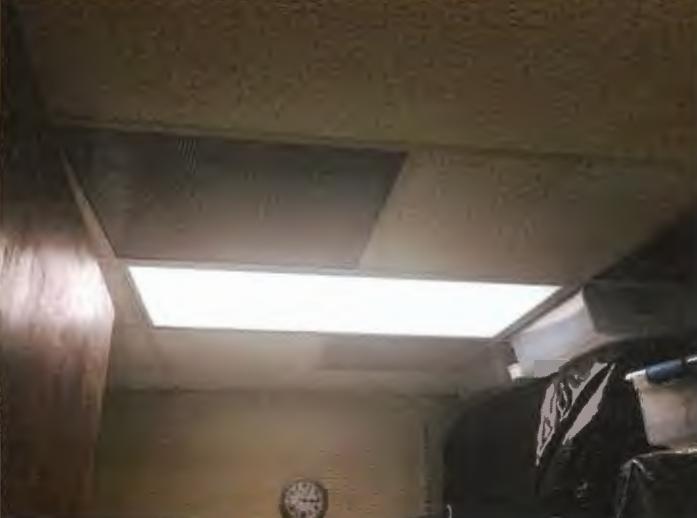
Damage Description: Floor, ceramic tile, 16x16 IN, thin set, stained, caused by rain water intrusion (Neuroscience Bldg., Floor 1, Laboratory)	Item #: 61	Damage Description: Ceiling, 2 FT x 4 FT acoustic tile, suspended, deformed, caused by rain water intrusion (Neuroscience Bldg., Floor 1, Laboratory R526)	Item #: 62
Additional Comments:		Additional Comments:

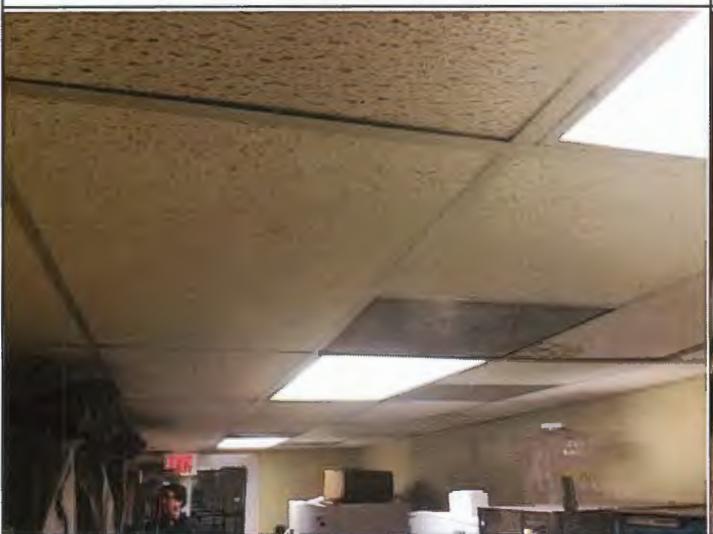
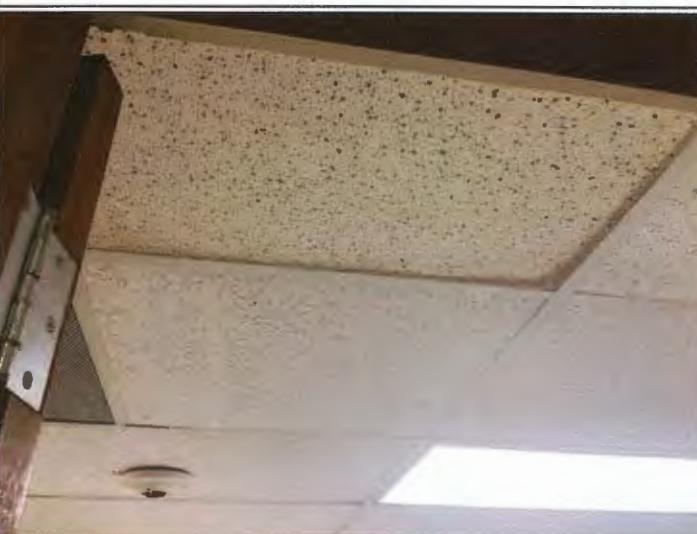
Damage Description: Ceiling, 2 FT x 4 FT acoustic tile, suspended, deformed, caused by rain water intrusion (Neuroscience Bldg., Floor 1, Hallway)	Item #: 63	Damage Description: Ceiling, 2 FT x 4 FT acoustic tile, suspended, deformed, caused by rain water intrusion (Neuroscience Bldg., Floor 1, Conference R524)	Item #: 64
Additional Comments:		Additional Comments:

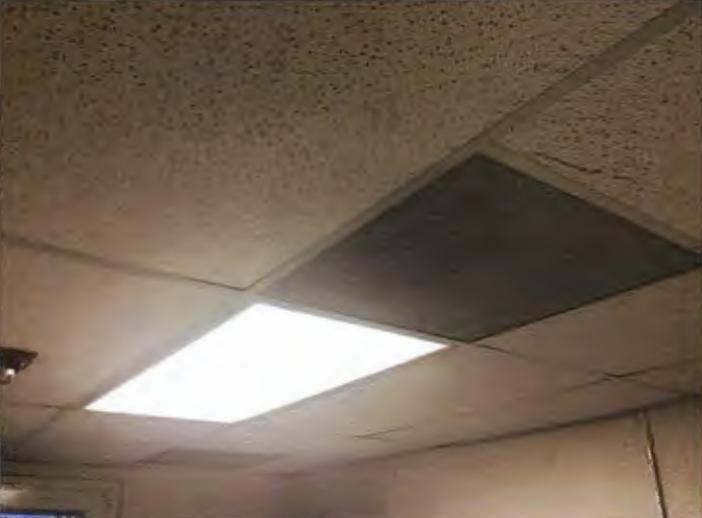
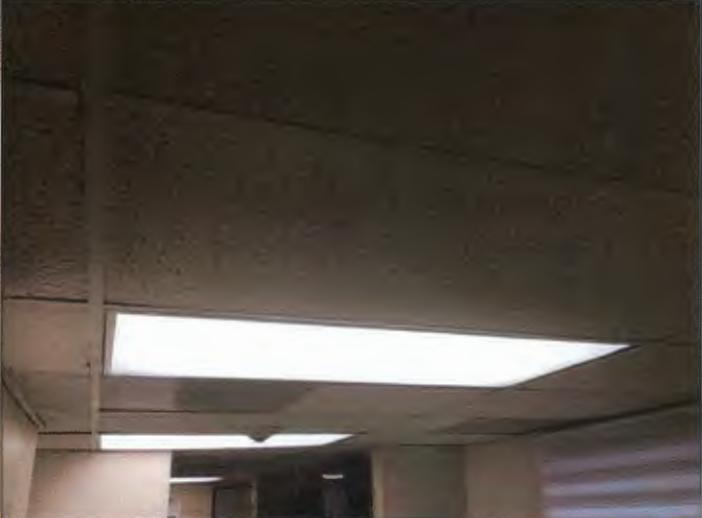
Damage Description: Ceiling, 2 FT x 4 FT acoustic tile, suspended, deformed, caused by rain water intrusion (Neuroscience Bldg., Floor 1, Office R511)	Item #: 65	Damage Description: Ceiling, 2 FT x 4 FT acoustic tile, suspended, deformed, caused by rain water intrusion (Neuroscience Bldg., Floor 1, Office)	Item #: 66
Additional Comments:		Additional Comments:

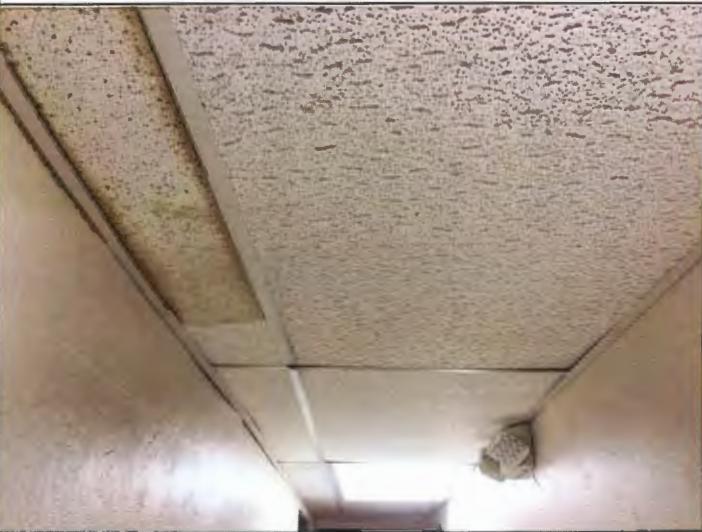
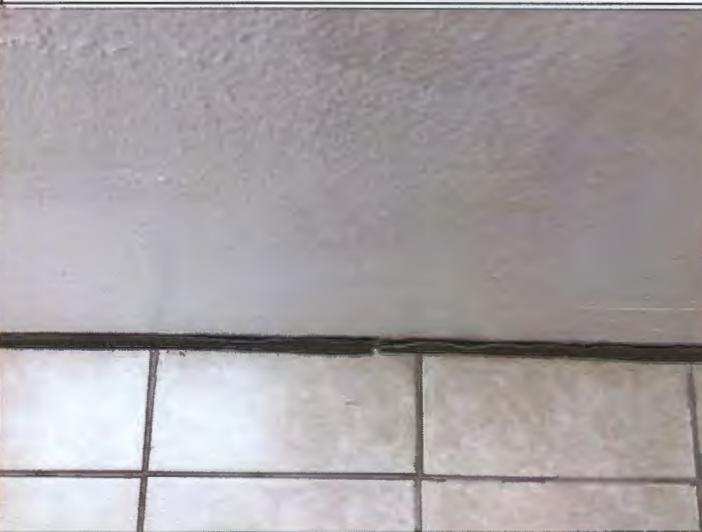
Damage Description: Ceiling, 2 FT x 4 FT acoustic tile, suspended, deformed, caused by rain water intrusion (Neuroscience Bldg., Floor 1, Hallway)	Item #: 67	Damage Description: Base Lining, vinyl, 4 IN, detached, caused by rain water intrusion (Neuroscience Bldg., Floor 1, Hallway)	Item #: 68
Additional Comments:		Additional Comments:

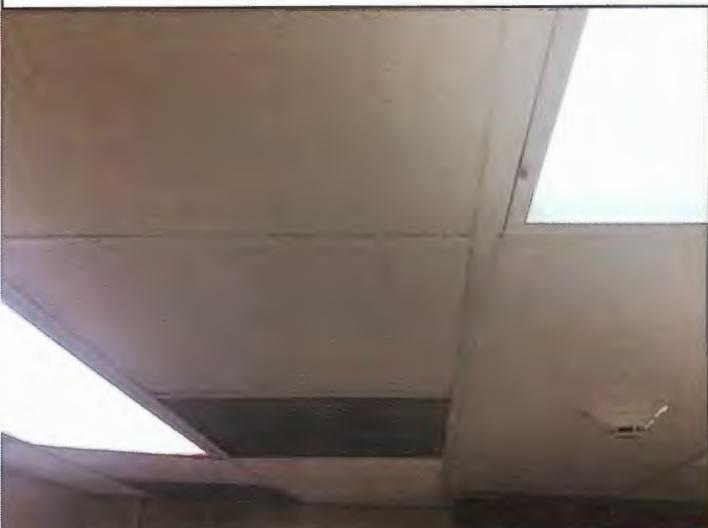
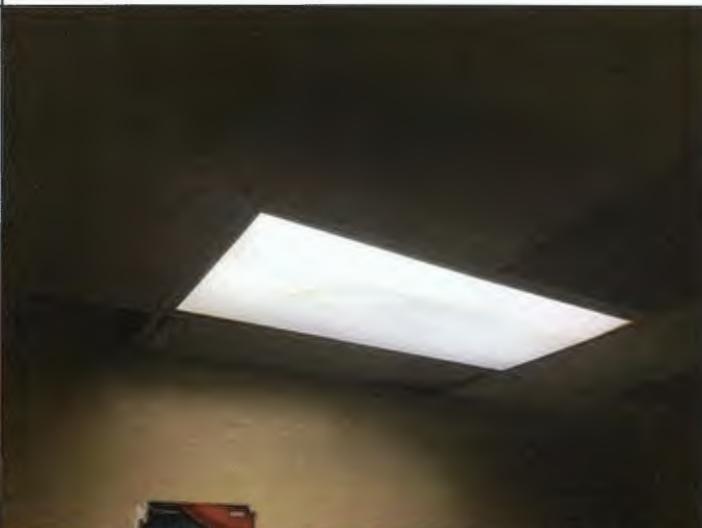
Damage Description: Ceiling, 2 FT x 4 FT acoustic tile, suspended, deformed, caused by rain water intrusion (Neuroscience Bldg., Floor 1, Office)	Item #: 69	Damage Description: Light, fluorescent, recessed Troffer, electrical issues, caused by rain water intrusion (Neuroscience Bldg., Floor 1, Office)	Item #: 70
Additional Comments:		Additional Comments:

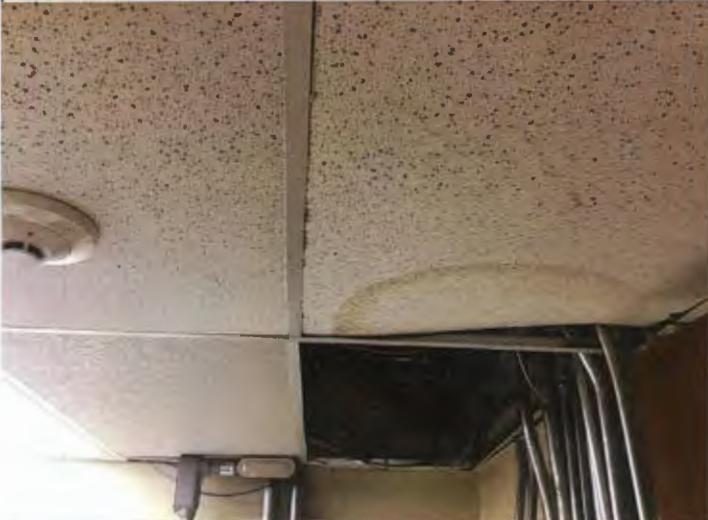
Damage Description: Ceiling, 2 FT x 4 FT acoustic tile, suspended, deformed, caused by rain water intrusion (Neuroscience Bldg., Floor 1, Office R522)	Item #: 72	Damage Description:	Item #: Enter #
Additional Comments:		Additional Comments:
