<b>Applicant:</b> Universidad Central Del Caribe, Inc.	<b>Damage Inventory:</b> 305240	<b>Category:</b> E
<b>WO #</b> 46525 <b>FIPS#</b> 021-UNUGB-00	<b>Date:</b> 09/04-17/2019 <b>GPS:</b> 18.365953, -66.153767	
<b>Inspector:</b> Gregory Sondergeld / Alexander Nieves	<b>Damage Facility:</b> Main Bldg.

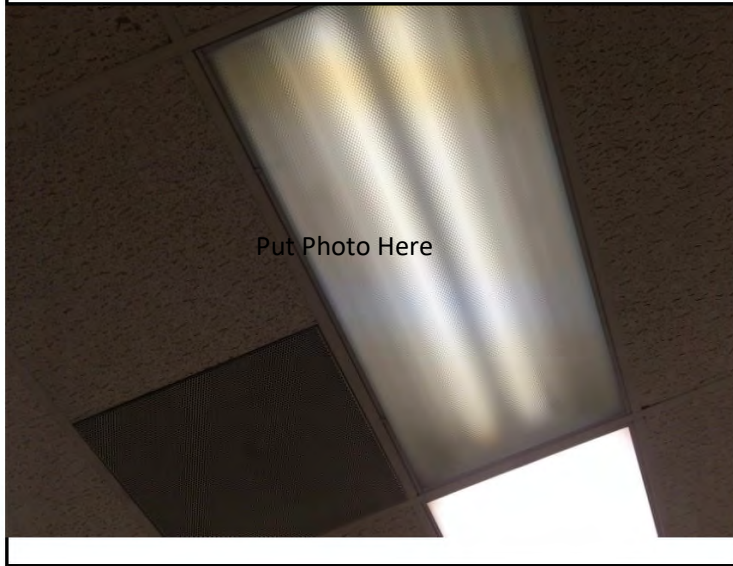
<b>Damage Description:</b>	<b>Item #:</b> 5
Light, fluorescent, recessed Troffer, electrical issues, caused by rainwater intrusion (Main Bldg., Floor 2, Laboratory R176)	
<b>Additional Comments:</b>

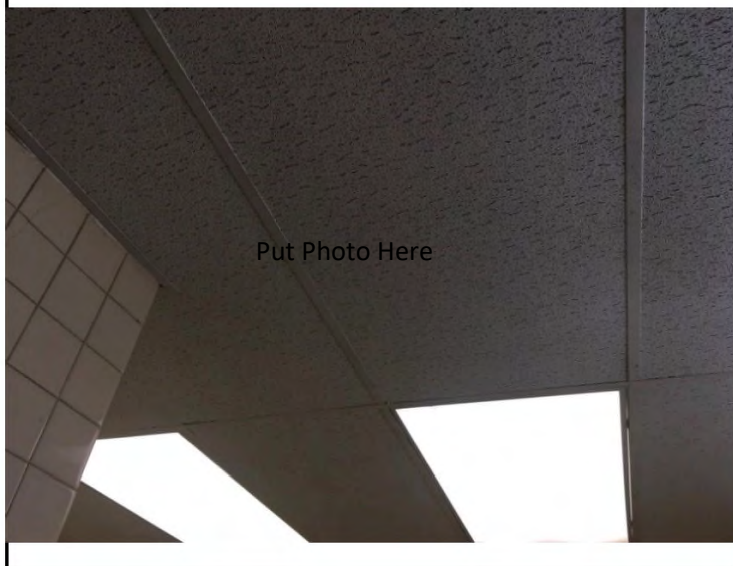
<b>Damage Description:</b>	<b>Item #:</b> 7
Ceiling, 2 FT x 4 FT acoustic tile, suspended, broken components, caused by rainwater intrusion (Main Bldg., Floor 2, Bathroom R163)	
<b>Additional Comments:</b>

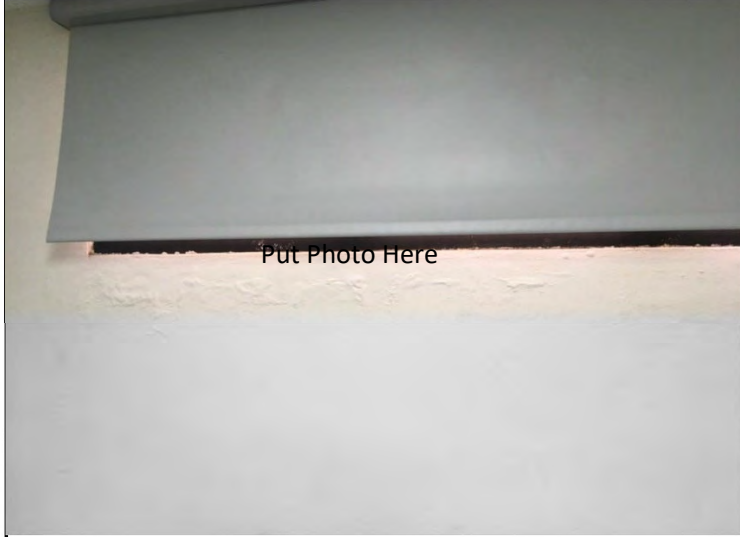
<b>Damage Description:</b>	<b>Item #:</b> 9	<b>Damage Description:</b>	<b>Item #:</b> 10
Wall, ¼ IN thick plaster on concrete, painted, torn with bubbles, caused by rainwater intrusion (Main Bldg., Floor 2, Classroom 166)		Window, Alum. window frames, perimeter caulking/sealing only, cracked, caused by wind-driven rain (Main Bldg., Floor 2, Classroom 166)	
<b>Additional Comments:</b>		<b>Additional Comments:</b>

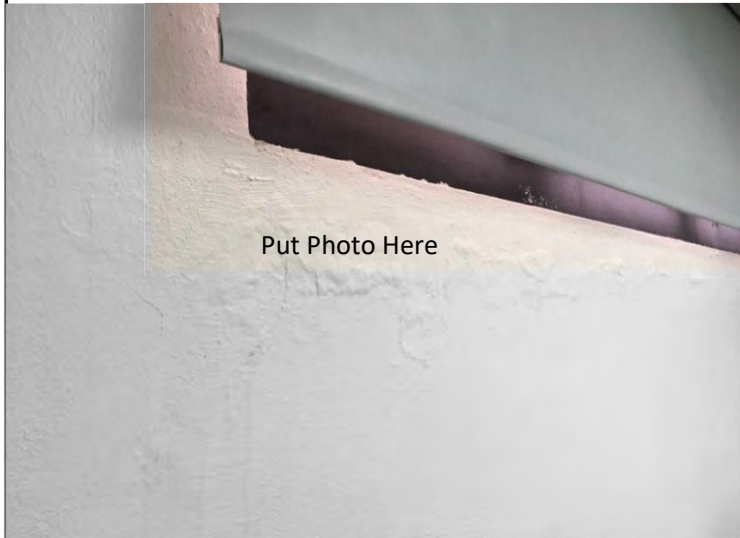
<b>Damage Description:</b>	<b>Item #:</b> 11	<b>Damage Description:</b>	<b>Item #:</b> 12
Wall, Patch ¼ IN thick plaster on concrete, repair, cracked, caused by rainwater intrusion (Main Bldg., Floor 2, Classroom 166)		Ceiling, 2 FT x 4 FT acoustic tile, suspended, deformed, caused by rainwater intrusion (Main Bldg., Floor 2, Classroom 166)	
<b>Additional Comments:</b>		<b>Additional Comments:</b>

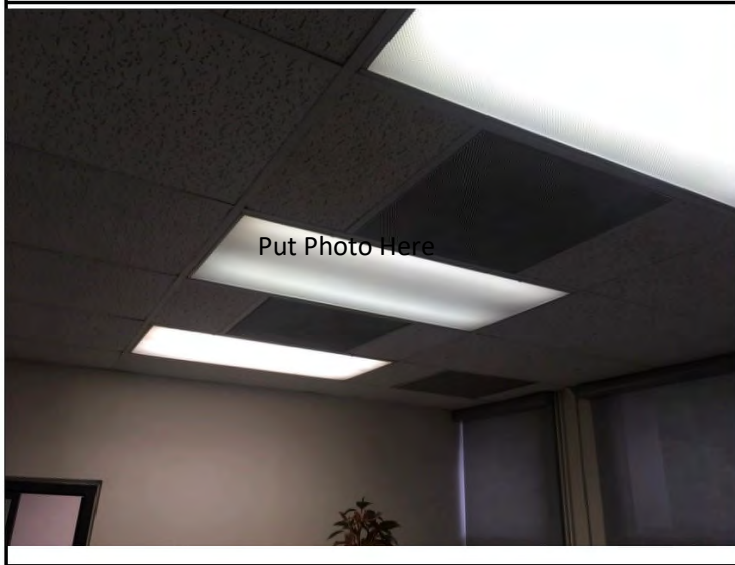
<b>Damage Description:</b>	<b>Item #:</b> 17
Ceiling, 2 FT x 4 FT acoustic tile, suspended, deformed, caused by rainwater intrusion (Main Bldg., Floor 2, Office R224)	
<b>Additional Comments:</b>

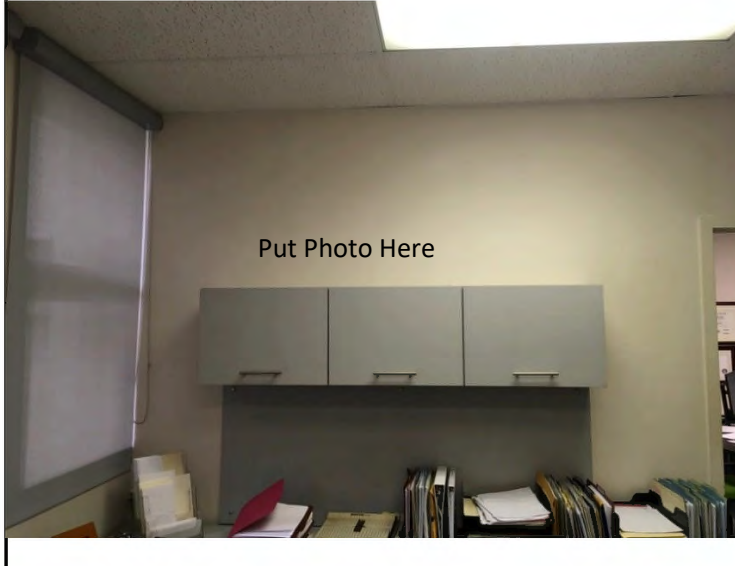
<b>Damage Description:</b>	<b>Item #:</b> 19
Wall, ¼ IN thick plaster on concrete, painted, discolored, caused by rainwater intrusion (Main Bldg., Floor 2, Office R224)	
<b>Additional Comments:</b>

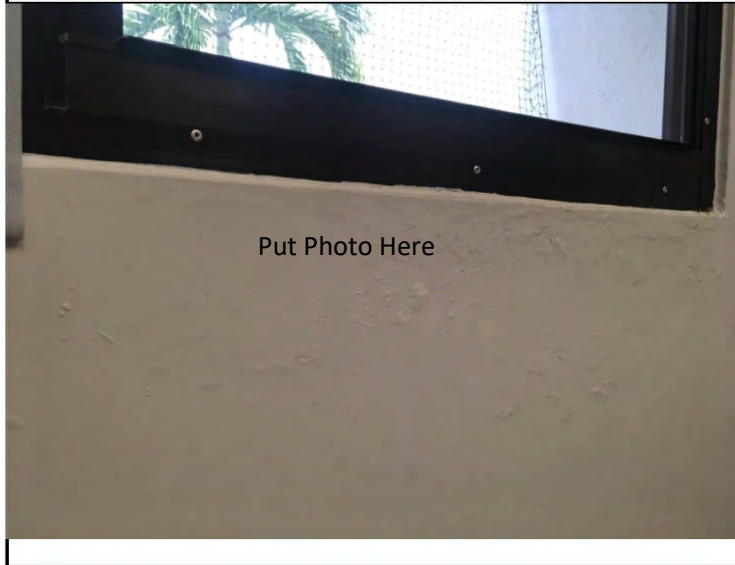
<b>Damage Description:</b>	<b>Item #:</b> 21
Wall, ¼ IN thick plaster on concrete, repair, cracked, caused by rainwater intrusion (Main Bldg., Floor 2, Office R223)	
<b>Additional Comments:</b>

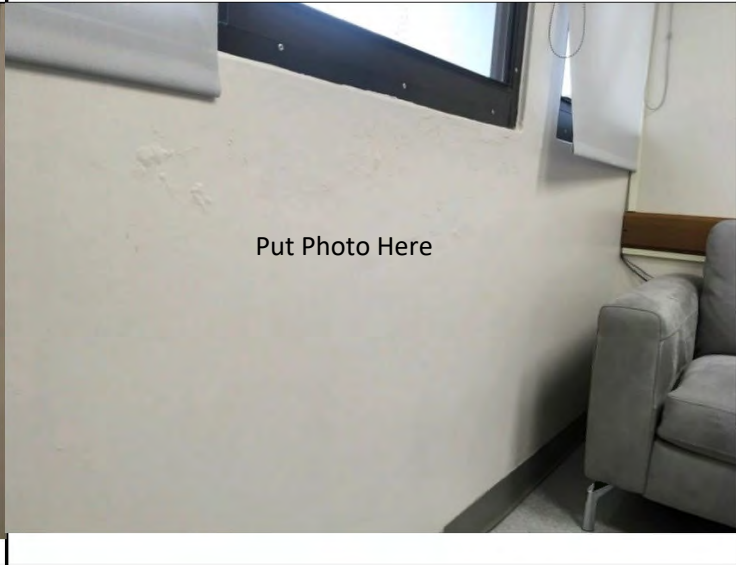
<b>Damage Description:</b>	<b>Item #:</b> 22
Wall, ¼ IN thick plaster on concrete, painted, discolored, caused by rainwater intrusion (Main Bldg., Floor 2, Office R223)	
<b>Additional Comments:</b>

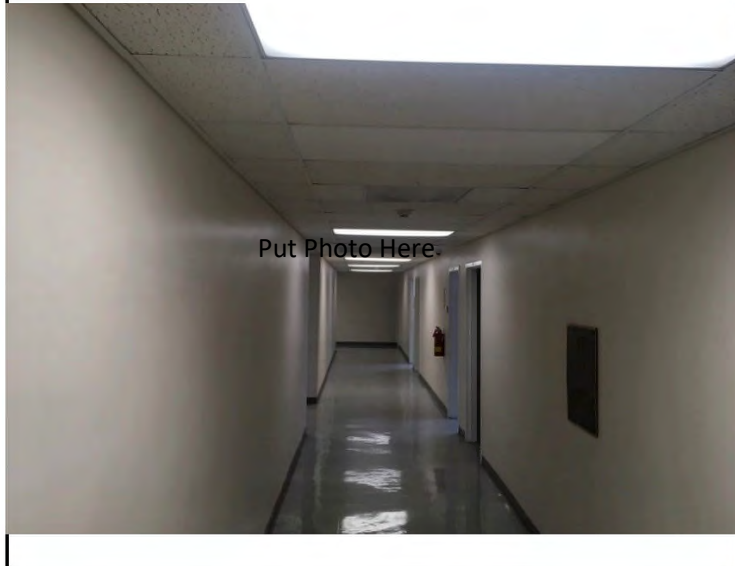
<b>Damage Description:</b>	<b>Item #:</b> 23
Ceiling, 2 FT x 4 FT acoustic tile, suspended, broken components, caused by rainwater intrusion (Main Bldg., Floor 2, Hallway)	
<b>Additional Comments:</b>

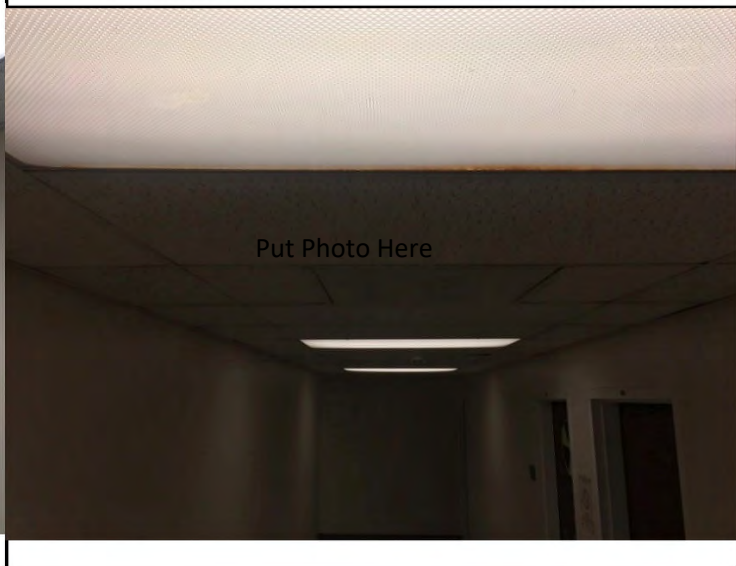
<b>Damage Description:</b>	<b>Item #:</b> 25
Light, fluorescent, recessed Troffer, electrical issues, caused by rainwater intrusion (Main Bldg., Floor 2, Hallway)	
<b>Additional Comments:</b>

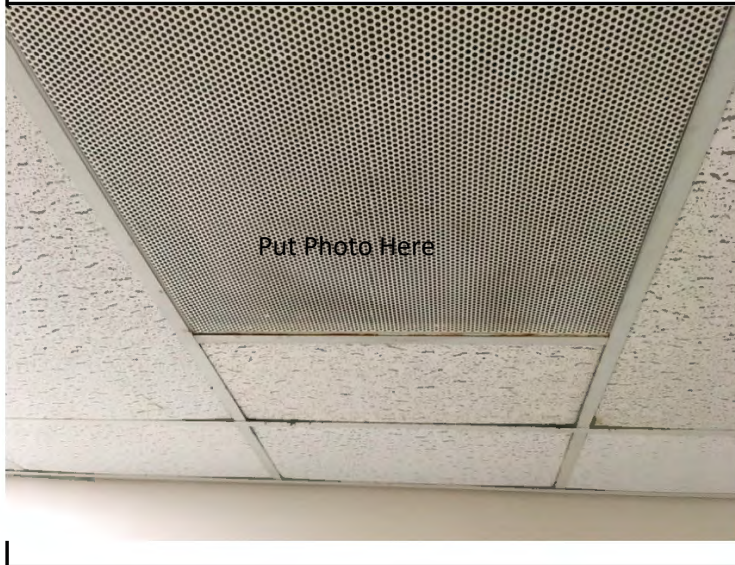
<b>Damage Description:</b>	<b>Item #:</b> 24	<b>Damage Description:</b>	<b>Item #:</b> 26
Ceiling, 2 FT x 4 FT acoustic tile, suspended, grid only, broken components, caused by rainwater intrusion (Main Bldg., Floor 2, Hallway)		Ceiling, drywall, repair and paint, cracked, caused by rainwater intrusion (Main Bldg., Floor 2, Hallway)	
<b>Additional Comments:</b>		<b>Additional Comments:</b>

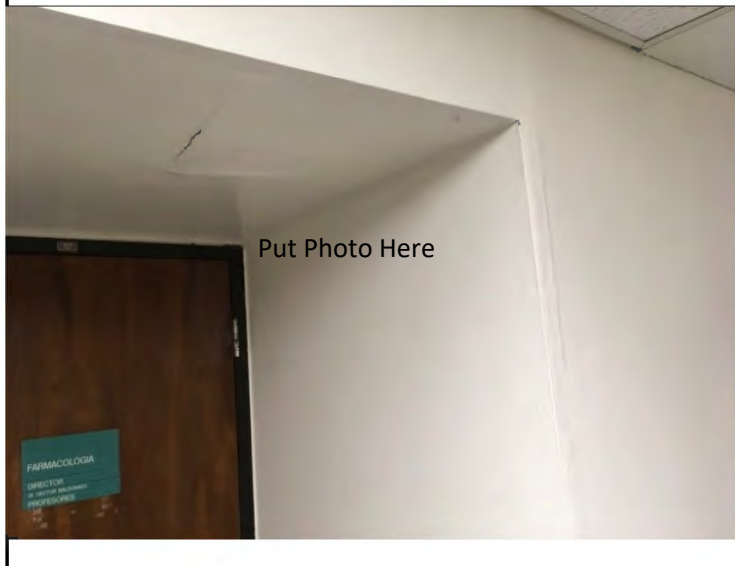
<b>Damage Description:</b>	<b>Item #:</b> 28	<b>Damage Description:</b>	<b>Item #:</b> 27
Ceiling, drywall, repair and paint, cracked, caused by rainwater intrusion (Main Bldg., Floor 2, Hallway R117)		Base Lining, vinyl, 4 IN, dislodged, caused by surface water flooding (Main Bldg., Floor 2, Hallway)	
<b>Additional Comments:</b>		<b>Additional Comments:</b>

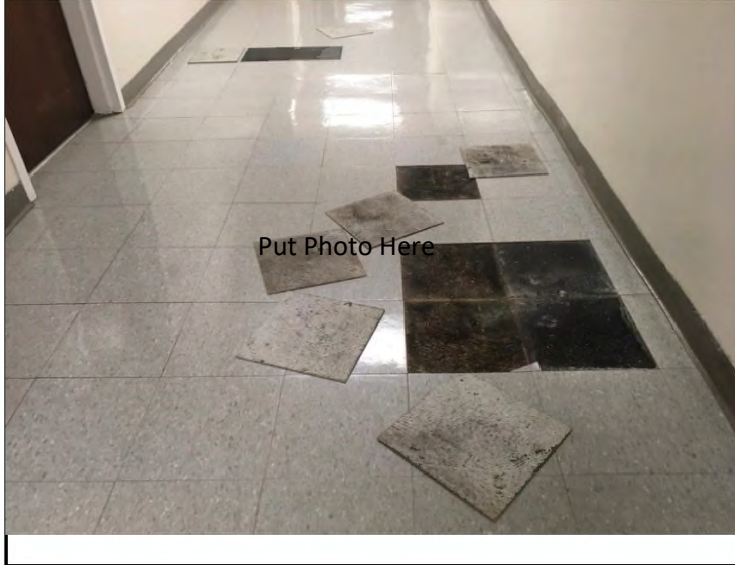
<b>Damage Description:</b>	<b>Item #:</b> 29
Floor, VCT, 12x12 IN, dislodged, caused by surface water flooding (Main Bldg., Floor 2, Hallway)	
<b>Additional Comments:</b>

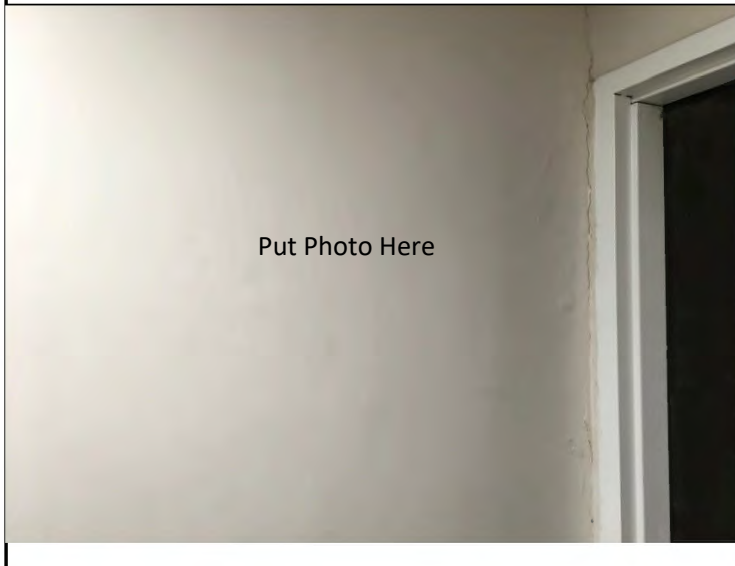
<b>Damage Description:</b>	<b>Item #:</b> 31
Wall, ¼ IN thick plaster on concrete, painted, discolored, caused by rainwater intrusion (Main Bldg., Floor 2, Hallway)	
<b>Additional Comments:</b>

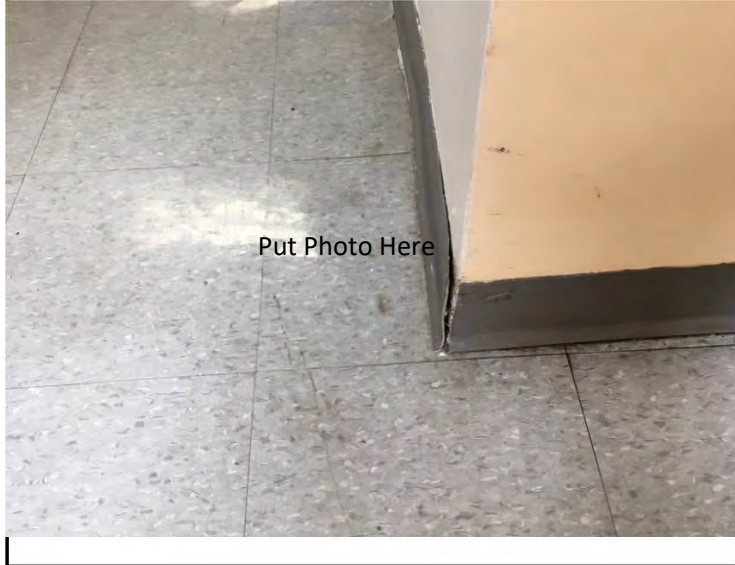
<b>Damage Description:</b>	<b>Item #:</b> 33
Base Lining, vinyl, 4 IN, dislodged, caused by surface water flooding (Main Bldg., Floor 2, Hallway Presidential Lobby)	
<b>Additional Comments:</b>

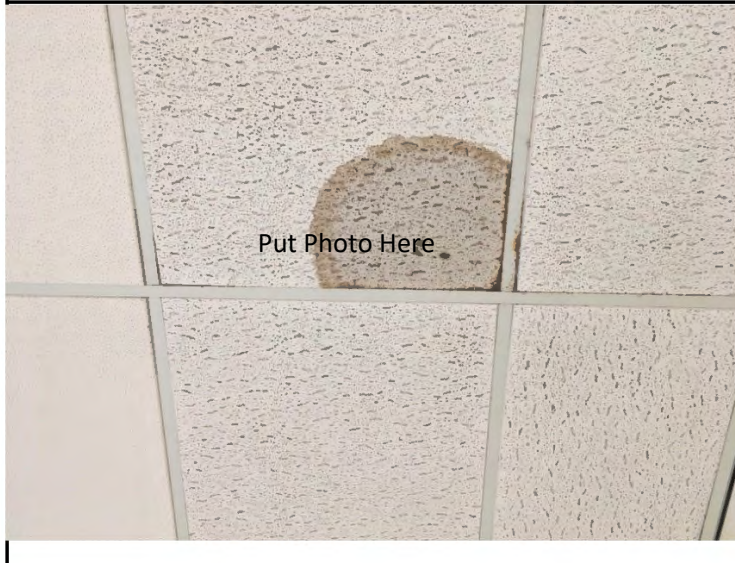
<b>Damage Description:</b>	<b>Item #:</b> 35
Ceiling, 2 FT x 2 FT acoustic tile, suspended, tegular, grid only, deformed, caused by rainwater intrusion (Main Bldg., Floor 2, Presidential Lobby)	
<b>Additional Comments:</b>

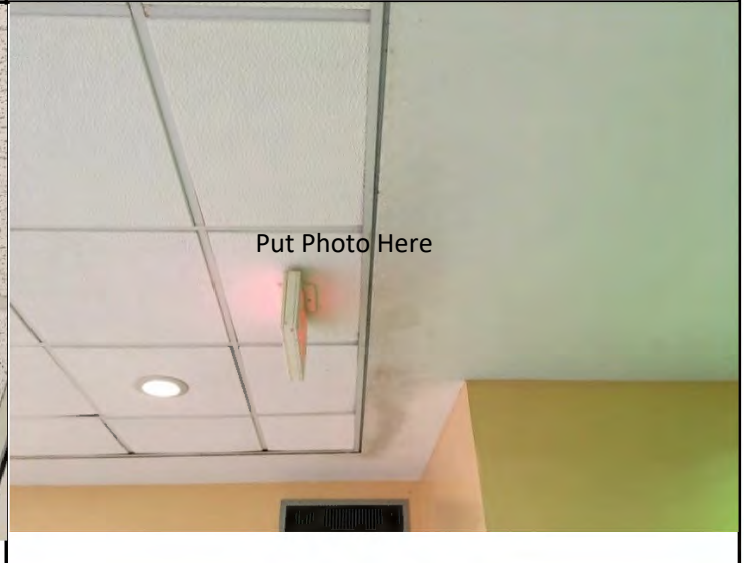
<b>Damage Description:</b>	<b>Item #:</b> 36
Ceiling, drywall, repair, discolored, caused by rainwater intrusion (Main Bldg., Floor 2, Presidential Lobby)	
<b>Additional Comments:</b>

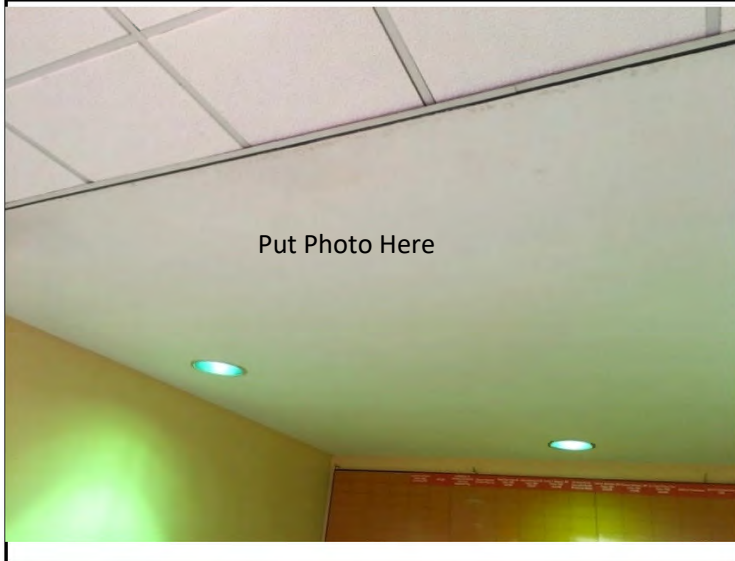
<b>Damage Description:</b>	<b>Item #:</b> 37
Ceiling, drywall, paint, discolored, caused by rainwater intrusion (Main Bldg., Floor 2, Presidential Lobby)	
<b>Additional Comments:</b>

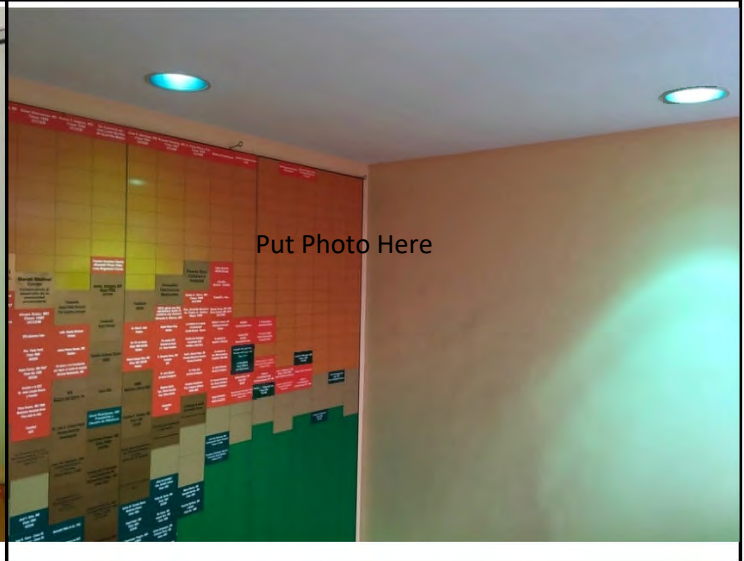
<b>Damage Description:</b>	<b>Item #:</b> 38
Wall, 1/4 IN thick plaster on concrete, painted, discolored, caused by rainwater intrusion (Main Bldg., Floor 2, Stairway)	
<b>Additional Comments:</b>

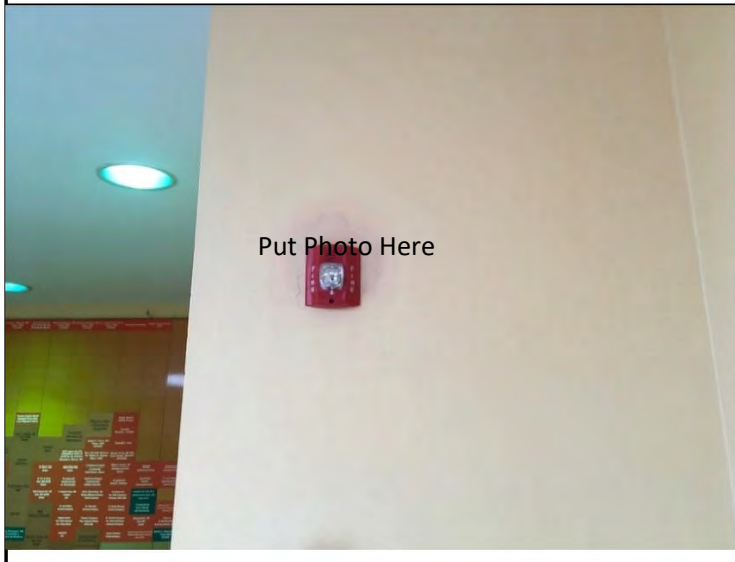
<b>Damage Description:</b>	<b>Item #:</b> 39
Wall, 1/4 IN thick plaster on concrete, painted, discolored, caused by rainwater intrusion (Main Bldg., Floor 2, Presidential Lobby)	
<b>Additional Comments:</b>

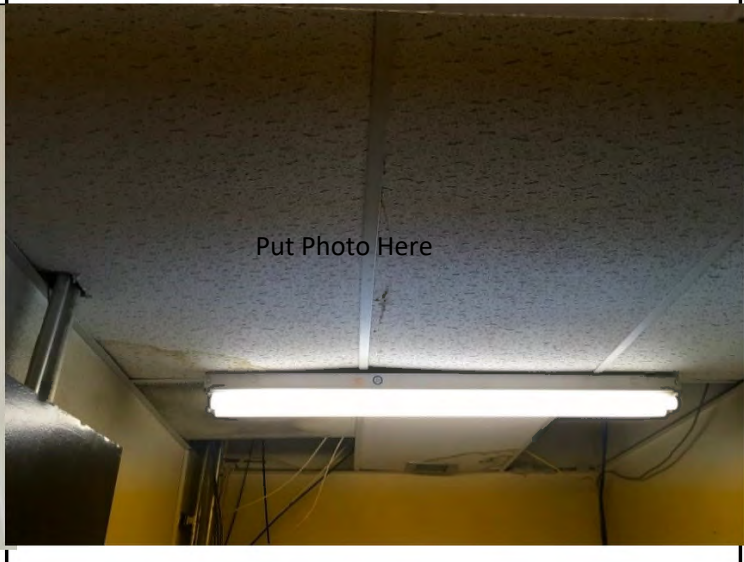
<b>Damage Description:</b>	<b>Item #:</b> 40
Ceiling, 2 FT x 4 FT acoustic tile, suspended, cracked, caused by rainwater intrusion (Main Bldg., Floor 2, Elevator Machine Room)	
<b>Additional Comments:</b>

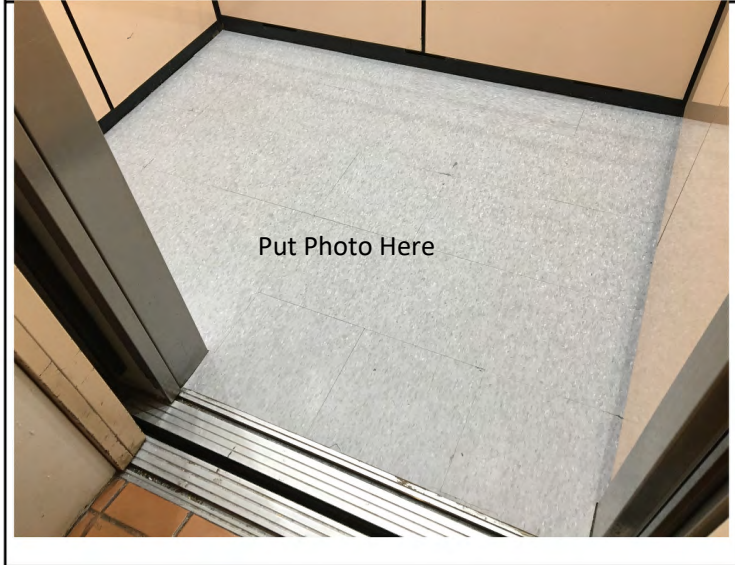
<b>Damage Description:</b>	<b>Item #:</b> 41
Building Interior, Elevator 340 at lobby, floor, 12 IN X 12 IN VCT, detached due to water infiltration (Main Bldg., Entire Building)	
<b>Additional Comments:</b>

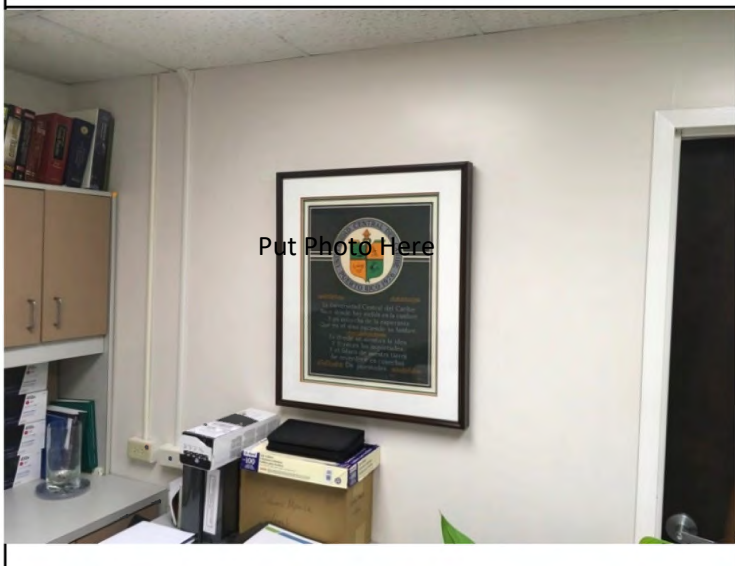
<b>Damage Description:</b>	<b>Item #:</b> 43
Wall, ¼ IN thick plaster on concrete, painted, discolored, caused by rainwater intrusion (Main Bldg., Floor 2, Office R215)	
<b>Additional Comments:</b>

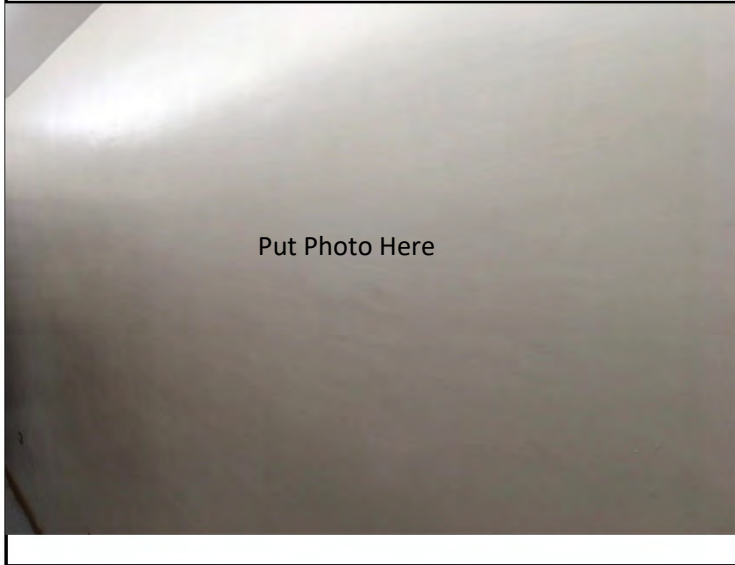
<b>Damage Description:</b>	<b>Item #:</b> 45
Wall, ¼ IN thick plaster on concrete, painted, discolored, caused by rainwater intrusion (Main Bldg., Floor 2, Conference)	
<b>Additional Comments:</b>

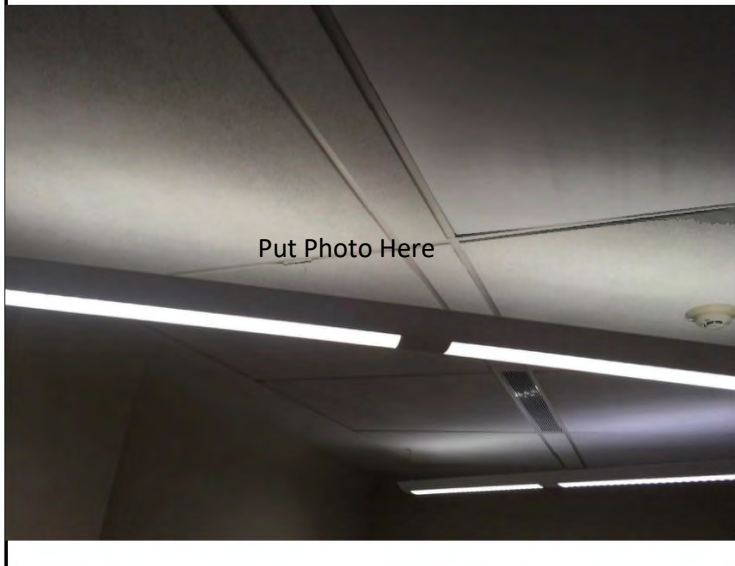
<b>Damage Description:</b>	<b>Item #:</b> 47
Ceiling, 4 FT x 4 FT acoustic tile, suspended, tegular, deformed, caused by rainwater intrusion (Main Bldg., Floor 2, Classroom R542)	
<b>Additional Comments:</b>

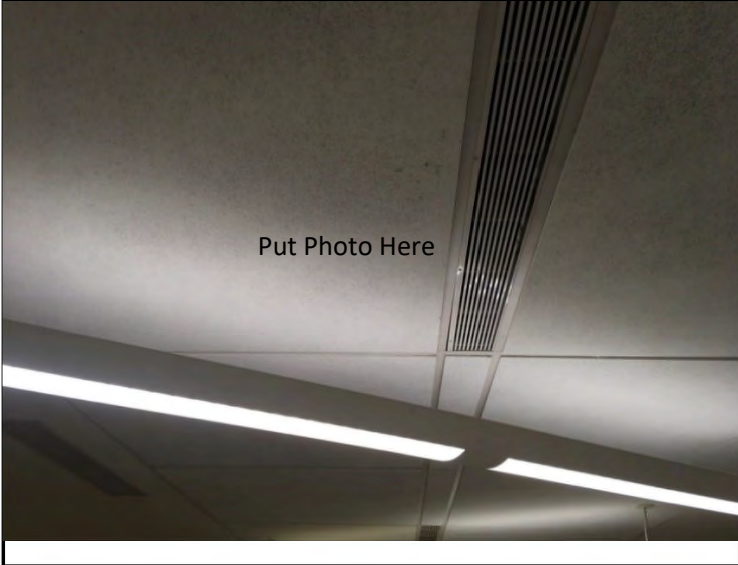
<b>Damage Description:</b>	<b>Item #:</b> 49	<b>Damage Description:</b>	<b>Item #:</b> 50
Ceiling, drywall, paint, discolored, caused by rainwater intrusion (Main Bldg., Floor 2, Classroom R542)		Base Lining, Base molding, wood, 2 5/8 IN x 1/2 IN, stained and urethane-finished, dislodged, caused by rainwater intrusion (Main Bldg., Floor 2, Classroom R542)	
<b>Additional Comments:</b>		<b>Additional Comments:</b>

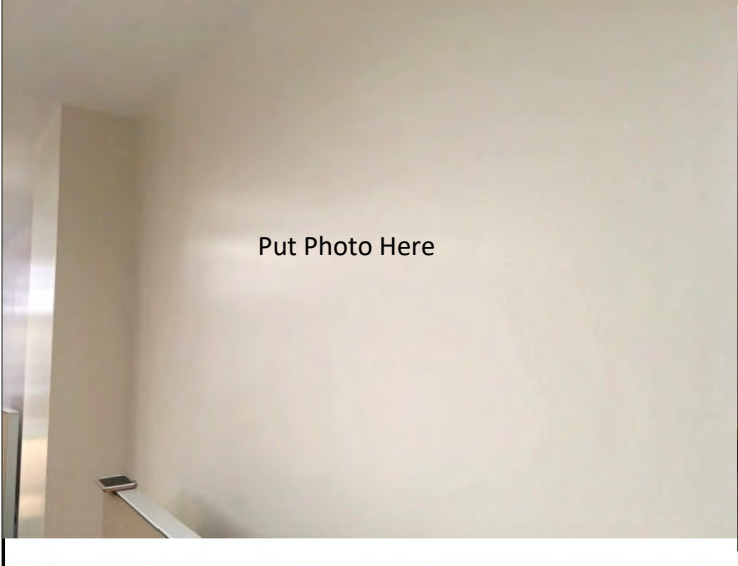
<b>Damage Description:</b>	<b>Item #:</b> 51	<b>Damage Description:</b>	<b>Item #:</b> 52
Wall, drywall, paint, discolored, caused by rainwater intrusion (Main Bldg., Floor 2, Classroom R542)		Wall, drywall, repair, deformed, caused by rainwater intrusion (Main Bldg., Floor 2, Classroom R542)	
<b>Additional Comments:</b>		<b>Additional Comments:</b>

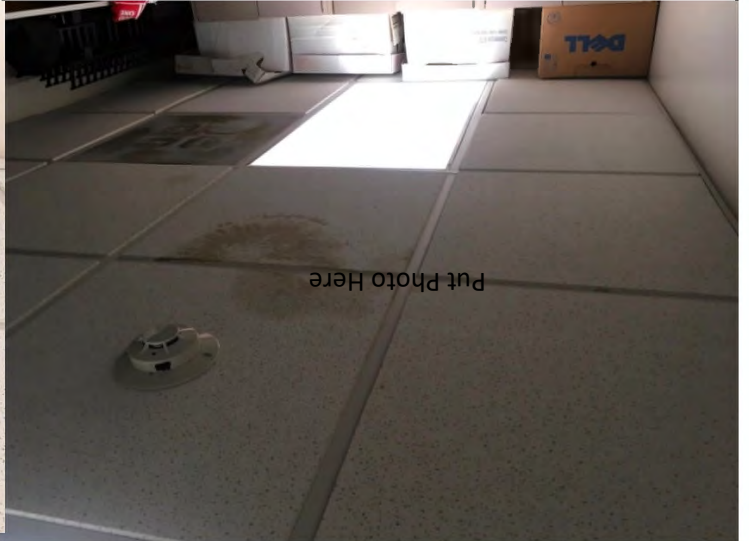
<b>Damage Description:</b>	<b>Item #:</b>	<b>53</b>
Ceiling, 2 FT x 2 FT acoustic tile, suspended, tegular, deformed, caused by rainwater intrusion (Main Bldg., Floor 2, Server Room)		
<b>Additional Comments:</b>

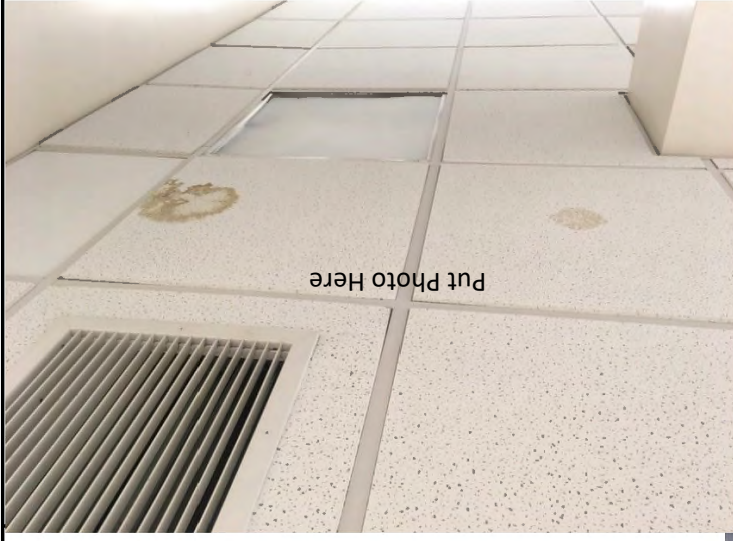
<b>Damage Description:</b>	<b>Item #:</b>	<b>54</b>
Ceiling, 2 FT x 2 FT acoustic tile, suspended, tegular, deformed, caused by rainwater intrusion (Main Bldg., Floor 2, Office RS44, 545,546)		
<b>Additional Comments:</b>

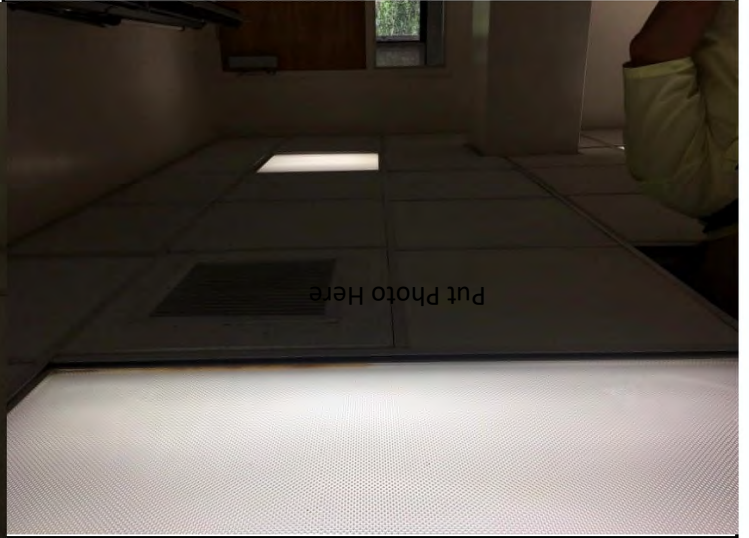
<b>Damage Description:</b>	<b>Item #:</b>	<b>55</b>
Light, fluorescent, recessed Troffer, electrical issues, caused by rainwater intrusion (Main Bldg., Floor 2, Office RS44)		
<b>Additional Comments:</b>

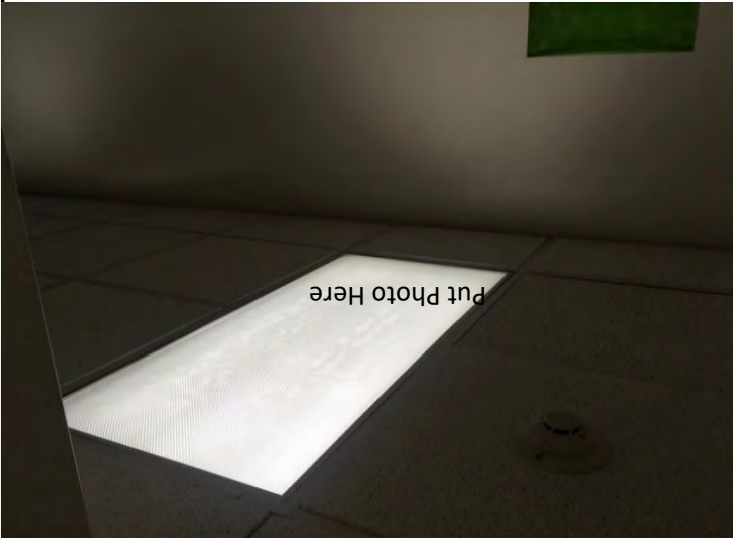
<b>Damage Description:</b>	<b>Item #:</b>	<b>56</b>
Light, fluorescent, recessed Troffer, acrylic prismatic lens only, discolored, caused by rainwater intrusion (Main Bldg., Floor 2, Office RS44)		
<b>Additional Comments:</b>

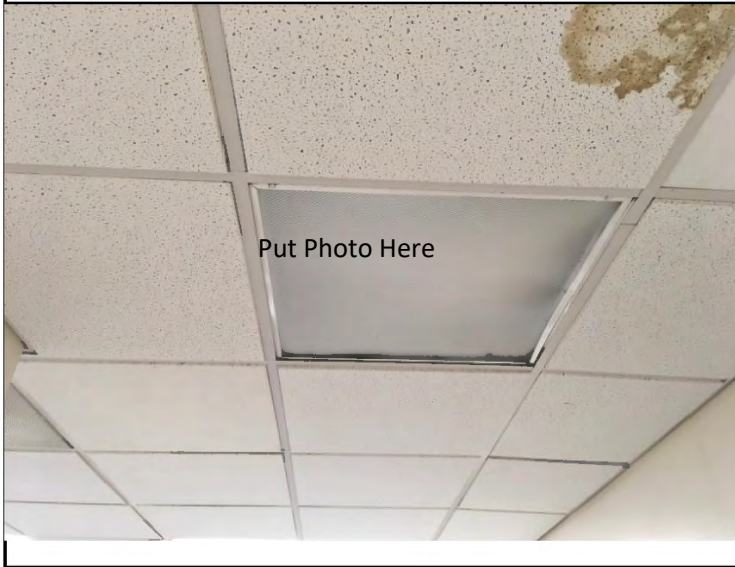
<b>Damage Description:</b>	<b>Item #:</b> 57
Light, fluorescent, recessed Troffer, electrical issues, caused by rainwater intrusion (Main Bldg., Floor 2, Office R544)	
<b>Additional Comments:</b>

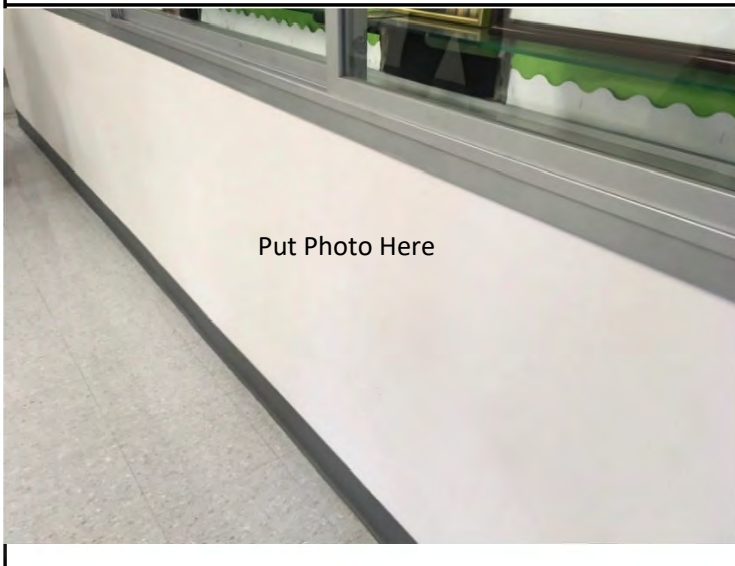
<b>Damage Description:</b>	<b>Item #:</b> 59 Wall,
drywall, painted, deformed, caused by rainwater intrusion (Main Bldg., Floor 1, Library R231)	
<b>Additional Comments:</b>

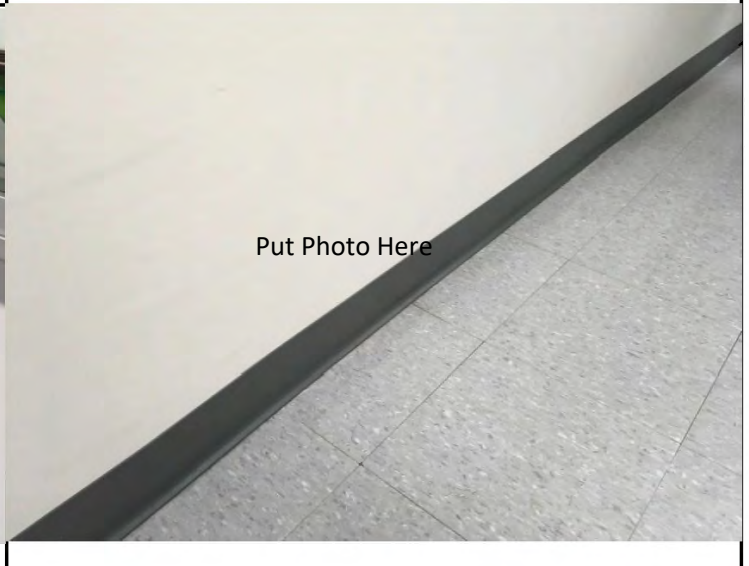
<b>Damage Description:</b>	<b>Item #:</b> 60
Base Lining, vinyl, 4 IN, deformed, caused by rainwater intrusion (Main Bldg., Floor 1, Library R231)	
<b>Additional Comments:</b>

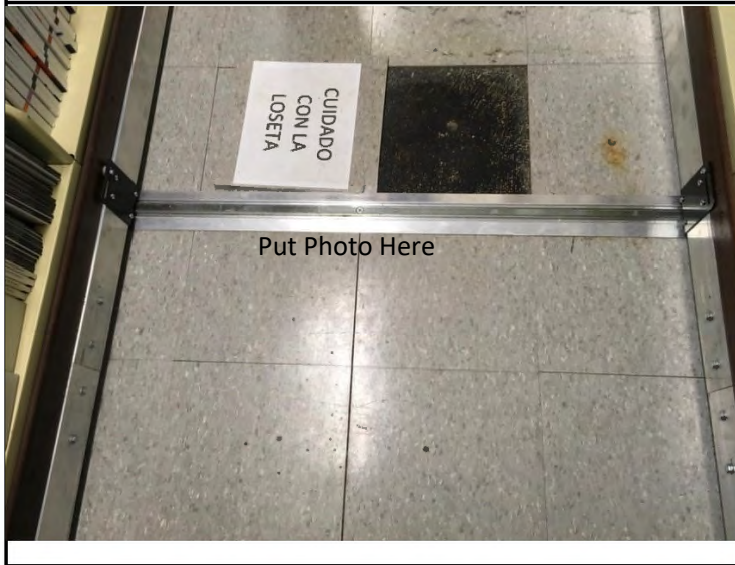
<b>Damage Description:</b>	<b>Item #:</b> 62
Floor, VCT, 12x12 IN, dislodged, caused by surface water flooding (Main Bldg., Floor 1, Library)	
<b>Additional Comments:</b>

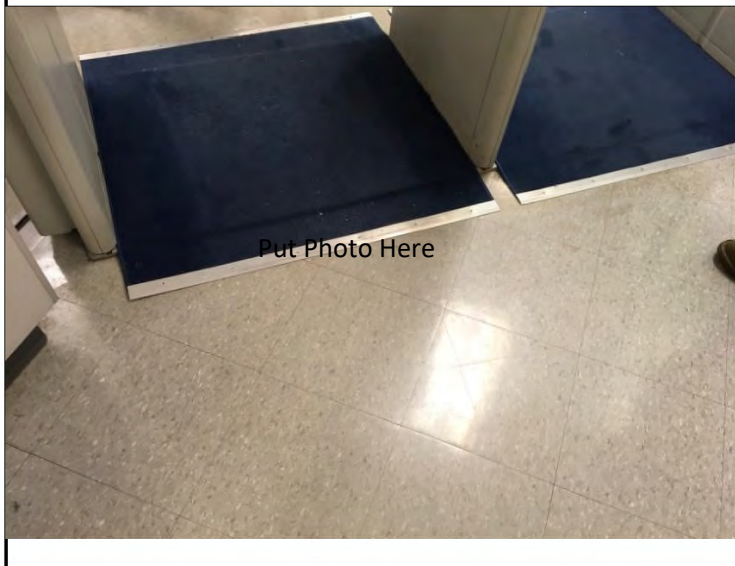
<b>Damage Description:</b>	<b>Item #:</b> 64
Floor, carpet, commercial-grade, including 12 LF of aluminum transition strip , discolored, caused by surface water flooding (Main Bldg., Floor 1, Library Including Rooms 204 @ 206)	
<b>Additional Comments:</b>

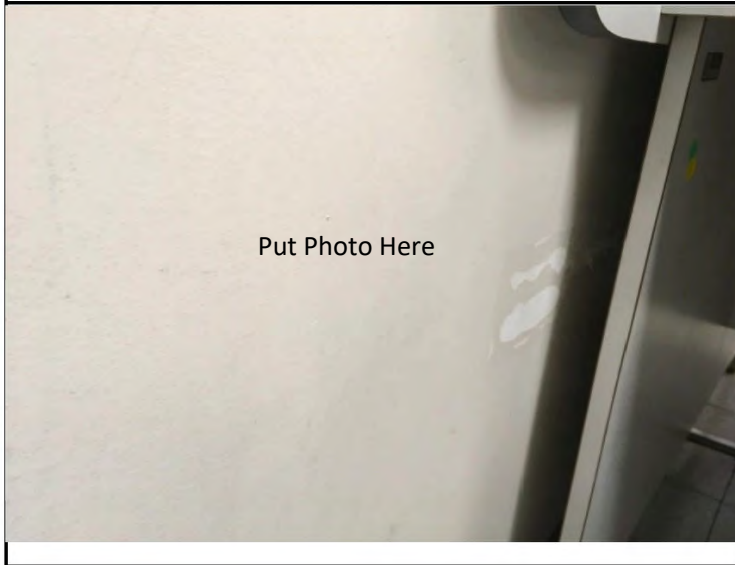
<b>Damage Description:</b>	<b>Item #:</b> 67
Wall, ¼ IN thick plaster on concrete, repair, cracked, caused by rainwater intrusion (Main Bldg., Floor 1, Library)	
<b>Additional Comments:</b>

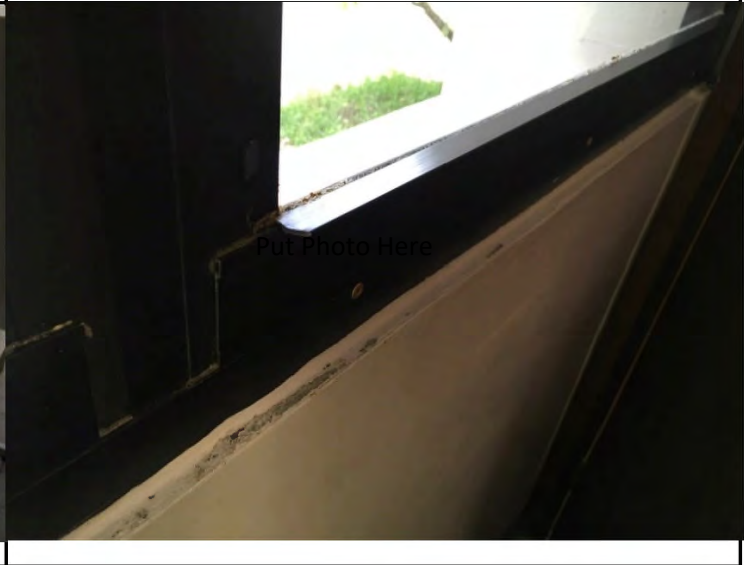
<b>Damage Description:</b>	<b>Item #:</b> 68
Window, Alum. window frames, perimeter caulking/sealing only, cracked, caused by wind-driven rain (Main Bldg., Floor 1, Library)	
<b>Additional Comments:</b>

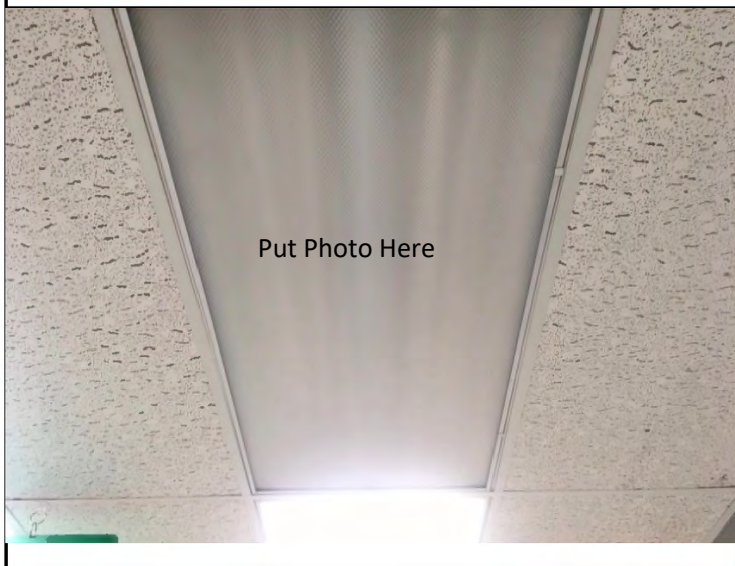
<b>Damage Description:</b>	<b>Item #:</b> 69
Light, fluorescent, recessed Troffer, electrical issues, caused by rainwater intrusion (Main Bldg., Floor 1, Library)	
<b>Additional Comments:</b>

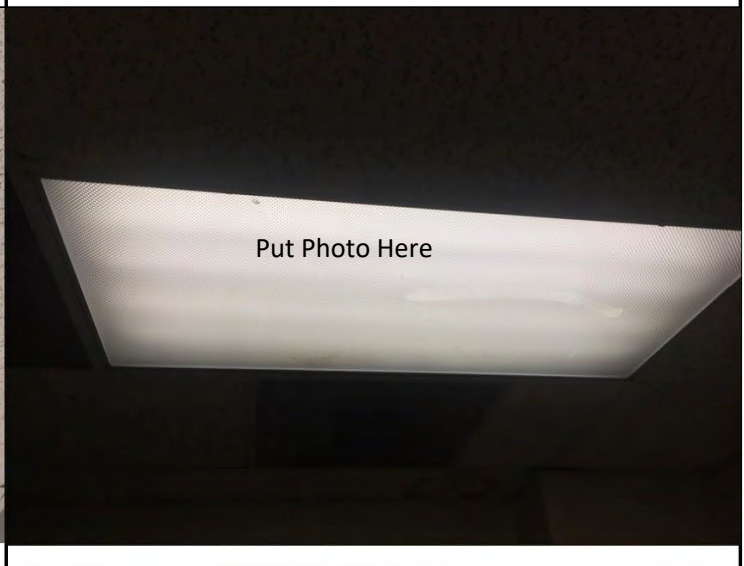
<b>Damage Description:</b>	<b>Item #:</b> 70
Light, fluorescent, recessed Troffer, acrylic prismatic lens only, discolored, caused by rainwater intrusion (Main Bldg., Floor 1, Library)	
<b>Additional Comments:</b>

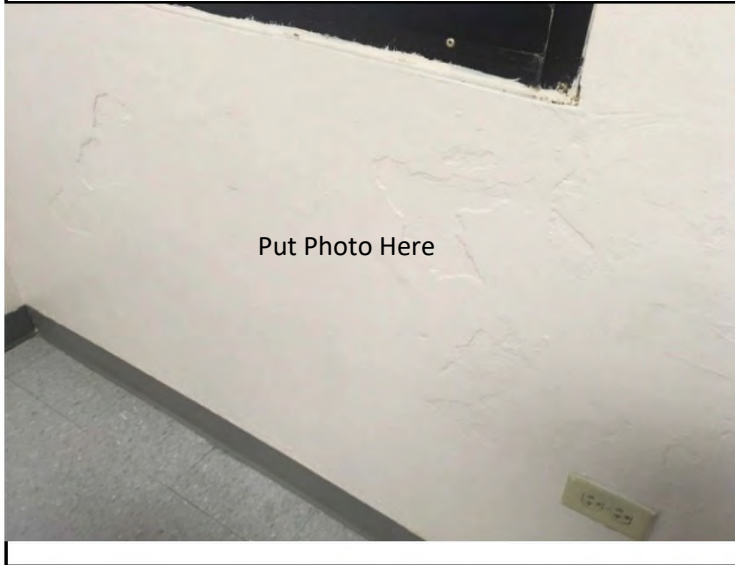
<b>Damage Description:</b>	<b>Item #:</b> 72
Wall, ¼ IN thick plaster on concrete, painted, repair spalling, cracked, caused by rainwater intrusion (Main Bldg., Floor 1, Classroom R357 & 356)	
<b>Additional Comments:</b>

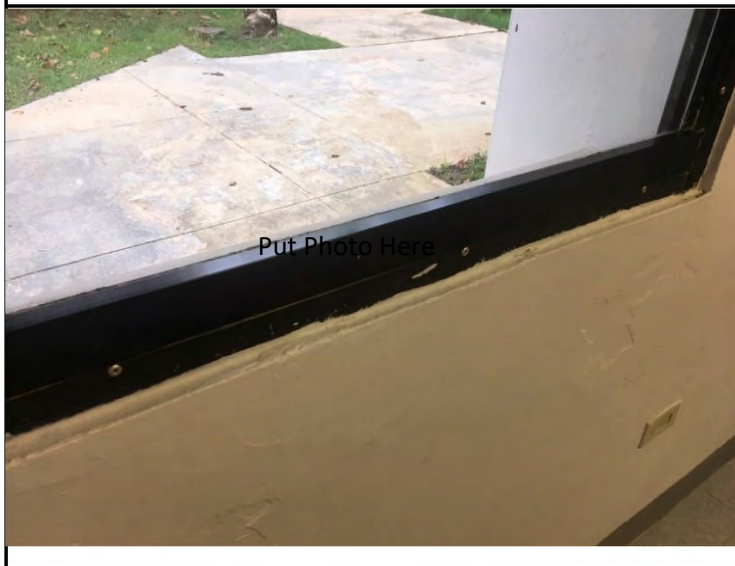
<b>Damage Description:</b>	<b>Item #:</b> 74
Window, Alum. window frames, perimeter caulking/sealing only, cracked, caused by rainwater intrusion (Main Bldg., Floor 1, Classroom R357 & 356)	
<b>Additional Comments:</b>

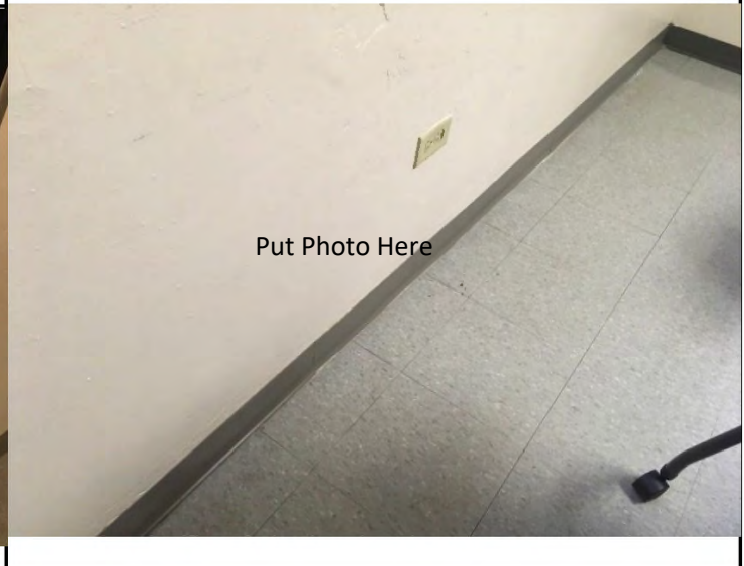
<b>Damage Description:</b>	<b>Item #:</b> 75
Base Lining, vinyl, 4 IN, deformed, caused by rainwater intrusion (Main Bldg., Floor 1, Classroom R357 & 356)	
<b>Additional Comments:</b>

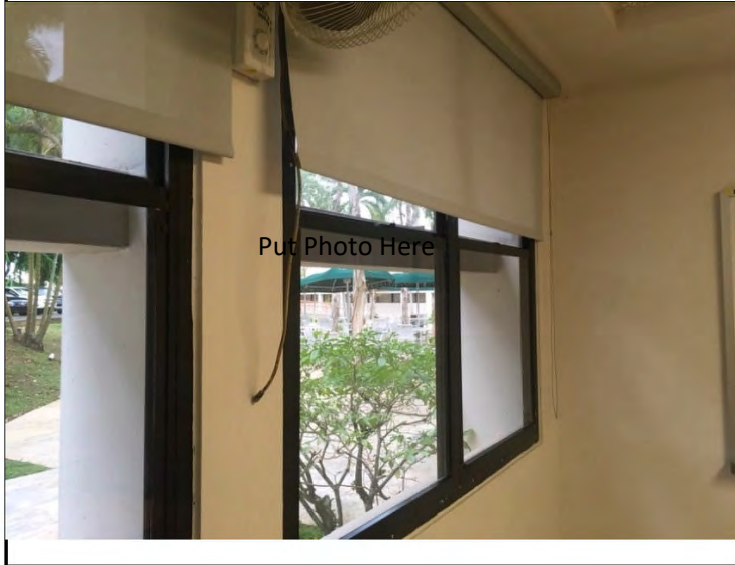
<b>Damage Description:</b>	<b>Item #:</b> 76	<b>Damage Description:</b>	<b>Item #:</b> 77
Vertical blinds, PVC, 3-IN blades, broken components, caused by rainwater intrusion (Main Bldg., Floor 1, Classroom R357 & R356)		Floor, VCT, 12x12 IN, dislodged, caused by surface water flooding (Main Bldg., Floor 1, Classroom R360)	
<b>Additional Comments:</b>		<b>Additional Comments:</b>

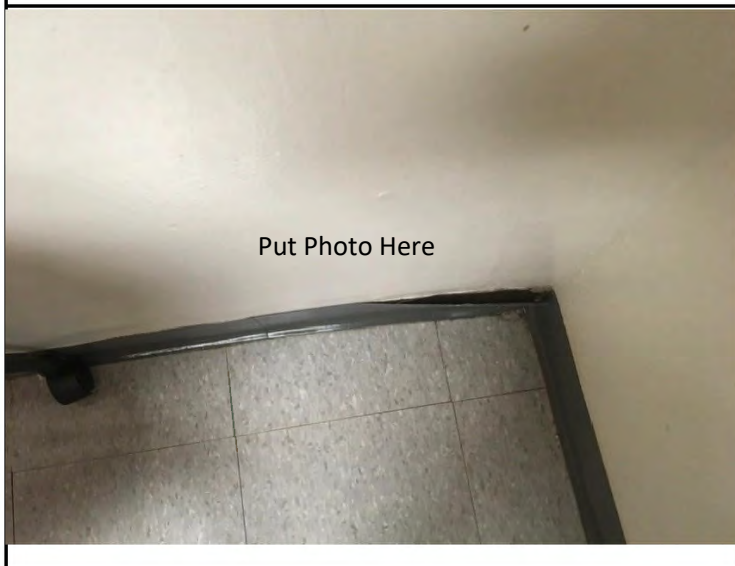
<b>Damage Description:</b>	<b>Item #:</b> 78	<b>Damage Description:</b>	<b>Item #:</b> 79
Base Lining, vinyl, 4 IN, deformed, caused by surface water flooding (Main Bldg., Floor 1, Classroom R360)		Wall, 1/4 IN thick plaster on concrete, repair, cracked, caused by rainwater intrusion (Main Bldg., Floor 1, Classroom R360)	
<b>Additional Comments:</b>		<b>Additional Comments:</b>

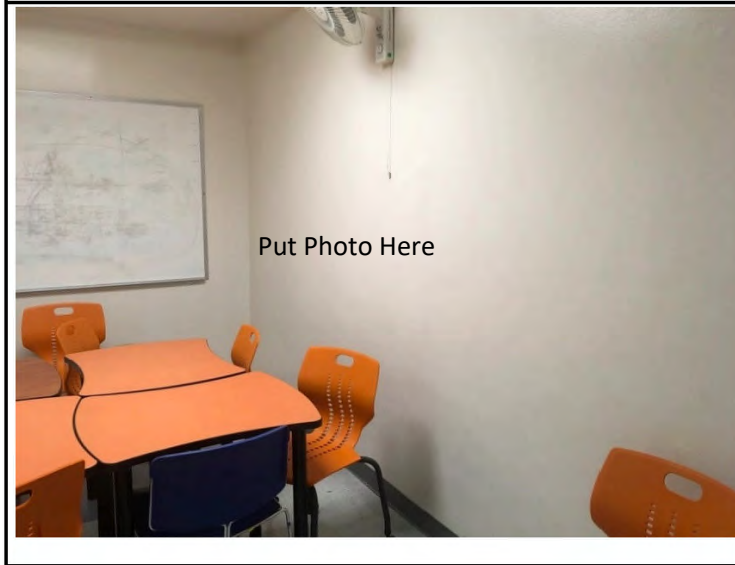
<b>Damage Description:</b>	<b>Item #:</b> 80
Wall, ¼ IN thick plaster on concrete, painted, discolored, caused by rainwater intrusion (Main Bldg., Floor 1, Classroom R360)	
<b>Additional Comments:</b>

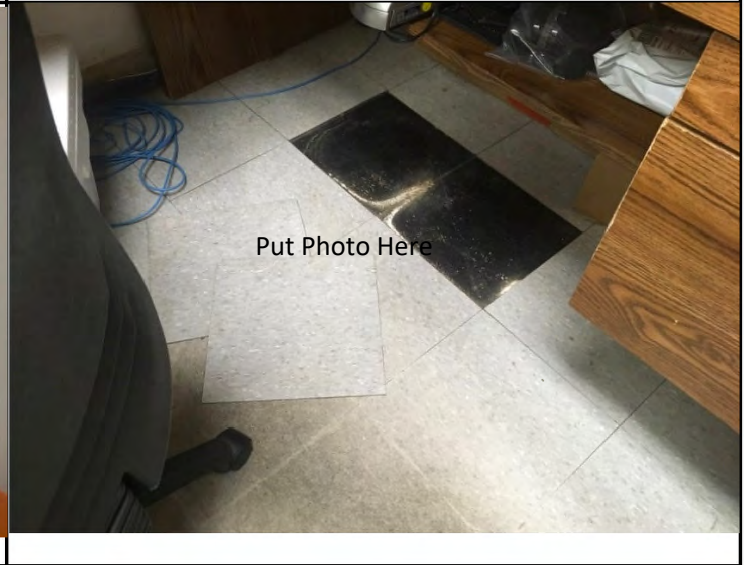
<b>Damage Description:</b>	<b>Item #:</b> 81
Floor, VCT, 12x12 IN, dislodged, caused by surface water flooding (Main Bldg., Floor 1, Office R201)	
<b>Additional Comments:</b>

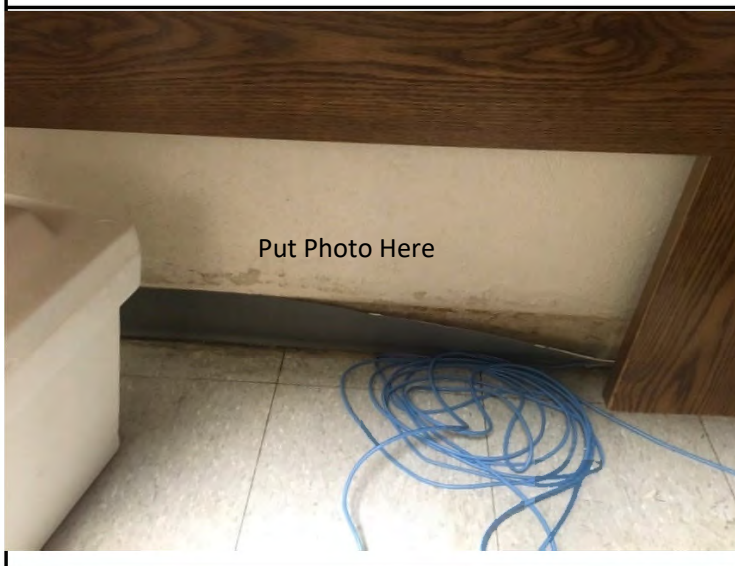
<b>Damage Description:</b>	<b>Item #:</b> 82
Base Lining, vinyl, 4 IN, dislodged, caused by rainwater intrusion (Main Bldg., Floor 1, Office R201)	
<b>Additional Comments:</b>
