<b>Applicant:</b> Universidad Central Del Caribe, Inc.	<b>Damage Inventory:</b> 305240	<b>Category:</b> E
<b>WO #</b> 46525 <b>FIPS#</b> 021-UNUGB-00	<b>Date:</b> 09/04-17/2019 <b>GPS:</b> 18.365953, -66.153767	
<b>Inspector:</b> Gregory Sondergeld / Alexander Nieves	<b>Damage Facility:</b> Main Bldg.

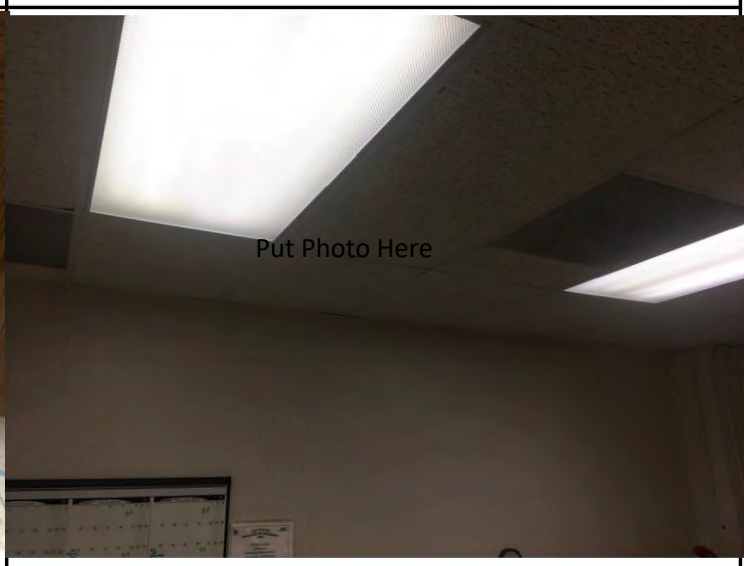
<b>Damage Description:</b>	<b>Item #:</b> 83
Ceiling, 2 FT x 4 FT acoustic tile, suspended, deformed, caused by rainwater intrusion (Main Bldg., Floor 1, Office R201)	
<b>Additional Comments:</b>

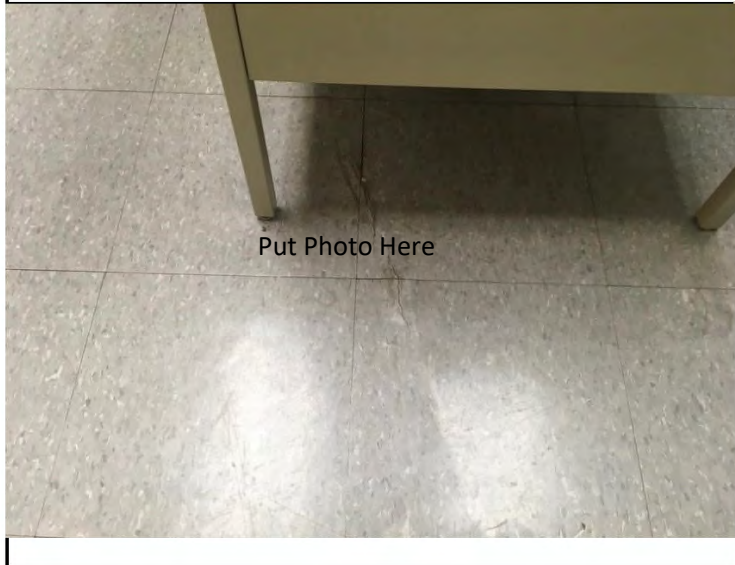
<b>Damage Description:</b>	<b>Item #:</b> 84
Floor, VCT, 12x12 IN, dislodged, caused by surface water flooding (Main Bldg., Floor 1, Office R202)	
<b>Additional Comments:</b>

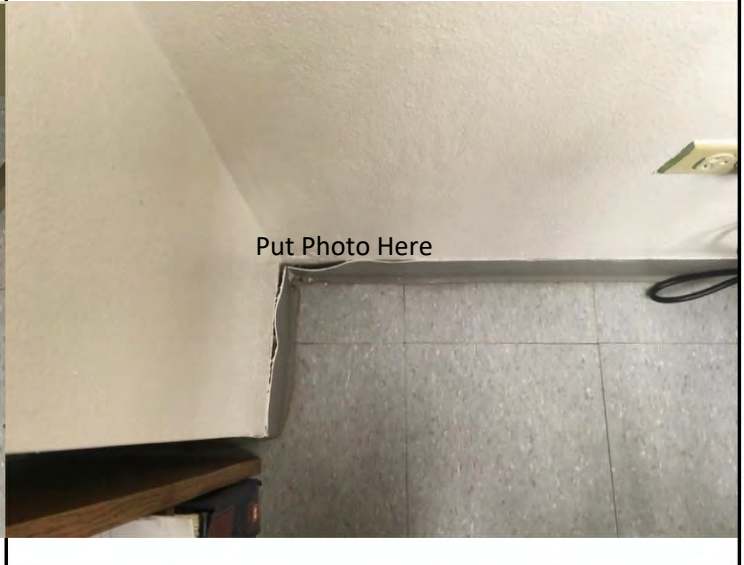
<b>Damage Description:</b>	<b>Item #:</b> 85
Base Lining, vinyl, 4 IN, dislodged, caused by surface water flooding (Main Bldg., Floor 1, Office R202)	
<b>Additional Comments:</b>

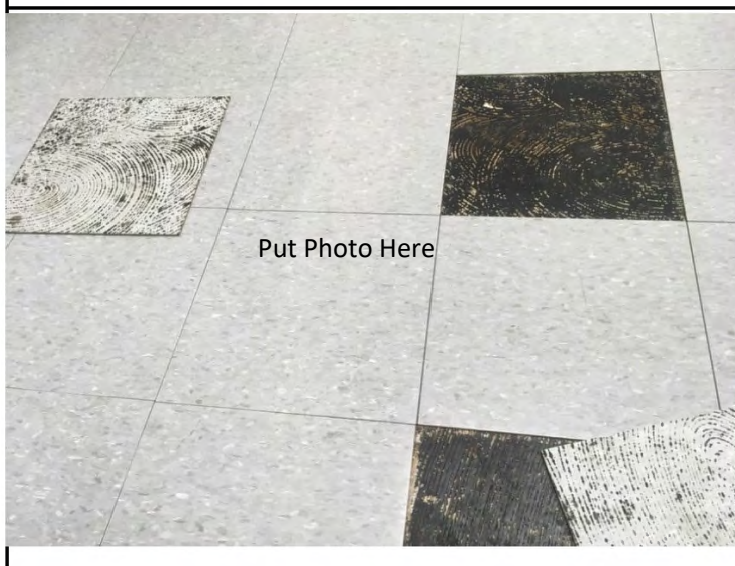
<b>Damage Description:</b>	<b>Item #:</b> 86
Floor, VCT, 12x12 IN, dislodged, caused by surface water flooding (Main Bldg., Floor 1, Office R200)	
<b>Additional Comments:</b>

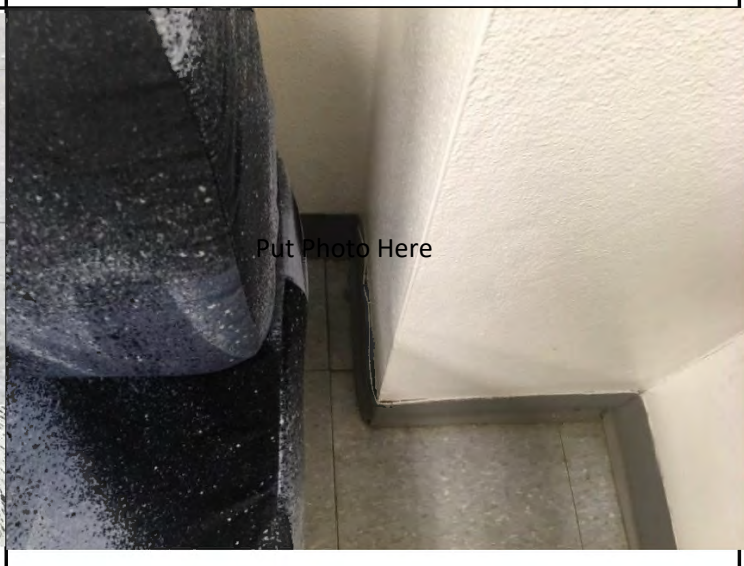
<b>Damage Description:</b>	<b>Item #:</b> 87
Base Lining, vinyl, 4 IN, dislodged, caused by surface water flooding (Main Bldg., Floor 1, Office R200)	
<b>Additional Comments:</b>

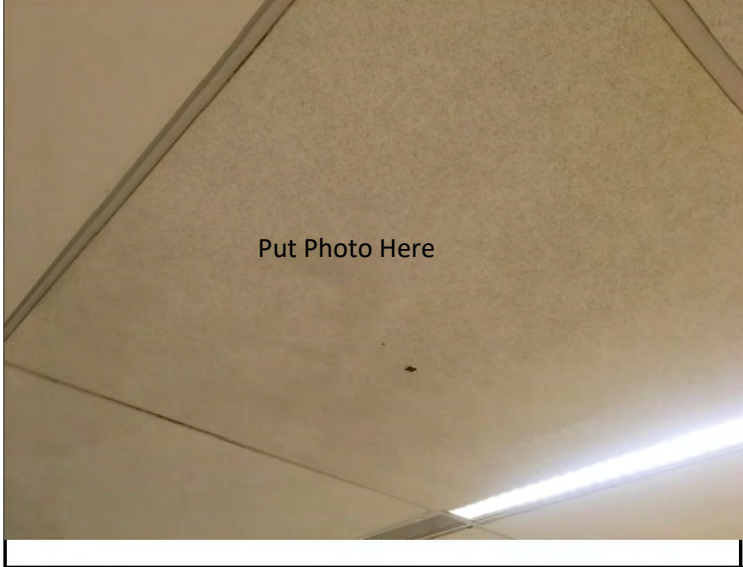
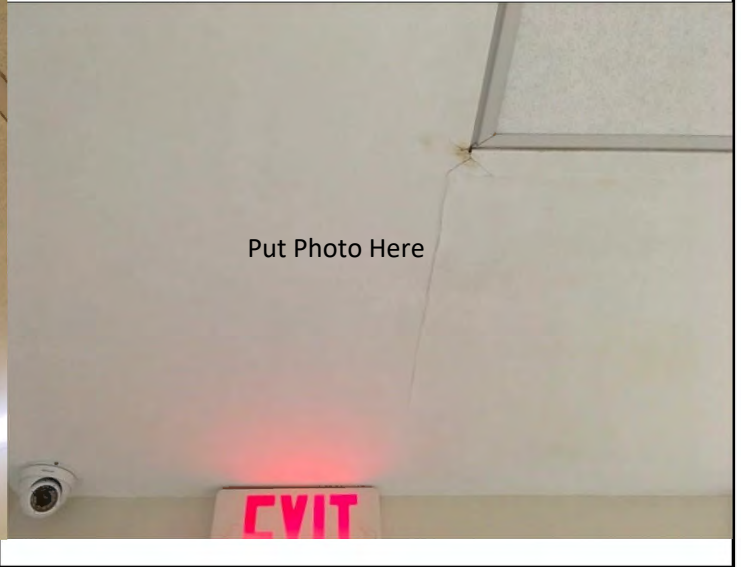
<b>Damage Description:</b>	<b>Item #:</b> 88	<b>Damage Description:</b>	<b>Item #:</b> 89
Ceiling, 4 FT x 4 FT acoustic tile, suspended, discolored, caused by rainwater intrusion (Main Bldg., Floor 2, Classroom R555, Computers Room)		Ceiling, drywall, repair, cracked, caused by rainwater intrusion (Main Bldg., Floor 2, Classroom R555, Computers Room)	
<b>Additional Comments:</b>		<b>Additional Comments:</b>

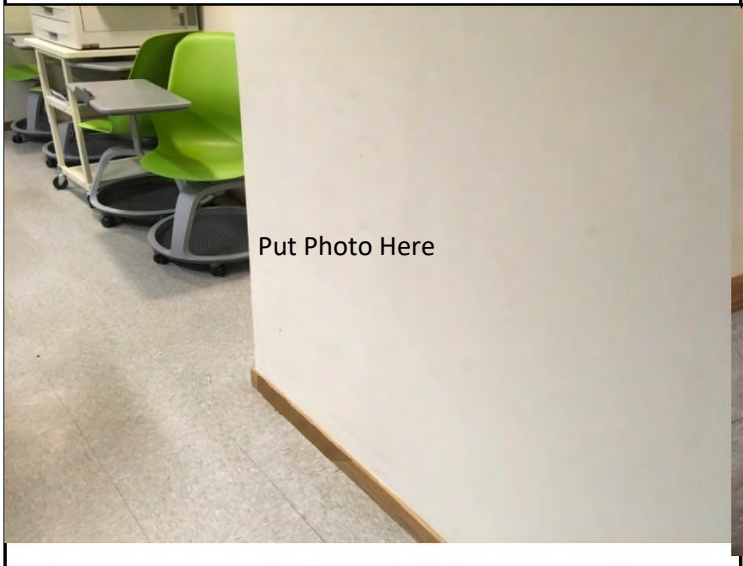
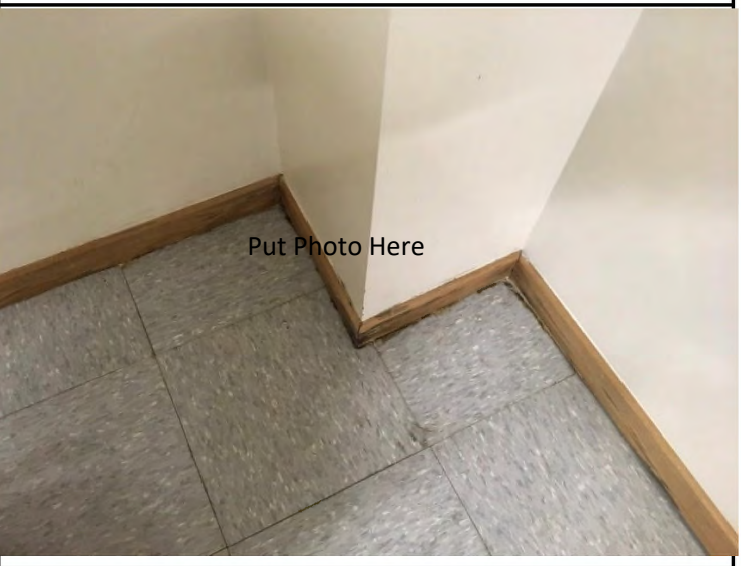
<b>Damage Description:</b>	<b>Item #:</b> 90	<b>Damage Description:</b>	<b>Item #:</b> 91
Wall, drywall, repair, discolored, caused by rainwater intrusion (Main Bldg., Floor 2, Classroom R555, Computers Room)		Base Lining, Base molding, wood, 2 5/8 IN x 1/2 IN, stained and urethane-finished, discolored, caused by rainwater intrusion (Main Bldg., Floor 2, Classroom R555, Computers Room)	
<b>Additional Comments:</b>		<b>Additional Comments:</b>

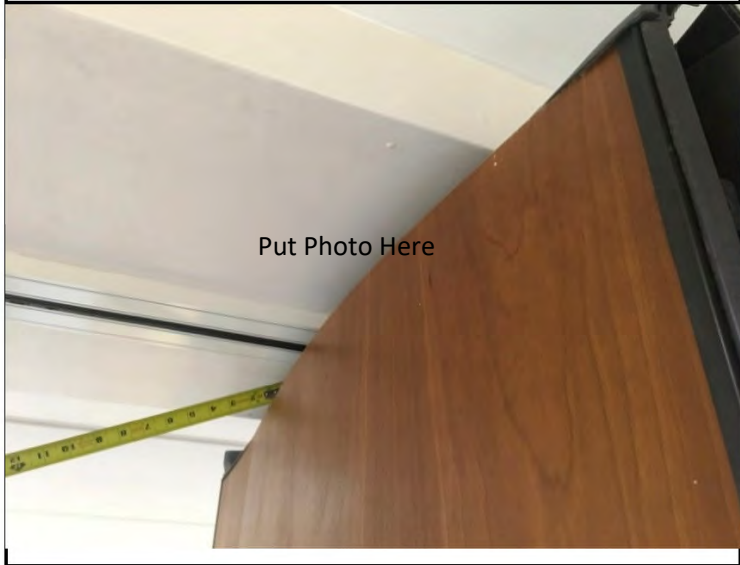
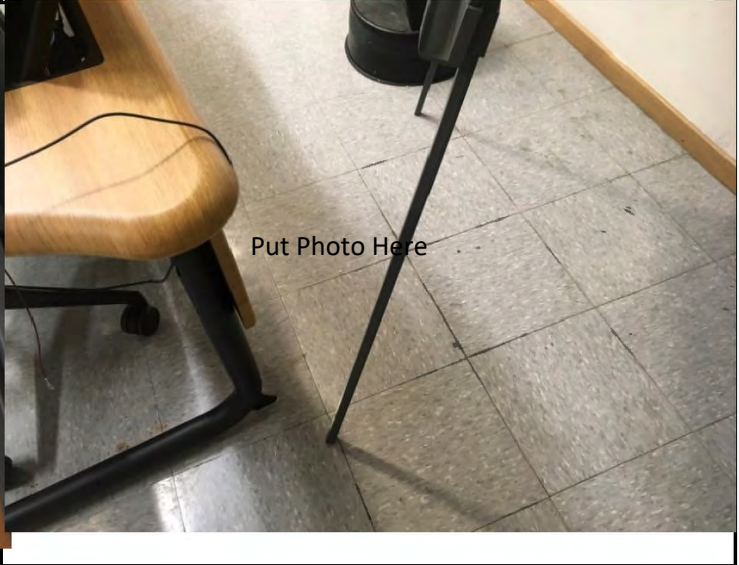
<b>Damage Description:</b>	<b>Item #:</b> 93	<b>Damage Description:</b>	<b>Item #:</b> 92
Commercial, manually-operated, sliding room partitions, suspended from top rail, double-faced wood veneer finish, and perimeter rubber gaskets, deformed, caused by rainwater intrusion (Main Bldg., Floor 2, Classroom R555, Computers Room)		Floor, VCT, 12x12 IN, detached, caused by surface water flooding (Main Bldg., Floor 2, Classroom R555, Computers Room)	
<b>Additional Comments:</b>		<b>Additional Comments:</b>

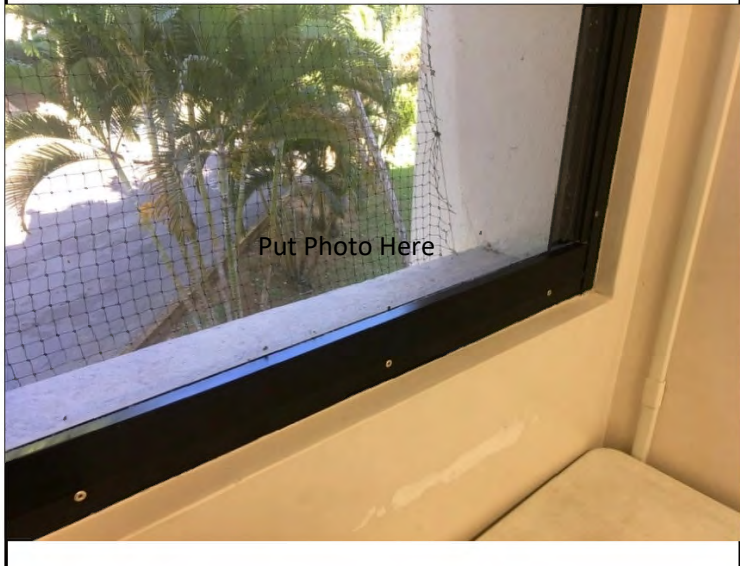
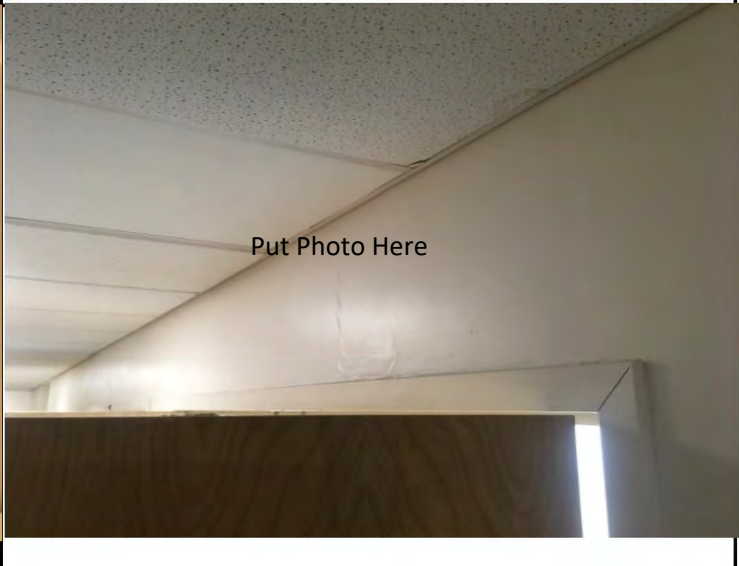
<b>Damage Description:</b>	<b>Item #:</b> 94	<b>Damage Description:</b>	<b>Item #:</b> 95
Window, Alum. window frames, perimeter caulking/sealing only, cracked, caused by wind-driven rain (Main Bldg., Floor 2, Classroom R553, Study Room)		Wall, drywall, repair, deformed, caused by rainwater intrusion (Main Bldg., Floor 2, Hallway Computer Laboratory)	
<b>Additional Comments:</b>		<b>Additional Comments:</b>

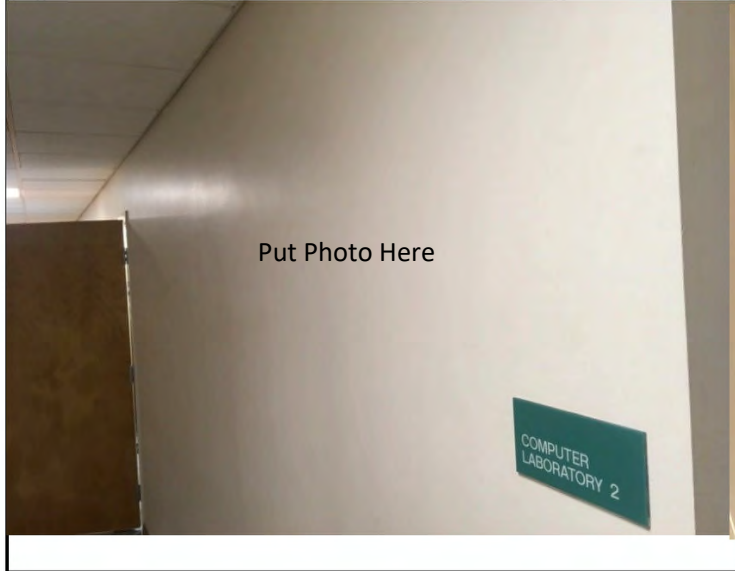
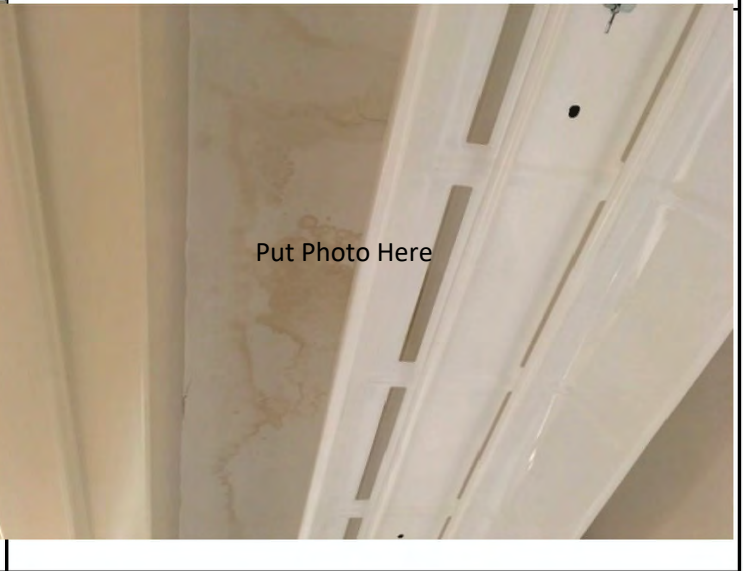
<b>Damage Description:</b>	<b>Item #:</b> 96	<b>Damage Description:</b>	<b>Item #:</b> 97
Wall, drywall, paint, discolored, caused by rainwater intrusion (Main Bldg., Floor 2, Hallway Computer Laboratory)		Ceiling, drywall, repair, deformed, caused by rainwater intrusion (Main Bldg., Floor 2, Electrical Room)	
<b>Additional Comments:</b>		<b>Additional Comments:</b>

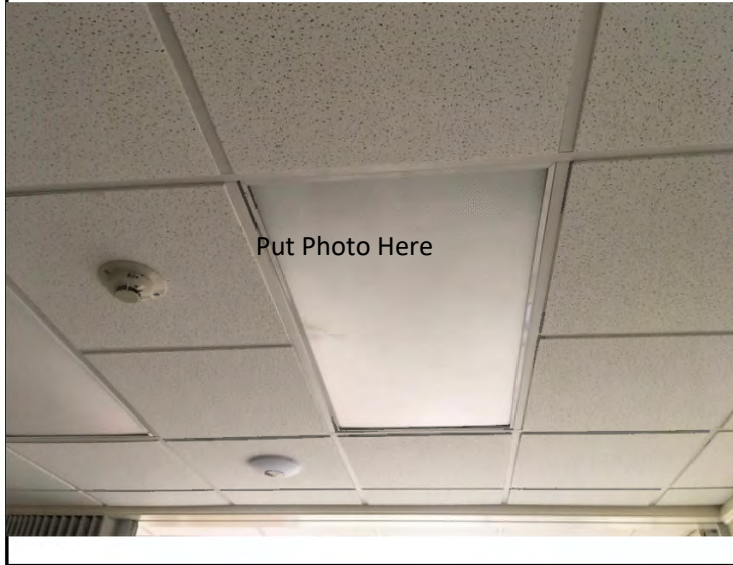
<b>Damage Description:</b>	<b>Item #:</b> 100
Light, fluorescent, recessed Troffer, acrylic prismatic lens only, discolored, caused by rainwater intrusion (Main Bldg., Floor 2, Study Room)	
<b>Additional Comments:</b>

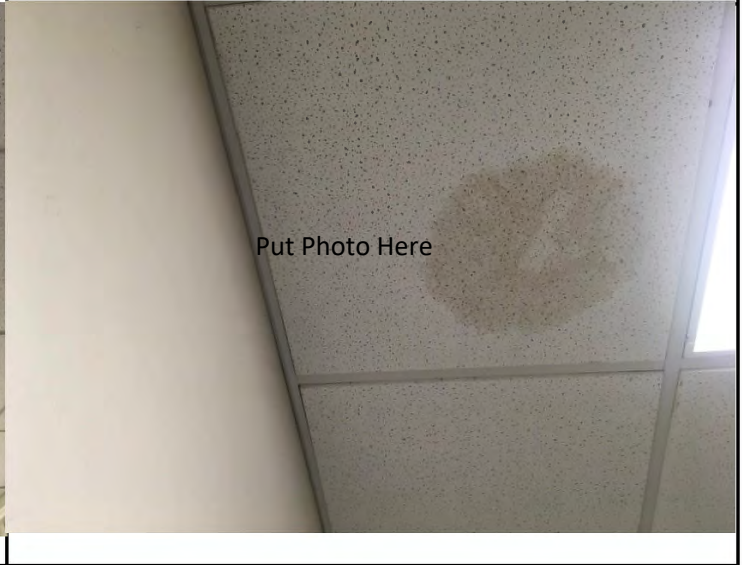
<b>Damage Description:</b>	<b>Item #:</b> 101
Ceiling, 2 FT x 2 FT acoustic tile, suspended, tegular, discolored, caused by rainwater intrusion (Main Bldg., Floor 2, Hallway Production)	
<b>Additional Comments:</b>

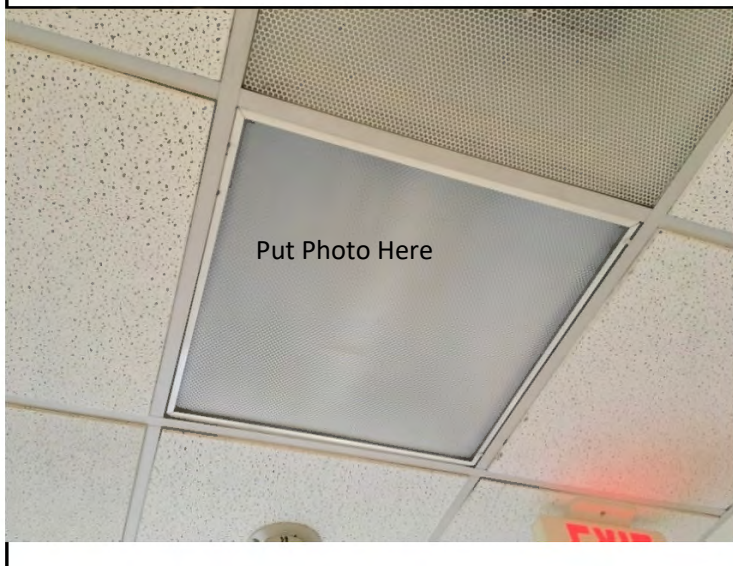
<b>Damage Description:</b>	<b>Item #:</b> 102
Light, fluorescent, recessed Troffer, broken components, caused by rainwater intrusion (Main Bldg., Floor 2, Hallway Production)	
<b>Additional Comments:</b>

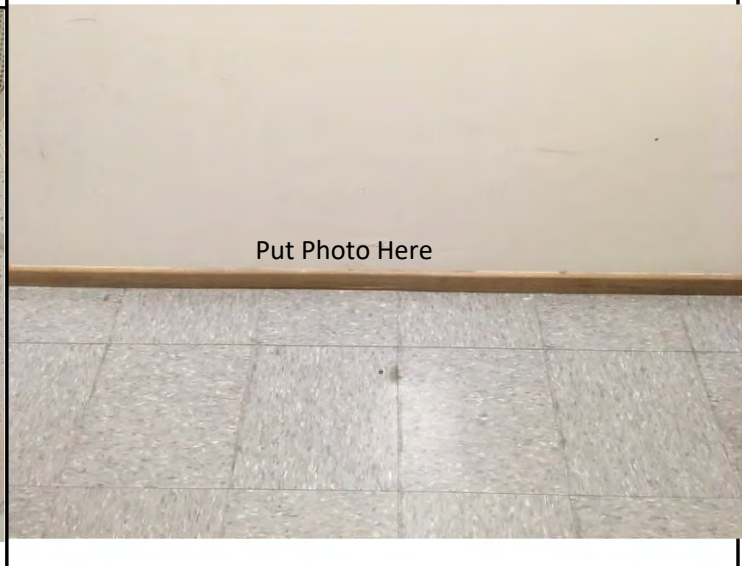
<b>Damage Description:</b>	<b>Item #:</b> 104
Base Lining, Base molding, wood, 2 5/8 IN x 1/2 IN, stained and urethane-finished, discolored, caused by surface water flooding (Main Bldg., Floor 2, Hallway Production)	
<b>Additional Comments:</b>

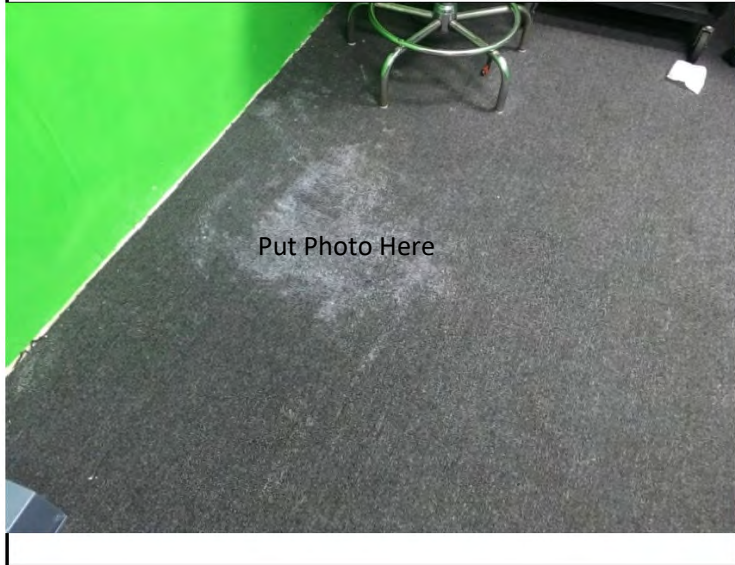
<b>Damage Description:</b>	<b>Item #:</b> 105
Floor, carpet, commercial-grade, discolored, caused by surface water flooding (Main Bldg., Floor 2, Classroom R548, Production Room)	
<b>Additional Comments:</b>

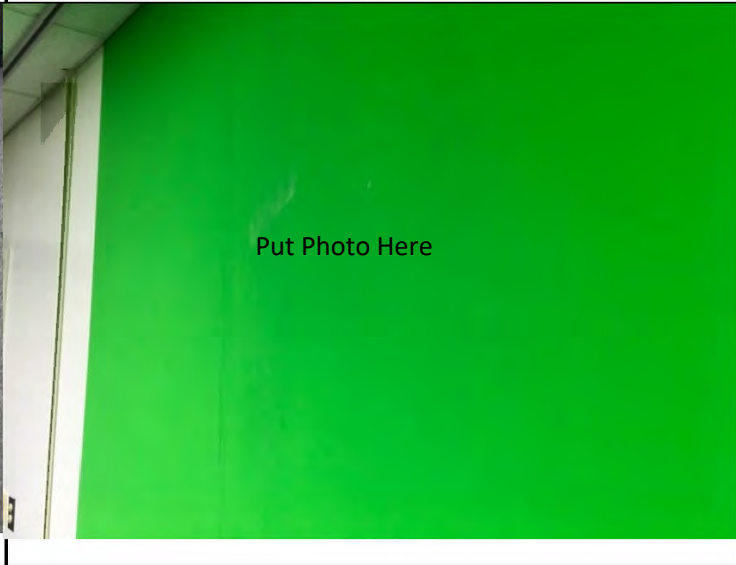
<b>Damage Description:</b>	<b>Item #:</b> 106
Wall, drywall, stainblock and paint, discolored, caused by rainwater intrusion (Main Bldg., Floor 2, Classroom R548, Production Room)	
<b>Additional Comments:</b>

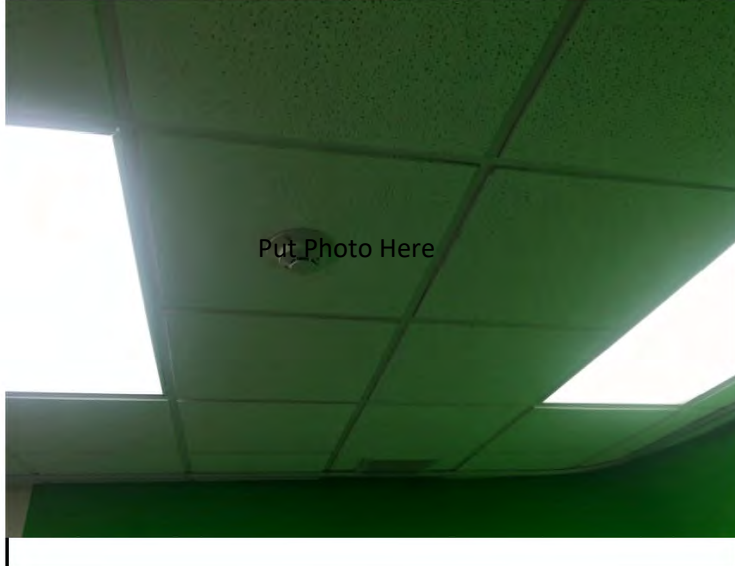
<b>Damage Description:</b>	<b>Item #:</b> 107
Ceiling, 2 FT x 2 FT acoustic tile, suspended, tegular, discolored, caused by rainwater intrusion (Main Bldg., Floor 2, Classroom R548, Production Room)	
<b>Additional Comments:</b>

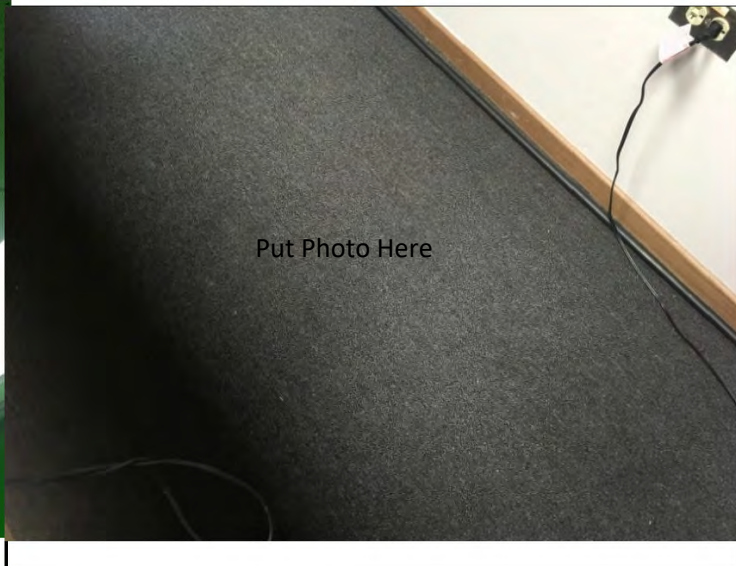
<b>Damage Description:</b>	<b>Item #:</b> 109
Floor, carpet, commercial-grade, discolored, caused by rainwater intrusion (Main Bldg., Floor 2, Classroom R549)	
<b>Additional Comments:</b>

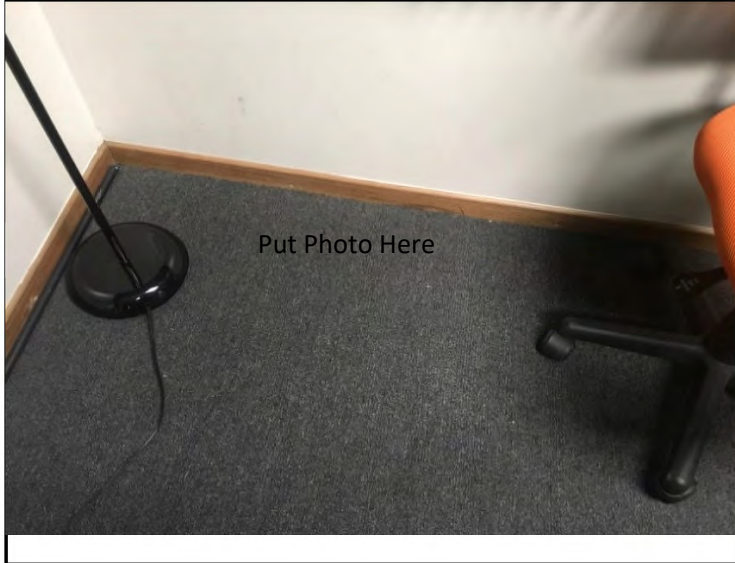
<b>Damage Description:</b>	<b>Item #:</b> 110
Base Lining, Base molding, wood, 2 5/8 IN x 1/2 IN, stained and urethane-finished, discolored, caused by surface water flooding (Main Bldg., Floor 2, Classroom R549)	
<b>Additional Comments:</b>

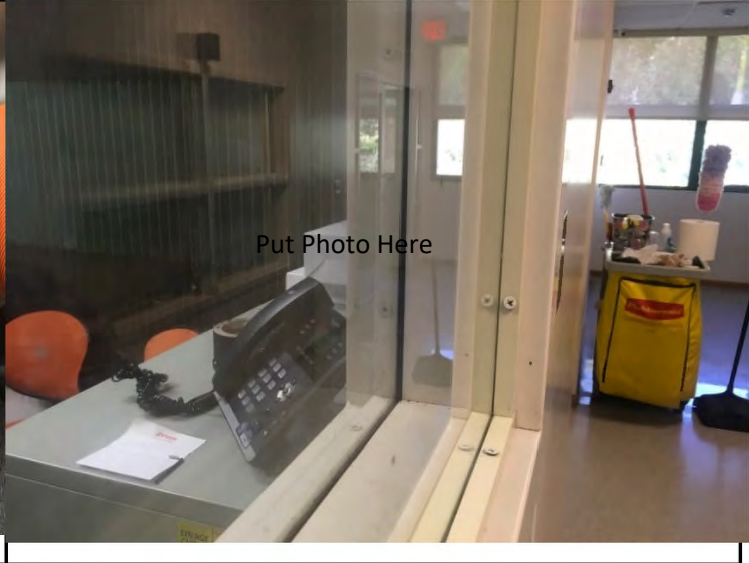
<b>Damage Description:</b>	<b>Item #:</b> 111
Window, Door, sidelight, non-insulated glazing, 16 IN x 30 IN, discolored, caused by rainwater intrusion (Main Bldg., Floor 2, Classroom R549)	
<b>Additional Comments:</b>

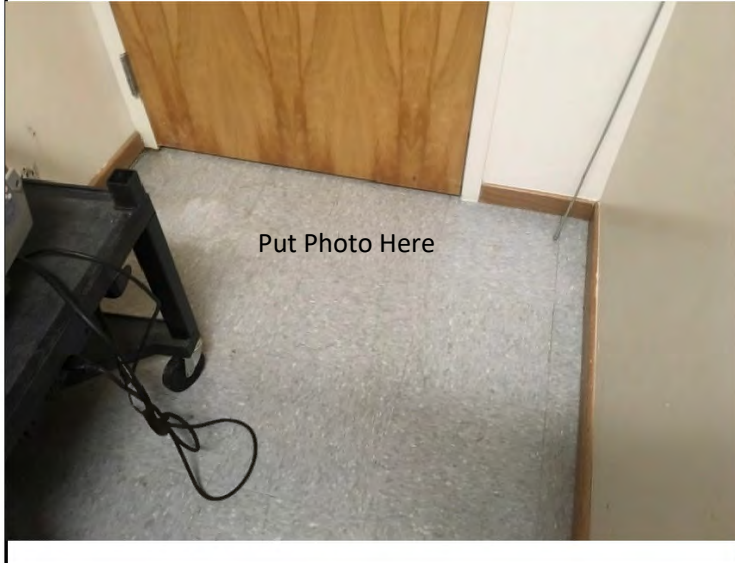
<b>Damage Description:</b>	<b>Item #:</b> 112
Floor, VCT, 12x12 IN, detached, caused by surface water flooding (Main Bldg., Floor 2, Classroom 547)	
<b>Additional Comments:</b>

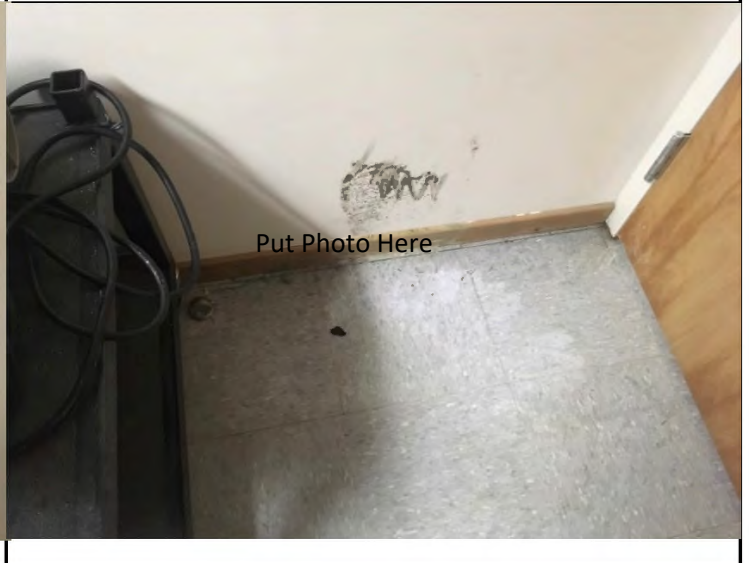
<b>Damage Description:</b>	<b>Item #:</b> 113
Base Lining, Base molding, wood, 2 5/8 IN x 1/2 IN, stained and urethane-finished, discolored, caused by surface water flooding (Main Bldg., Floor 2, Server Room)	
<b>Additional Comments:</b>

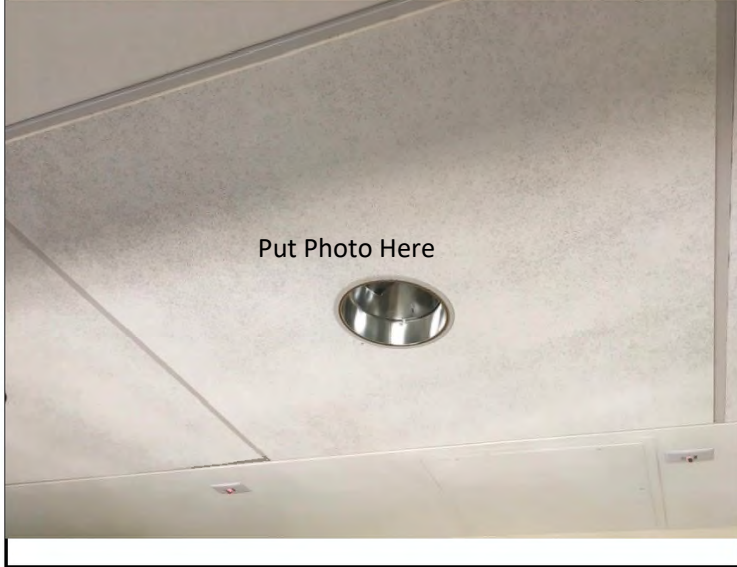
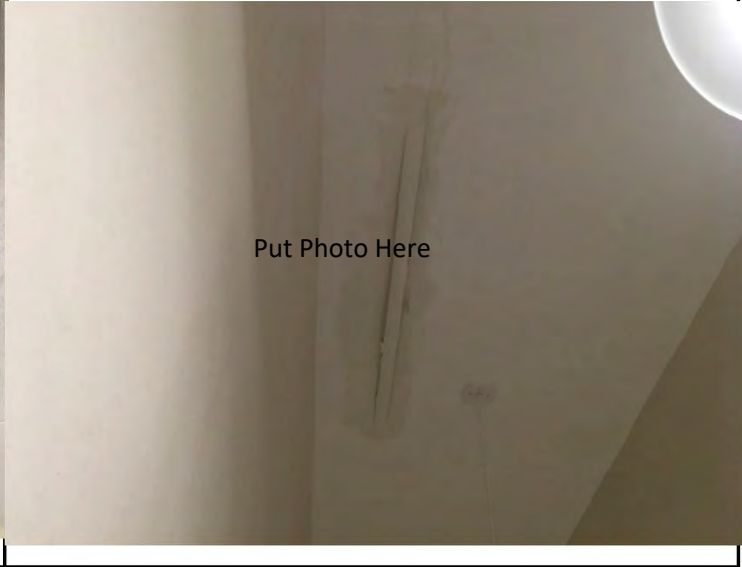
<b>Damage Description:</b>	<b>Item #:</b> 114	<b>Damage Description:</b>	<b>Item #:</b> 115
Light, Fluorescent, recessed, round, 8 IN Dia., 26-Watt, electrical issues, caused by rainwater intrusion (Main Bldg., Floor 2, Hallway Stairway)		Ceiling, drywall, repair, cracked, caused by rainwater intrusion (Main Bldg., Floor 2, Stairway Library)	
<b>Additional Comments:</b>		<b>Additional Comments:</b>

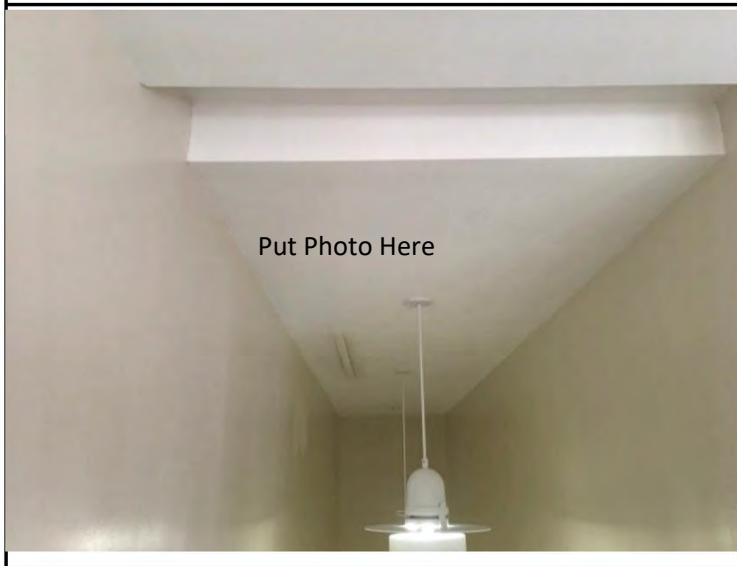
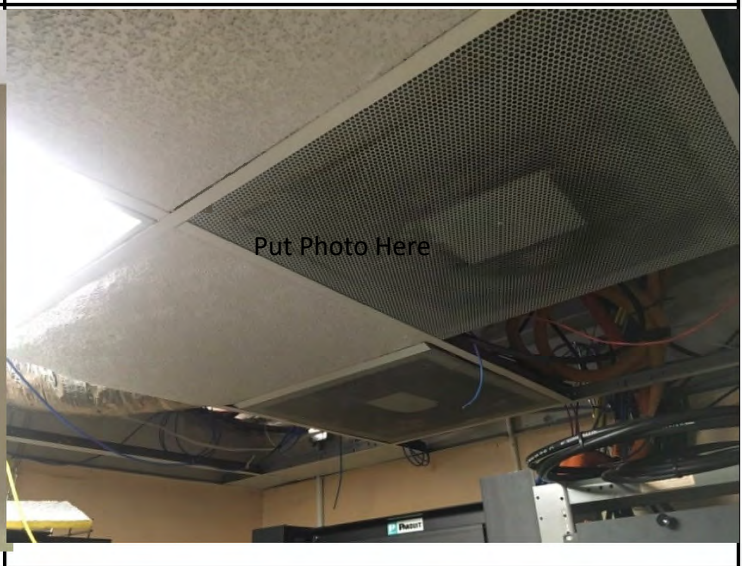
<b>Damage Description:</b>	<b>Item #:</b> 116	<b>Damage Description:</b>	<b>Item #:</b> 117
Ceiling, drywall, painted, discolored, caused by rainwater intrusion (Main Bldg., Floor 2, Stairway Library)		Ceiling, 2 FT x 4 FT acoustic tile, suspended, 15/16 IN thick, fiberglass-faced, with grid, broken components, caused by rainwater intrusion (Main Bldg., Floor 1, Server Room)	
<b>Additional Comments:</b>		<b>Additional Comments:</b>

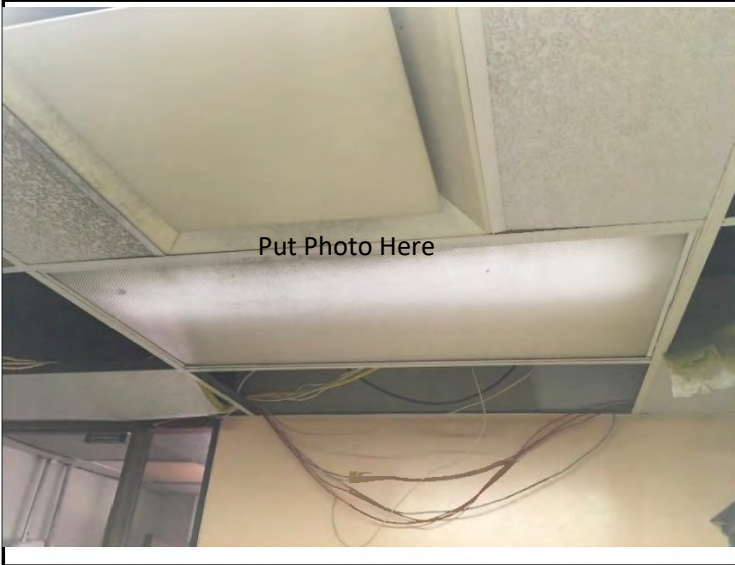
<b>Damage Description:</b>	<b>Item #:</b> 118
Light, fluorescent, recessed Troffer, electrical issues, caused by rainwater intrusion (Main Bldg., Floor 1, Server Room)	
<b>Additional Comments:</b>

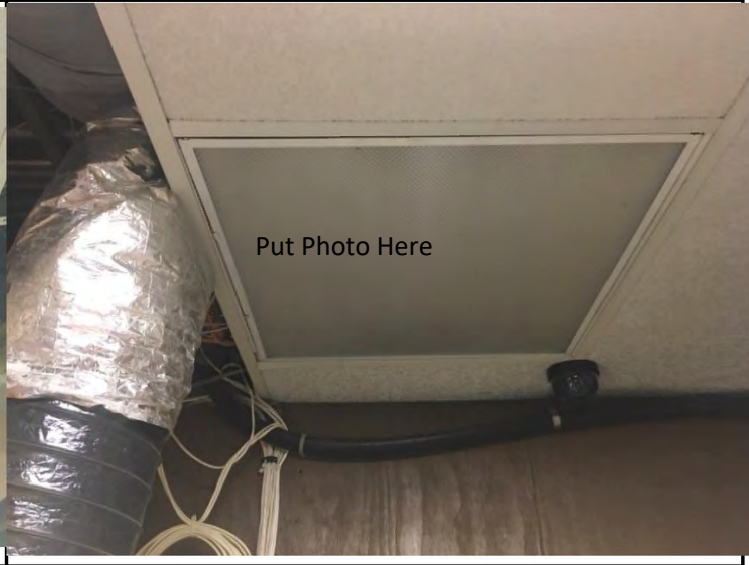
<b>Damage Description:</b>	<b>Item #:</b> 119
Light, fluorescent, recessed Troffer, electrical issues, caused by rainwater intrusion (Main Bldg., Floor 1, Server Room)	
<b>Additional Comments:</b>

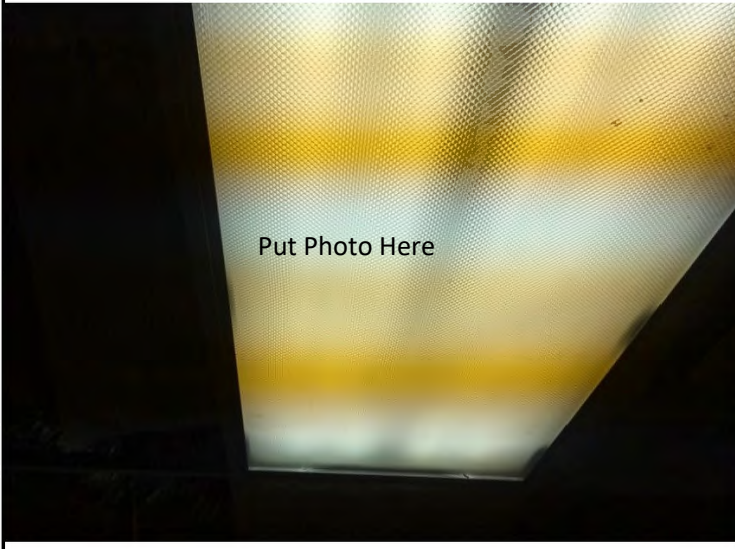
<b>Damage Description:</b>	<b>Item #:</b> 120
Light, fluorescent, recessed Troffer, acrylic prismatic lens only, deformed, caused by rainwater intrusion (Main Bldg., Floor 1, Server Room)	
<b>Additional Comments:</b>

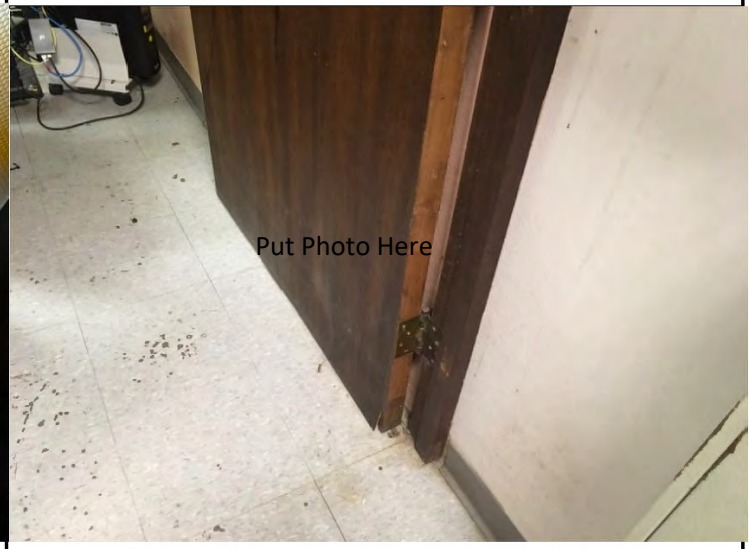
<b>Damage Description:</b>	<b>Item #:</b> 121
Door, 3070, wood slab, hollow-core, birch veneer, stained and urethane-finished, deformed, caused by rainwater intrusion (Main Bldg., Floor 1, Server Room )	
<b>Additional Comments:</b>

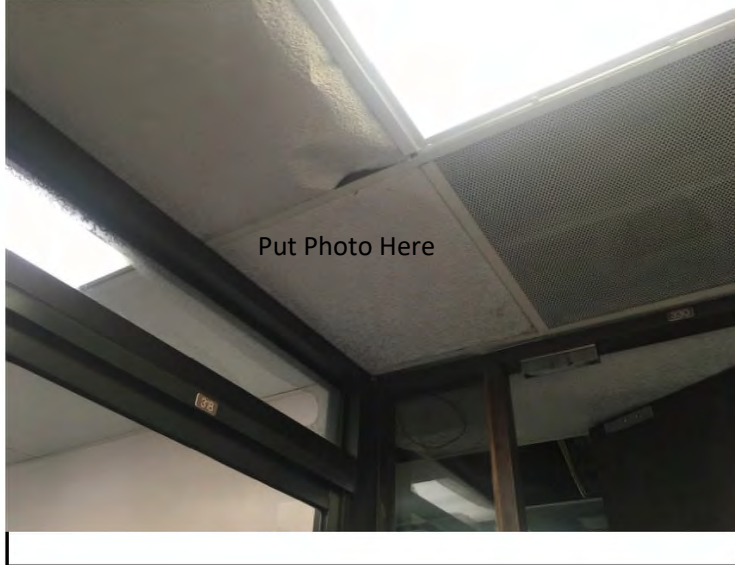
<b>Damage Description:</b>	<b>Item #:</b> 122
Ceiling, 2 FT x 4 FT acoustic tile suspended, with grid, deformed, caused by rainwater intrusion (Main Bldg., Floor 1, Server Room )	
<b>Additional Comments:</b>

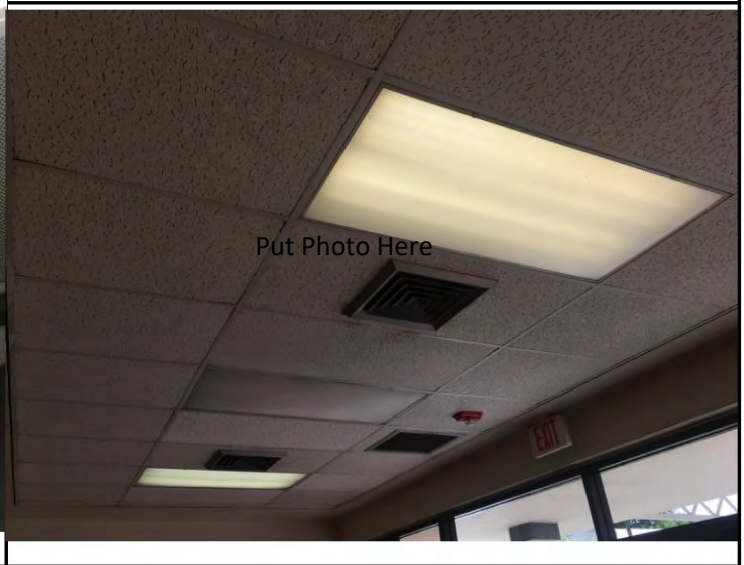
<b>Damage Description:</b>	<b>Item #:</b> 123
Ceiling, 2 FT x 4 FT acoustic tile, suspended, deformed, caused by rainwater intrusion (Main Bldg., Floor 1, Entrance Lobby)	
<b>Additional Comments:</b>

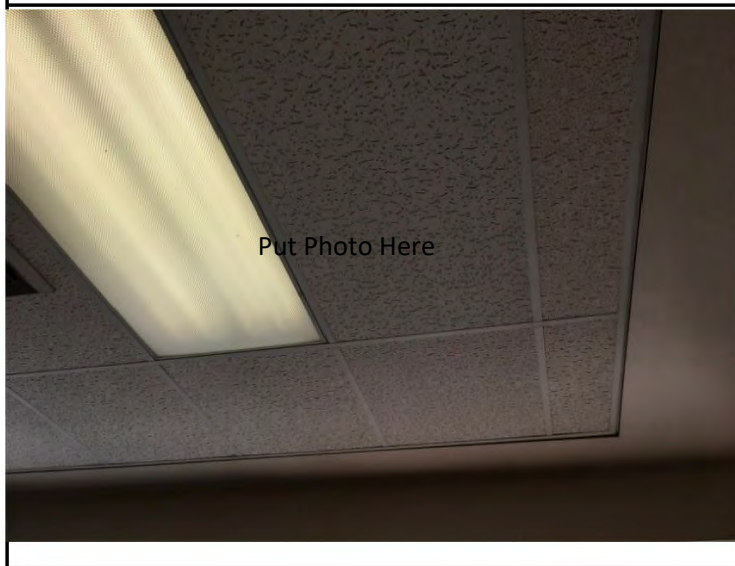
<b>Damage Description:</b>	<b>Item #:</b> 124
Ceiling, 2 FT x 4 FT acoustic tile, suspended, grid only, dislodged, caused by rainwater intrusion (Main Bldg., Floor 1, Entrance Lobby)	
<b>Additional Comments:</b>

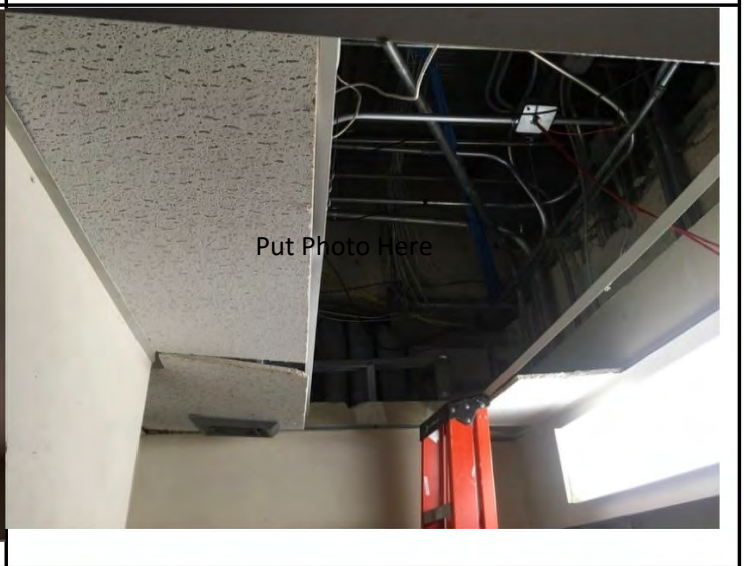
<b>Damage Description:</b>	<b>Item #:</b> 125
Ceiling, 2 FT x 4 FT acoustic tile, suspended, broken components, caused by rainwater intrusion (Main Bldg., Floor 1, Electrical Room)	
<b>Additional Comments:</b>

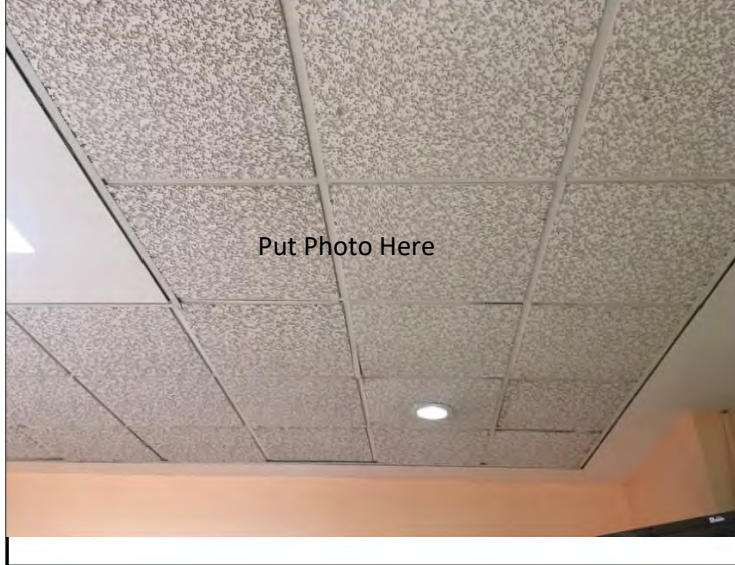
<b>Damage Description:</b>	<b>Item #:</b> 126
Ceiling, 2 FT x 2 FT acoustic tile, suspended, tegular, architectural/designer series, fissured, discolored, caused by rainwater intrusion (Main Bldg., Floor 1, Lobby)	
<b>Additional Comments:</b>

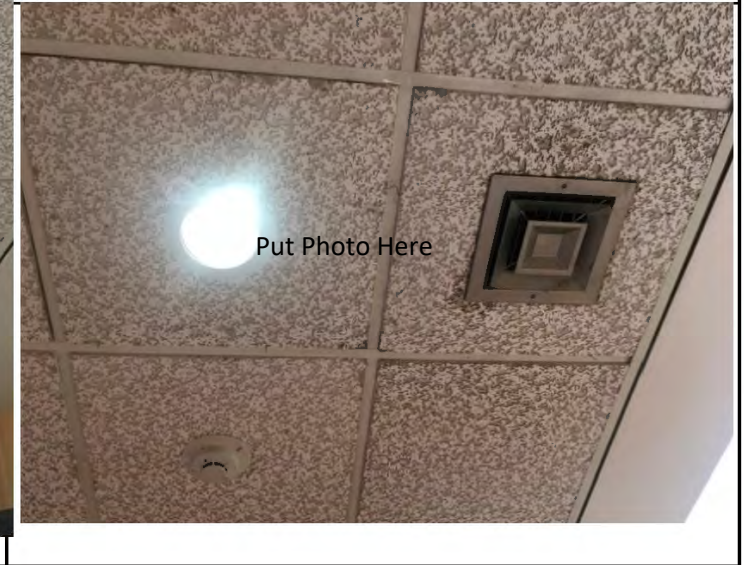
<b>Damage Description:</b>	<b>Item #:</b> 127
Ceiling, 2 FT x 2 FT acoustic tile, suspended, tegular, grid only, discolored caused by rainwater intrusion (Main Bldg., Floor 1, Lobby)	
<b>Additional Comments:</b>

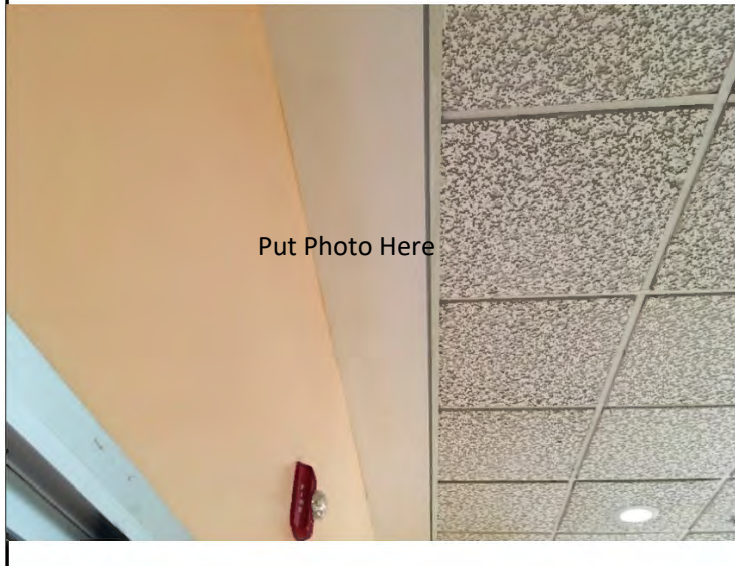
<b>Damage Description:</b>	<b>Item #:</b> 128
Ceiling, drywall, paint, discolored, caused by rainwater intrusion (Main Bldg., Floor 1, Lobby)	
<b>Additional Comments:</b>

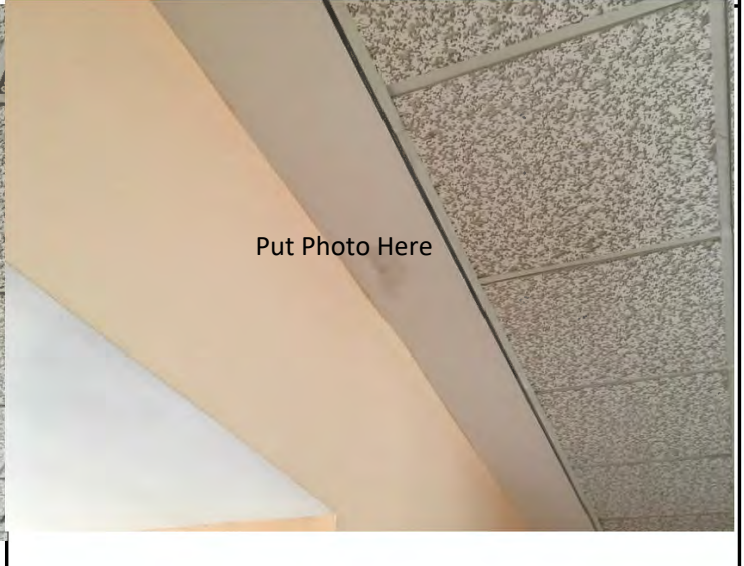
<b>Damage Description:</b>	<b>Item #:</b> 129
Ceiling, drywall, soffit, repair and paint, deformed, caused by rainwater intrusion (Main Bldg., Floor 1, Lobby)	
<b>Additional Comments:</b>

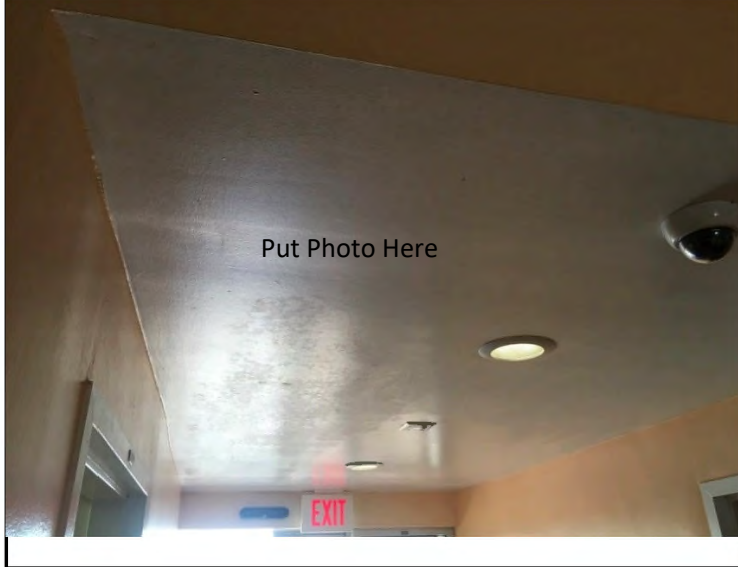
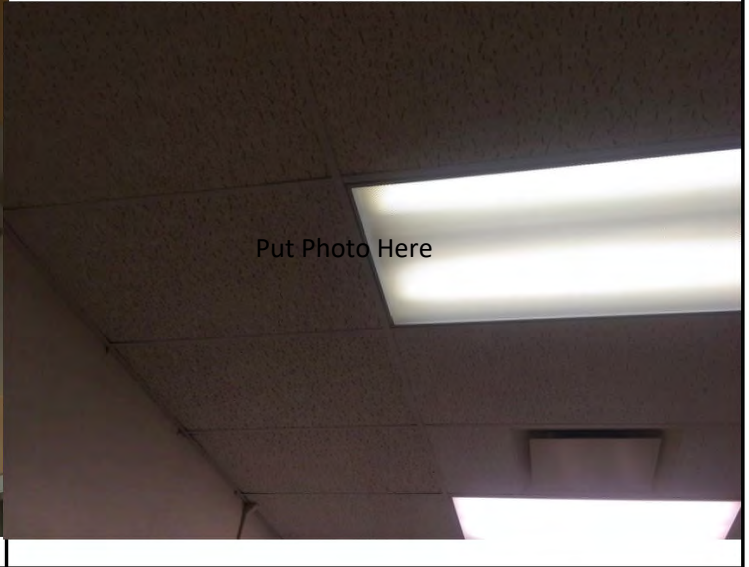
<b>Damage Description:</b>	<b>Item #:</b> 130	<b>Damage Description:</b>	<b>Item #:</b> 131
Ceiling, drywall, paint, discolored, caused by rainwater intrusion (Main Bldg., Floor 1, Lobby )		Ceiling, 2 FT x 4 FT acoustic tile, suspended, discolored, caused by rainwater intrusion (Main Bldg., Floor 1, Office R198)	
<b>Additional Comments:</b>		<b>Additional Comments:</b>

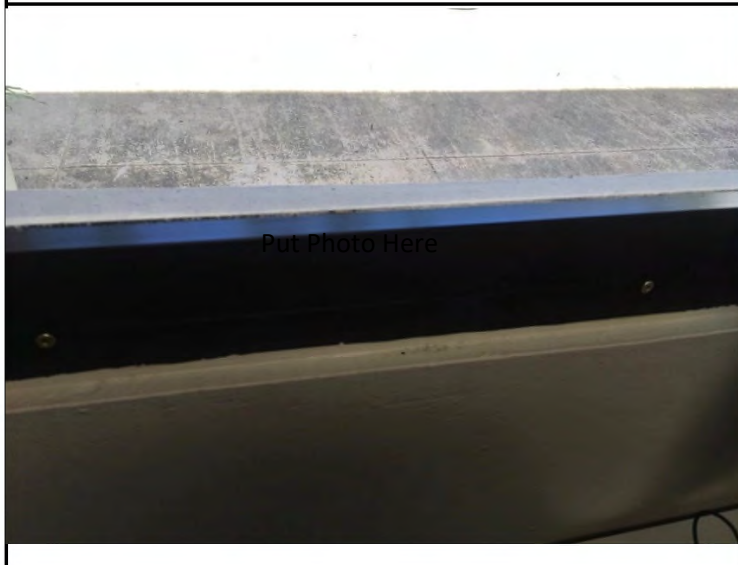
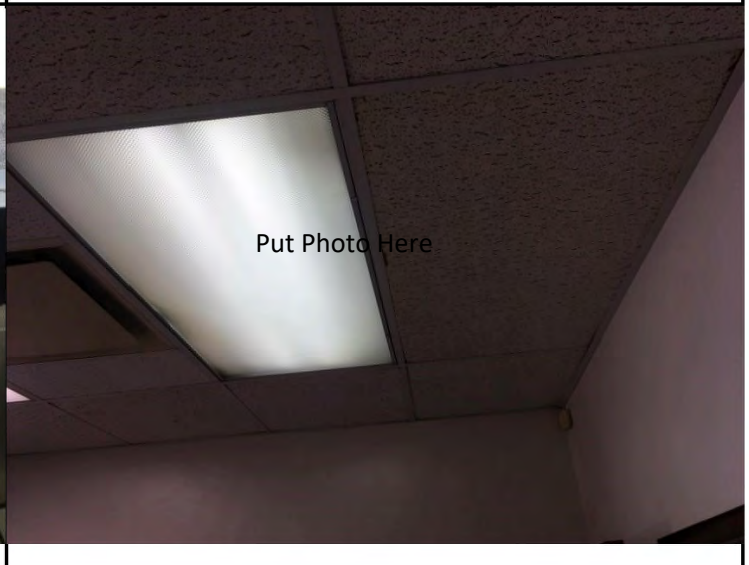
<b>Damage Description:</b>	<b>Item #:</b> 132	<b>Damage Description:</b>	<b>Item #:</b> 133
Window, Alum. window frames, perimeter caulking/sealing only, cracked, caused by wind-driven rain (Main Bldg., Floor 1, Office R198)		Ceiling, 2 FT x 4 FT acoustic tile, suspended, discolored, caused by rainwater intrusion (Main Bldg., Floor 1, Office R197)	
<b>Additional Comments:</b>		<b>Additional Comments:</b>
