<b>Applicant:</b> Universidad Central Del Caribe, Inc.	<b>Damage Inventory:</b> 305240	<b>Category:</b> E
<b>WO #</b> 46525 <b>FIPS#</b> 021-UNUGB-00	<b>Date:</b> 09/04-17/2019 <b>GPS:</b> 18.365953, -66.153767	
<b>Inspector:</b> Gregory Sondergeld / Alexander Nieves	<b>Damage Facility:</b> Main Bldg.

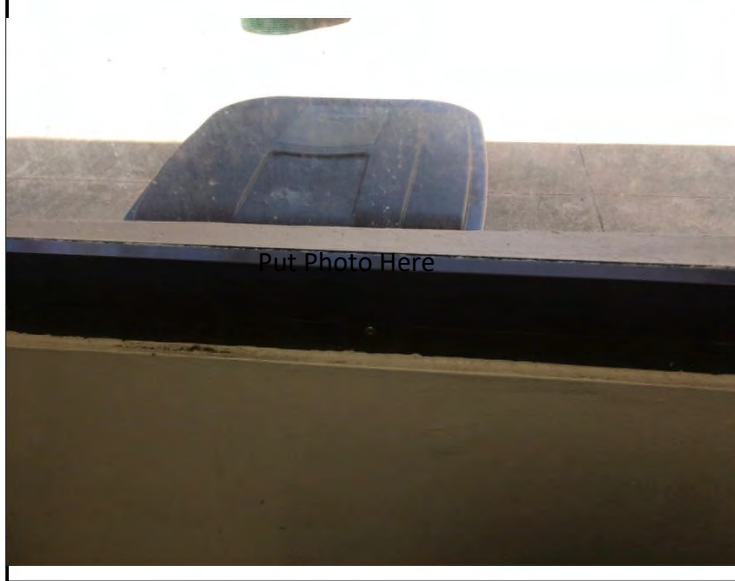
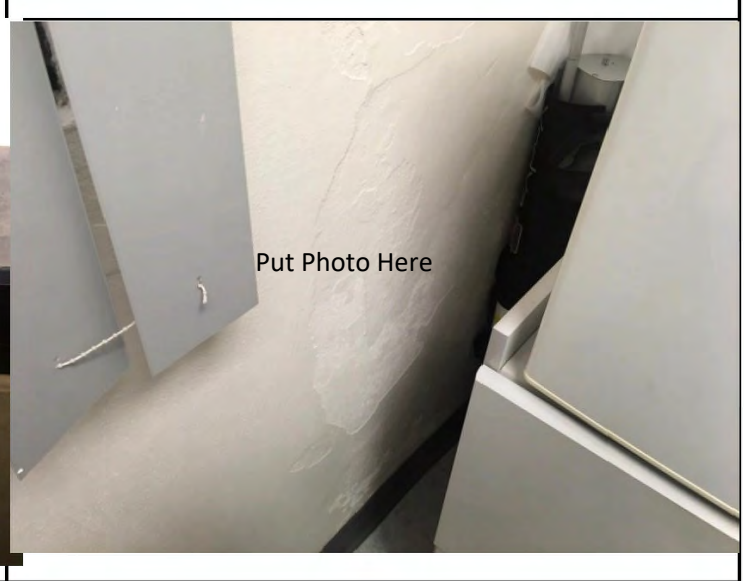
<b>Damage Description:</b>	<b>Item #:</b> 134	<b>Damage Description:</b>	<b>Item #:</b> 135
Window, Alum. window frames, perimeter caulking/sealing only, cracked, caused by wind-driven rain (Main Bldg., Floor 1, Office R197)		Wall, ¼ IN thick plaster on concrete, repair, cracked, caused by rainwater intrusion (Main Bldg., Floor 1, Office R197)	
<b>Additional Comments:</b>		<b>Additional Comments:</b>

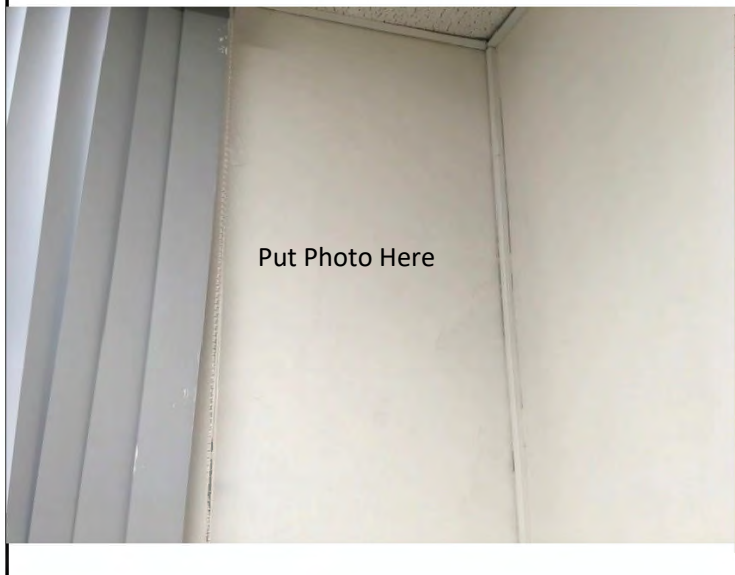
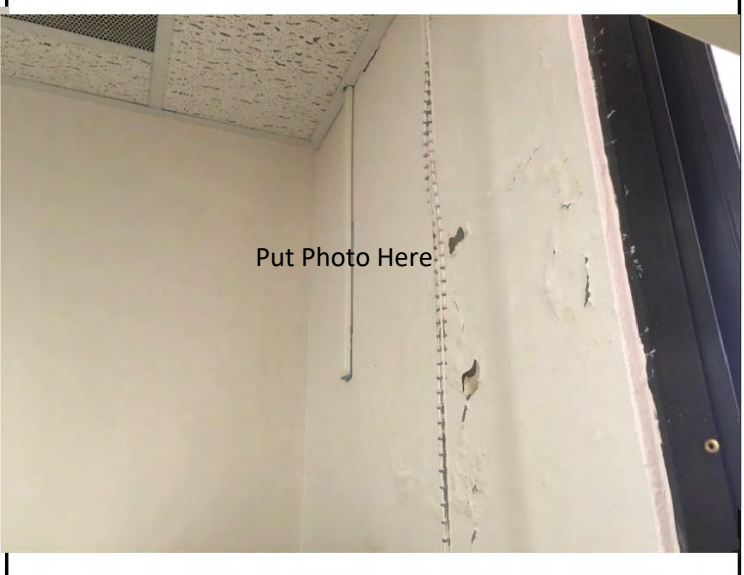
<b>Damage Description:</b>	<b>Item #:</b> 136	<b>Damage Description:</b>	<b>Item #:</b> 137
Wall, ¼ IN thick plaster on concrete, painted, discolored, caused by rainwater intrusion (Main Bldg., Floor 1, Office R197)		Wall, ¼ IN thick plaster on concrete, painted, repair spalling, cracked, caused by rainwater intrusion (Main Bldg., Floor 1, Office R195)	
<b>Additional Comments:</b>		<b>Additional Comments:</b>

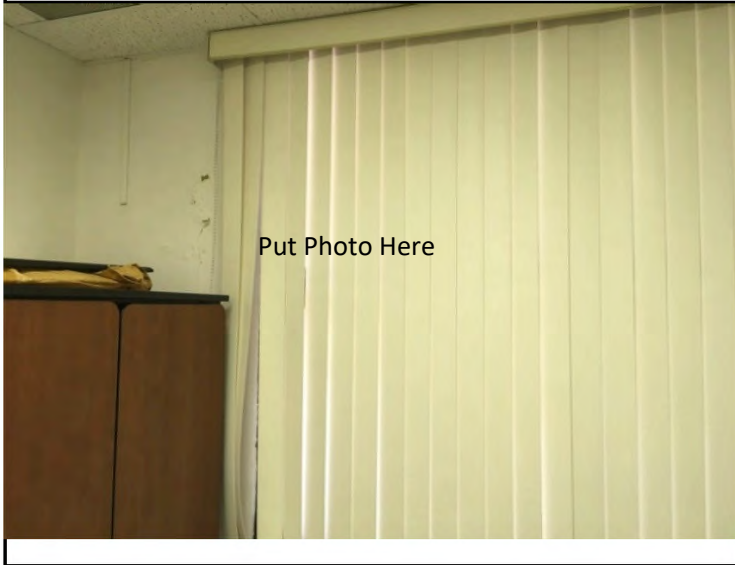
<b>Damage Description:</b>	<b>Item #:</b> 138
Wall, ¼ IN thick plaster on concrete, painted, peeling paint, caused by rainwater intrusion (Main Bldg., Floor 1, Office R195)	
<b>Additional Comments:</b>

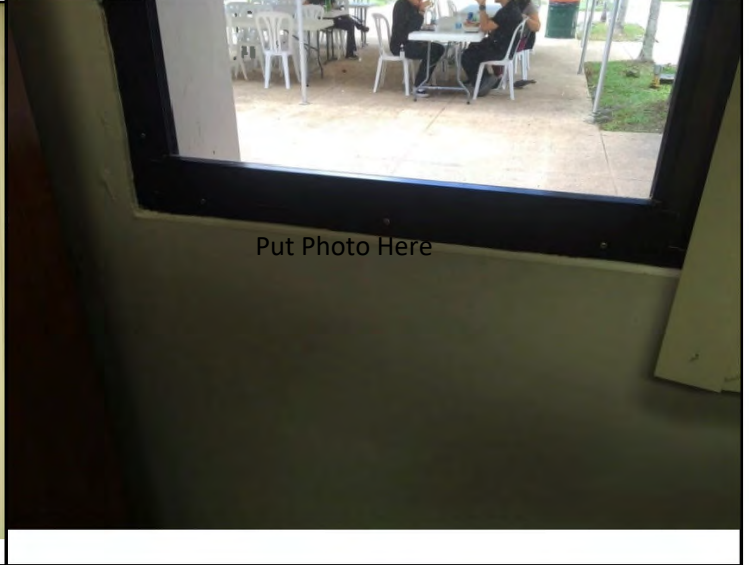
<b>Damage Description:</b>	<b>Item #:</b> 139
Window, Alum. window frames, perimeter caulking/sealing only, cracked, caused by wind-driven rain (Main Bldg., Floor 1, Office R195)	
<b>Additional Comments:</b>

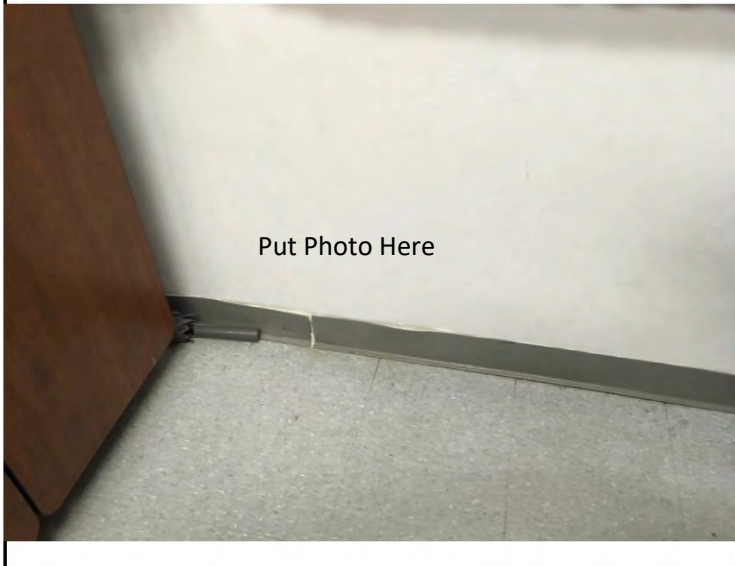
<b>Damage Description:</b>	<b>Item #:</b> 140
Base Lining, vinyl, 4 IN, detached, caused by rainwater intrusion (Main Bldg., Floor 1, Office R195)	
<b>Additional Comments:</b>

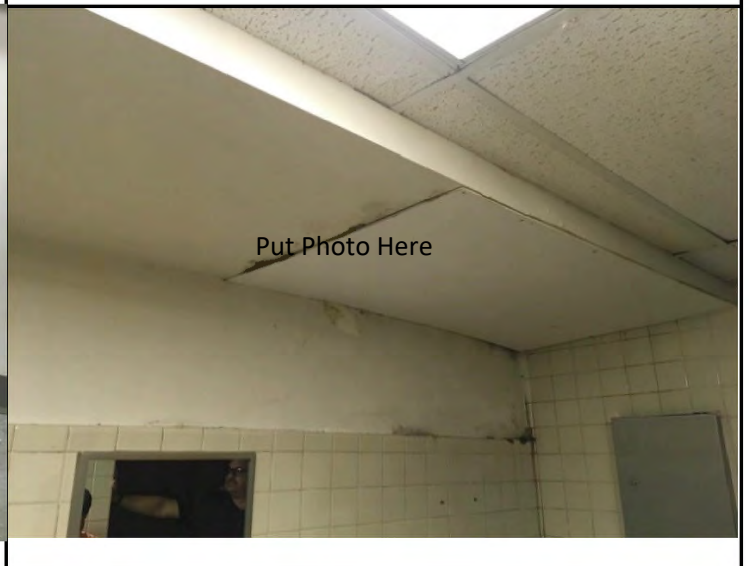
<b>Damage Description:</b>	<b>Item #:</b> 141
Ceiling, drywall, repair and paint, deformed, caused by rainwater intrusion (Main Bldg., Floor 1, Bathroom R107)	
<b>Additional Comments:</b>

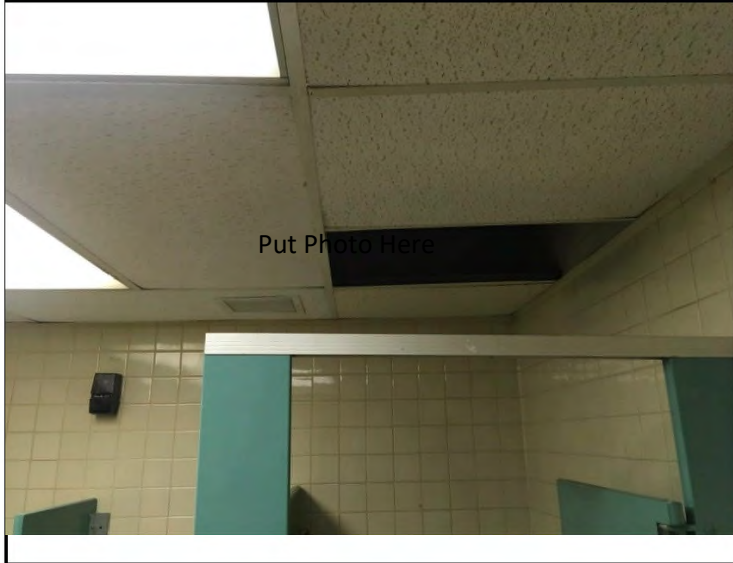
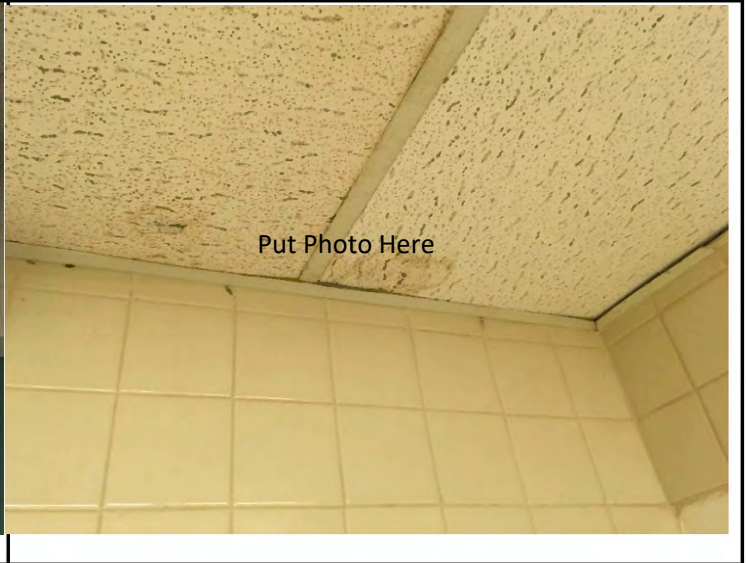
<b>Damage Description:</b>	<b>Item #:</b> 142	<b>Damage Description:</b>	<b>Item #:</b> 143
Ceiling, 2 FT x 4 FT acoustic tile, suspended, discolored, caused by rainwater intrusion (Main Bldg., Floor 1, Bathroom R107)		Ceiling, 2 FT x 4 FT acoustic tile, suspended, grid, outside L-angle only, discolored, caused by rain water intrusion (Main Bldg., Floor 1, Bathroom R107)	
<b>Additional Comments:</b>		<b>Additional Comments:</b>

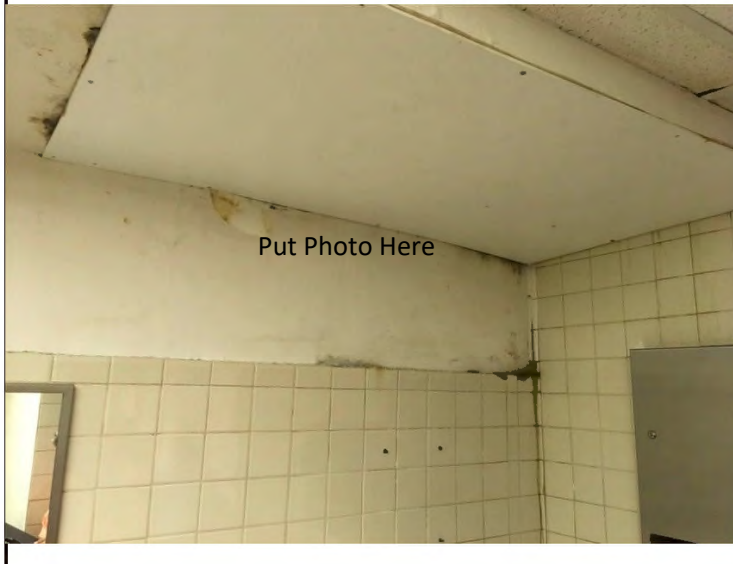
<b>Damage Description:</b>	<b>Item #:</b> 144	<b>Damage Description:</b>	<b>Item #:</b> 145
Wall, drywall, repair and paint, deformed, caused by rainwater intrusion (Main Bldg., Floor 1, Bathroom R107)		Wall, 4 IN x 4 IN ceramic tile, detached, caused by rainwater intrusion (Main Bldg., Floor 1, Bathroom R107)	
<b>Additional Comments:</b>		<b>Additional Comments:</b>

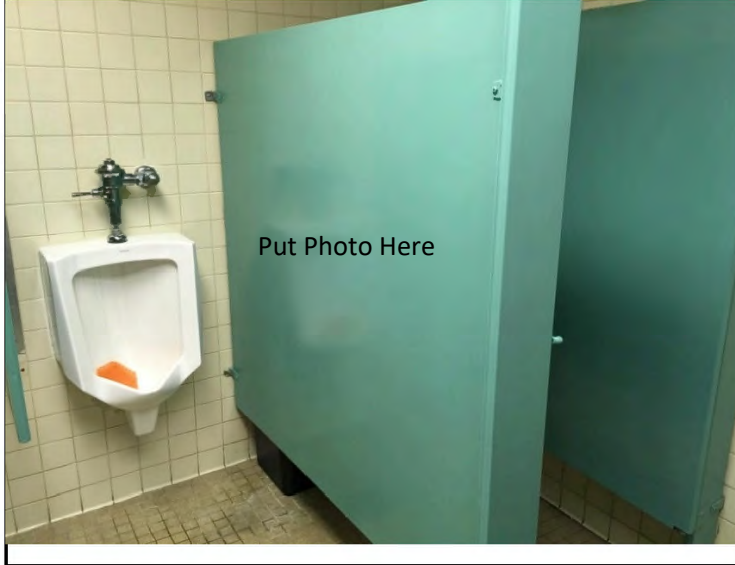
**Damage Description:**      **Item #:** 146  
Steel toilet and urinal partitions, clean/prep/paint, discolored, caused by rainwater intrusion (Main Bldg., Floor 1, Bathroom R107)

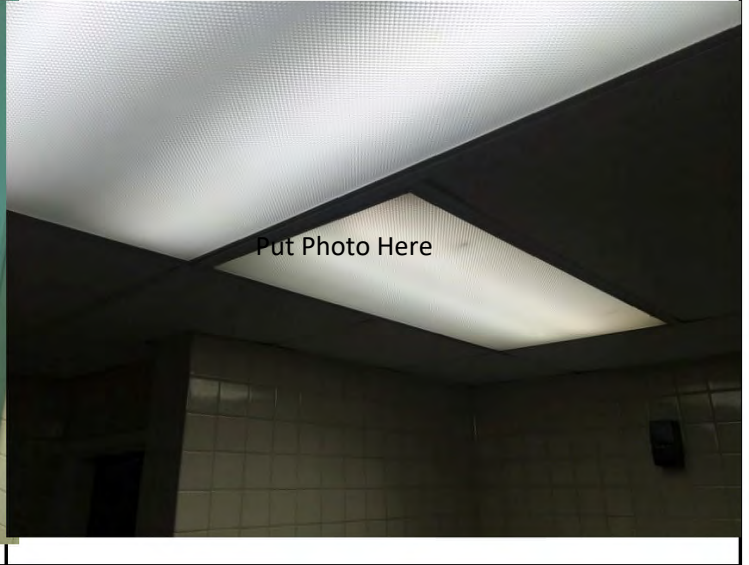
**Damage Description:**      **Item #:** 147  
Light, fluorescent, recessed Troffer, acrylic prismatic lens only, discolored, caused by rainwater intrusion (Main Bldg., Floor 1, Bathroom R107)

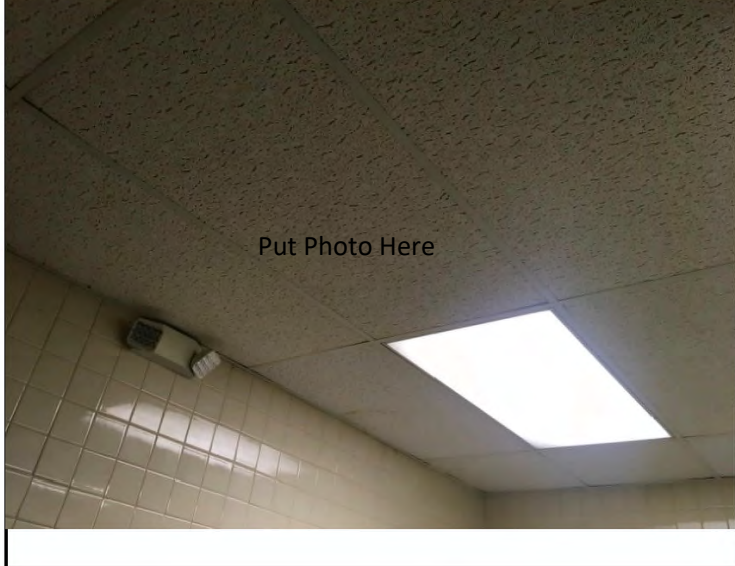
**Damage Description:**      **Item #:** 148  
Ceiling, 2 FT x 4 FT acoustic tile, suspended, deformed, caused by rainwater intrusion (Main Bldg., Floor 1, Bathroom R106)

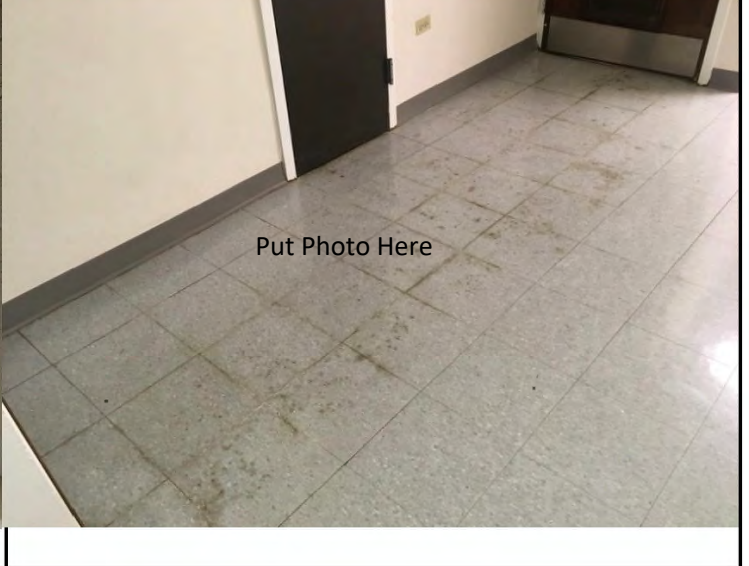
**Damage Description:**      **Item #:** 149  
Floor, VCT, 12x12 IN, detached, caused by surface water flooding (Main Bldg., Floor 1, Hallway, Faculty Bathroom)

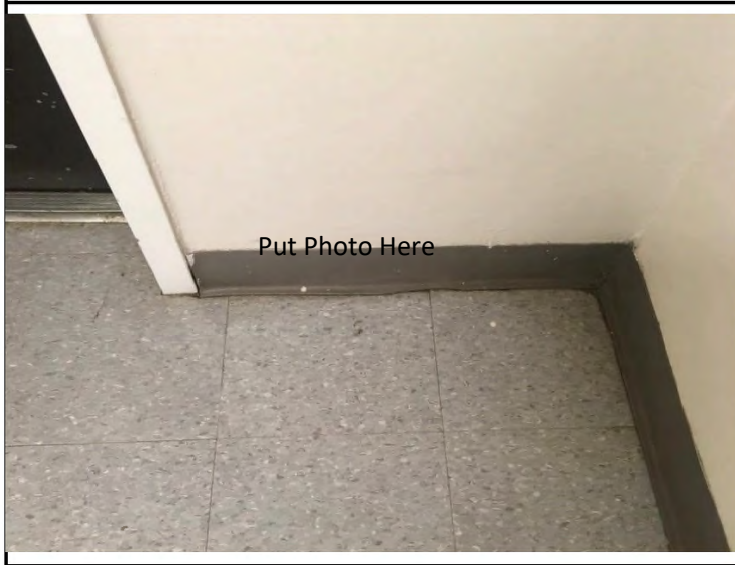
<b>Damage Description:</b>	<b>Item #:</b> 150
Base Lining, vinyl, 4 IN, detached, caused by surface water flooding (Main Bldg., Floor 1, Hallway, Faculty Bathroom)	
<b>Additional Comments:</b>

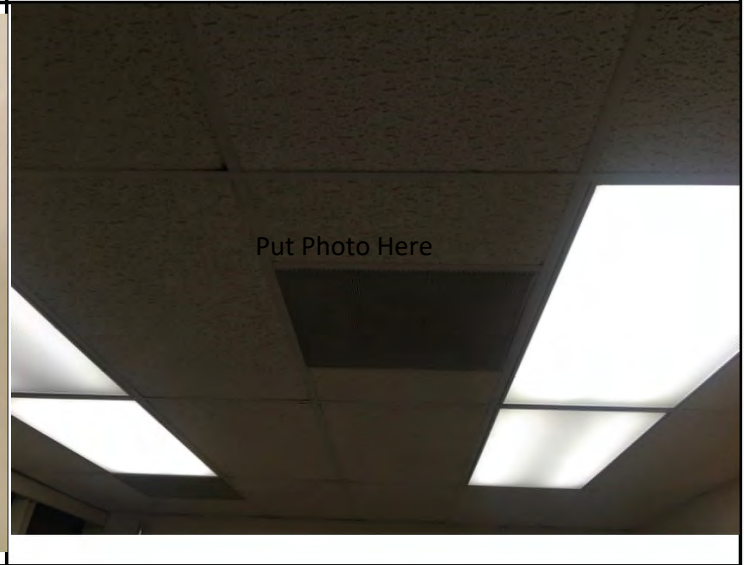
<b>Damage Description:</b>	<b>Item #:</b> 151
Ceiling, 2 FT x 4 FT acoustic tile, suspended, deformed, caused by rainwater intrusion (Main Bldg., Floor 1, Dining Room 101)	
<b>Additional Comments:</b>

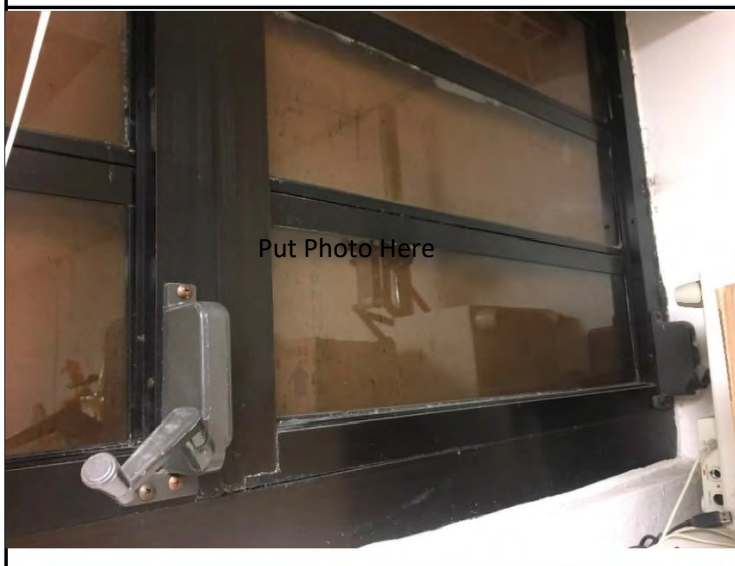
<b>Damage Description:</b>	<b>Item #:</b> 152
Window, Alum. window frames, Jalousie-style vent, perimeter caulking/sealing only, cracked, caused by wind-driven rain (Main Bldg., Floor 1, Dining Room R101)	
<b>Additional Comments:</b>

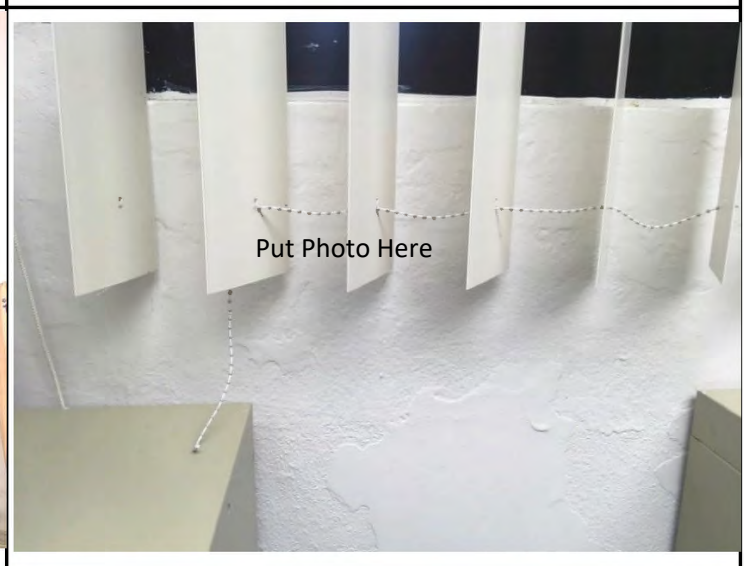
<b>Damage Description:</b>	<b>Item #:</b> 153
Wall, ¼ IN thick plaster on concrete, painted, cracked, caused by rainwater intrusion (Main Bldg., Floor 1, Dining Room R101)	
<b>Additional Comments:</b>

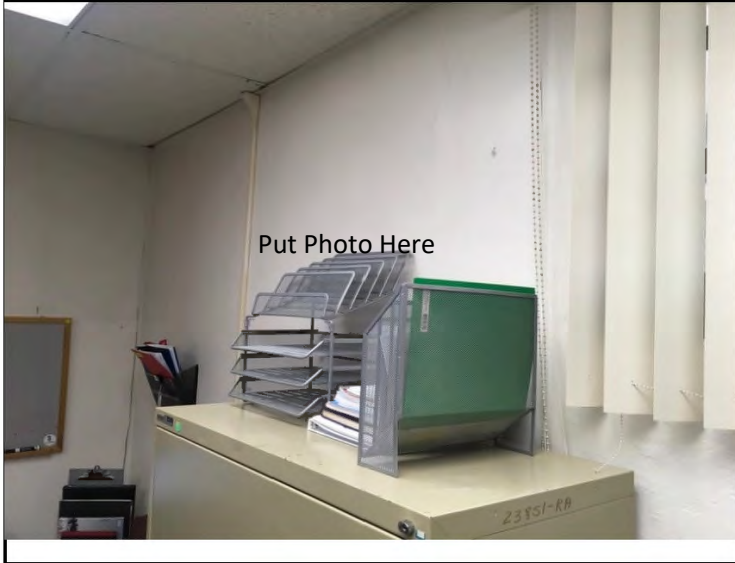
<b>Damage Description:</b>	<b>Item #:</b> 154
Wall, ¼ IN thick plaster on concrete, painted, discolored, caused by rainwater intrusion (Main Bldg., Floor 1, Dining Room R101)	
<b>Additional Comments:</b>

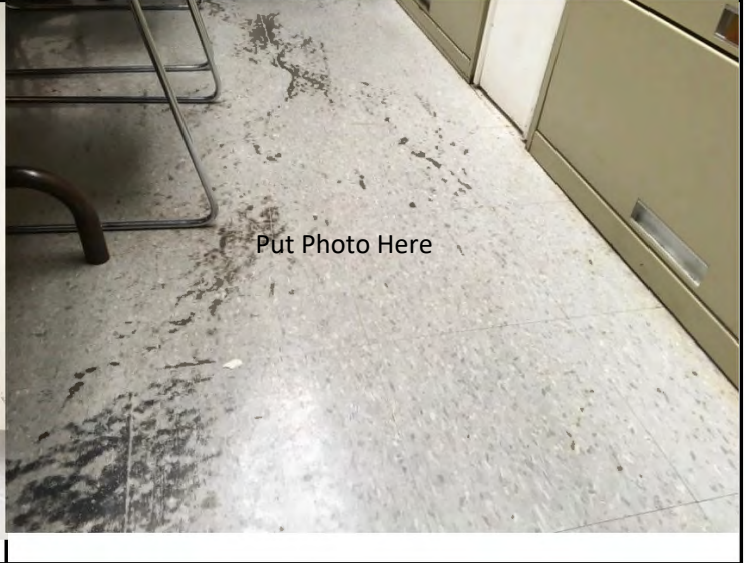
<b>Damage Description:</b>	<b>Item #:</b> 155
Floor, VCT, 12x12 IN, detached, caused by surface water flooding (Main Bldg., Floor 1, Dining Room R101)	
<b>Additional Comments:</b>

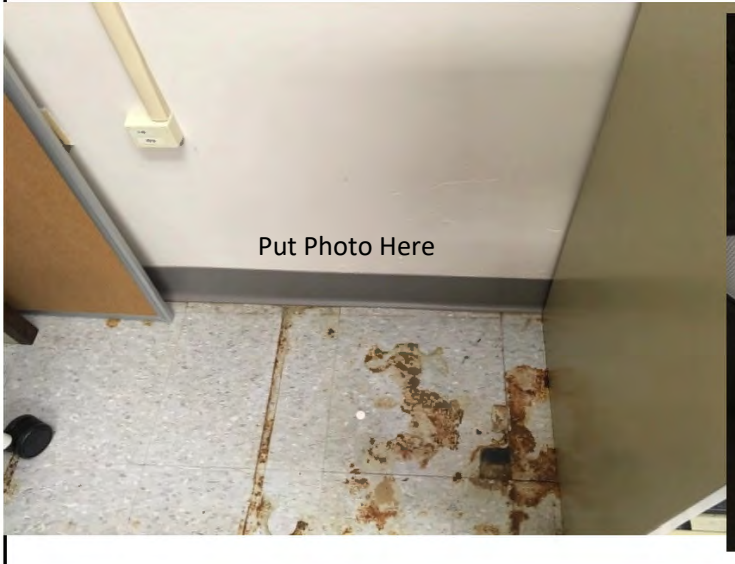
<b>Damage Description:</b>	<b>Item #:</b> 156
Base Lining, vinyl, 4 IN, detached, caused by surface water flooding (Main Bldg., Floor 1, Dining Room R101)	
<b>Additional Comments:</b>

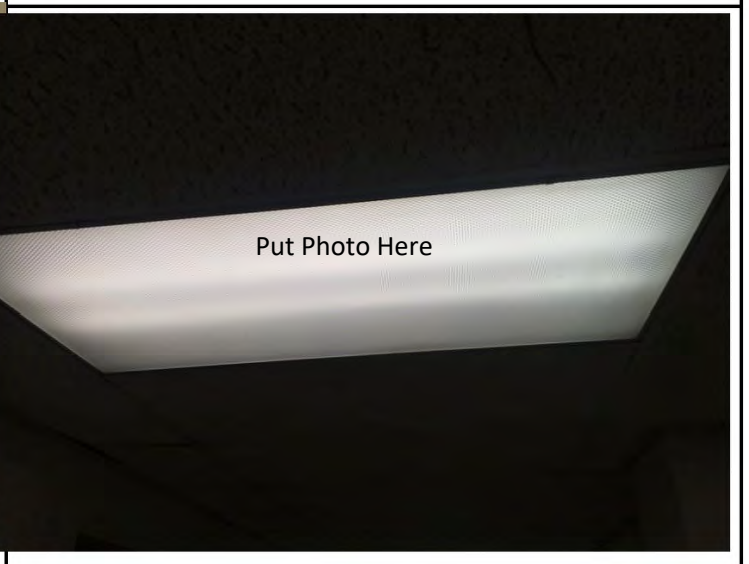
<b>Damage Description:</b>	<b>Item #:</b> 157
Light, fluorescent, recessed Troffer, acrylic prismatic lens only, discolored, caused by rainwater intrusion (Main Bldg., Floor 1, Bathroom R106)	
<b>Additional Comments:</b>

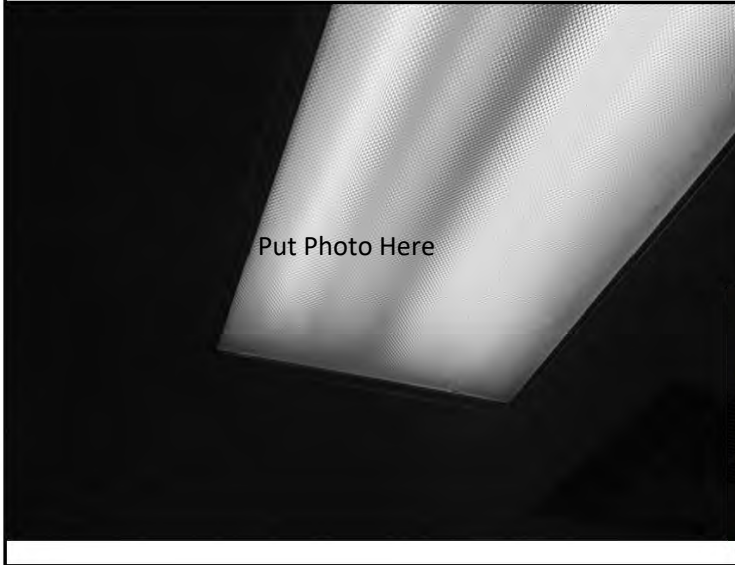
<b>Damage Description:</b>	<b>Item #:</b> 158
Light, fluorescent, recessed Troffer, acrylic prismatic lens only, cracked, caused by rainwater intrusion (Main Bldg., Floor 1, Laboratory R097)	
<b>Additional Comments:</b>

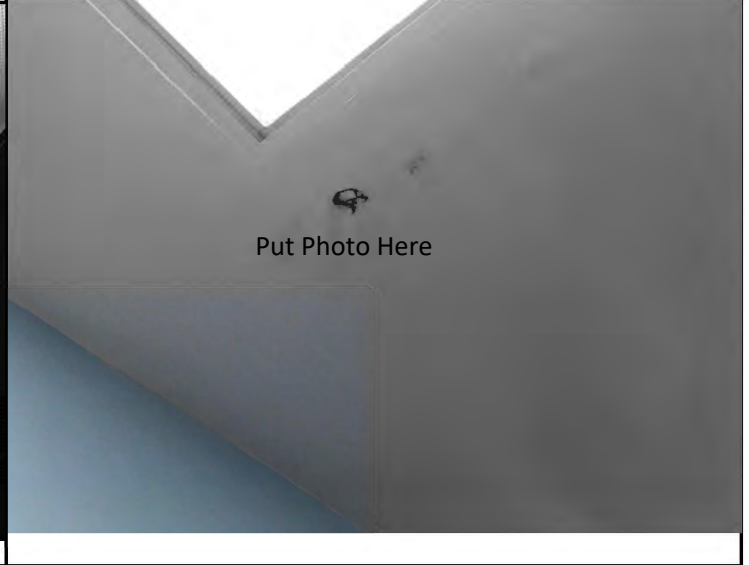
<b>Damage Description:</b>	<b>Item #:</b> 159
Ceiling, drywall, repair, deformed and moldy above, caused by rainwater intrusion (Main Bldg., Floor 1, Laboratory R097)	
<b>Additional Comments:</b>

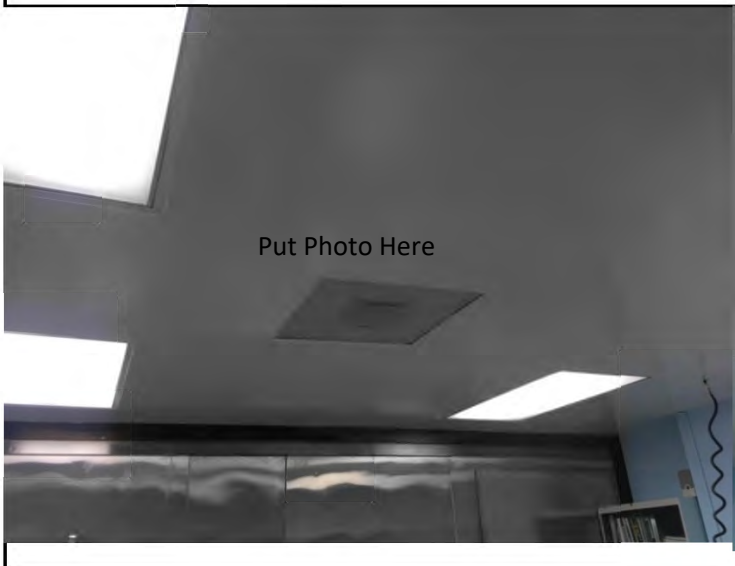
<b>Damage Description:</b>	<b>Item #:</b> 160
Ceiling, drywall, paint, discolored and moldy above, caused by rainwater intrusion (Main Bldg., Floor 1, Laboratory R097)	
<b>Additional Comments:</b>

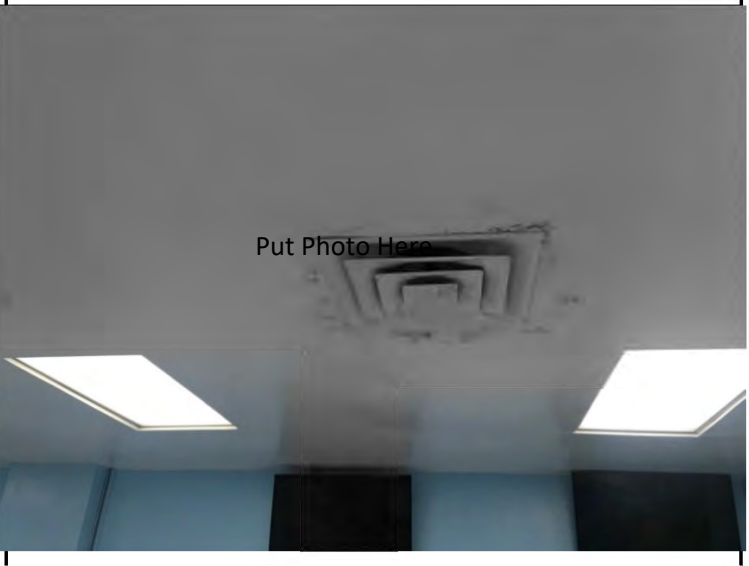
<b>Damage Description:</b>	<b>Item #:</b> 161
Ceiling, Suspended ceiling system, 2-IN main Tees with 1 13/16-IN cross Tees, 5/8 IN Drywall, mold-resistant, painted, oxidized, caused by rainwater intrusion (Main Bldg., Floor 1, Laboratory R094)	
<b>Additional Comments:</b>

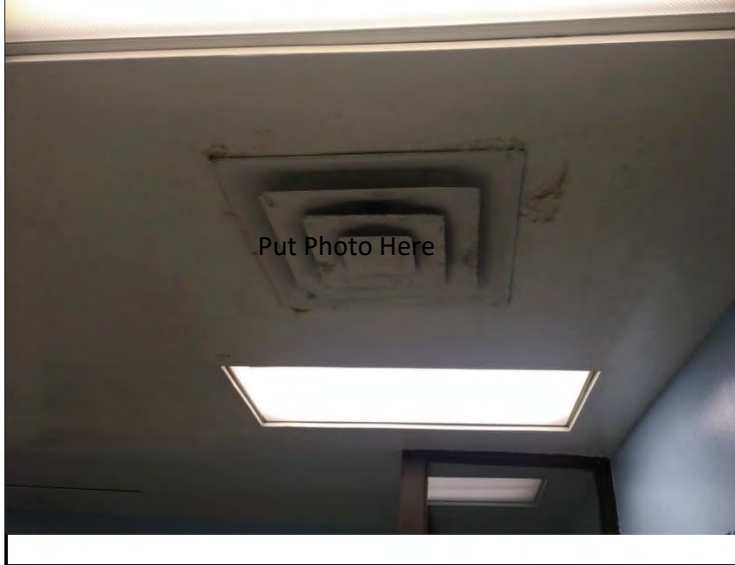
<b>Damage Description:</b>	<b>Item #:</b> 162
Air Conditioning, HVAC, ceiling diffusers, 4-way, painted steel, 2 FT x 2 FT, oxidized, caused by rain water intrusion (Main Bldg., Floor 1, Laboratory R094)	
<b>Additional Comments:</b>

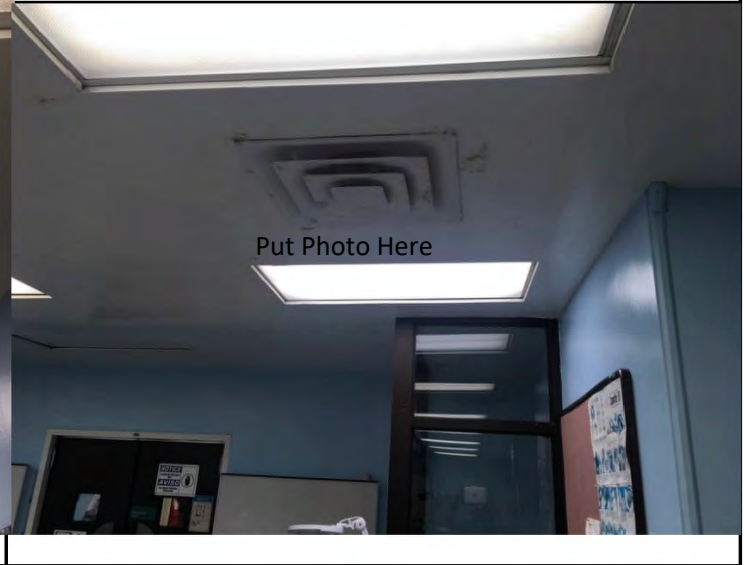
<b>Damage Description:</b>	<b>Item #:</b> 163
Light, fluorescent, recessed Troffer (4-bulb), oxidized, caused by rain water intrusion (Main Bldg., Floor 1, Laboratory R094)	
<b>Additional Comments:</b>

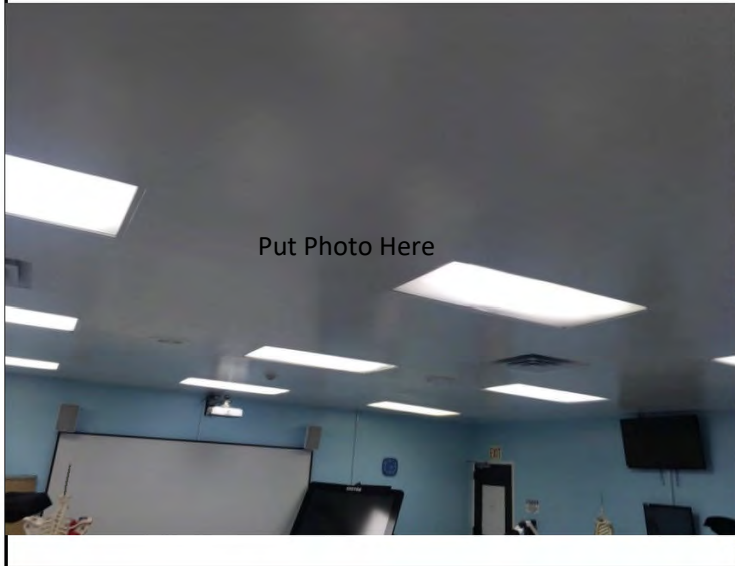
<b>Damage Description:</b>	<b>Item #:</b> 164
Ceiling, drywall, paint, discolored and moldy above, caused by rainwater intrusion (Main Bldg., Floor 1, Laboratory R094)	
<b>Additional Comments:</b>

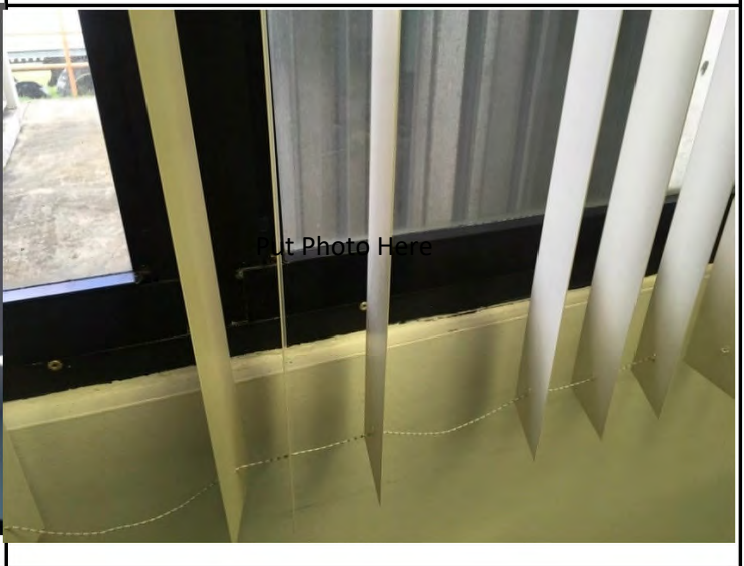
<b>Damage Description:</b>	<b>Item #:</b> 165
Window, Alum. window frames, perimeter caulking/sealing only, cracked, caused by wind-driven rain (Main Bldg., Floor 1, Office R067)	
<b>Additional Comments:</b>

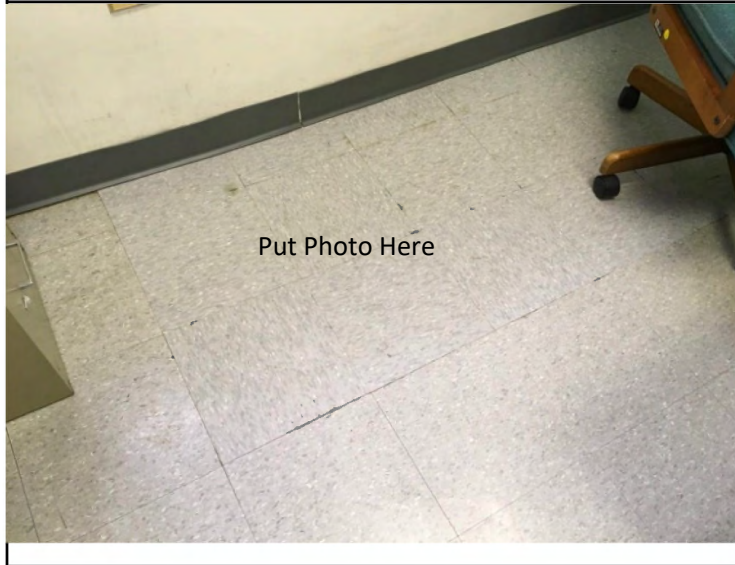
<b>Damage Description:</b>	<b>Item #:</b> 166
Floor, VCT, 12x12 IN, detached, caused by surface water flooding (Main Bldg., Floor 1, Office R067)	
<b>Additional Comments:</b>

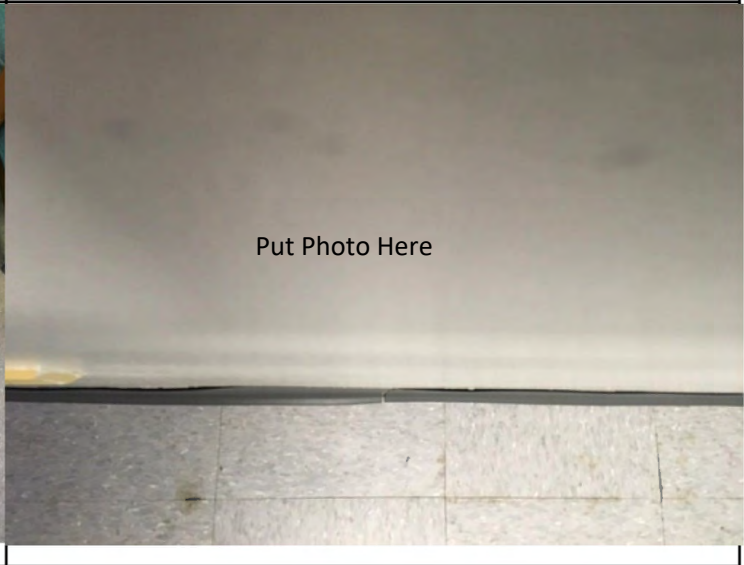
<b>Damage Description:</b>	<b>Item #:</b> 167
Base Lining, vinyl, 4 IN, detached, caused by surface water flooding (Main Bldg., Floor 1, Office R067)	
<b>Additional Comments:</b>

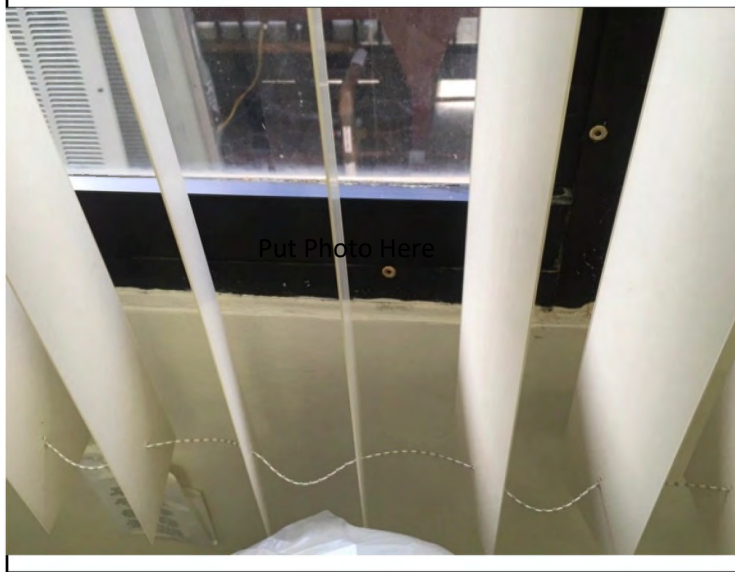
<b>Damage Description:</b>	<b>Item #:</b> 168
Window, Alum. window frames, perimeter caulking/sealing only, cracked, caused by wind-driven rain (Main Bldg., Floor 1, Office R069)	
<b>Additional Comments:</b>

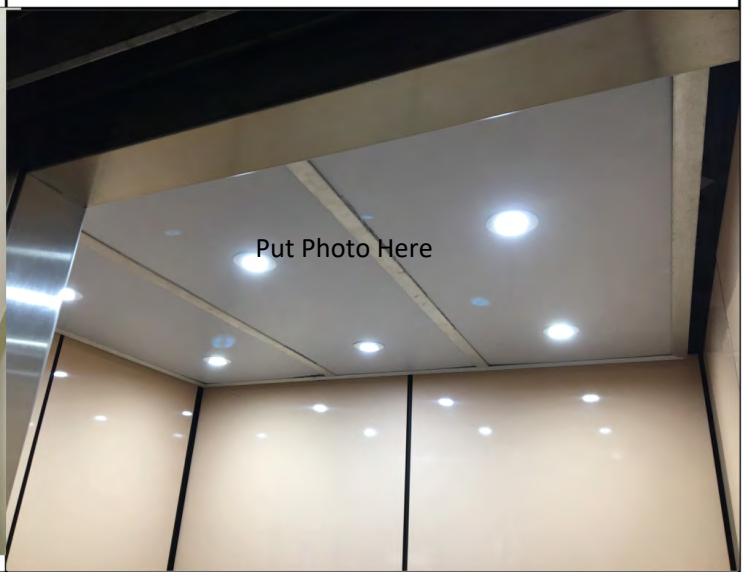
<b>Damage Description:</b>	<b>Item #:</b> 169
Building Interior, Elevator 340 at lobby, ceiling, wood plastic laminated and recessed LED down lights, damaged due to water infiltration.	
<b>Additional Comments:</b>
