Applicant: Universidad Central Del Caribe, Inc.	Damage Inventory: 305240	Category: E
WO # 46525 FIPS# 021-UNUGB-00	Date: 09/04-17/2019 GPS: 18.365953, -66.153767	
Inspector: Gregory Sondergeld / Alexander Nieves	Damage Facility: Main Bldg.

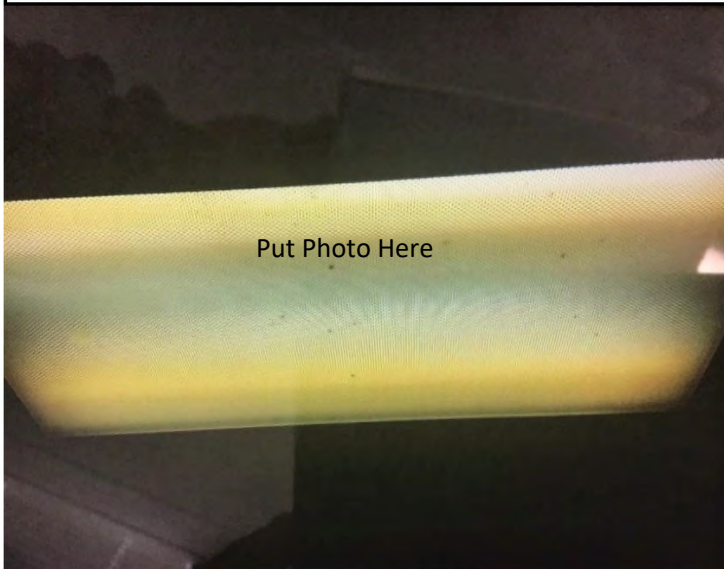
Damage Description:	Item #: 1	Damage Description:	Item #: 2
Light, fluorescent, recessed Troffer, acrylic prismatic lens only, discolored, caused by rainwater intrusion (Main Bldg., Basement, Laboratory ARC 010)		Floor, VCT, 12x12 IN, detached, caused by surface water flooding (Main Bldg., Basement, Laboratory ARC 010)	
Additional Comments:		Additional Comments:

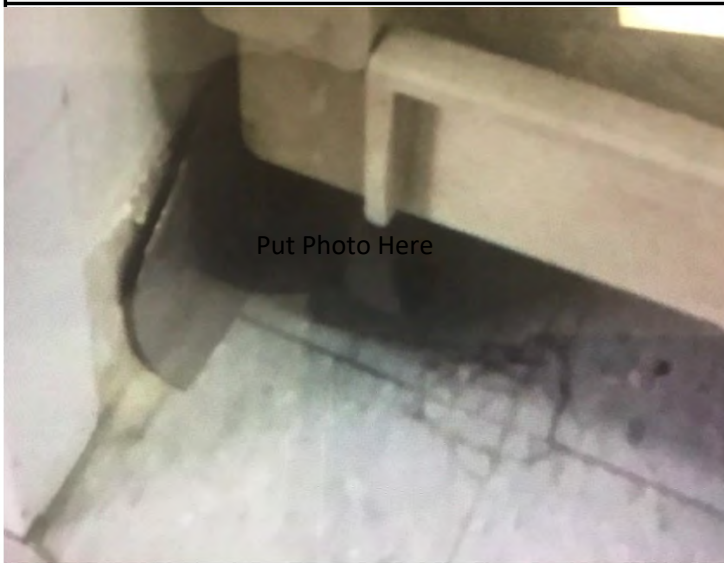
Damage Description:	Item #: 3	Damage Description:	Item #: 4
Base Lining, vinyl, 4 IN, detached, caused by surface water flooding (Main Bldg., Basement, Laboratory ARC 010)		Floor, VCT, 12x12 IN, detached, caused by surface water flooding (Main Bldg., Basement, Laboratory ARC 014)	
Additional Comments:		Additional Comments:

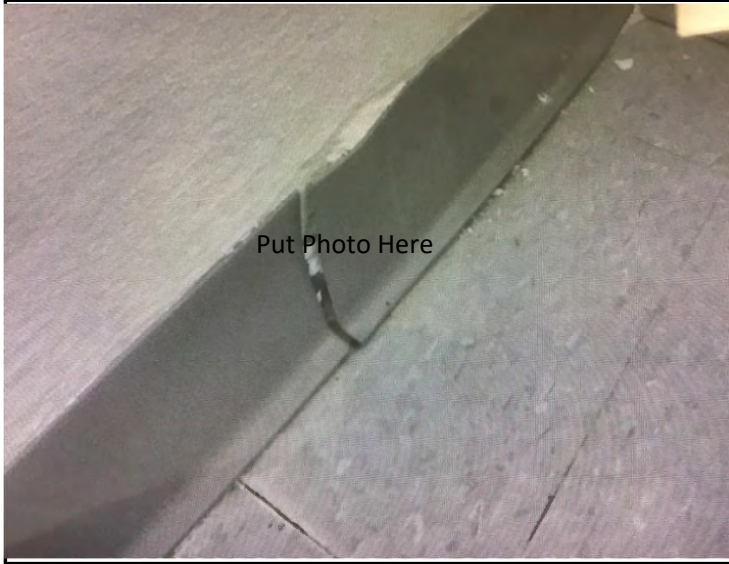
Damage Description:	Item #: 5	Damage Description:	Item #: 6
Base Lining, vinyl, 4 IN, detached, caused by surface water flooding (Main Bldg., Basement, Laboratory ARC 014)		Wall, ¼ IN thick plaster on concrete, repair spalling and paint, cracked, caused by rainwater intrusion (Main Bldg., Basement, Laboratory ARC 015)	
Additional Comments:		Additional Comments:

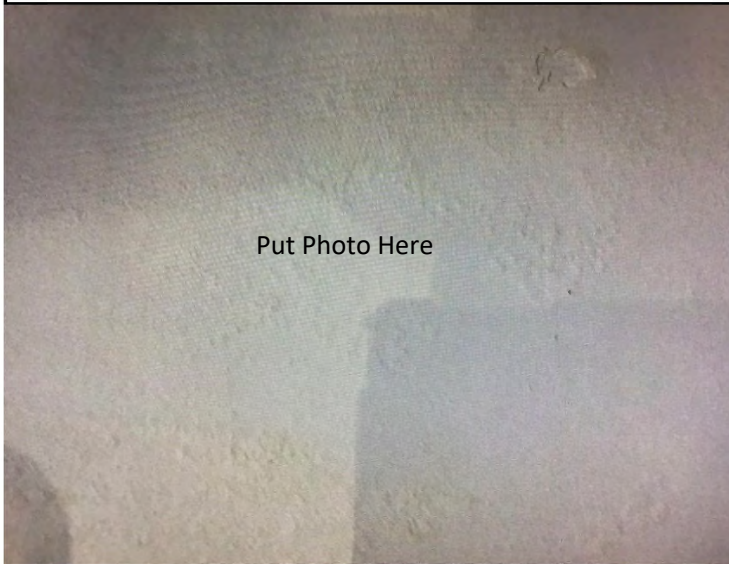
Damage Description:	Item #: 7	Damage Description:	Item #: 8 Wall,
Wall, ¼ IN thick plaster on concrete, repair spalling and paint, cracked, caused by rainwater intrusion (Main Bldg., Basement, Laboratory ARC 016)		¼ IN thick plaster on concrete, painted, peeling paint, caused by rainwater intrusion (Main Bldg., Basement, Laboratory ARC 017)	
Additional Comments:		Additional Comments:

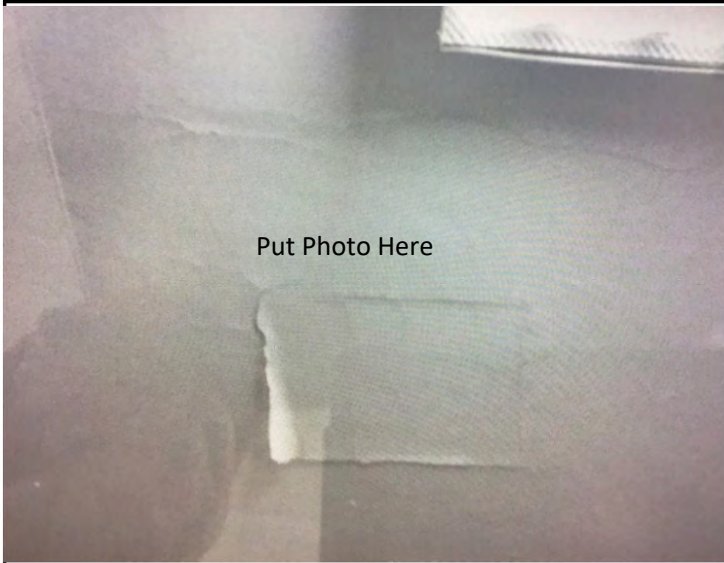
Damage Description:	Item #: 13	Damage Description:	Item #: 14
Ceiling, drywall, repair, detached, caused by rainwater intrusion (Main Bldg., Basement, Laboratory ARC 024)		Wall, ¼ IN thick plaster on concrete, painted, discolored, caused by rainwater intrusion (Main Bldg., Basement, Laboratory ARC 024)	
Additional Comments:		Additional Comments:

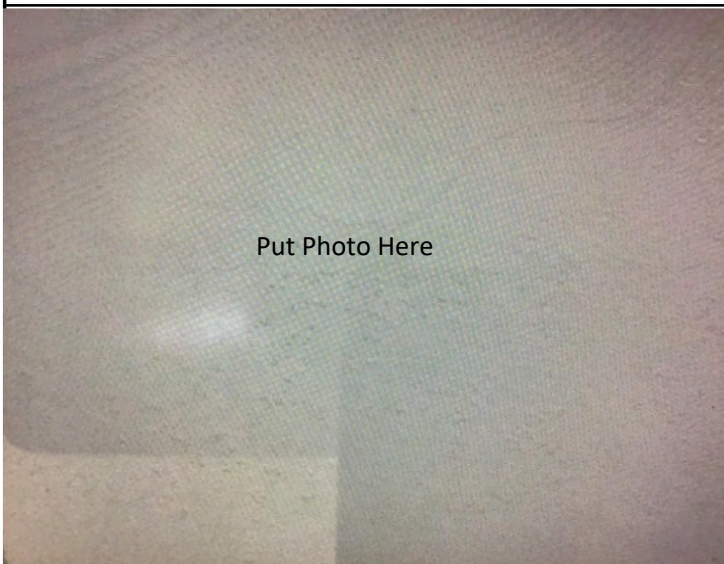
Damage Description:	Item #: 15	Damage Description:	Item #: 16
Wall, ¼ IN thick plaster on concrete, repair spalling and paint, cracked, caused by rainwater intrusion (Main Bldg., Basement, Laboratory ARC 025)		Light, fluorescent, surface-mounted, vapor-resistant, 6 IN x 48 IN, acrylic lens cover only, discolored, caused by rainwater intrusion (Main Bldg., Basement, Laboratory ARC 025)	
Additional Comments:		Additional Comments:

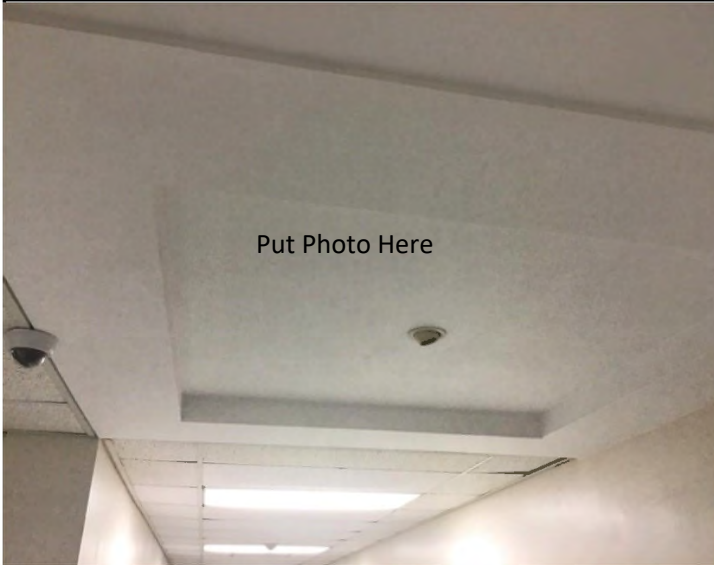
Damage Description:	Item #: 21	Damage Description:	Item #: 22
Ceiling, drywall, soffit, paint, discolored, caused by rainwater intrusion (Main Bldg., Floor 1, Hallway)		Wall, ¼ IN thick plaster on concrete, repair spalling, cracked, caused by rainwater intrusion (Main Bldg., Floor 1, Hallway)	
Additional Comments:		Additional Comments:

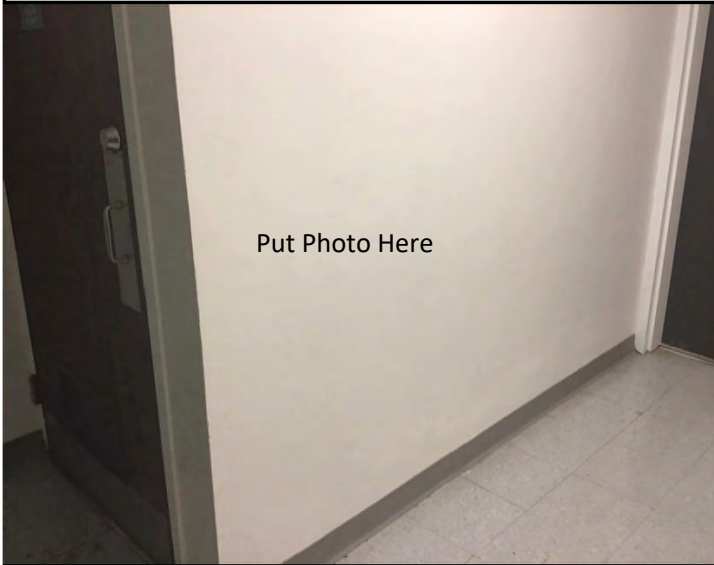
Damage Description:	Item #: 23	Damage Description:	Item #: 24
Wall, ¼ IN thick plaster on concrete, painted, discolored, caused by rainwater intrusion (Main Bldg., Floor 1, Hallway)		Wall, ¼ IN thick plaster on concrete, repair spalling, peeling paint, caused by rainwater intrusion (Main Bldg., Floor 1, Hallway)	
Additional Comments:		Additional Comments:

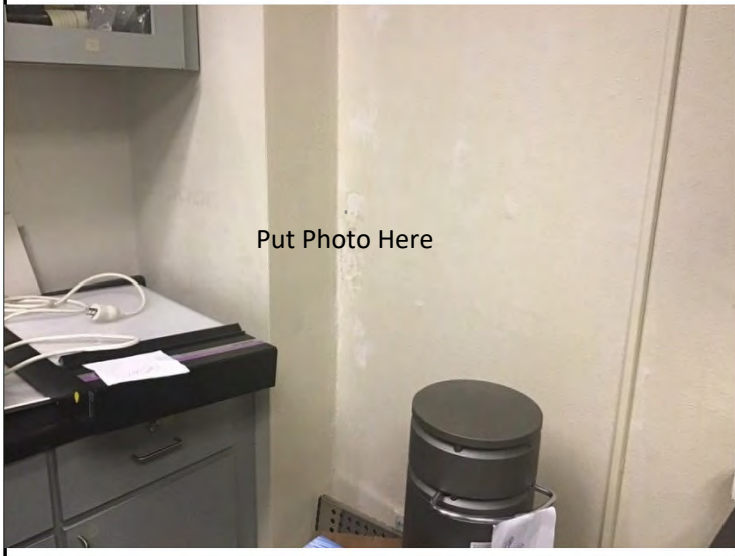
Damage Description:	Item #: 58
Wall, 1/4 IN thick plaster on concrete, repair spalling, cracked, caused by rainwater intrusion (Main Bldg., Basement, Laboratory R003)	
Additional Comments:

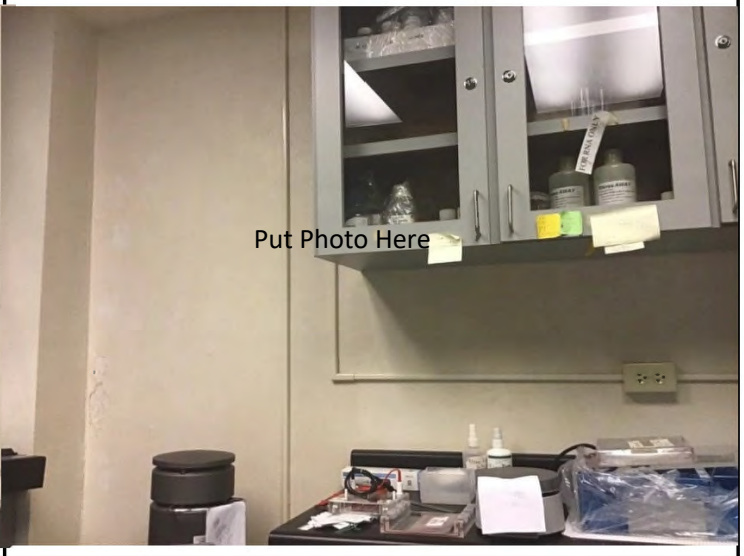
Damage Description:	Item #: 59 Wall,
1/4 IN thick plaster on concrete, painted, peeling paint, caused by rainwater intrusion (Main Bldg., Basement, Laboratory R003)	
Additional Comments:

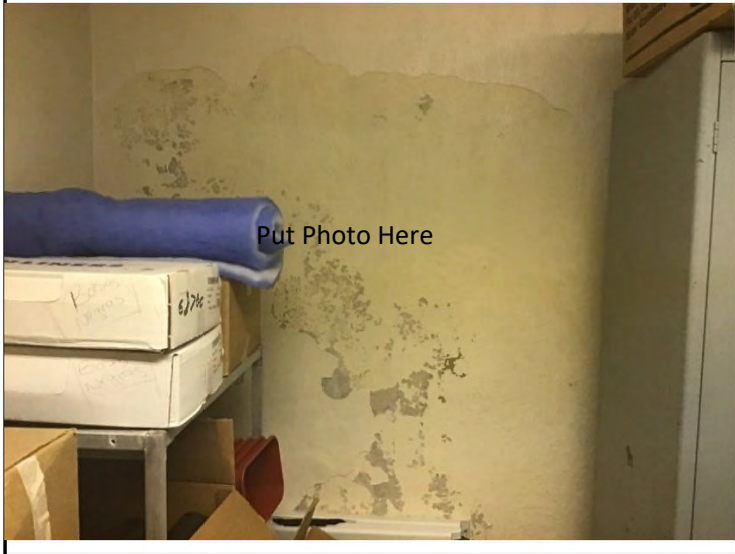
Damage Description:	Item #: 79
Wall, ¼ IN thick plaster on concrete, repair spalling and paint, cracked, caused by rainwater intrusion (Main Bldg., Basement, Storage Room R031)	
Additional Comments:

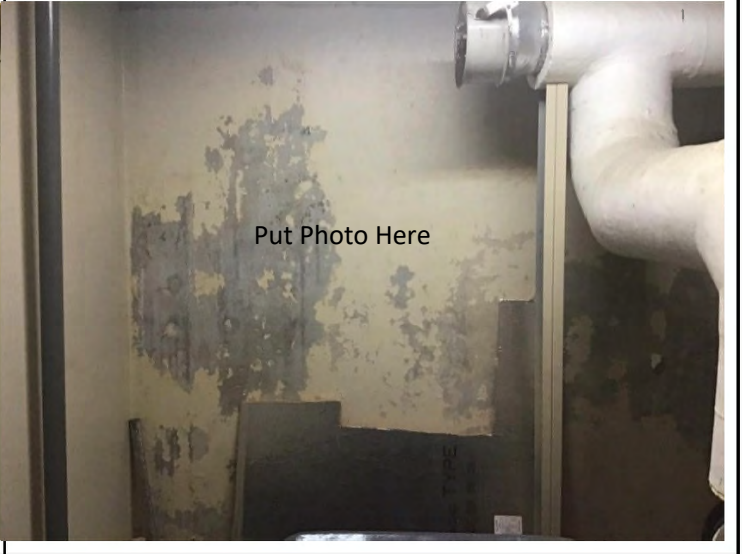
Damage Description:	Item #: 80
Wall, ¼ IN thick plaster on concrete, repair spalling and paint, cracked, caused by rainwater intrusion (Main Bldg., Basement, Mechanical Room)	
Additional Comments:

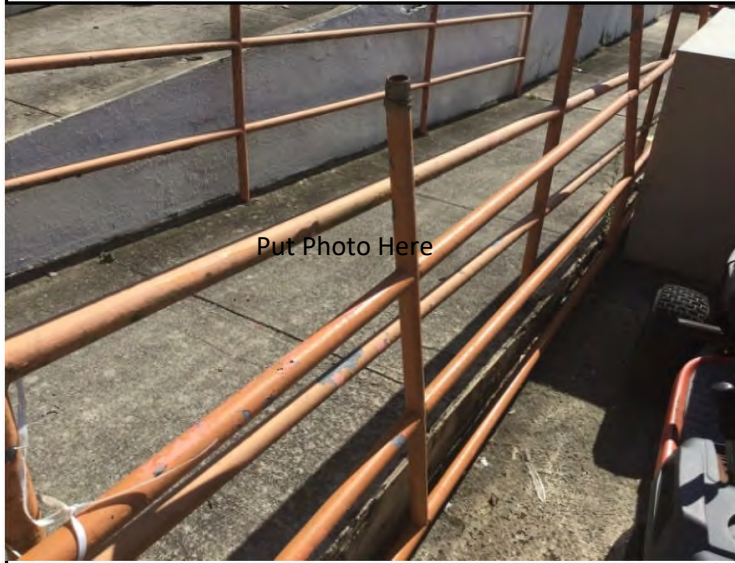
Damage Description:	Item #: 83
Hand Rail, Guard rail, galvanized steel piping, 1 1/2-IN dia., triple rail, painted finish, broken components, caused by wind-blown debris (Main Bldg., Exterior, Ramp)	
Additional Comments:
