Applicant: Universidad Central Del Caribe, Inc.	Damage Inventory: 305240	Category: E
WO # 46525 FIPS# 021-UNUGB-00	Date: 09/04-17/2019 GPS: 18.365953, -66.153767	
Inspector: Gregory Sondergeld / Alexander Nieves	Damage Facility: Main Bldg.

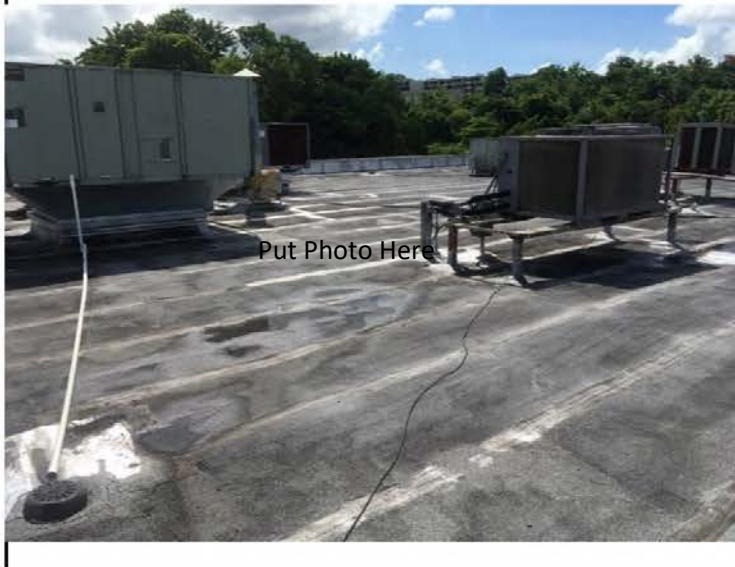
Damage Description:	Item #: 1
Roof, BUR asphaltic membrane, 3-ply, with rigid insulation and silver oxide coating, deformed, caused by wind-driven rain (Main Bldg., Roof)	
Additional Comments:

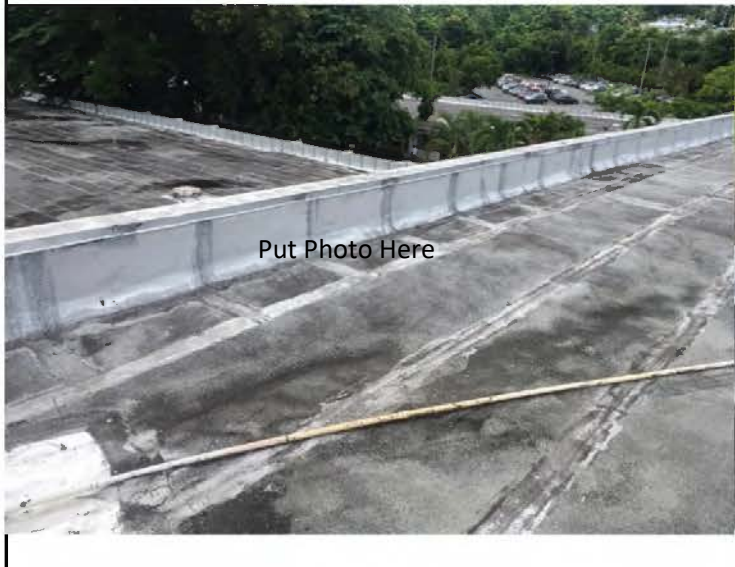
Damage Description:	Item #: 3
Roof, Flashing, Parapet Wall Perimeter, deformed, caused by wind-driven rain (Main Bldg., Roof)	
Additional Comments:

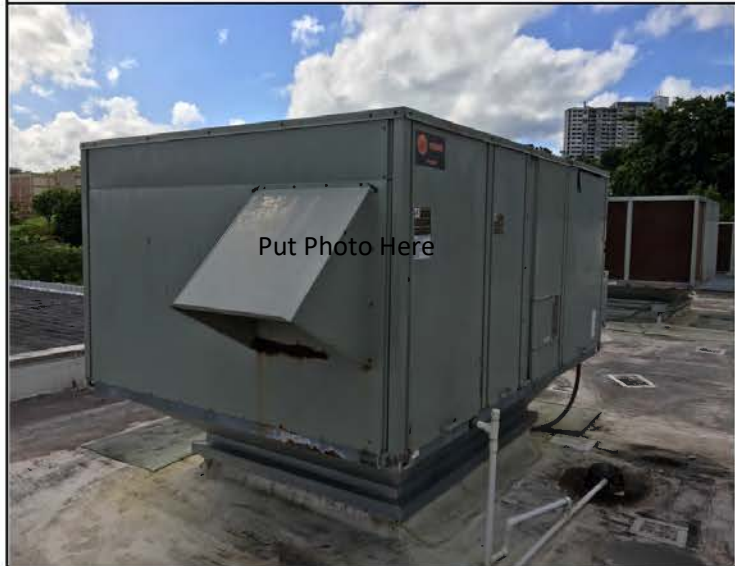
Damage Description:	Item #: 5	Damage Description:	Item #: 6
Air Conditioning, 15 Ton Package Unit, blown covers, caused by high winds (Main Bldg., Roof)		Air Conditioning, 15 Ton Package Unit, broken condenser fins, enclosure deformed, caused by wind-blown debris (Main Bldg., Roof)	
Additional Comments: Water infiltrated to the A/C ducts through the space created by blown covers Model # TCD180F400BA Serial # 120210113D		Additional Comments: Model # TTA180E400AA Serial # 14073LONTA

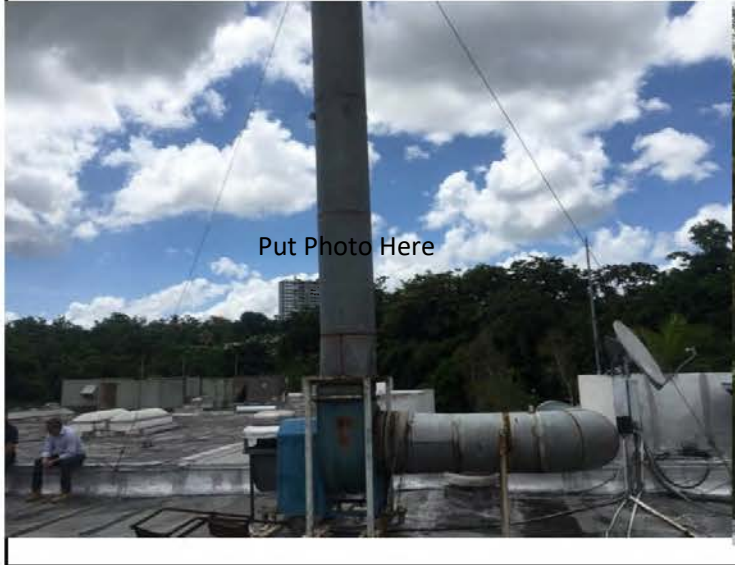
Damage Description:	Item #:	9
Exhaust Fan, 2 FT Dia. Exhaust pipe, Morgue Area, broken components, caused by high winds (Main Bldg., Roof)		
Additional Comments:

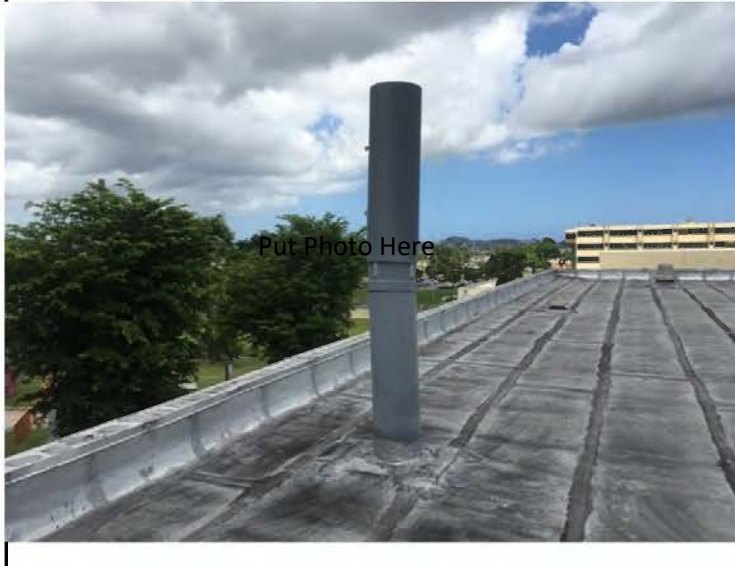
Damage Description:	Item #:	11
Exhaust, 18 IN Dia, head of exhaust fan, missing components, caused by high winds (Main Bldg., Roof)		
Additional Comments:

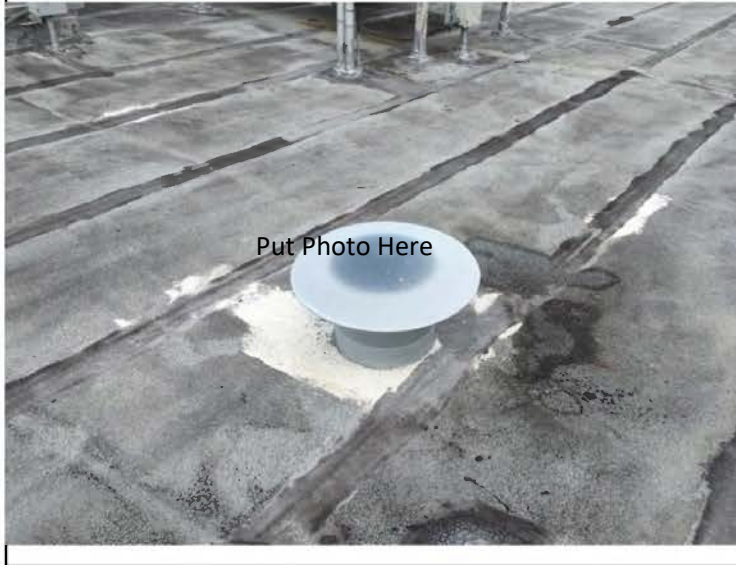
Damage Description:	Item #: 13
Exhaust, 18 IN Dia, head of exhaust fan, missing components, caused by high winds (Main Bldg., Roof)	
Additional Comments:

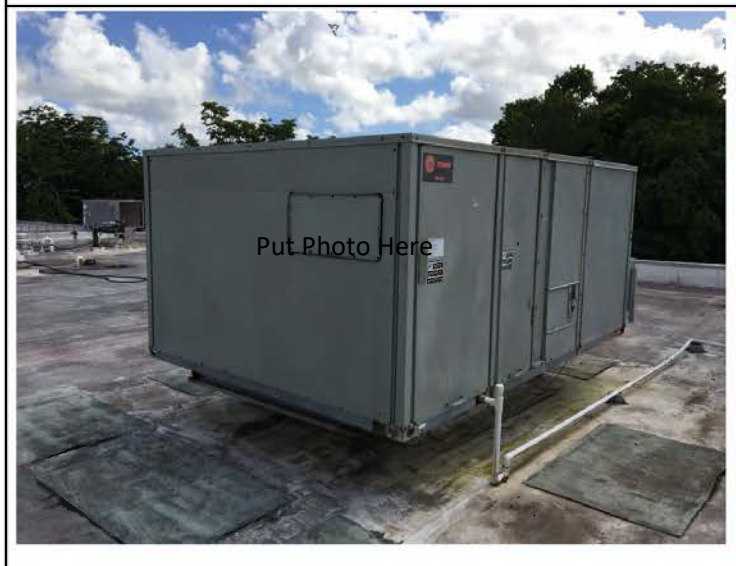
Damage Description:	Item #: 15
Air Conditioning, 15 Ton Package Unit, blown covers, caused by high winds (Main Bldg., Roof)	
Additional Comments: Water infiltrated to the A/C ducts through the space created by blown covers Model # TCD180E400BA Serial # 102710308D

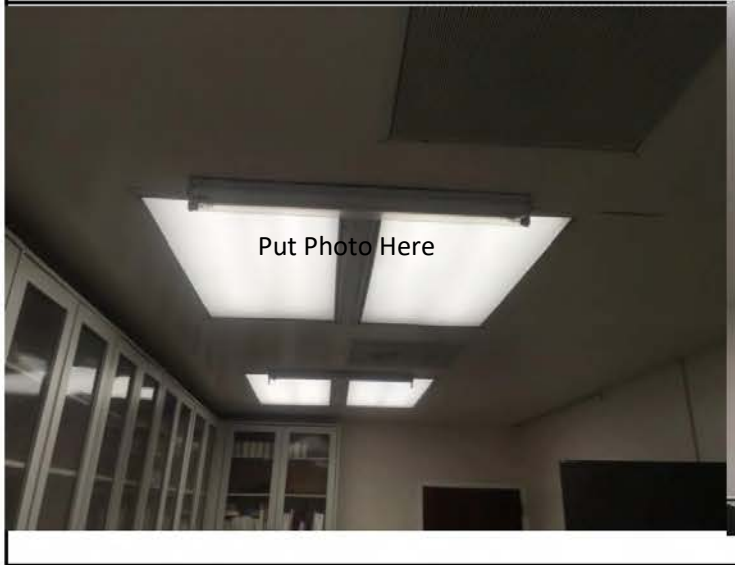
Damage Description:	Item #: 17
Ceiling, drywall paint, discolored, caused by rainwater intrusion (Main Bldg., Floor 2, Laboratory R181)	
Additional Comments:

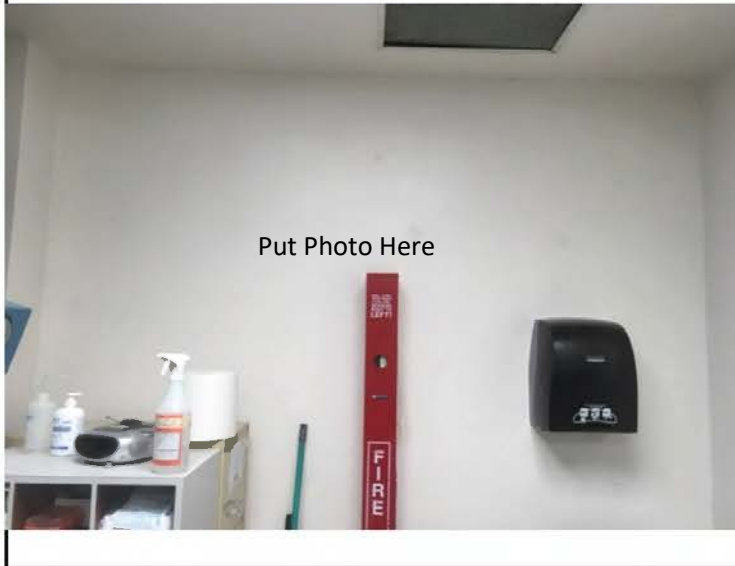
Damage Description:	Item #: 19
Wall, ¼ IN thick plaster on concrete, painted, discolored, caused by rainwater intrusion (Main Bldg., Floor 2, Laboratory R181)	
Additional Comments:

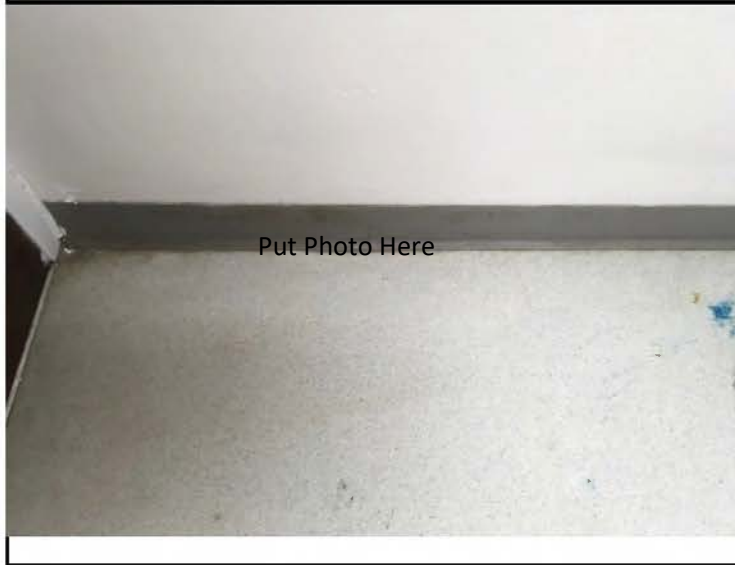
Damage Description:	Item #: 21
Base Lining, vinyl, 4 IN, dislodged, caused by rainwater intrusion (Main Bldg., Floor 2, Laboratory R181)	
Additional Comments:

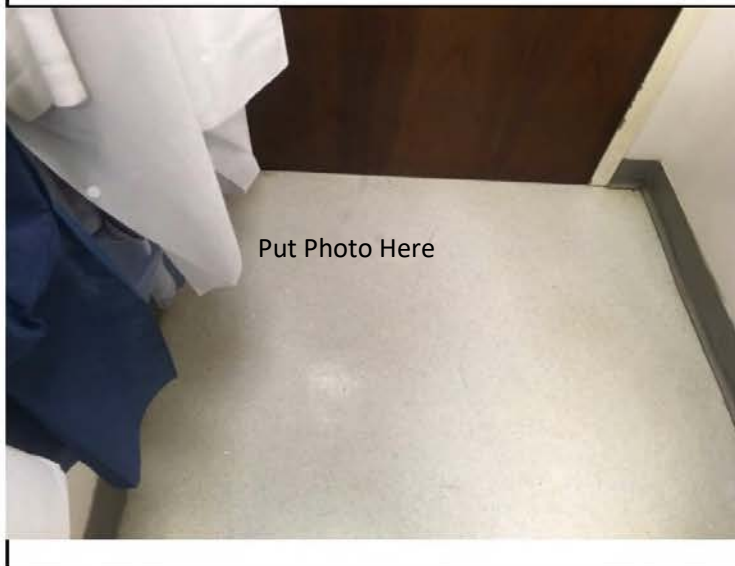
Damage Description:	Item #: 23
Floor, Linoleum, commercial-grade, deformed, caused by rainwater intrusion (Main Bldg., Floor 2, Laboratory R133)	
Additional Comments:

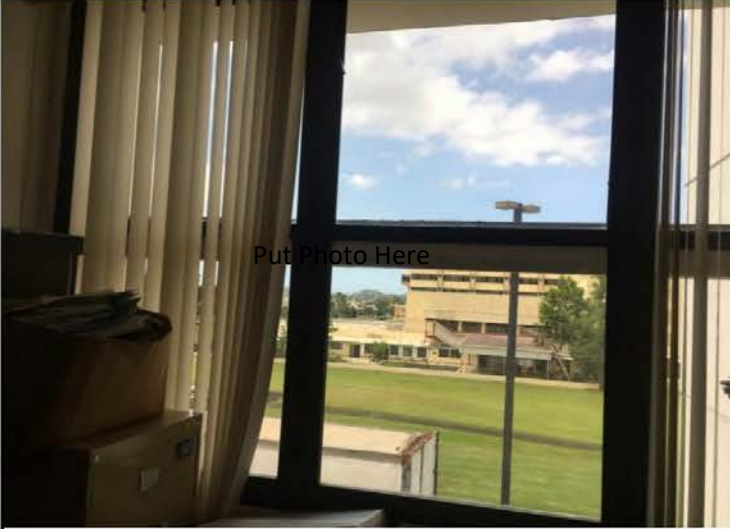
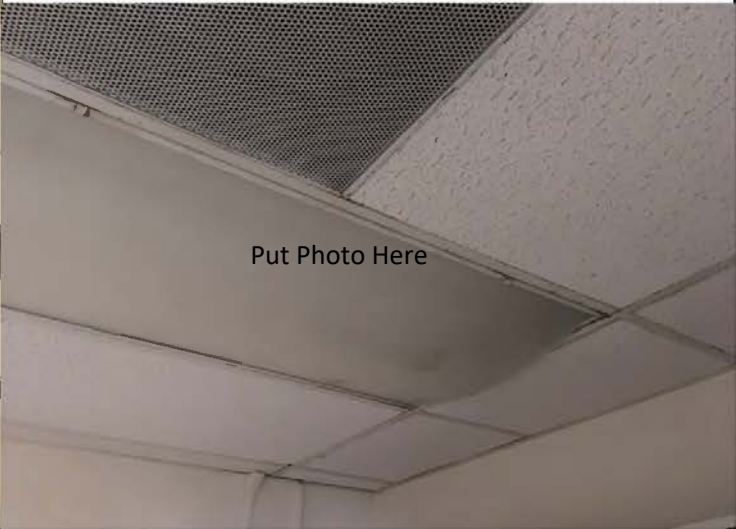
Damage Description:	Item #: 27	Damage Description:	Item #: 28
Window, Alum. window frames, Exterior perimeter caulking/sealing only, peeling paint, caused by high winds (Main Bldg., Floor 2, Office R135)		Light, Fluorescent, recessed Troffer, acrylic lens cover only, prismatic, deformed, caused by rainwater intrusion (Main Bldg., Floor 2, Office R138)	
Additional Comments:		Additional Comments:

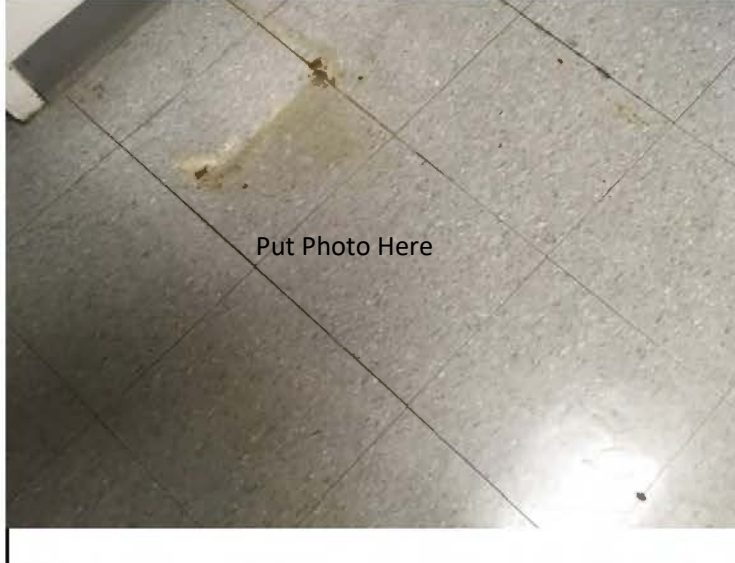
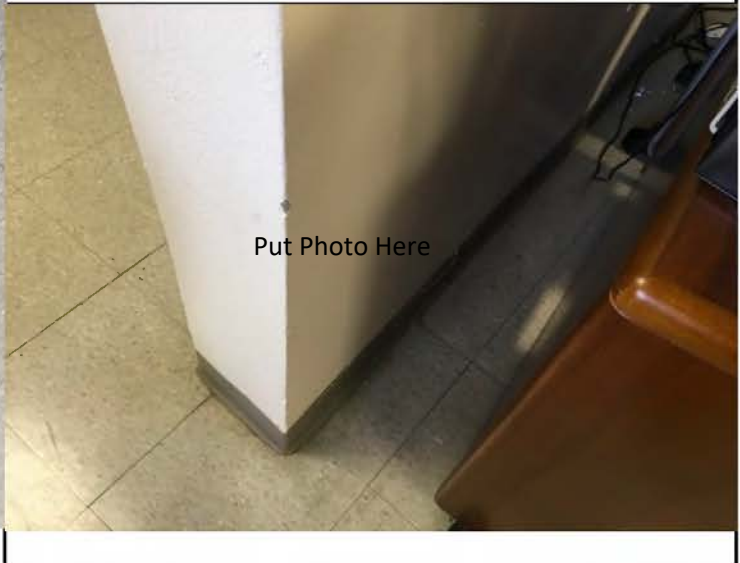
Damage Description:	Item #: 29	Damage Description:	Item #: 30
VCT, 12x12 IN, discolored, caused by rainwater intrusion (Main Bldg., Floor 2, Hallway)		Base Lining, vinyl, 4 IN, dislodged, caused by rainwater intrusion (Main Bldg., Floor 2, Hallway)	
Additional Comments:		Additional Comments:

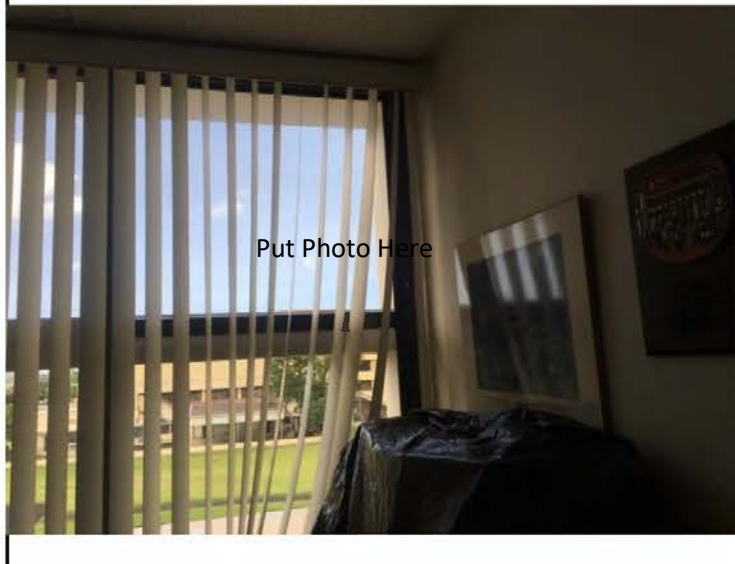
Damage Description:	Item #: 31	Damage Description:	Item #: 32
Window, Alum. window frames, perimeter caulking/sealing only, cracked, caused by rainwater intrusion (Main Bldg., Floor 2, Office R141)		Ceiling, 2 FT x 4 FT acoustic tile, suspended with grid, discolored, caused by rainwater intrusion (Main Bldg., Floor 2, Office)	
Additional Comments:		Additional Comments:

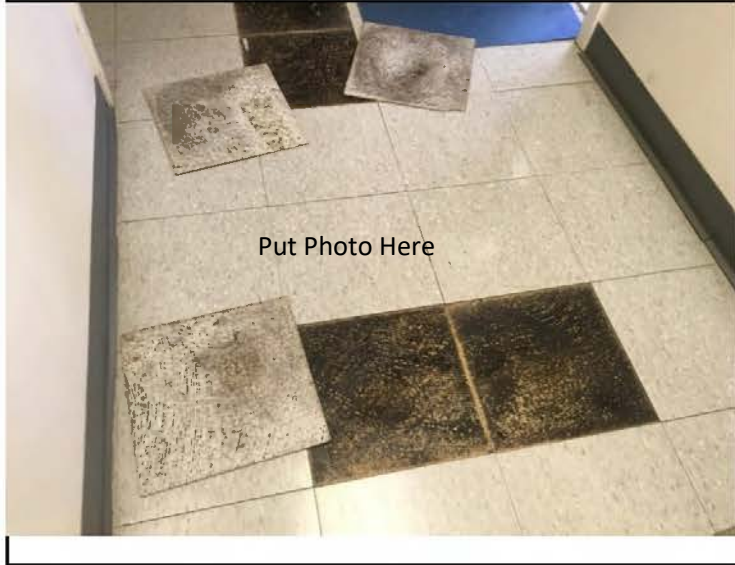
Damage Description:	Item #: 33
Floor, VCT, 12x12 IN, detached, caused by surface water flooding (Main Bldg., Floor 2, Hallway R291)	
Additional Comments:

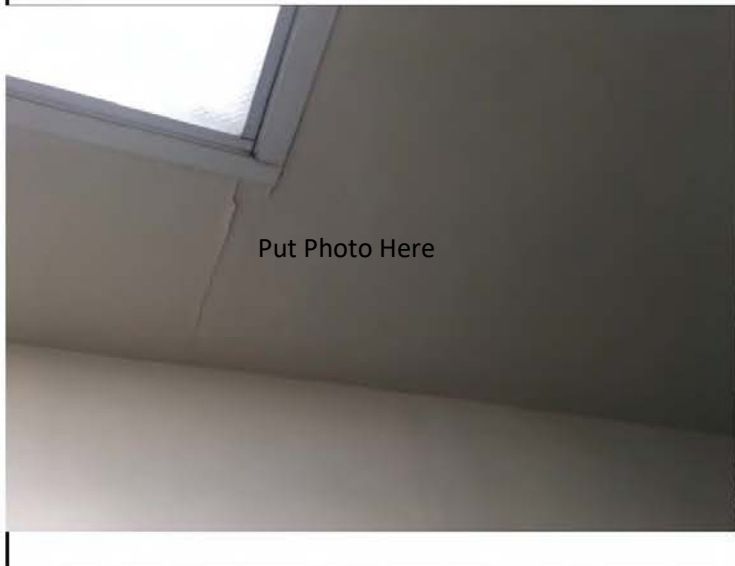
Damage Description:	Item #: 35
Ceiling, drywall, repair, cracked, caused by rainwater intrusion (Main Bldg., Floor 2, Hallway R291)	
Additional Comments:

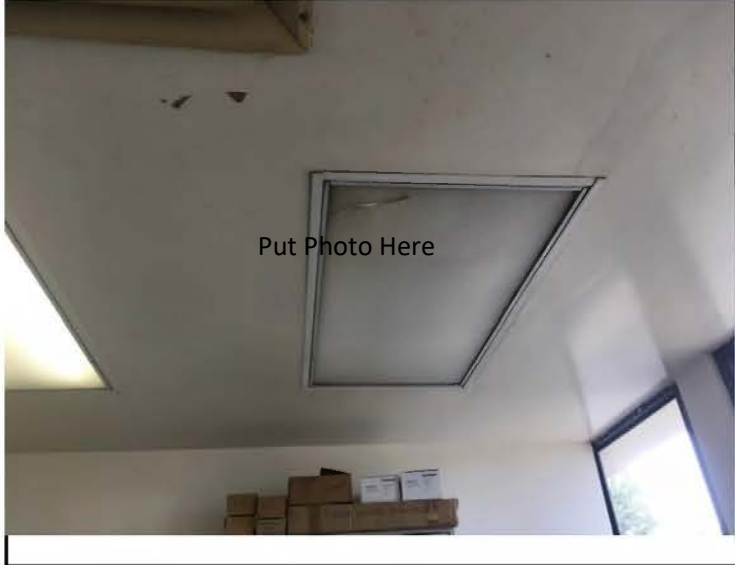
Damage Description:	Item #: 38
Light, fluorescent, recessed Troffer, broken components, caused by wind-driven rain (Main Bldg., Floor 2, Laboratory R143)	
Additional Comments:

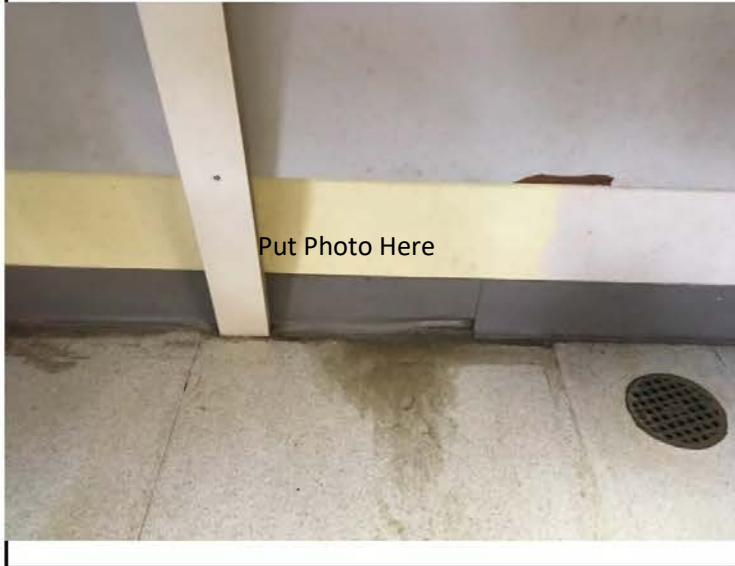
Damage Description:	Item #: 40
Base Lining, vinyl, 4 IN, detached, caused by rainwater intrusion (Main Bldg., Floor 2, Laboratory R143)	
Additional Comments:

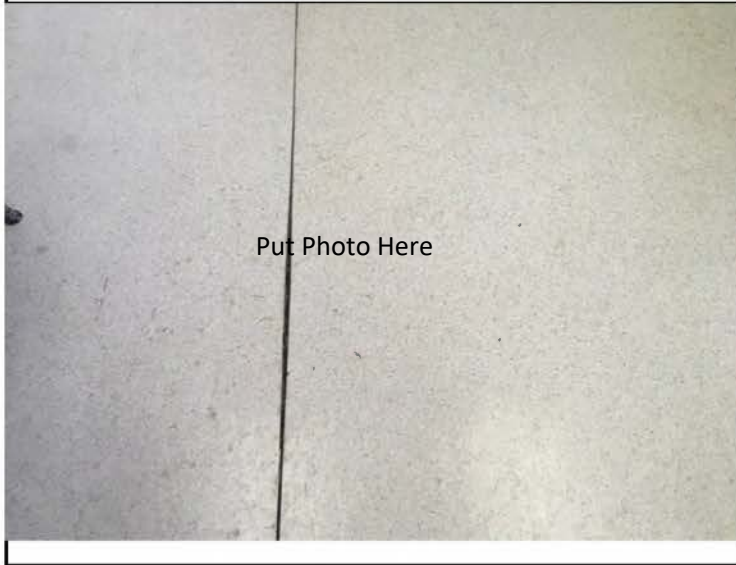
Damage Description:	Item #: 42	Damage Description:	Item #: 44
Floor, Linoleum, commercial-grade, detached, caused by rainwater intrusion (Main Bldg., Floor 2, Laboratory R144)		Ceiling, drywall, repair and paint, cracked, caused by rainwater intrusion (Main Bldg., Floor 2, Laboratory R144)	
Additional Comments:		Additional Comments:

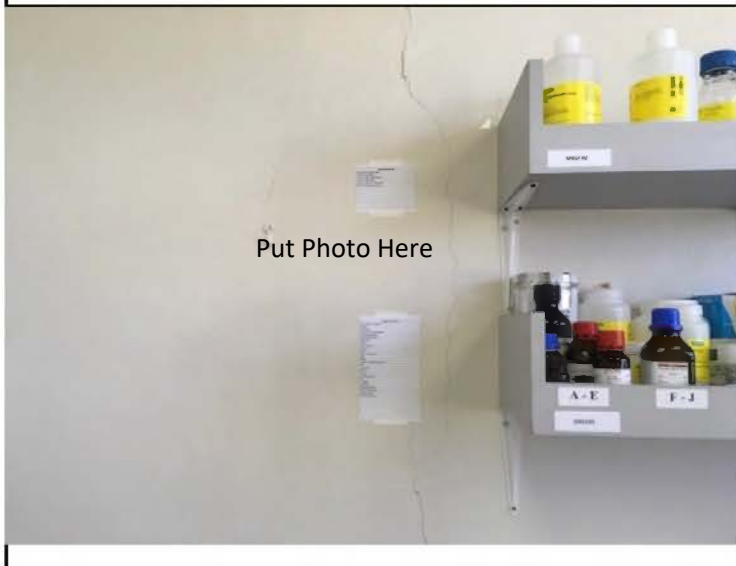
Damage Description:	Item #: 45	Damage Description:	Item #: 46
Wall, ¼ IN thick plaster on concrete, painted, with spalls, cracked, caused by rainwater intrusion (Main Bldg., Floor 2, Laboratory R144)		Wall, drywall, discolored, caused by rainwater intrusion (Main Bldg., Floor 2, Laboratory R144)	
Additional Comments:		Additional Comments:

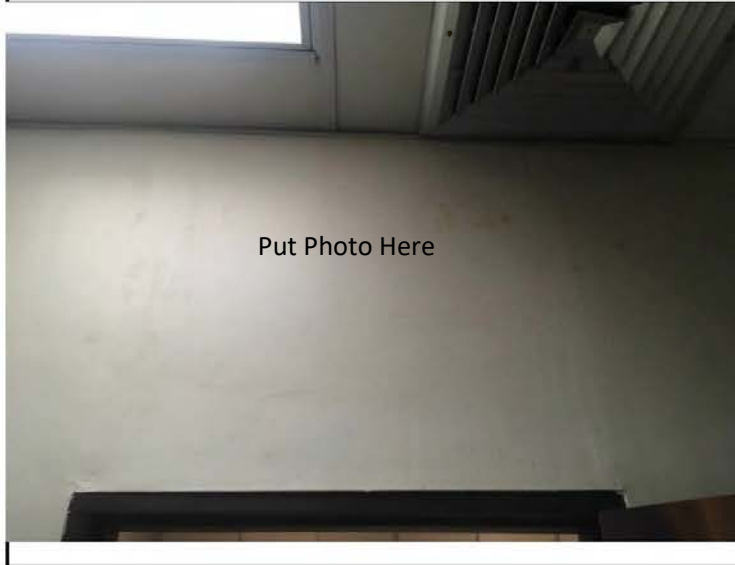
Damage Description:	Item #: 51
Wall, drywall, repair and paint , discolored, caused by rainwater intrusion (Main Bldg., Floor 2, Kitchen 145)	
Additional Comments:

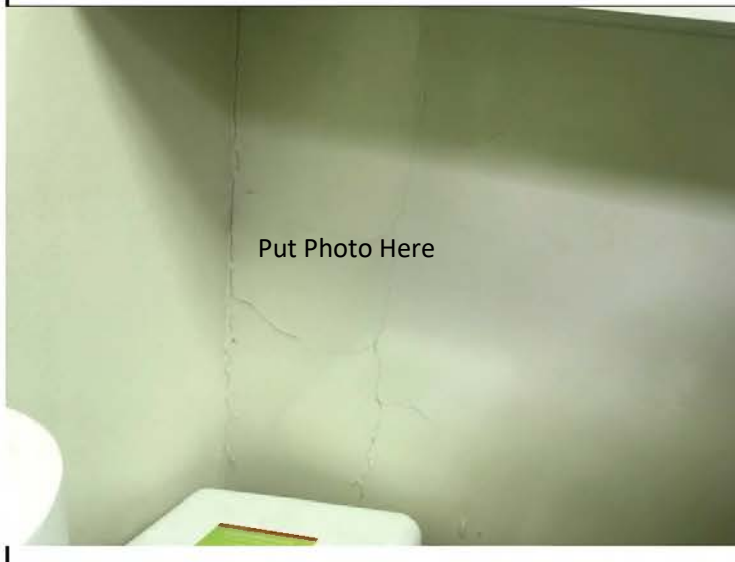
Damage Description:	Item #: 54
Wall, ¼ IN thick plaster on concrete, painted, with spalls, cracked, caused by rainwater intrusion (Main Bldg., Floor 2, Laboratory R147)	
Additional Comments:

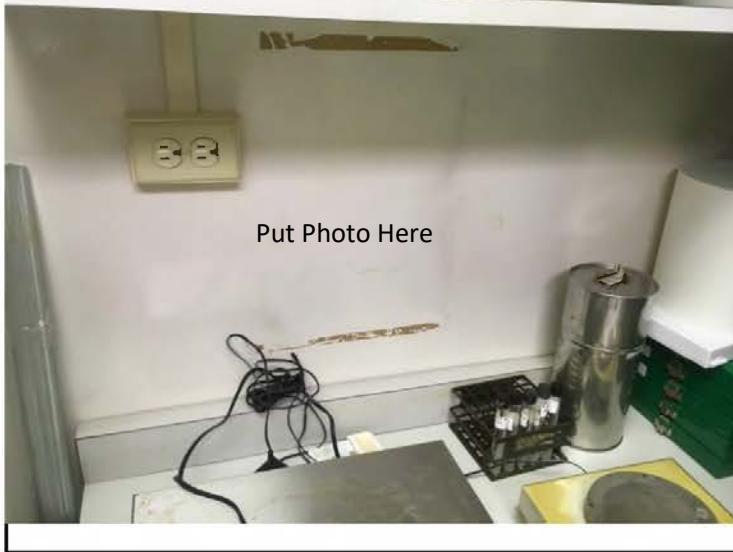
Damage Description:	Item #: 56
Wall, ¼ IN thick plaster on concrete, painted, discolored, caused by rainwater intrusion (Main Bldg., Floor 2, Laboratory R147)	
Additional Comments:

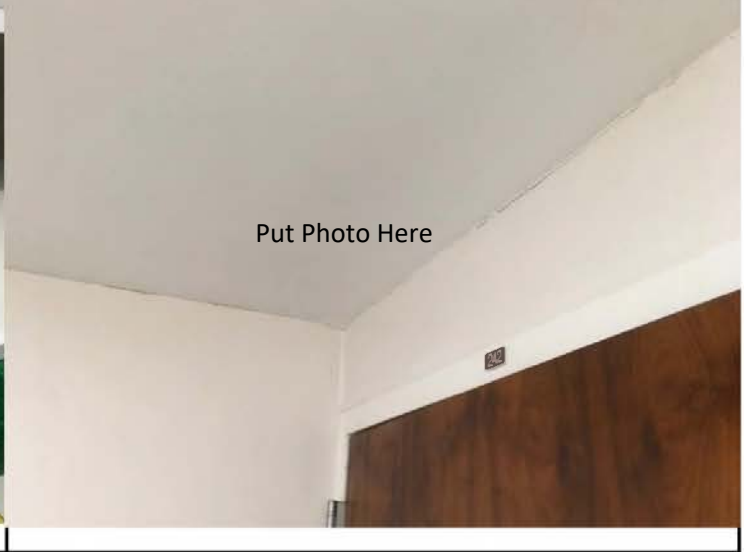
Damage Description:	Item #: 57
Wall, drywall and concrete joint, repair, cracked, caused by rainwater intrusion (Main Bldg., Floor 2, Laboratory R146)	
Additional Comments:

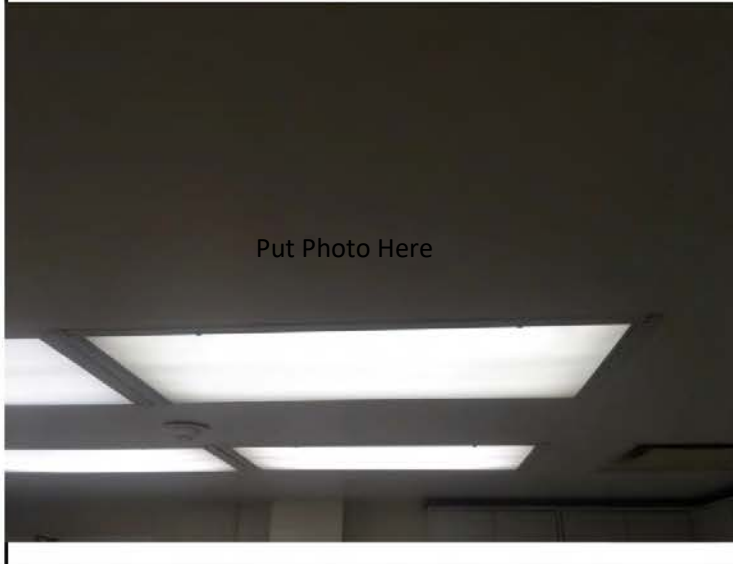
Damage Description:	Item #: 58
Ceiling, drywall, painted, discolored, caused by rainwater intrusion (Main Bldg., Floor 2, Laboratory R146)	
Additional Comments:

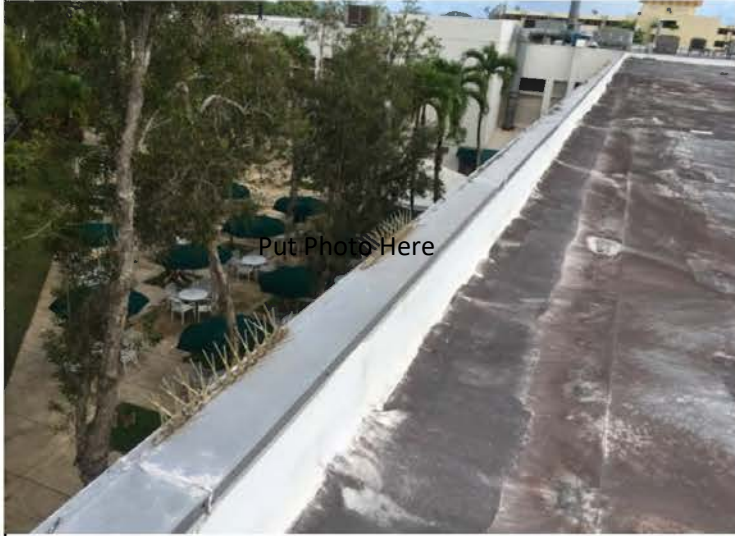
Damage Description:	Item #: 60
Bird spike strips, perching deterrents, 6 IN H, broken components, caused by high winds (Main Bldg., Roof)	
Additional Comments:

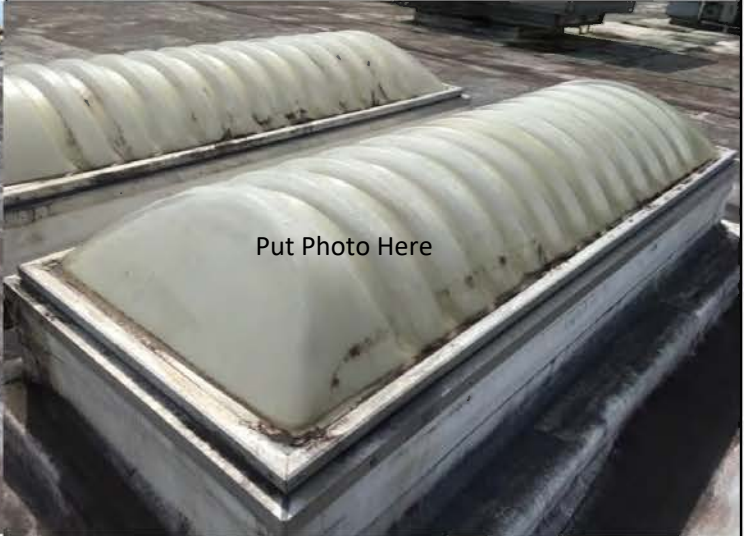
Damage Description:	Item #: 61
Acrylic Skylight Domes, 3 FT W x 8 FT L x 1 FT H, cracked, caused by wind-blown debris (Main Bldg., Roof)	
Additional Comments:

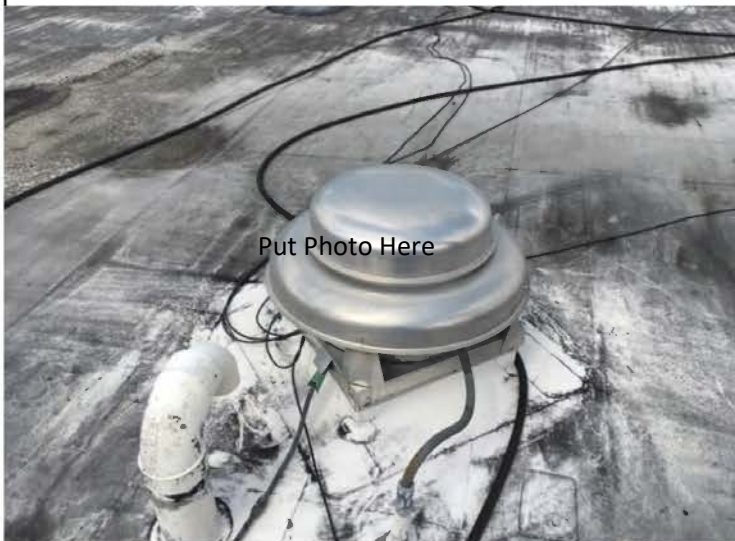
Damage Description:	Item #: 62
Rooftop Air Extractor, 2 FT Dia., alum. dome cover with 1/2-HP motor, broken components, caused by high winds (Main Bldg., Roof)	
Additional Comments:

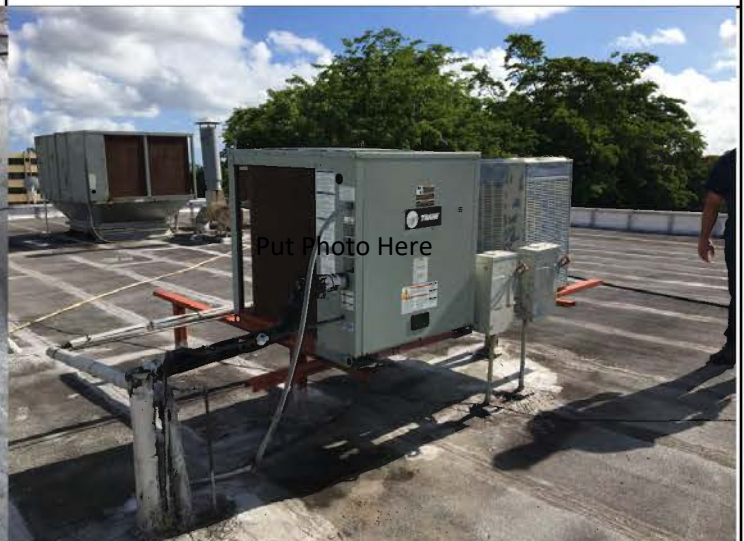
Damage Description:	Item #: 63
Air Conditioning, 7.5 Ton Package Unit, broken components, completely damaged, caused by high winds (Main Bldg., Roof)	
<u>This unit was included in a Cat B project.</u>	
Additional Comments: Shown in the photo is the replaced unit Model # TTA090G400AA Serial # 172435YTYA

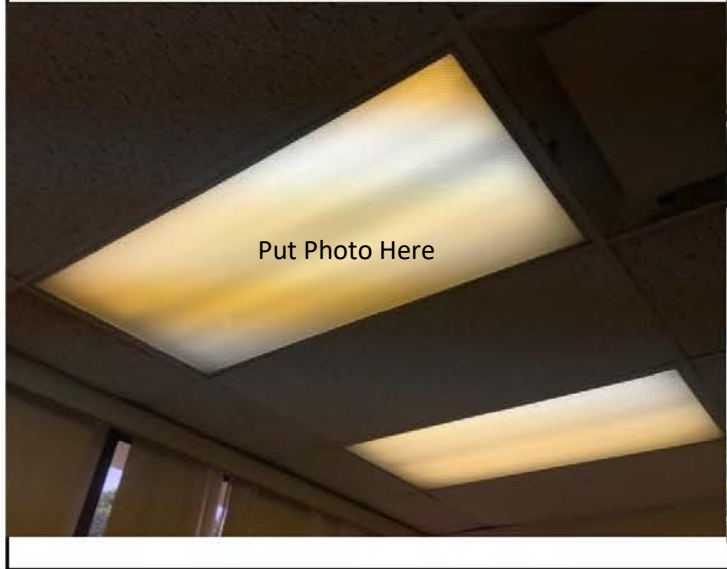
Damage Description:	Item #: 64	Damage Description:	Item #: 65
Ceiling, 2 FT x 4 FT acoustic tile, suspended, deformed, caused by rainwater intrusion (Main Bldg., Floor 2, Office R119)		Light, fluorescent, recessed Troffer, electrical issues, caused by rainwater intrusion (Main Bldg., Floor 2, Office R119)	
Additional Comments:		Additional Comments:

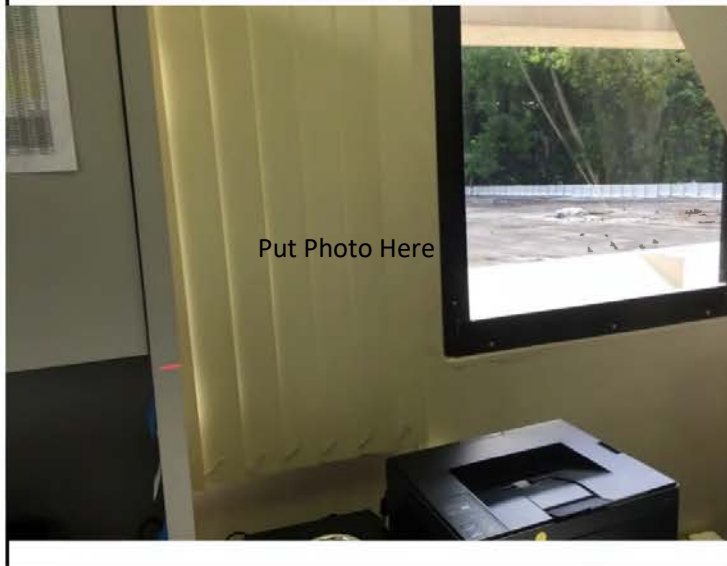
Damage Description:	Item #: 66	Damage Description:	Item #: 67
Window, Alum. window frames, perimeter caulking/sealing only, cracked, caused by rainwater intrusion (Main Bldg., Floor 2, Office R119)		Wall, ¼ IN thick plaster on concrete, painted, with spalls, cracked, caused by high winds (Main Bldg., Floor 2, Office R119)	
Additional Comments:		Additional Comments:

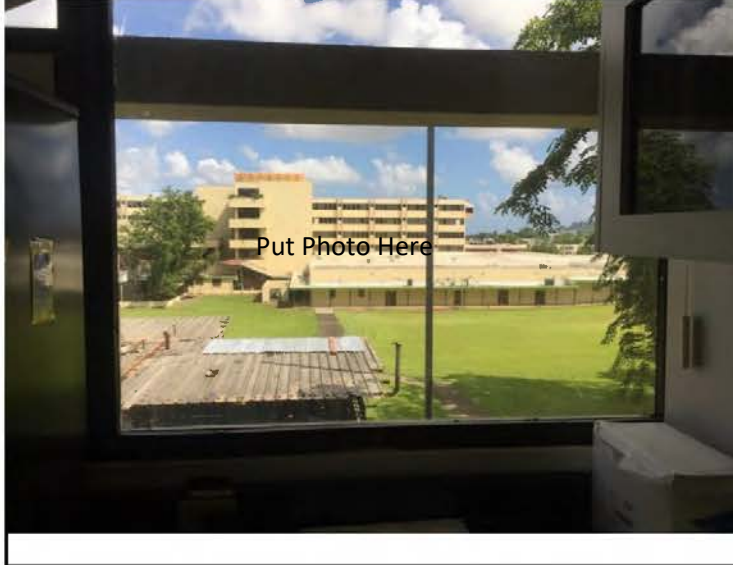
Damage Description:	Item #: 68
Window, Window frame, aluminum, dislodged, caused by high winds (Main Bldg., Floor 2, Laboratory R122)	
Additional Comments:

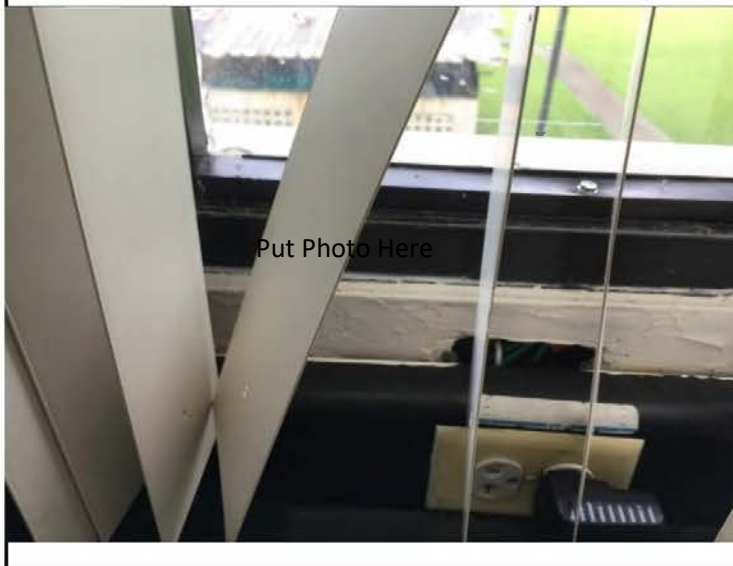
Damage Description:	Item #: 70
Window, Alum. window frames, perimeter caulking/sealing only, cracked, caused by wind-driven rain (Main Bldg., Floor 2, Laboratory R122)	
Additional Comments:

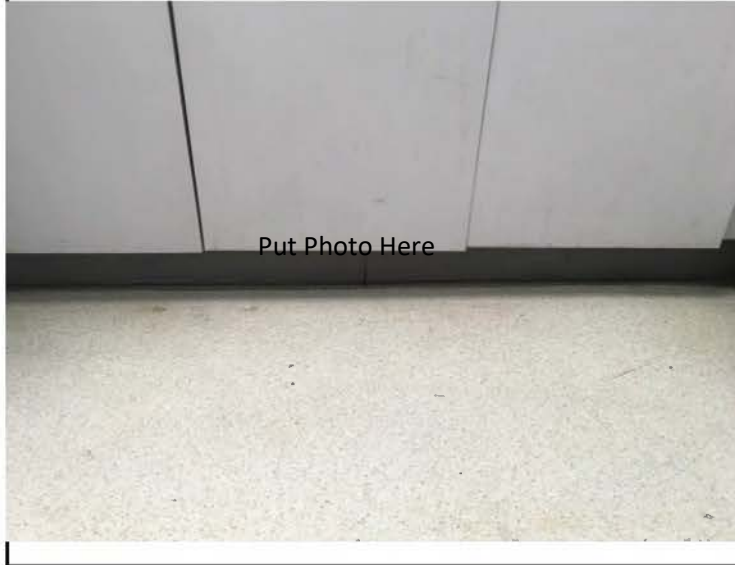
Damage Description:	Item #: 72
Base Lining, vinyl, 4 IN, deformed, caused by surface water flooding (Main Bldg., Floor 2, Laboratory R122)	
Additional Comments:

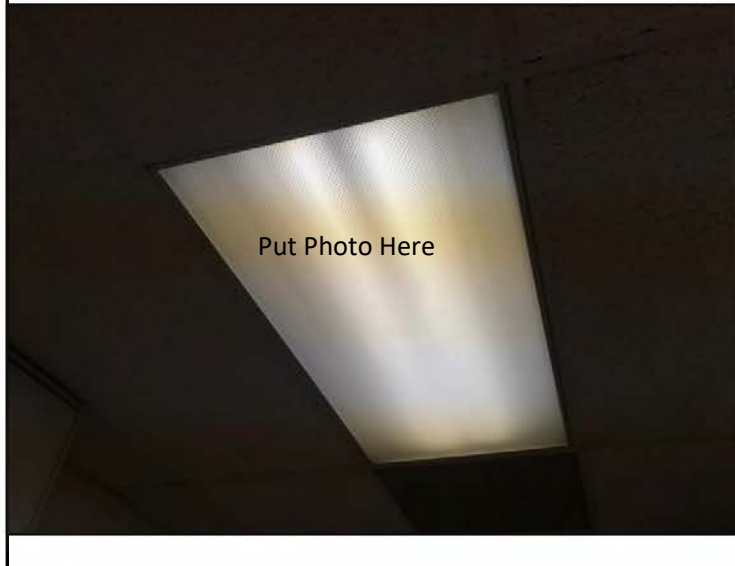
Damage Description:	Item #: 75
Light, Fluorescent, recessed Troffer, acrylic lens cover only, prismatic, discolored, caused by rainwater intrusion (Main Bldg., Floor 2, Laboratory R120)	
Additional Comments:

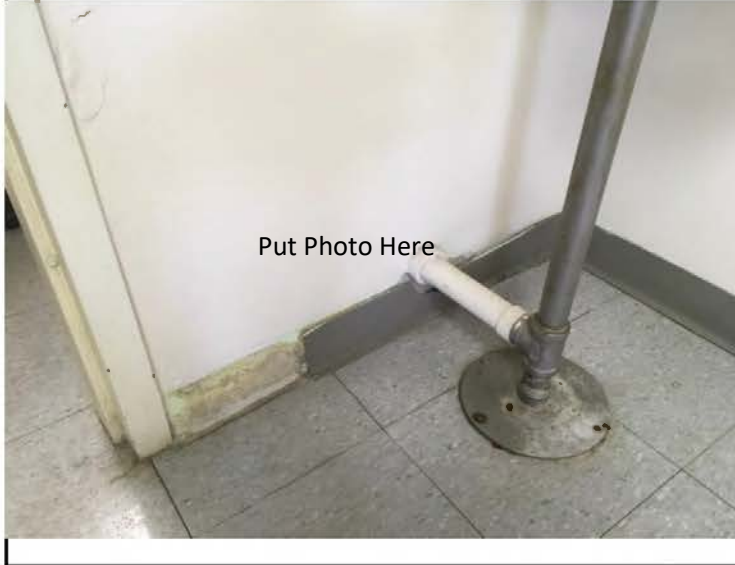
Damage Description:	Item #: 78
Floor, VCT, 12x12 IN, dislodged, caused by surface water flooding (Main Bldg., Floor 2, Storage Room R121)	
Additional Comments:

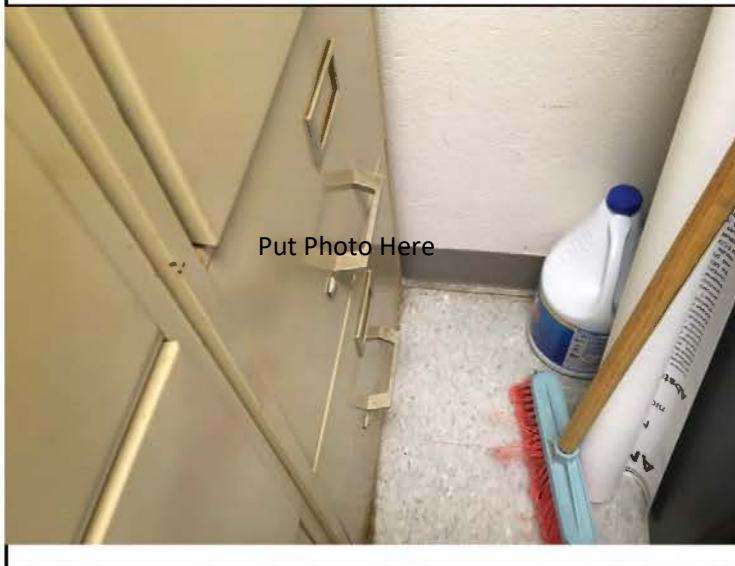
Damage Description:	Item #: 79
Base Lining, vinyl, 4 IN, dislodged, caused by surface water flooding (Main Bldg., Floor 2, Storage Room R121)	
Additional Comments:

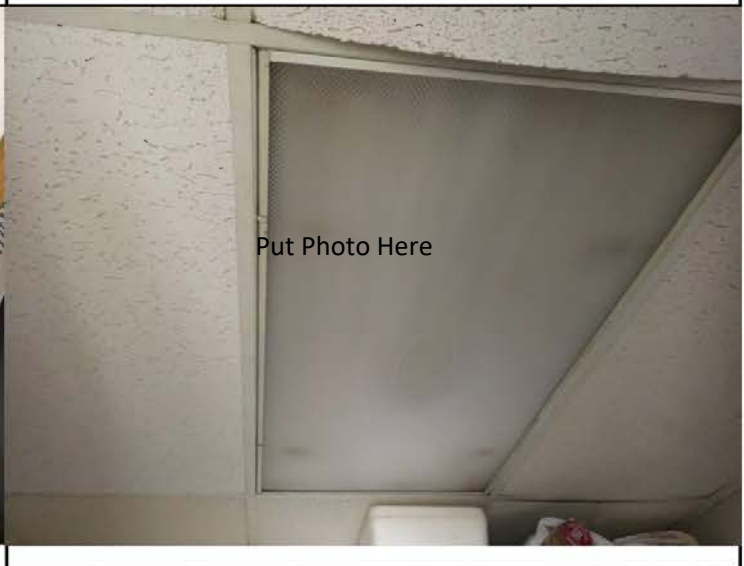
Damage Description:	Item #: 80
Light, Fluorescent, recessed Troffer, acrylic lens cover only, prismatic, discolored, caused by rainwater intrusion (Main Bldg., Floor 2, Storage Room R121)	
Additional Comments:

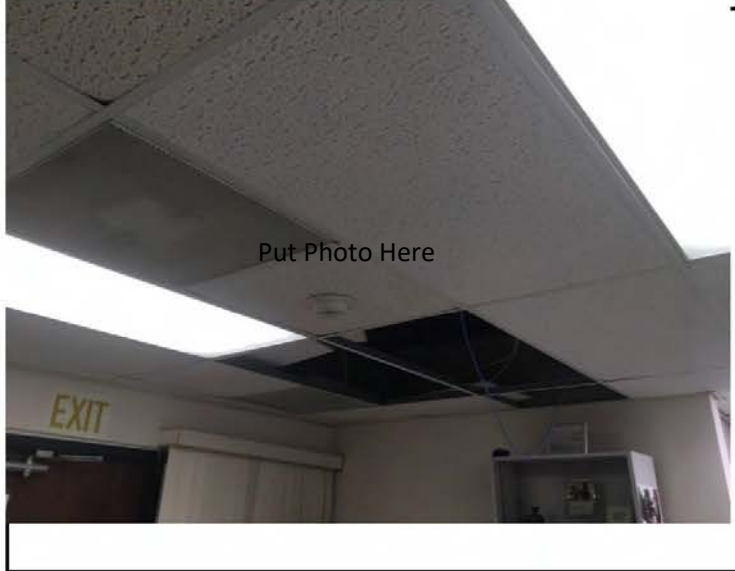
Damage Description:	Item #: 81
Ceiling, 2 FT x 4 FT acoustic tile, suspended, dislodged, caused by rainwater intrusion (Main Bldg., Floor 2, Entire Floor)	
Additional Comments:

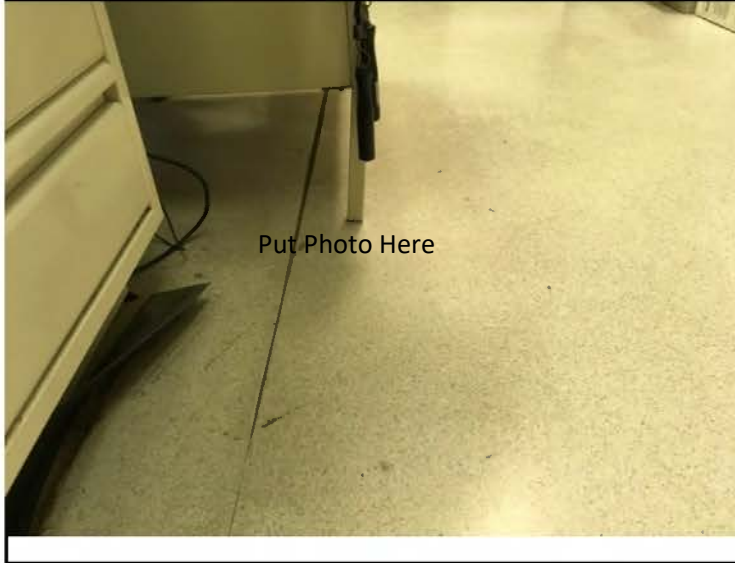
Damage Description:	Item #: 85	Damage Description:	Item #: 86
Floor, Linoleum, commercial-grade, dislodged, caused by surface water flooding (Main Bldg., Floor 2, Laboratory R386)		Base Lining, vinyl, 4 IN, deformed, caused by surface water flooding (Main Bldg., Floor 2, Laboratory R386)	
Additional Comments:		Additional Comments:

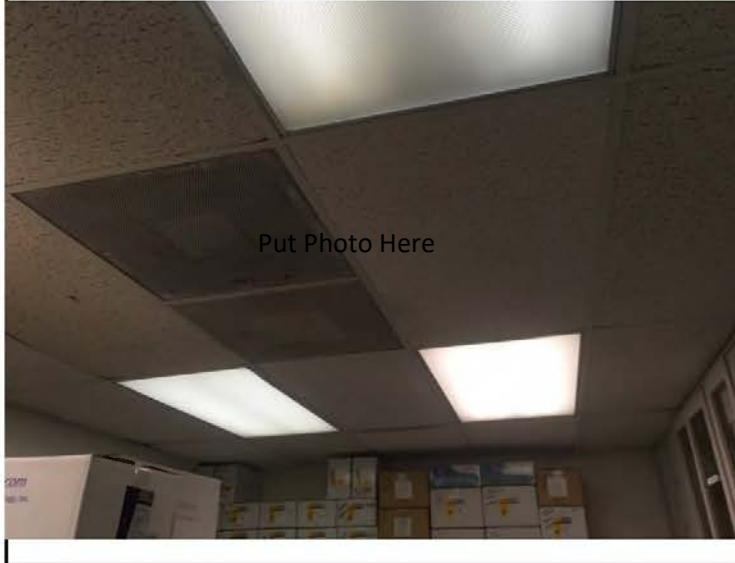
Damage Description:	Item #: 87	Damage Description:	Item #: 88
Ceiling, 2 FT x 4 FT acoustic tile, suspended, deformed, caused by rainwater intrusion (Main Bldg., Floor 2, Laboratory R386)		Window, Alum. window frames, perimeter caulking/sealing only, cracked, caused by wind-driven rain (Main Bldg., Floor 2, Laboratory R111)	
Additional Comments:		Additional Comments:

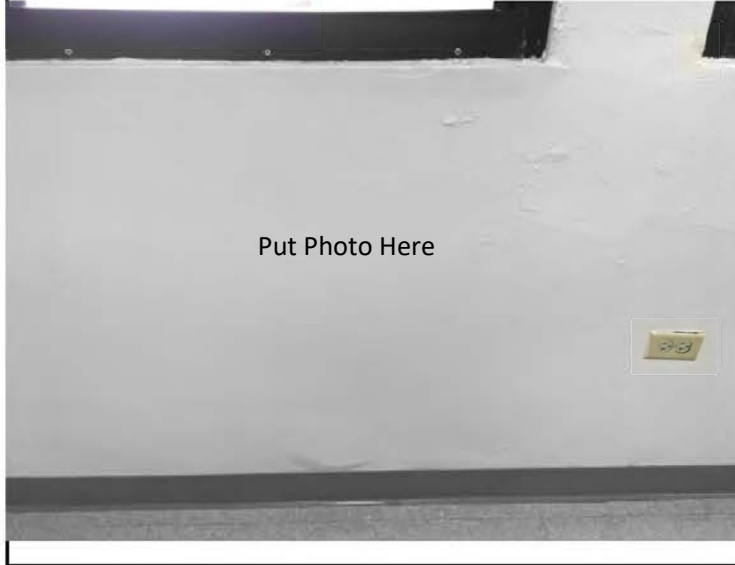
Damage Description:	Item #: 89
Wall, ¼ IN thick plaster on concrete, painted, torn with bubbles, caused by rainwater intrusion (Main Bldg., Floor 2, Laboratory R111)	
Additional Comments:

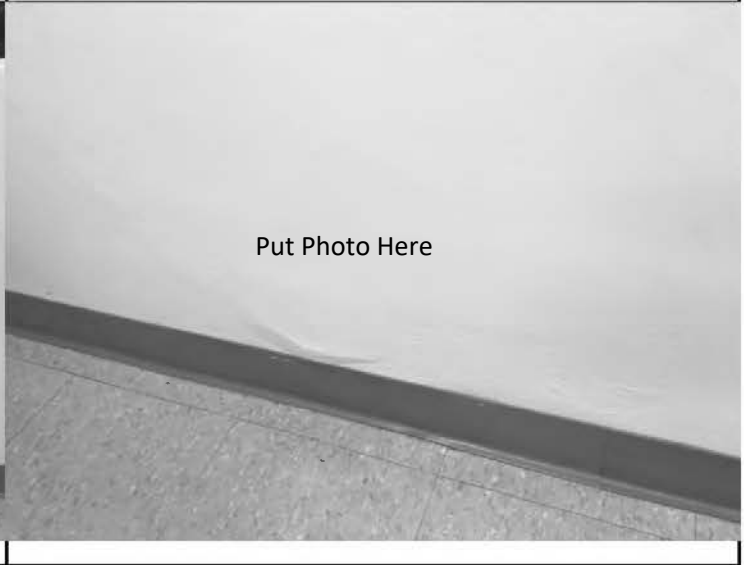
Damage Description:	Item #: 90
Wall, ¼ IN thick plaster on concrete, painted, with spalls, cracked, caused by rainwater intrusion (Main Bldg., Floor 2, Laboratory R111)	
Additional Comments:

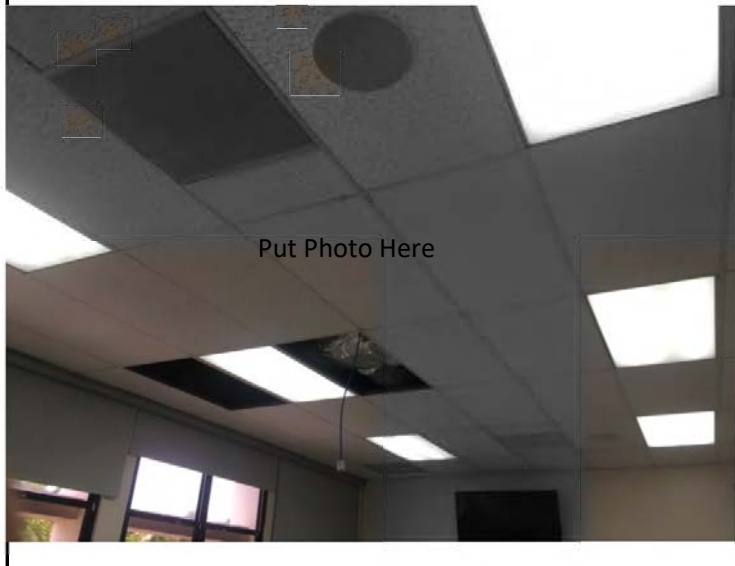
Damage Description:	Item #: 91
Ceiling, 2 FT x 4 FT acoustic tile, suspended, deformed, caused by rainwater intrusion (Main Bldg., Floor 2, Laboratory R111)	
Additional Comments:

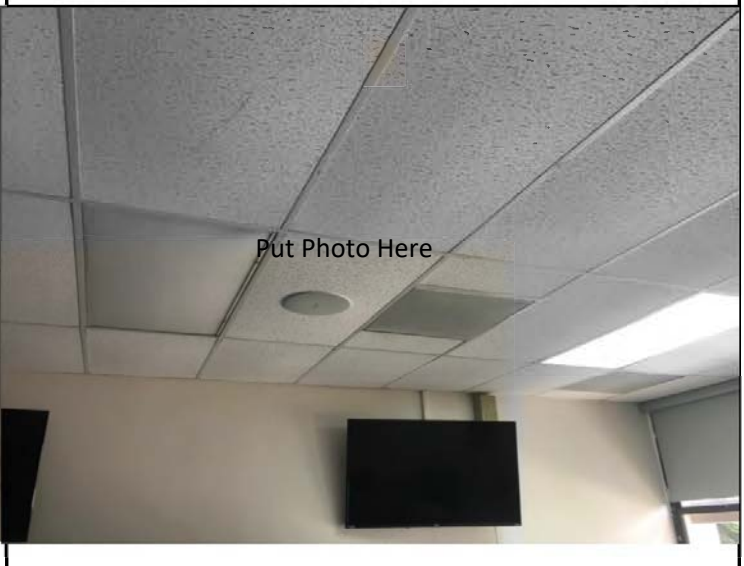
Damage Description:	Item #: 92
Light, florescent, recessed Troffer, electrical issues, caused by rainwater intrusion (Main Bldg., Floor 2, Laboratory R111)	
Additional Comments:

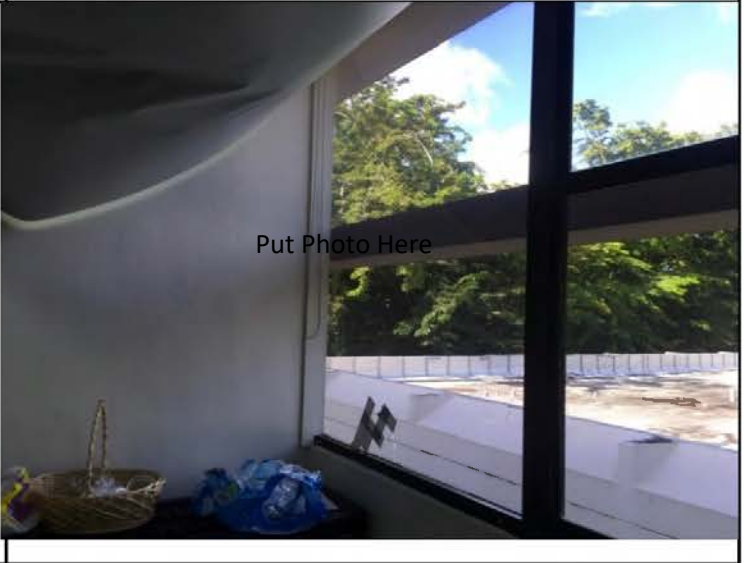
Damage Description:	Item #:	Enter #	Damage Description:	Item #:	108
Additional Comments:			Window, Glass, 3/16-IN thick, single-glazed, tinted, broken components, caused by wind blow debris (Main Bldg., Floor 2, Classroom R113)	Additional Comments:
