Applicant: Universidad Central Del Caribe, Inc.	Damage Inventory: 305240	Category: E
WO # 46525 FIPS# 021-UNUGB-00	Date: 09/04-17/2019 GPS: 18.365953, -66.153767	
Inspector: Gregory Sondergeld / Alexander Nieves	Damage Facility: Main Bldg.

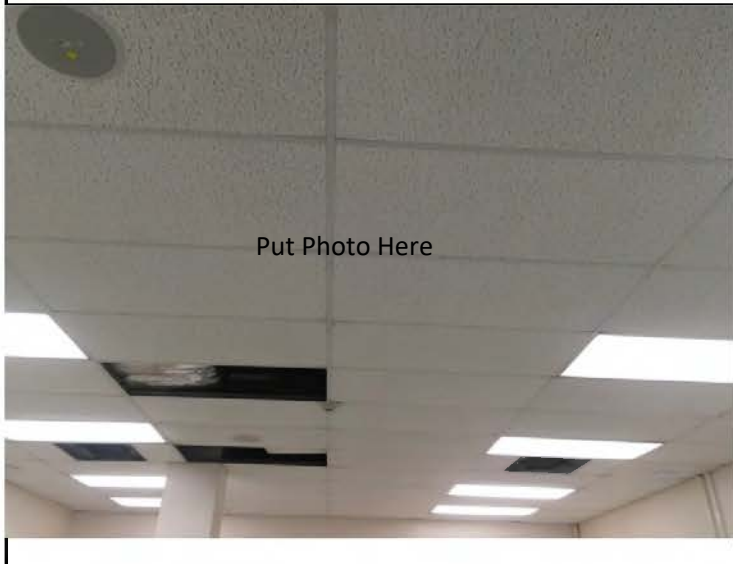
Damage Description:	Item #:	109	Damage Description:	Item #:	110
Ceiling, 2 FT x 4 FT acoustic tile, suspended, deformed, caused by rainwater intrusion (Main Bldg., Floor 2, Classroom R113)	Additional Comments:		Window, Alum. window frames, perimeter caulking/sealing only, cracked, caused by rainwater intrusion (Main Bldg., Floor 2, Classroom R113)	Additional Comments:

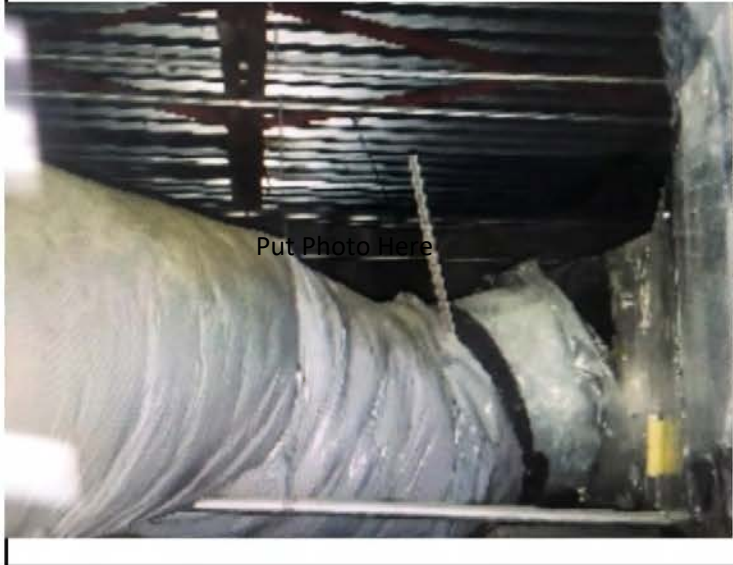
Damage Description:	Item #: 111
Air Conditioning, A/C Ductwork, 16 IN Dia, round, galv. mounting flange only, broken components, caused by high winds (Main Bldg., Floor 2, Classroom R113)	
Additional Comments:

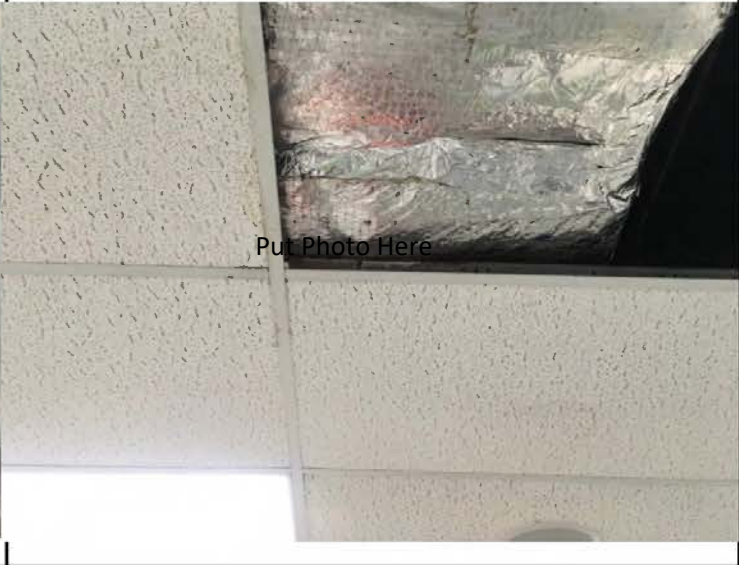
Damage Description:	Item #: 112
Ceiling, 2 FT x 4 FT acoustic tile, suspended, grid only, broken components, caused by wind-blown debris (Main Bldg., Floor 2, Classroom R113)	
Additional Comments:

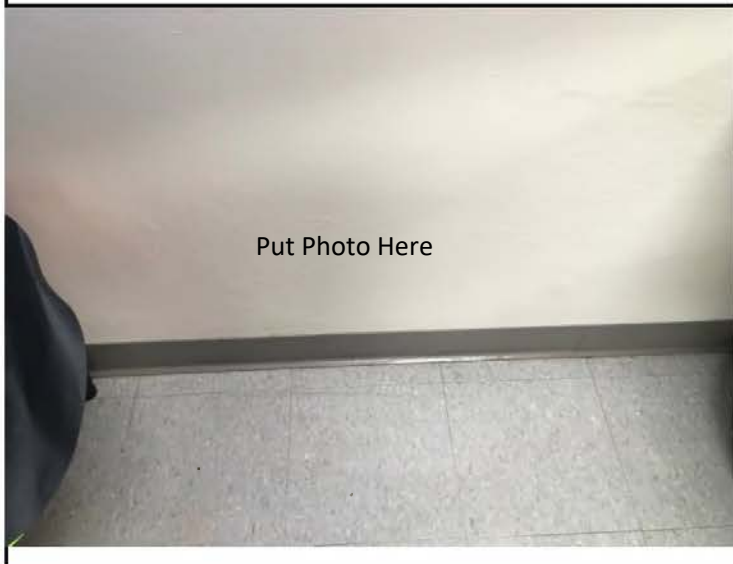
Damage Description:	Item #: 113
Base Lining, vinyl, 4 IN, deformed, caused by rainwater intrusion (Main Bldg., Floor 2, Classroom R113)	
Additional Comments:

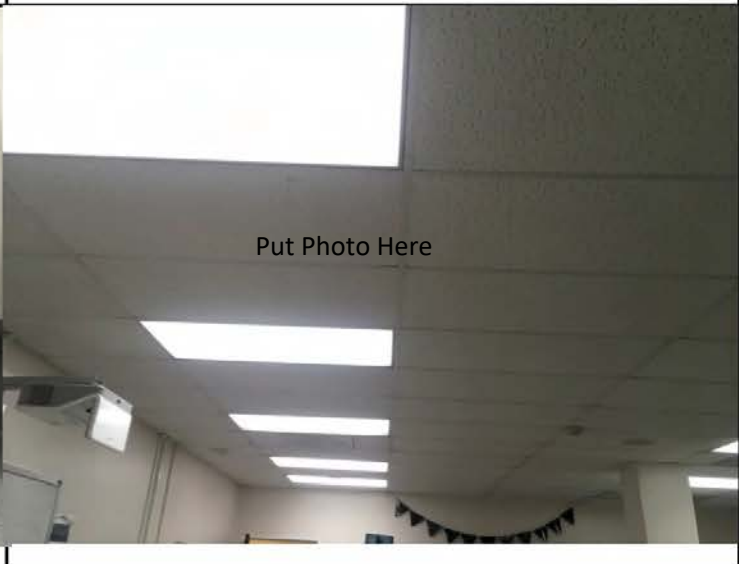
Damage Description:	Item #: 114
Ceiling, 2 FT x 4 FT acoustic tile, suspended, deformed, caused by rainwater intrusion (Main Bldg., Floor 2, Classroom R115)	
Additional Comments:

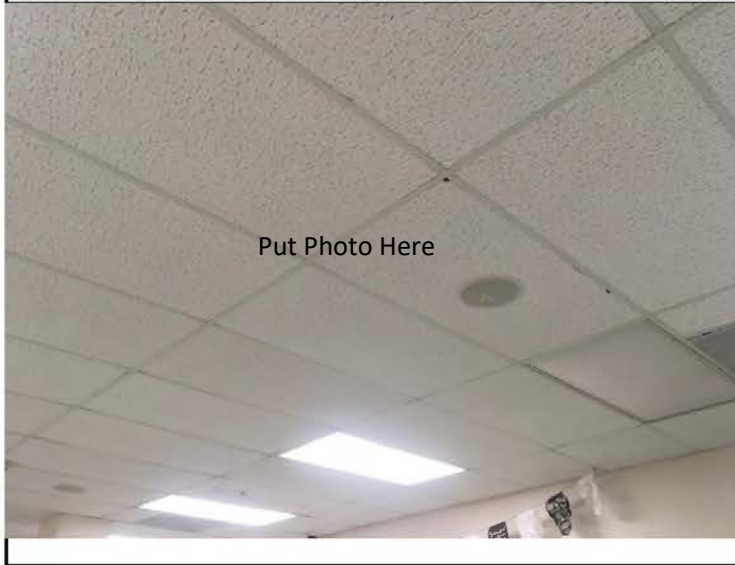
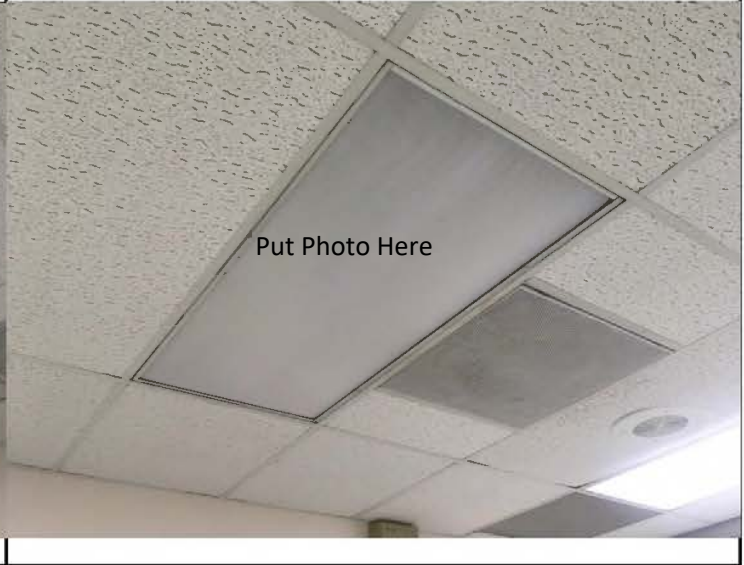
Damage Description:	Item #: 115	Damage Description:	Item #: 116
Ceiling, 2 FT x 4 FT acoustic tile, suspended, with grid, deformed, caused by rainwater intrusion (Main Bldg., Floor 2, Classroom R115)		Light, fluorescent, recessed Troffer, electrical issues, caused by rainwater intrusion (Main Bldg., Floor 2, Classroom R115)	
Additional Comments:		Additional Comments:

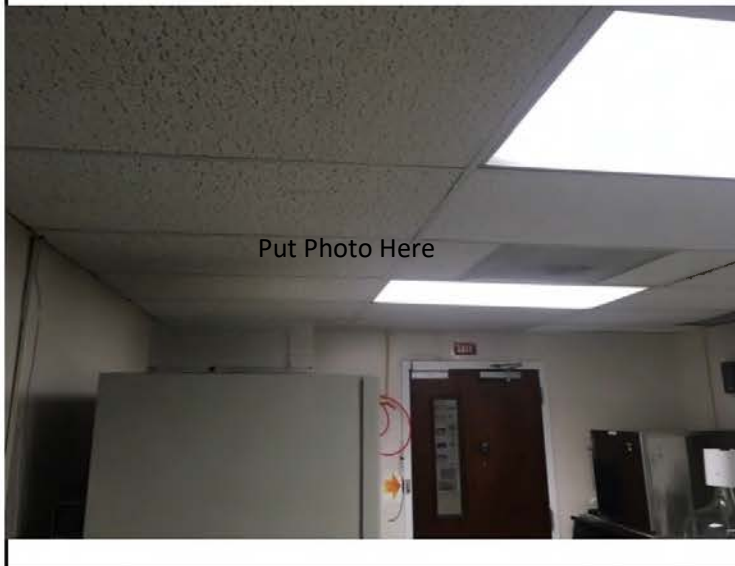
Damage Description:	Item #: 117	Damage Description:	Item #: 118
Ceiling, 2 FT x 4 FT acoustic tile, suspended, deformed, caused by rainwater intrusion (Main Bldg., Floor 2, Laboratory R167)		Ceiling, 2 FT x 4 FT acoustic tile, suspended, grid only, deformed, caused by rainwater intrusion (Main Bldg., Floor 2, Laboratory R167)	
Additional Comments:		Additional Comments:

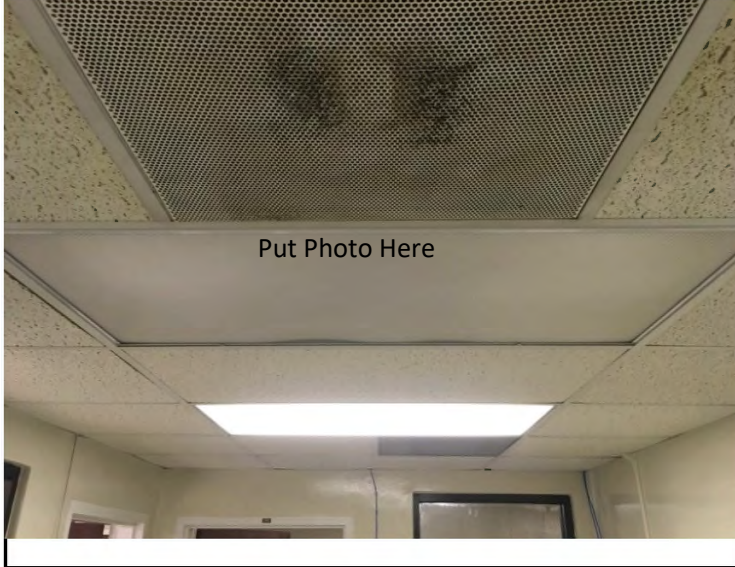
Damage Description:	Item #: 119
Ceiling, 2 FT x 4 FT acoustic tile, suspended, deformed, caused by rainwater intrusion (Main Bldg., Floor 2, Laboratory R173)	
Additional Comments:

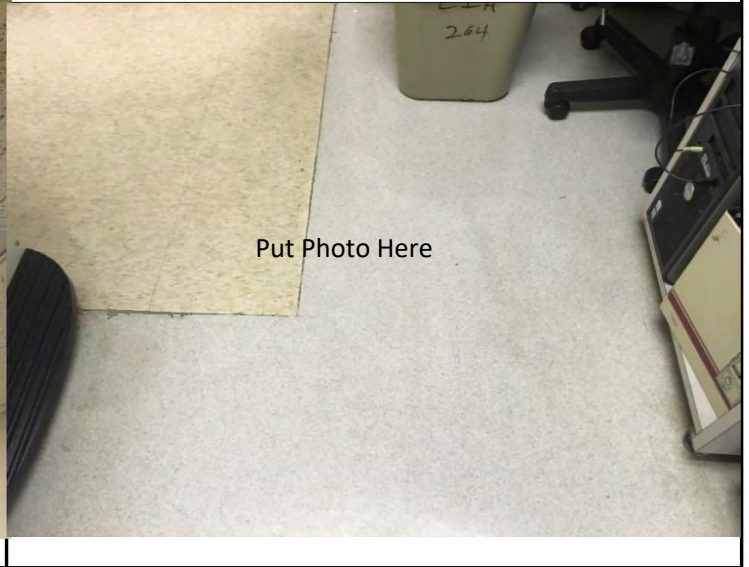
Damage Description:	Item #: 120
Floor, Linoleum, commercial-grade, dislodged, caused by surface water flooding (Main Bldg., Floor 2, Laboratory R173)	
Additional Comments:

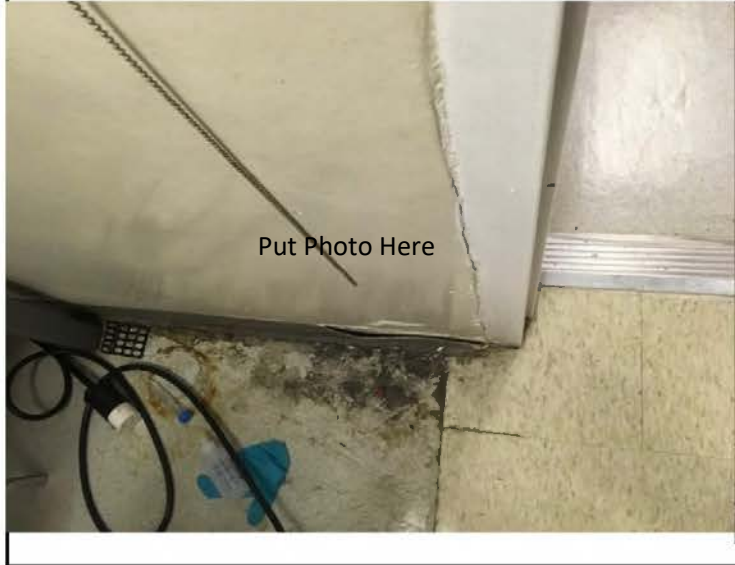
Damage Description:	Item #: 123
Base Lining, vinyl, 4 IN, dislodged, caused by surface water flooding (Main Bldg., Floor 2, Laboratory R173)	
Additional Comments:

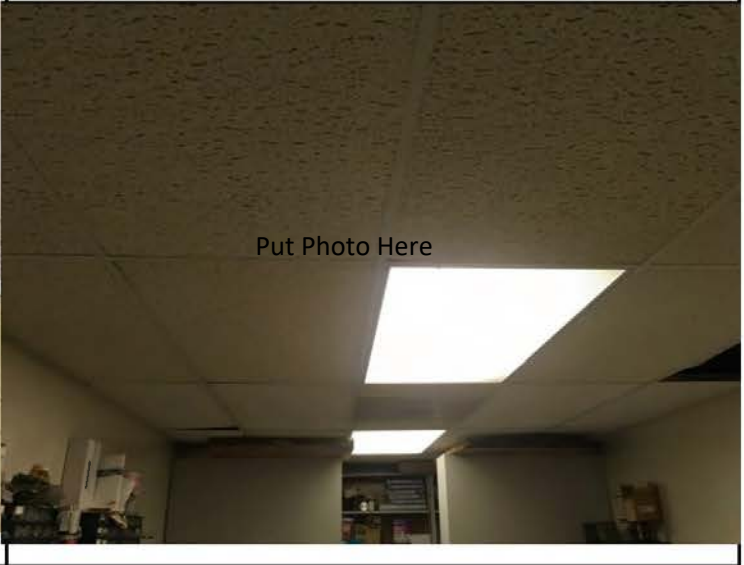
Damage Description:	Item #: 124
Ceiling, 2 FT x 4 FT acoustic tile, suspended, deformed, caused by rainwater intrusion (Main Bldg., Floor 2, Laboratory R174)	
Additional Comments:

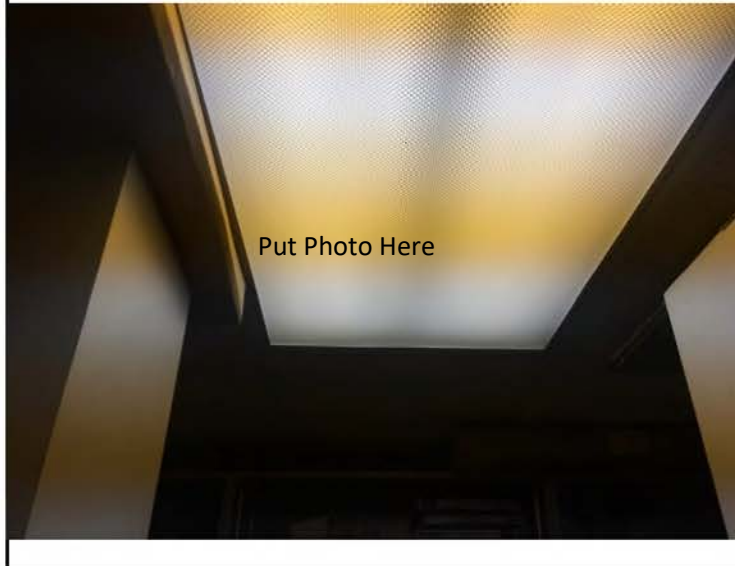
Damage Description:	Item #: 125
Light, Fluorescent, recessed Troffer, acrylic lens cover only, prismatic, discolored, caused by rainwater intrusion (Main Bldg., Floor 2, Laboratory R174)	
Additional Comments:

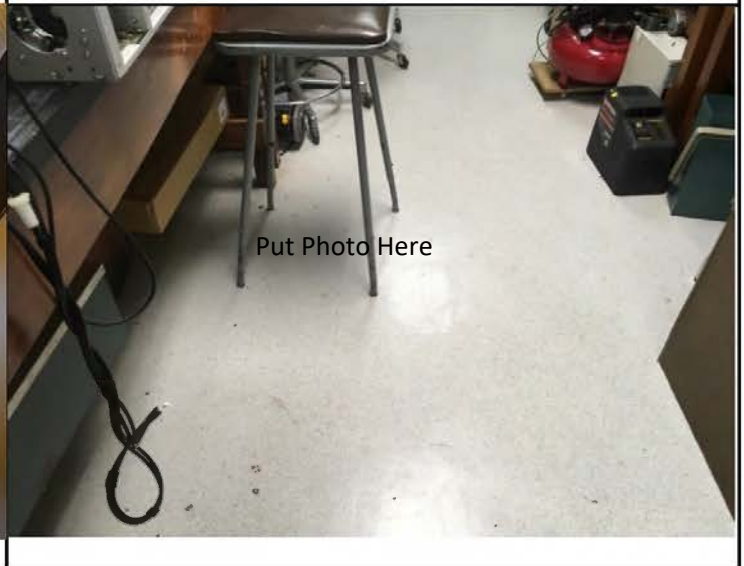
Damage Description:	Item #: 126
Floor, Linoleum, commercial-grade, dislodged, caused by surface water flooding (Main Bldg., Floor 2, Laboratory R174)	
Additional Comments:

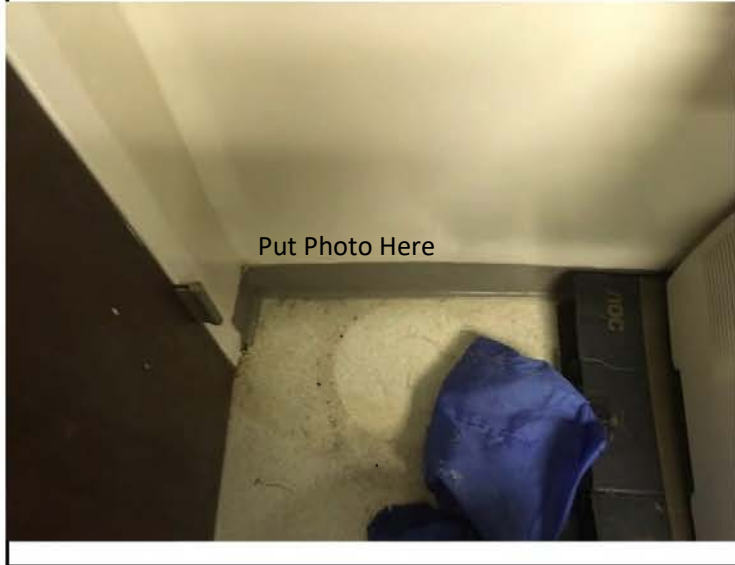
Damage Description:	Item #: 127
Base Lining, vinyl, 4 IN, dislodged, caused by surface water flooding (Main Bldg., Floor 2, Laboratory R174)	
Additional Comments:

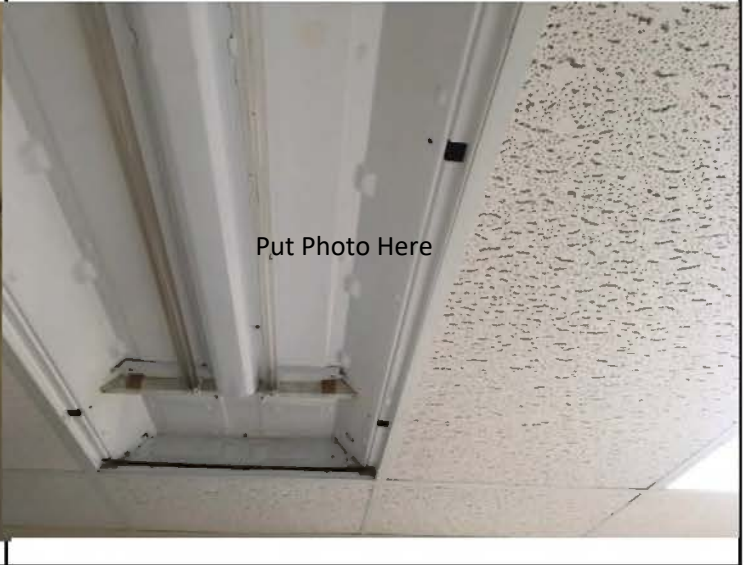
Damage Description:	Item #: 128
Ceiling, 2 FT x 4 FT acoustic tile, suspended, deformed, caused by rainwater intrusion (Main Bldg., Floor 2, Laboratory R171)	
Additional Comments:

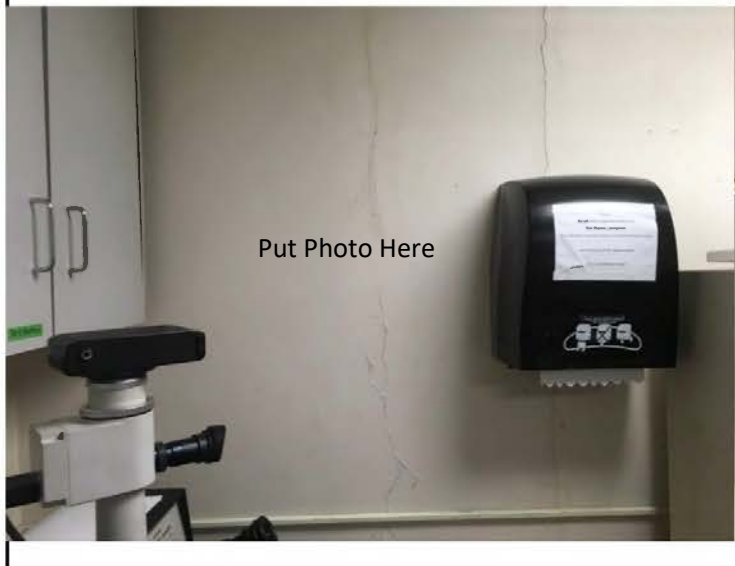
Damage Description:	Item #: 129
Wall, ¼ IN thick plaster on concrete, painted, with spalls, cracked, caused by rainwater intrusion (Main Bldg., Floor 2, Laboratory R171)	
Additional Comments:

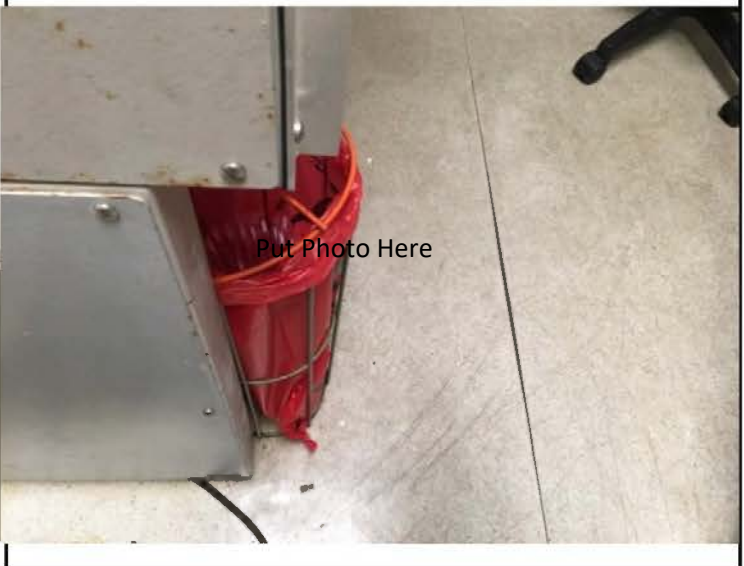
Damage Description:	Item #: 131
Floor, Linoleum, commercial-grade, dislodged, caused by surface water flooding (Main Bldg., Floor 2, Laboratory R171)	
Additional Comments:

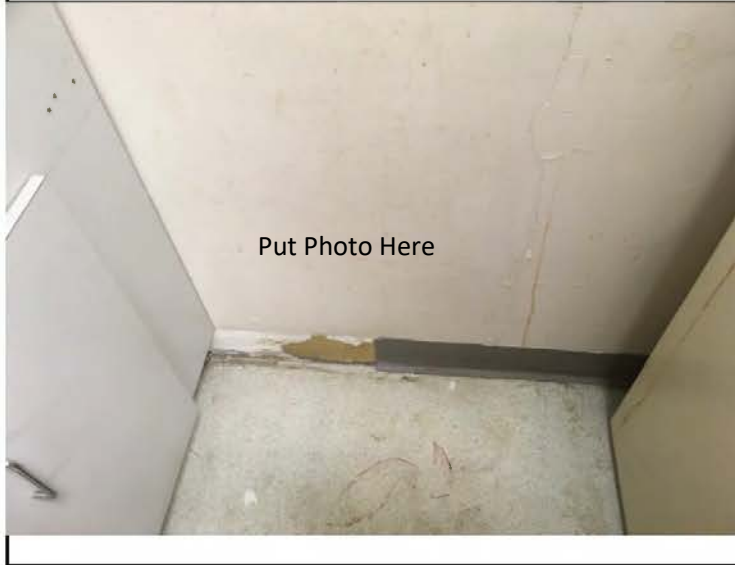
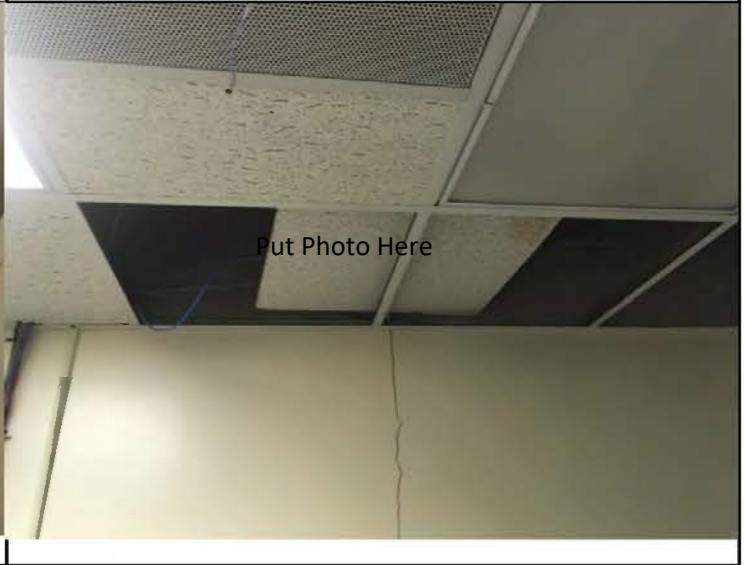
Damage Description:	Item #: 132	Damage Description:	Item #: 133
Base Lining, vinyl, 4 IN, dislodged, caused by surface water flooding (Main Bldg., Floor 2, Laboratory R171)		Ceiling, 2 FT x 4 FT acoustic tile, suspended, deformed, caused by rainwater intrusion (Main Bldg., Floor 2, Laboratory R168)	
Additional Comments:		Additional Comments:

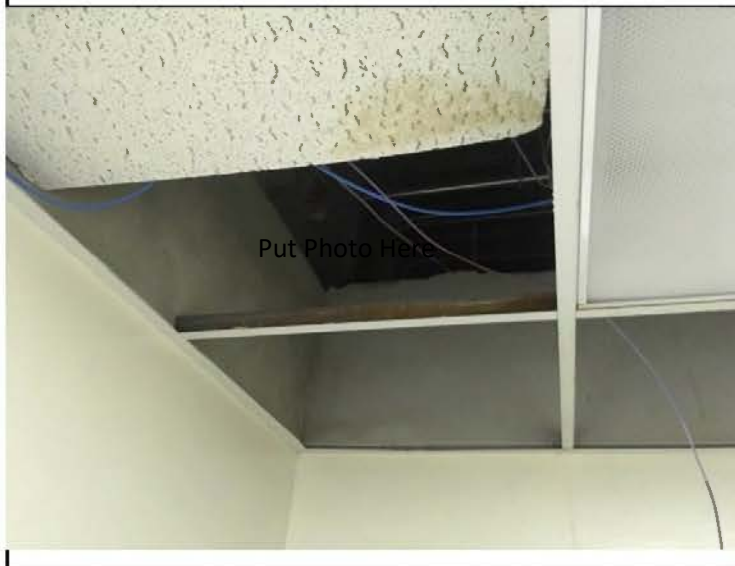
Damage Description:	Item #: 134	Damage Description:	Item #: 135
Ceiling, 2 FT x 4 FT acoustic tile, suspended, grid only, deformed, caused by rainwater intrusion (Main Bldg., Floor 2, Laboratory R168)		Floor, Linoleum, commercial-grade, dislodged, caused by surface water flooding (Main Bldg., Floor 2, Laboratory R168)	
Additional Comments:		Additional Comments:

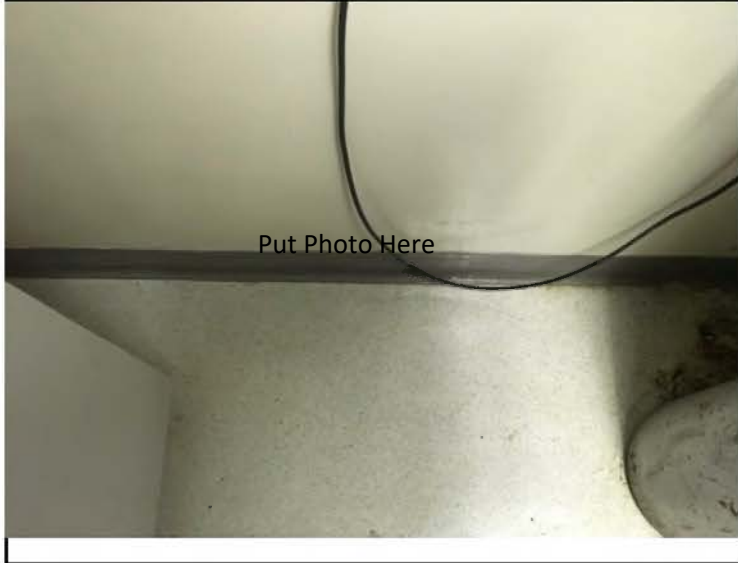
Damage Description:	Item #: 136
Base Lining, vinyl, 4 IN, deformed, caused by rainwater intrusion (Main Bldg., Floor 2, Laboratory R168)	
Additional Comments:

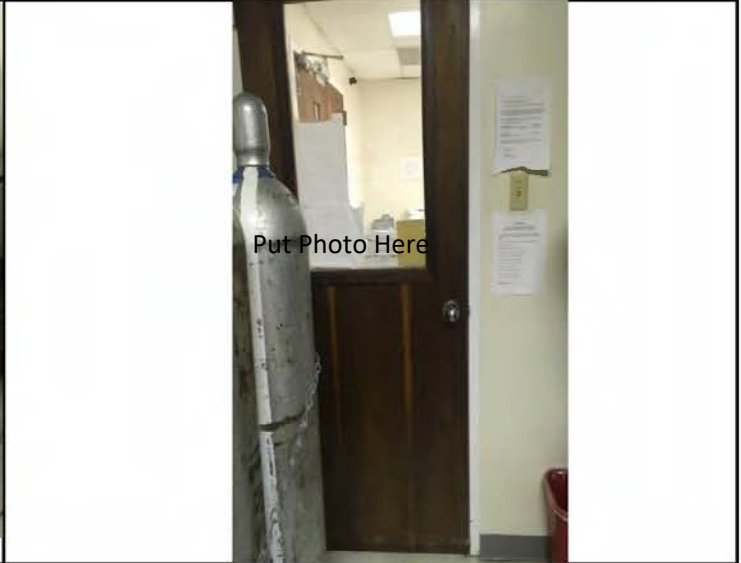
Damage Description:	Item #: 137
Door, Wood, with 24 IN x 30 IN vision lite, deformed, caused by surface water flooding (Main Bldg., Floor 2, Laboratory R168)	
Additional Comments:

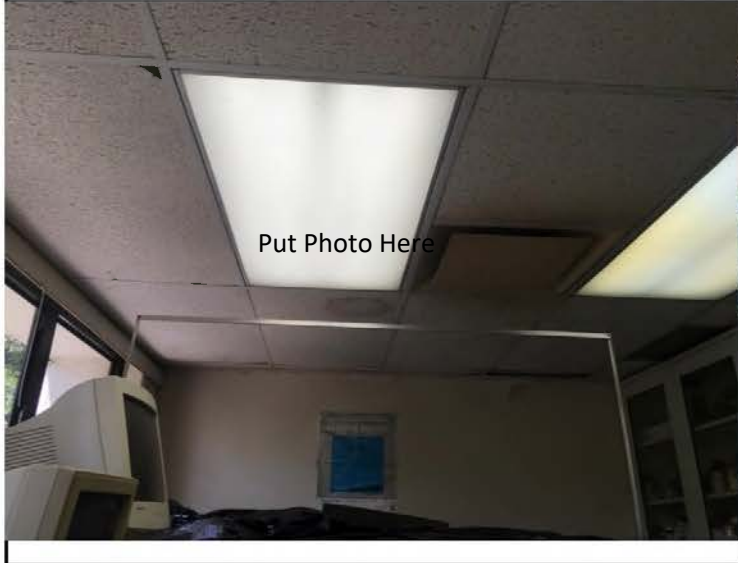
Damage Description:	Item #: 138
Ceiling, 2 FT x 4 FT acoustic tile, suspended, deformed, caused by rainwater intrusion (Main Bldg., Floor 2, Laboratory R151)	
Additional Comments:

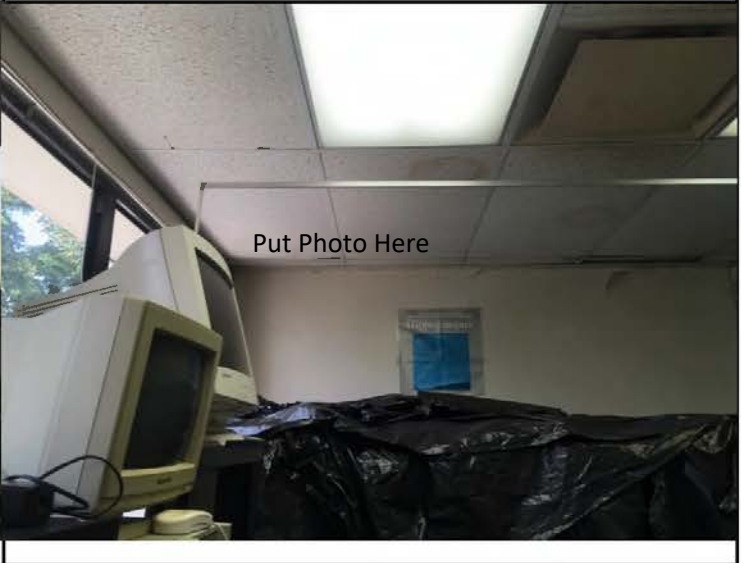
Damage Description:	Item #: 139
Ceiling, 2 FT x 4 FT acoustic tile, suspended, grid only, deformed, caused by rainwater intrusion (Main Bldg., Floor 2, Laboratory R151)	
Additional Comments:

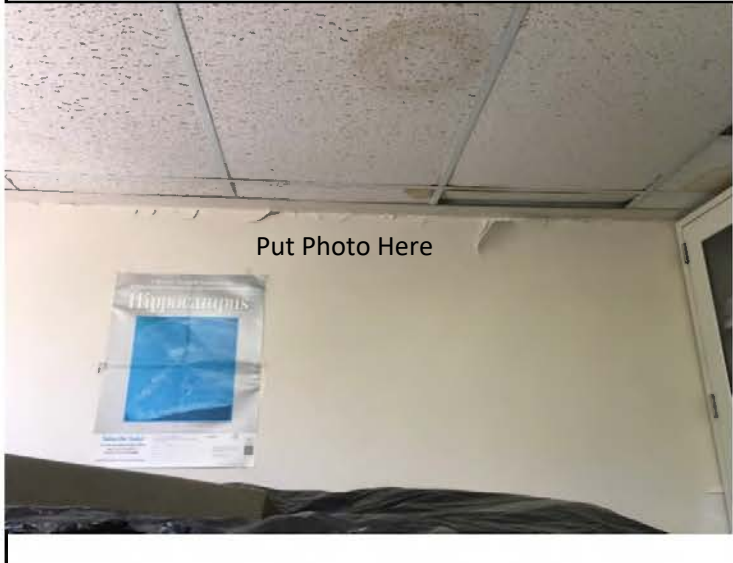
Damage Description:	Item #: 140
Wall, ¼ IN thick plaster on concrete, painted, peeling paint, caused by rainwater intrusion (Main Bldg., Floor 2, Laboratory R151)	
Additional Comments:

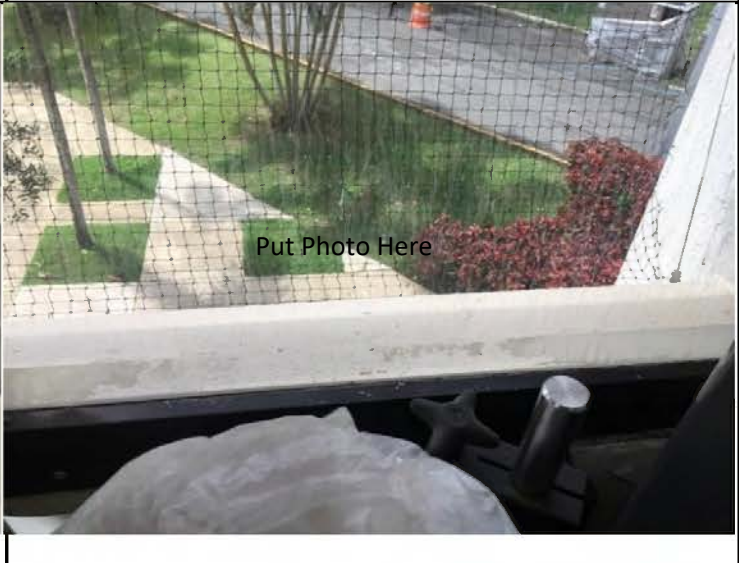
Damage Description:	Item #: 141
Window, Alum. window frames, perimeter caulking/sealing only, cracked, caused by rainwater intrusion (Main Bldg., Floor 2, Laboratory R151)	
Additional Comments:

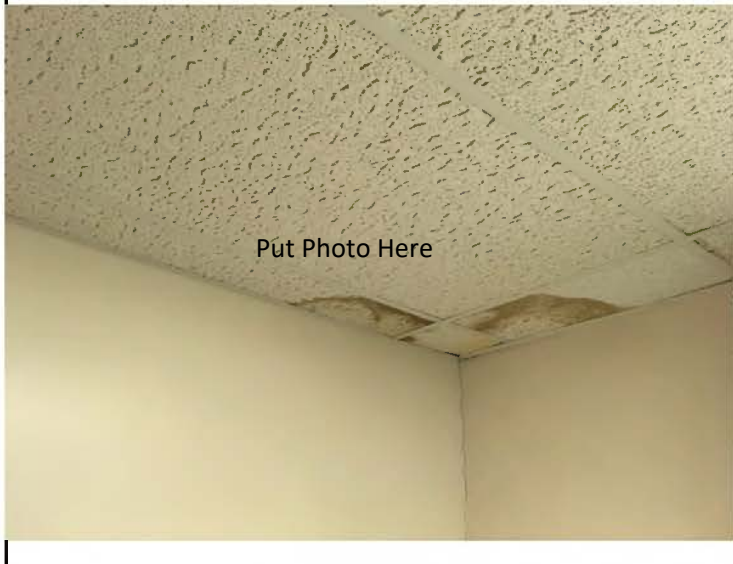
Damage Description:	Item #: 142
Ceiling, 2 FT x 4 FT acoustic tile, suspended, discolored, caused by rainwater intrusion (Main Bldg., Floor 2, Laboratory R150)	
Additional Comments:

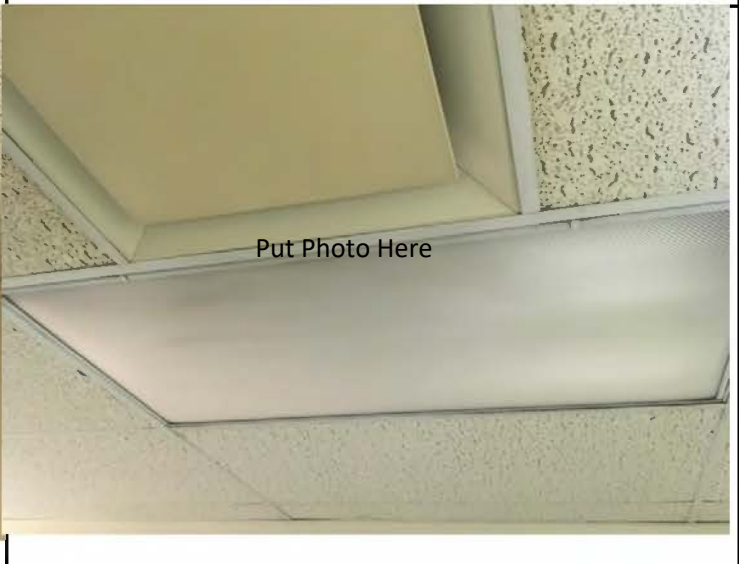
Damage Description:	Item #: 143
Light, fluorescent, recessed Troffer, electrical issues, caused by rainwater intrusion (Main Bldg., Floor 2, Laboratory R150)	
Additional Comments:

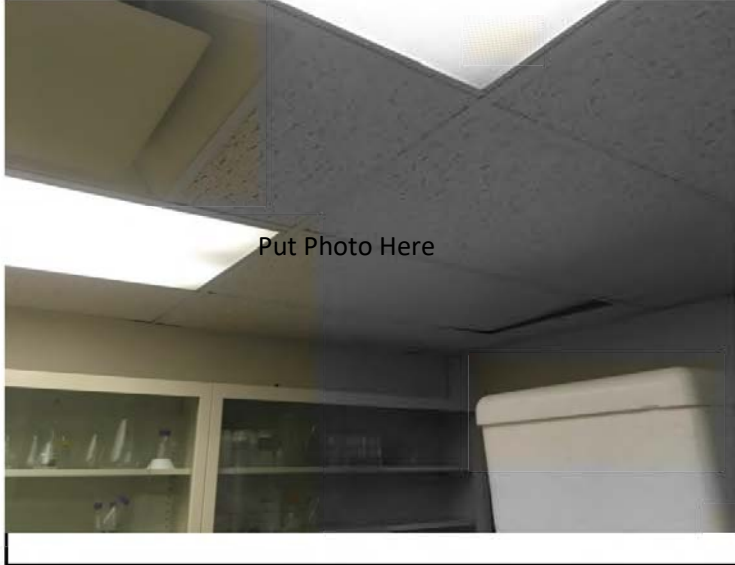
Damage Description:	Item #: 144
Ceiling, 2 FT x 4 FT acoustic tile, suspended, deformed, caused by rainwater intrusion (Main Bldg., Floor 2, Laboratory 499)	
Additional Comments:

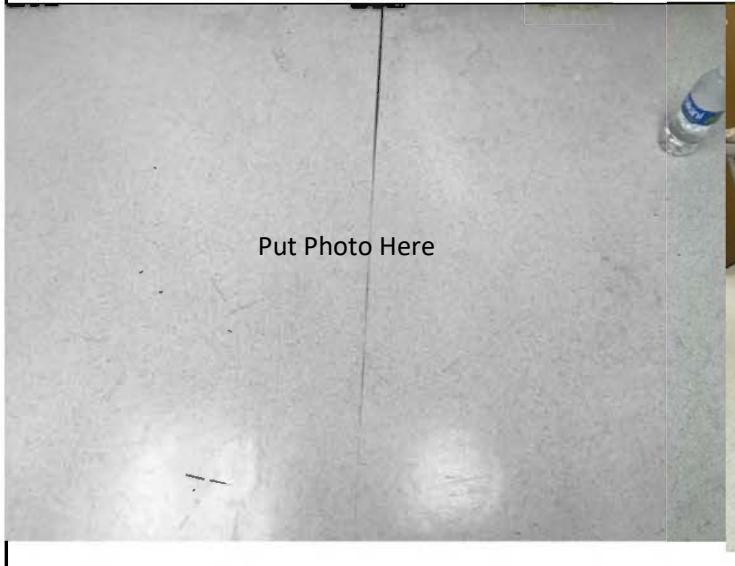
Damage Description:	Item #: 146
Floor, Linoleum, commercial-grade, dislodged, caused by surface water flooding (Main Bldg., Floor 2, Laboratory R499)	
Additional Comments:

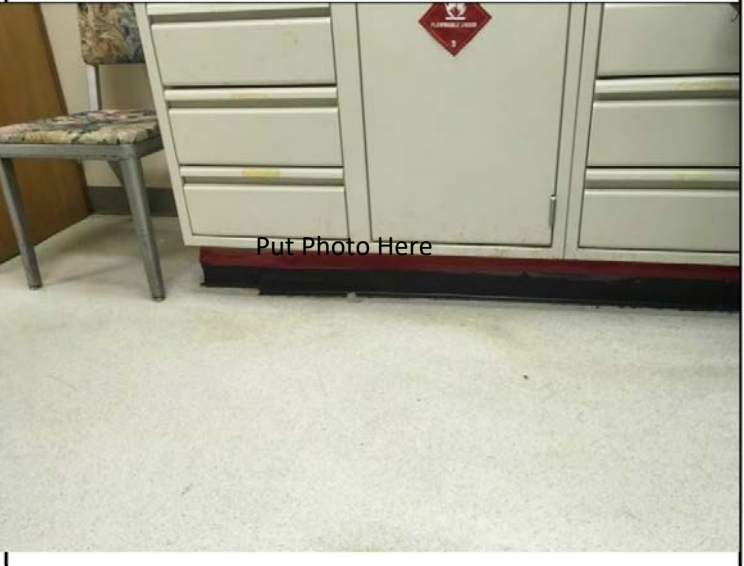
Damage Description:	Item #: 147
Base Lining, vinyl, 4 IN, deformed, caused by surface water flooding (Main Bldg., Floor 2, Laboratory R499)	
Additional Comments:

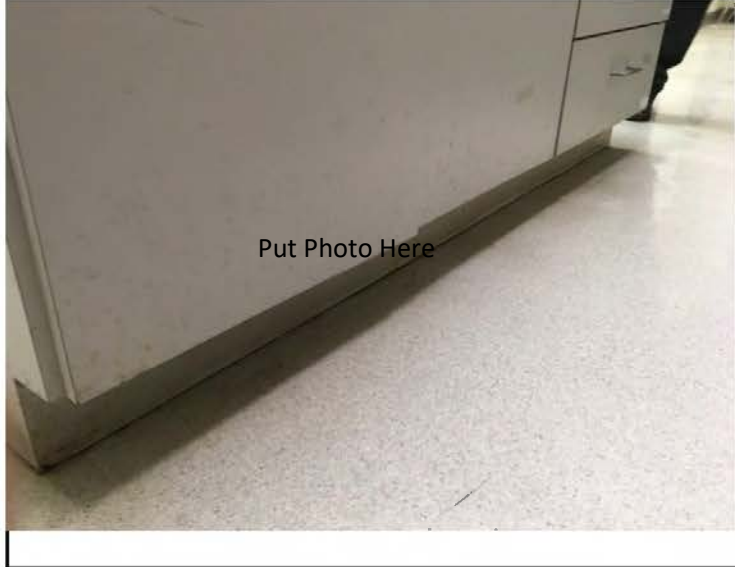
Damage Description:	Item #: 148
Base Lining, vinyl, 4 IN, deformed, caused by surface water flooding (Main Bldg., Floor 2, Laboratory 162)	
Additional Comments:

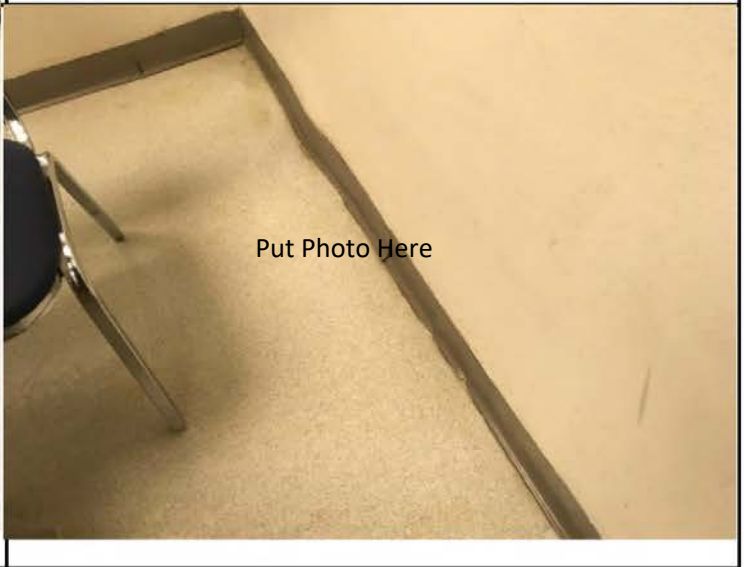
Damage Description:	Item #: 149
Base Lining, vinyl, 4 IN, deformed, caused by surface water flooding (Main Bldg., Floor 2, Dining Room R149)	
Additional Comments:

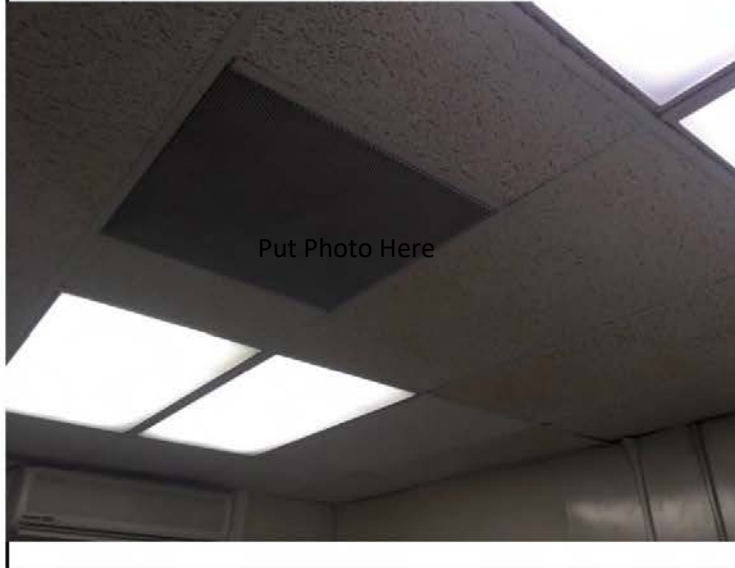
Damage Description:	Item #: 150
Ceiling, 2 FT x 4 FT acoustic tile, suspended, deformed, caused by rainwater intrusion (Main Bldg., Floor 2, Laboratory R161)	
Additional Comments:

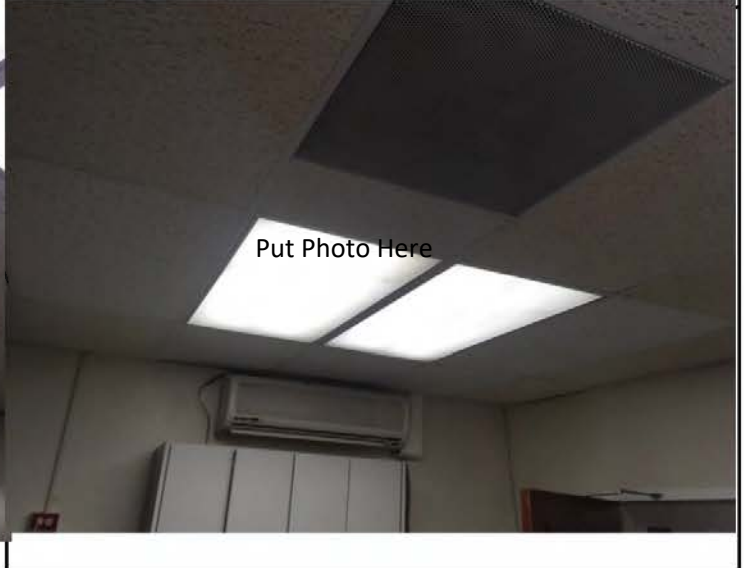
Damage Description:	Item #: 151
Light, Fluorescent, recessed Troffer, acrylic lens cover only, prismatic, electrical issues, caused by rainwater intrusion (Main Bldg., Floor 2, Laboratory R161)	
Additional Comments:

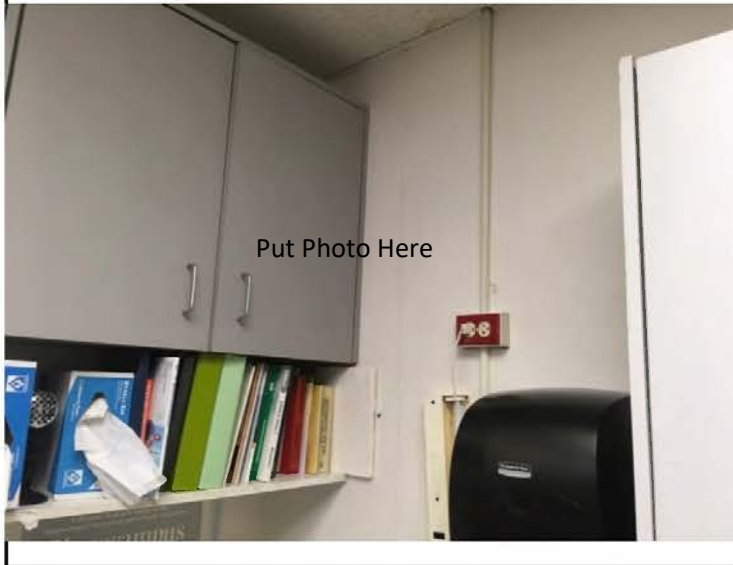
Damage Description:	Item #: 152
Wall, ¼ IN thick plaster on concrete, painted, discolored, caused by rainwater intrusion (Main Bldg., Floor 2, Laboratory R161)	
Additional Comments:

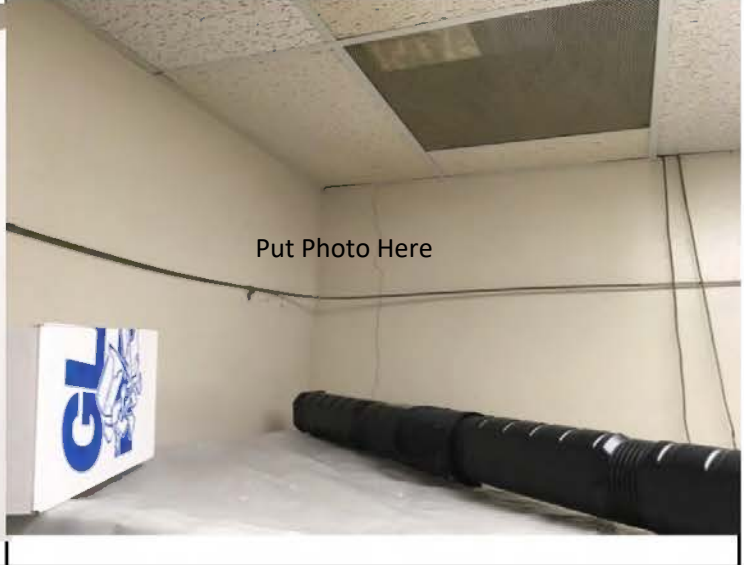
Damage Description:	Item #: 153
Wall, Concrete wall, repair, cracked, caused by rainwater intrusion (Main Bldg., Floor 2, Laboratory R161)	
Additional Comments:

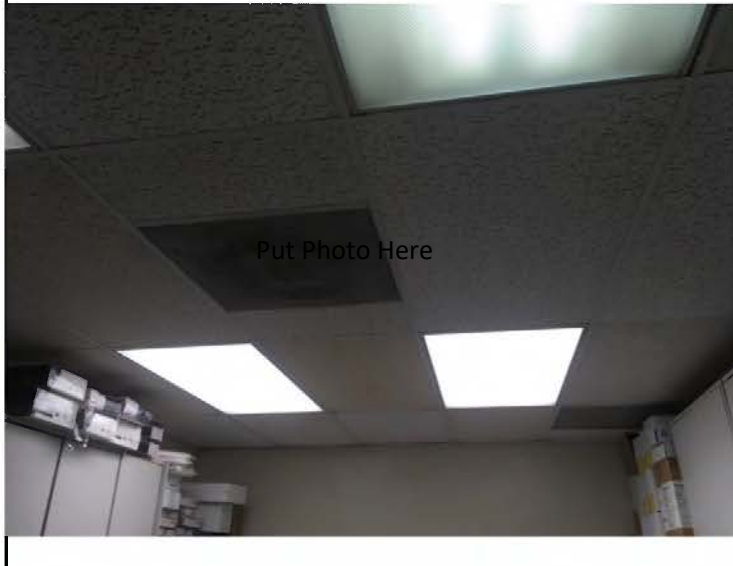
Damage Description:	Item #: 154
Ceiling, 2 FT x 4 FT acoustic tile, suspended, deformed, caused by rainwater intrusion (Main Bldg., Floor 2, Laboratory R159)	
Additional Comments:

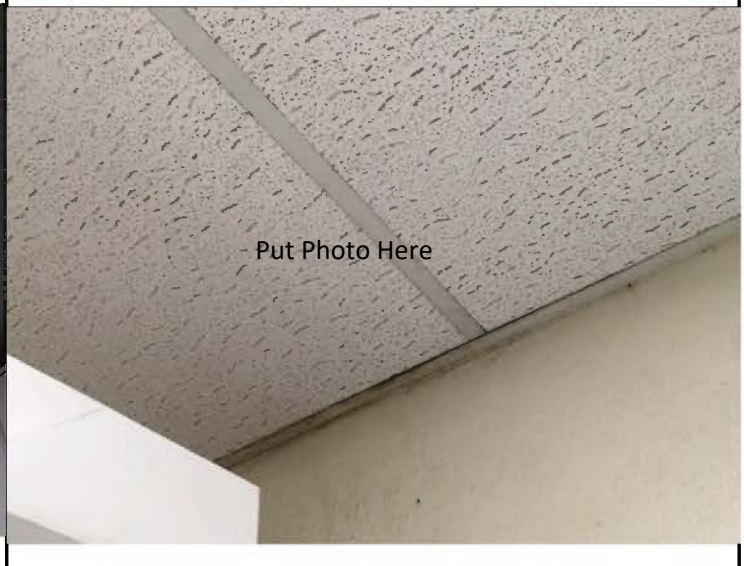
Damage Description:	Item #: 155
Ceiling, 2 FT x 4 FT acoustic tile, suspended, grid only, dislodged, caused by rainwater intrusion (Main Bldg., Floor 2, Laboratory R159)	
Additional Comments:

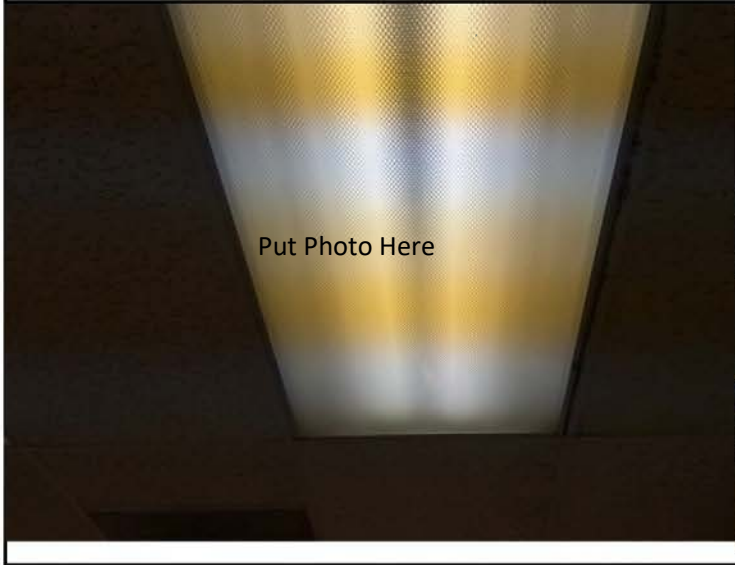
Damage Description:	Item #: 156
Light, Fluorescent, recessed Troffer, acrylic lens cover only, prismatic, discolored, caused by rainwater intrusion (Main Bldg., Floor 2, Laboratory R159)	
Additional Comments:

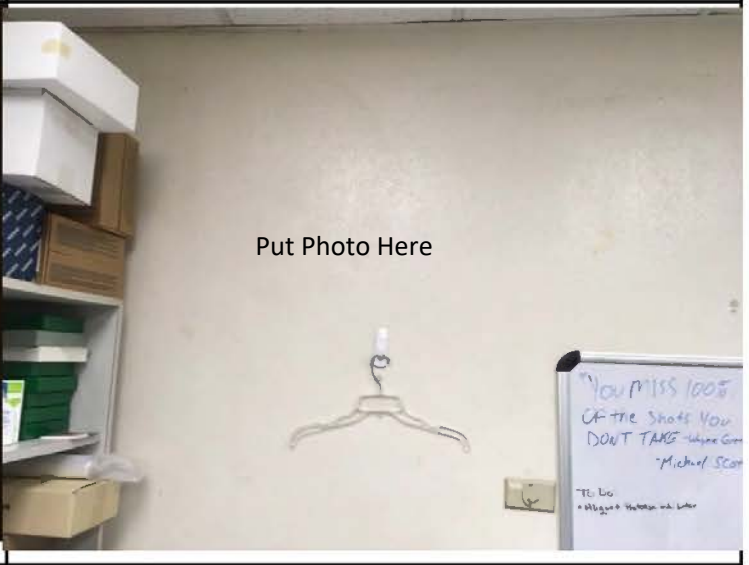
Damage Description:	Item #: 157
Wall, Concrete wall, clean/sanitize/repaint, discolored, caused by rainwater intrusion (Main Bldg., Floor 2, Laboratory R159)	
Additional Comments:

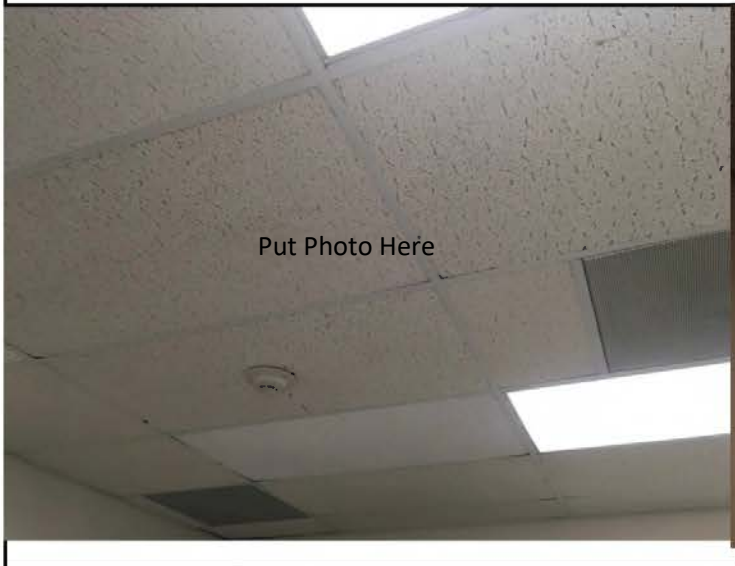
Damage Description:	Item #: 158
Ceiling, 2 FT x 4 FT acoustic tile, suspended, cracked, caused by rainwater intrusion (Main Bldg., Floor 2, Hallway Lobby, Bio-Chemistry)	
Additional Comments:

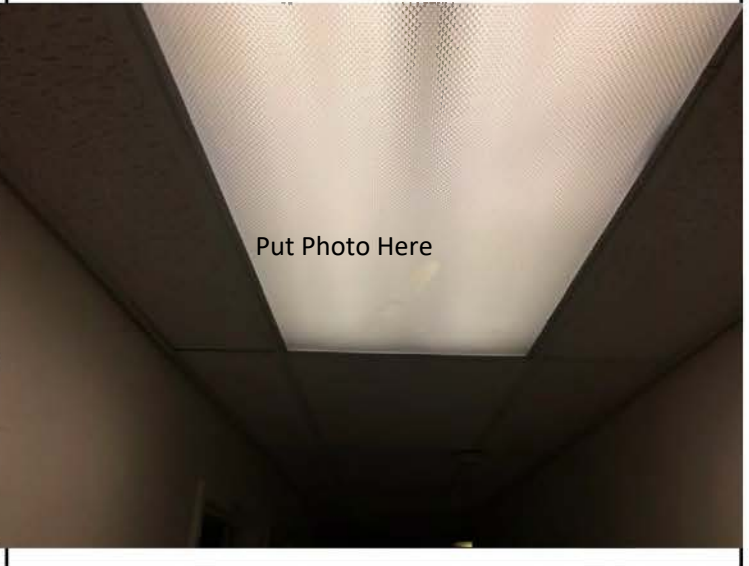
Damage Description:	Item #: 159
Light, Fluorescent, recessed Troffer, acrylic lens cover only, prismatic, discolored, caused by rainwater intrusion (Main Bldg., Floor 2, Hallway Lobby, Bio-Chemistry)	
Additional Comments:

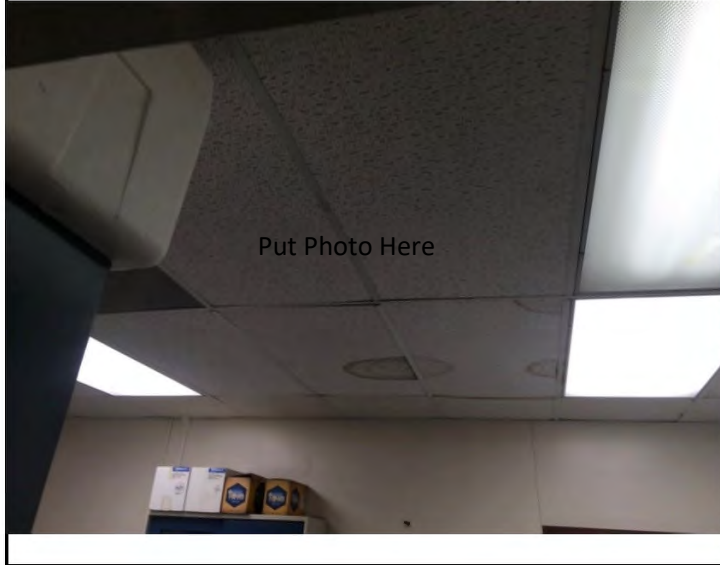
Damage Description:	Item #: 160
Ceiling, 2 FT x 4 FT acoustic tile, suspended, deformed, caused by rainwater intrusion (Main Bldg., Floor 2, Laboratory R175)	
Additional Comments:

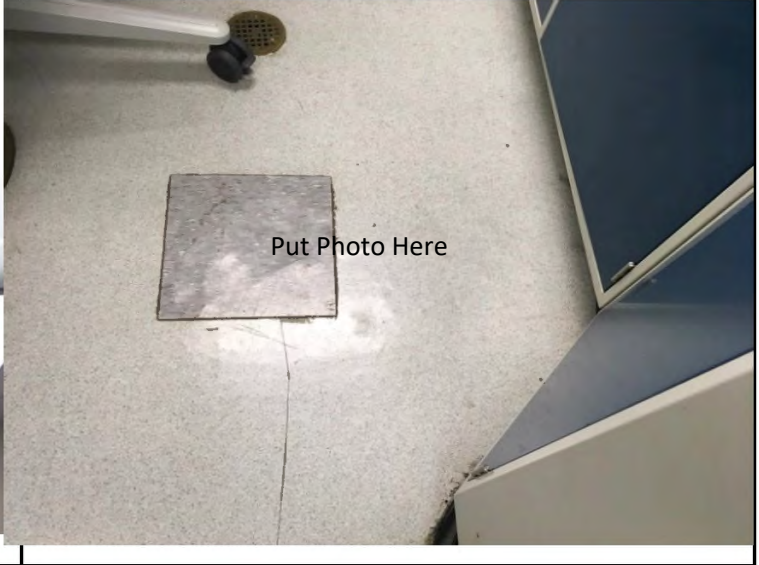
Damage Description:	Item #: 161
Floor, Linoleum, commercial-grade, dislodged, caused by surface water flooding (Main Bldg., Floor 2, Laboratory R175)	
Additional Comments:
