Applicant: Universidad Central Del Caribe, Inc.	Damage Inventory: 305240	Category: E
WO # 46525 FIPS# 021-UNUGB-00	Date: 09/04-17/2019 GPS: 18.365953, -66.153767	
Inspector: Gregory Sondergeld / Alexander Nieves	Damage Facility: Main Bldg.

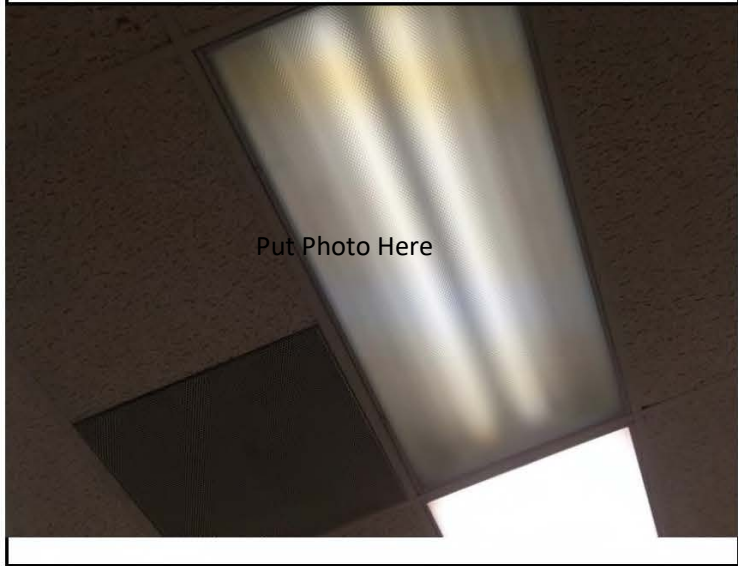
Damage Description:	Item #: 6
Ceiling, 2 FT x 4 FT acoustic tile, suspended, deformed, caused by rainwater intrusion (Main Bldg., Floor 2, Laboratory R383)	
Additional Comments:

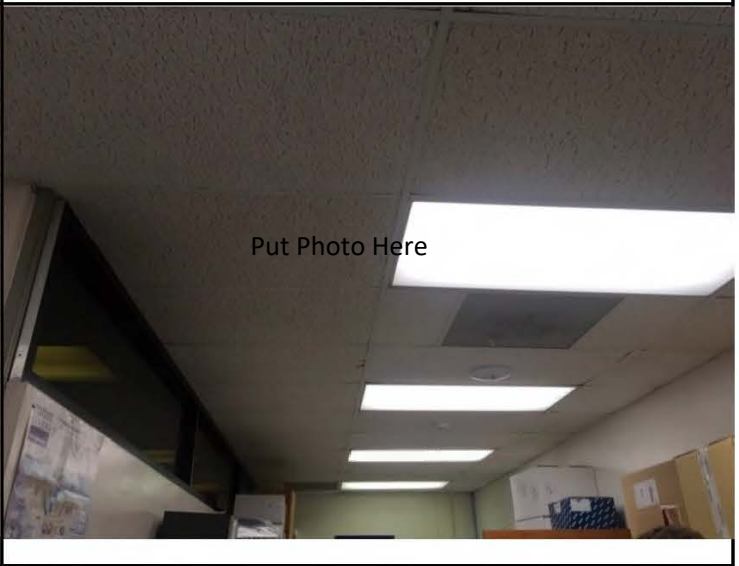
Damage Description:	Item #: 7
Ceiling, 2 FT x 4 FT acoustic tile, suspended, broken components, caused by rainwater intrusion (Main Bldg., Floor 2, Bathroom R163)	
Additional Comments:

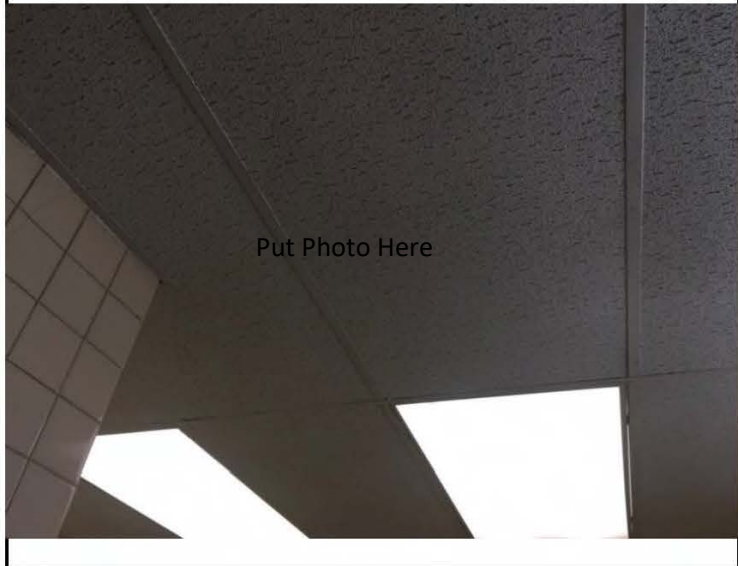
Damage Description:	Item #: 8
Light, fluorescent, recessed Troffer, acrylic prismatic lens only, discolored, caused by rainwater intrusion (Main Bldg., Floor 2, Bathroom R163)	
Additional Comments:

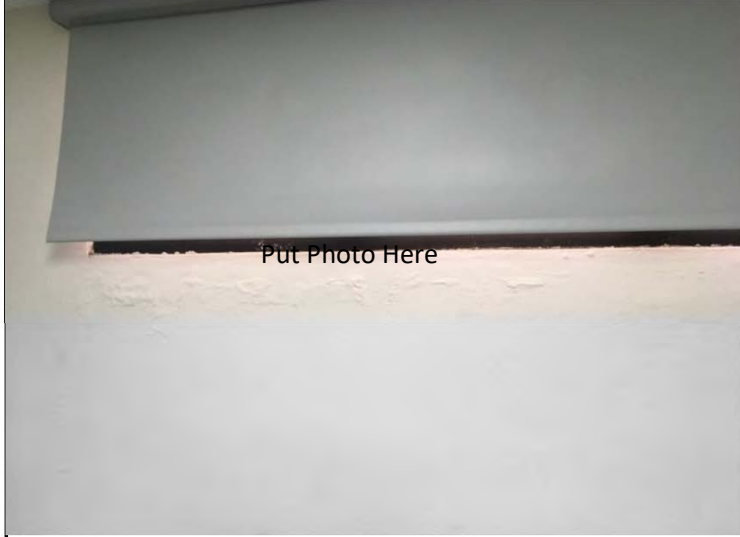
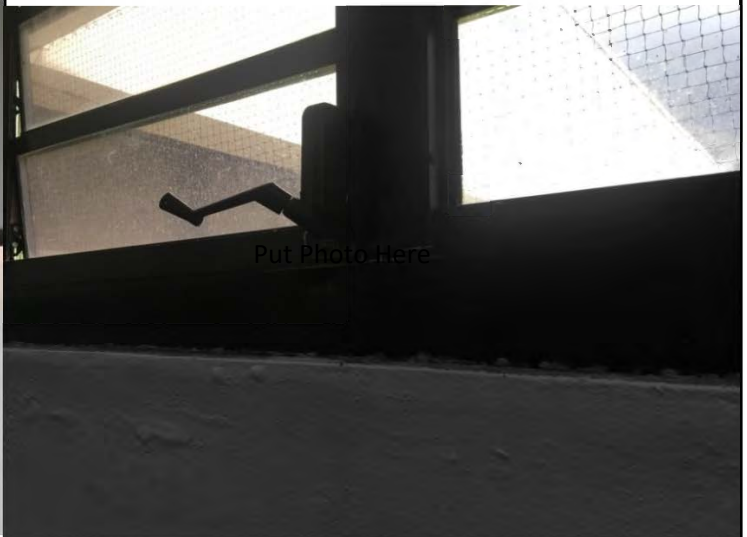
Damage Description:	Item #: 9	Damage Description:	Item #: 10
Wall, ¼ IN thick plaster on concrete, painted, torn with bubbles, caused by rainwater intrusion (Main Bldg., Floor 2, Classroom 166)		Window, Alum. window frames, perimeter caulking/sealing only, cracked, caused by wind-driven rain (Main Bldg., Floor 2, Classroom 166)	
Additional Comments:		Additional Comments:

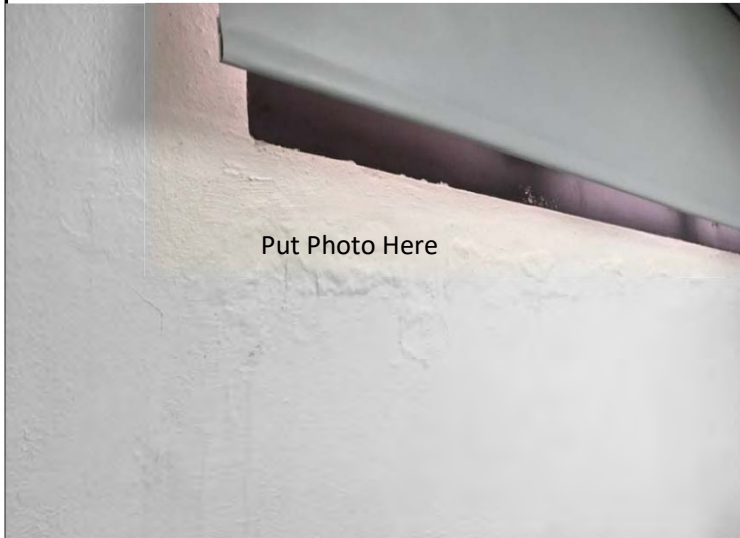
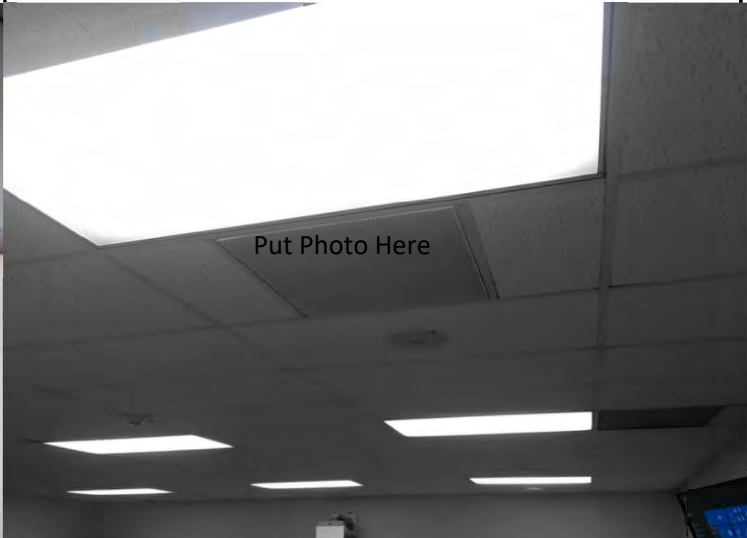
Damage Description:	Item #: 11	Damage Description:	Item #: 12
Wall, Patch ¼ IN thick plaster on concrete, repair, cracked, caused by rainwater intrusion (Main Bldg., Floor 2, Classroom 166)		Ceiling, 2 FT x 4 FT acoustic tile, suspended, deformed, caused by rainwater intrusion (Main Bldg., Floor 2, Classroom 166)	
Additional Comments:		Additional Comments:

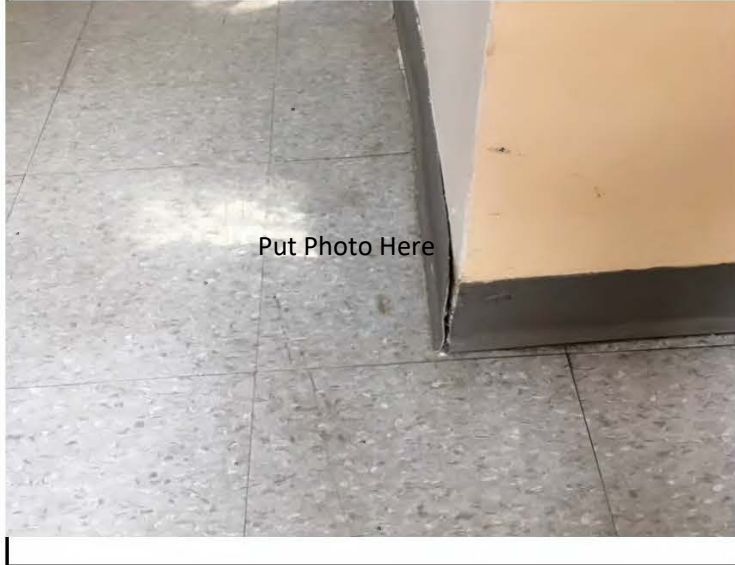
Damage Description:	Item #: 33
Base Lining, vinyl, 4 IN, dislodged, caused by surface water flooding (Main Bldg., Floor 2, Hallway Presidential Lobby)	
Additional Comments:

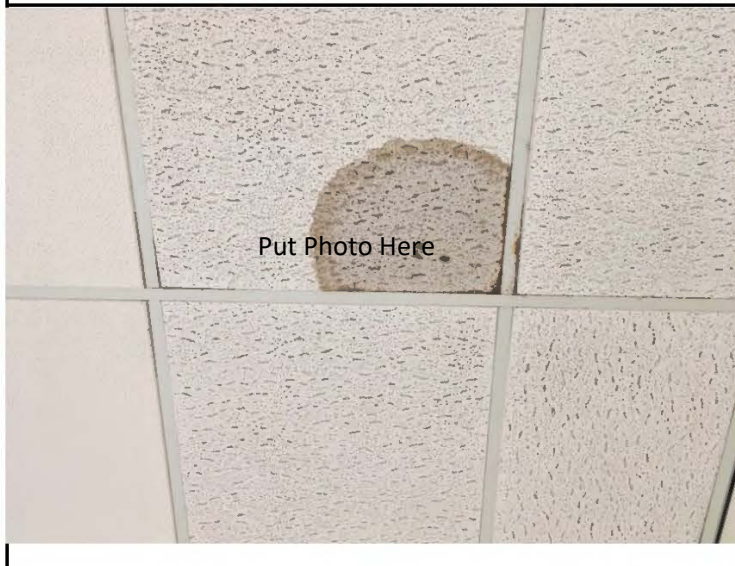
Damage Description:	Item #: 35
Ceiling, 2 FT x 2 FT acoustic tile, suspended, tegular, grid only, deformed, caused by rainwater intrusion (Main Bldg., Floor 2, Presidential Lobby)	
Additional Comments:

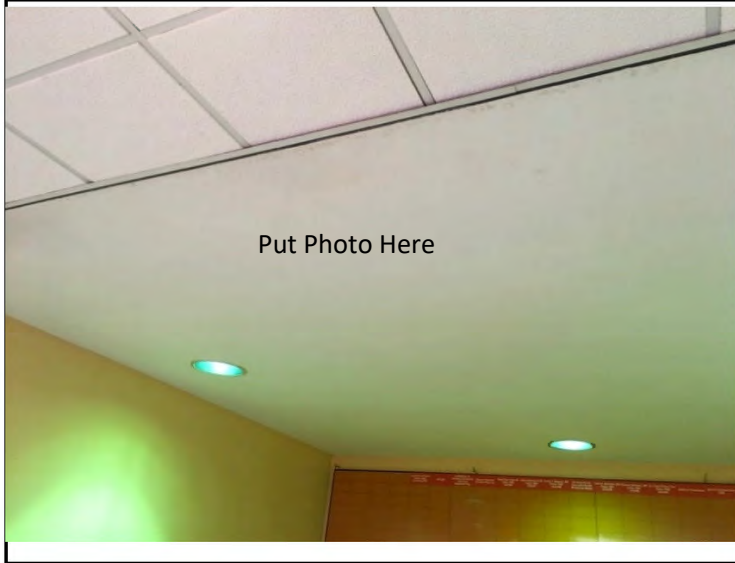
Damage Description:	Item #: 37	Damage Description:	Item #: 38
Ceiling, drywall, paint, discolored, caused by rainwater intrusion (Main Bldg., Floor 2, Presidential Lobby)		Wall, ¼ IN thick plaster on concrete, painted, discolored, caused by rainwater intrusion (Main Bldg., Floor 2, Stairway)	
Additional Comments:		Additional Comments:

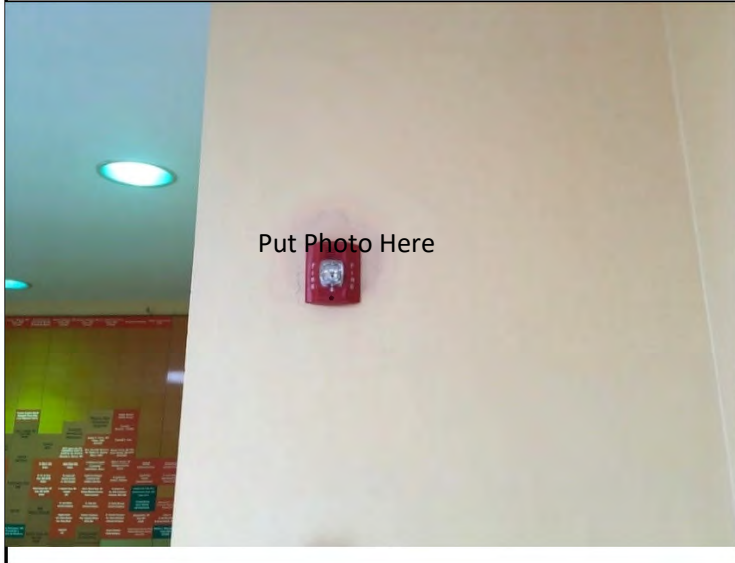
Damage Description:	Item #: 39	Damage Description:	Item #: 40
Wall, ¼ IN thick plaster on concrete, painted, discolored, caused by rainwater intrusion (Main Bldg., Floor 2, Presidential Lobby)		Ceiling, 2 FT x 4 FT acoustic tile, suspended, cracked, caused by rainwater intrusion (Main Bldg., Floor 2, Elevator Machine Room)	
Additional Comments:		Additional Comments:

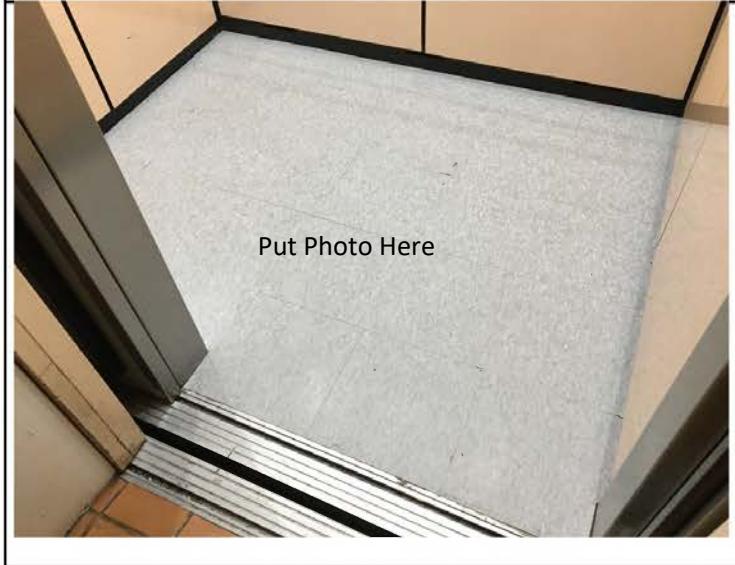
Damage Description: **Item #:** 41
 Building Interior, Elevator 340 at lobby, floor, 12 IN X 12 IN VCT, detached due to water infiltration (Main Bldg., Entire Building)

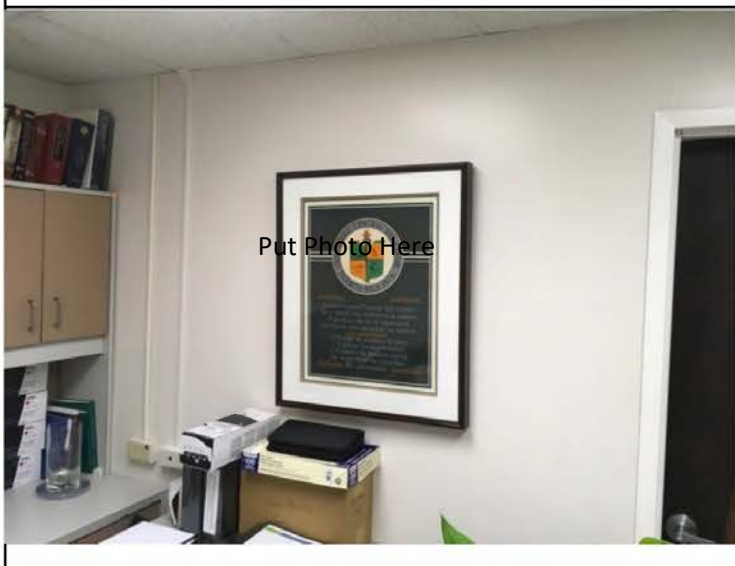
Damage Description: **Item #:** 43
 Wall, ¼ IN thick plaster on concrete, painted, discolored, caused by rainwater intrusion (Main Bldg., Floor 2, Office R215)

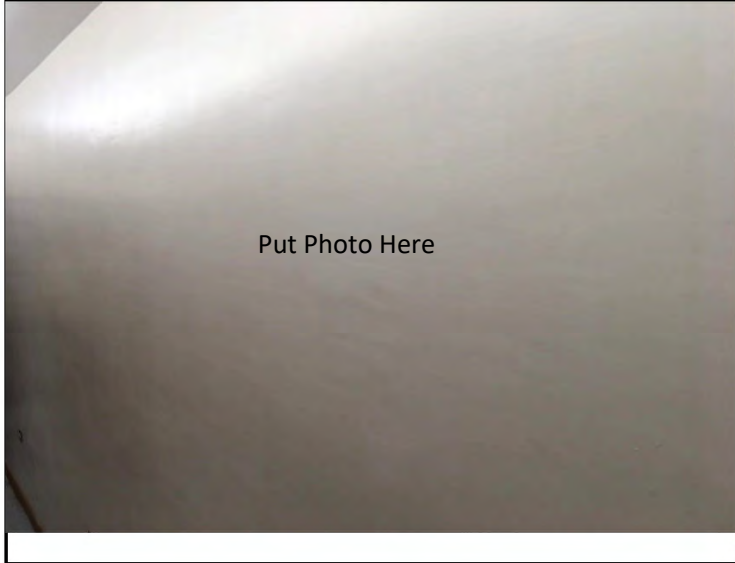
Damage Description:	Item #: 45	Damage Description:	Item #: 46
Wall, ¼ IN thick plaster on concrete, painted, discolored, caused by rainwater intrusion (Main Bldg., Floor 2, Conference)		Ceiling, drywall, repair and paint, dislodged, caused by rainwater intrusion (Main Bldg., Floor 2, Conference)	
Additional Comments:		Additional Comments:

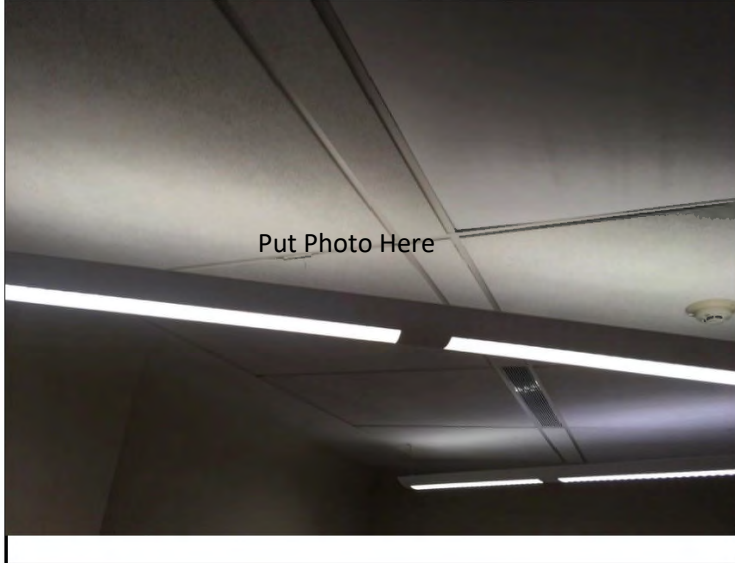
Damage Description:	Item #: 47	Damage Description:	Item #: 48
Ceiling, 4 FT x 4 FT acoustic tile, suspended, tegular, deformed, caused by rainwater intrusion (Main Bldg., Floor 2, Classroom R542)		Wall, drywall, repair, deformed, caused by rainwater intrusion (Main Bldg., Floor 2, Classroom R542)	
Additional Comments:		Additional Comments:

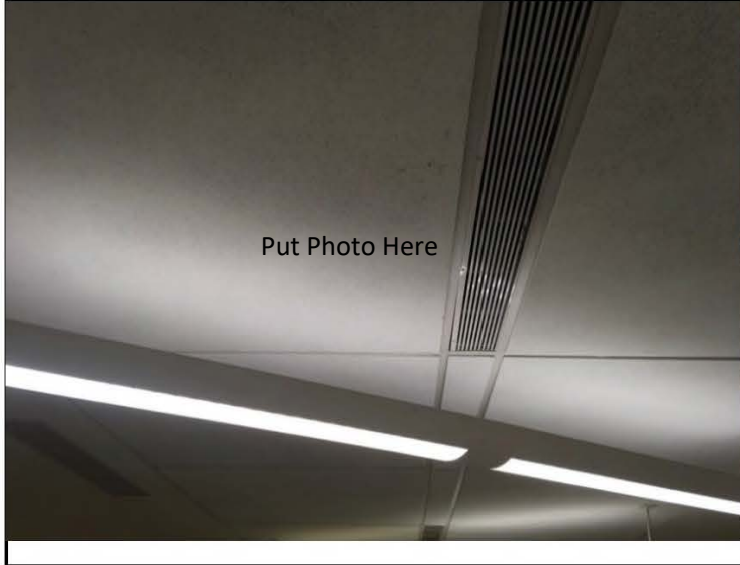
Damage Description:	Item #: 49	Damage Description:	Item #: 50
Ceiling, drywall, paint, discolored, caused by rainwater intrusion (Main Bldg., Floor 2, Classroom R542)		Base Lining, Base molding, wood, 2 5/8 IN x 1/2 IN, stained and urethane-finished, dislodged, caused by rainwater intrusion (Main Bldg., Floor 2, Classroom R542)	
Additional Comments:		Additional Comments:

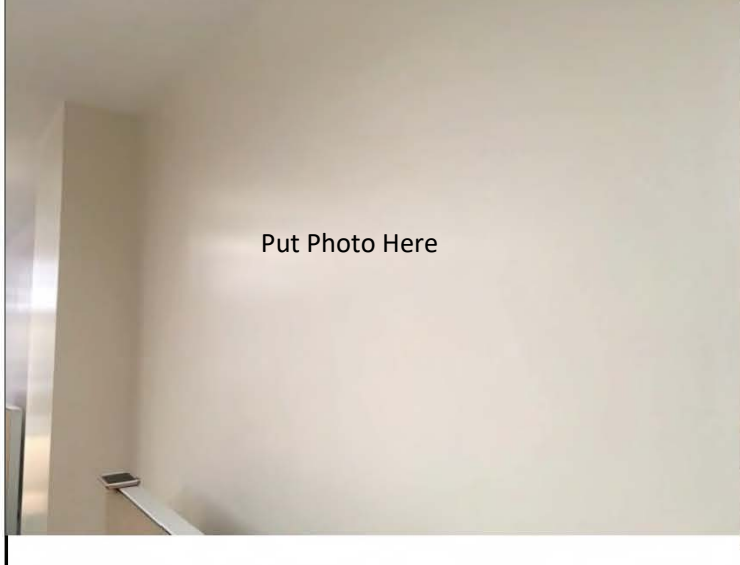
Damage Description:	Item #: 51	Damage Description:	Item #: 52
Wall, drywall, paint, discolored, caused by rainwater intrusion (Main Bldg., Floor 2, Classroom R542)		Wall, drywall, repair, deformed, caused by rainwater intrusion (Main Bldg., Floor 2, Classroom R542)	
Additional Comments:		Additional Comments:

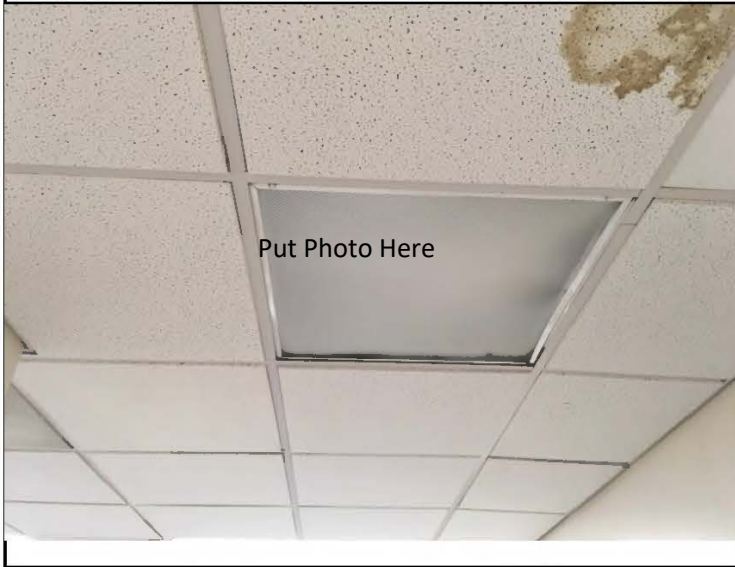
Damage Description:	Item #: 57
Light, fluorescent, recessed Troffer, electrical issues, caused by rainwater intrusion (Main Bldg., Floor 2, Office R544)	
Additional Comments:

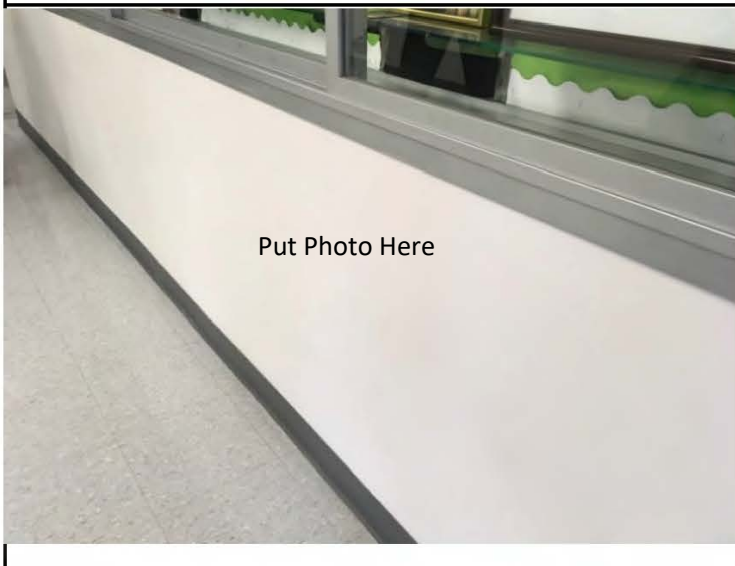
Damage Description:	Item #: 59 Wall,
drywall, painted, deformed, caused by rainwater intrusion (Main Bldg., Floor 1, Library R231)	
Additional Comments:

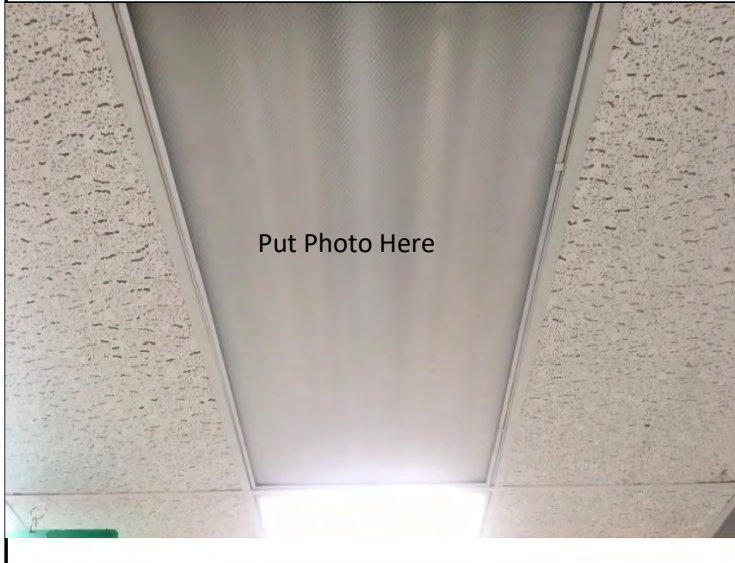
Damage Description:	Item #: 69
Light, fluorescent, recessed Troffer, electrical issues, caused by rainwater intrusion (Main Bldg., Floor 1, Library)	
Additional Comments:

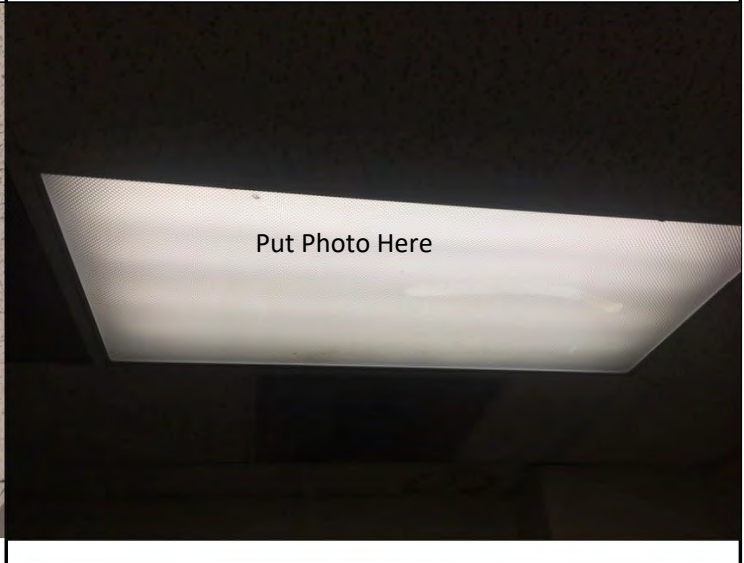
Damage Description:	Item #: 70
Light, fluorescent, recessed Troffer, acrylic prismatic lens only, discolored, caused by rainwater intrusion (Main Bldg., Floor 1, Library)	
Additional Comments:

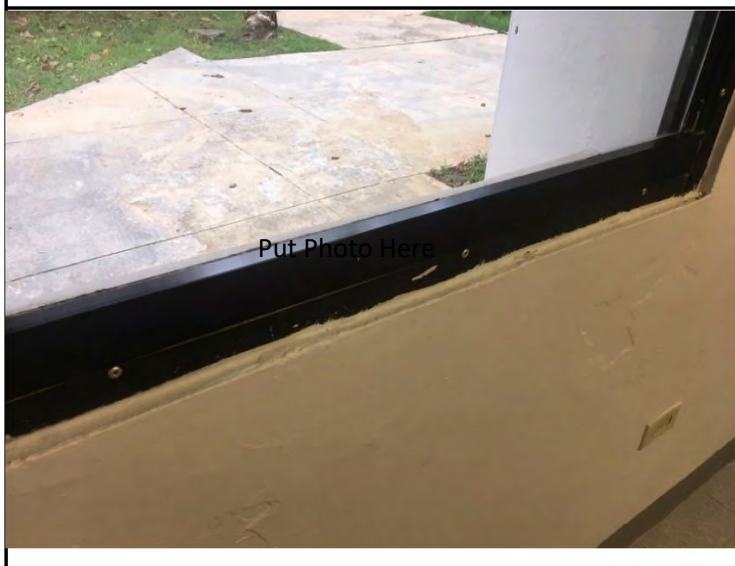
Damage Description:	Item #: 75
Base Lining, vinyl, 4 IN, deformed, caused by rainwater intrusion (Main Bldg., Floor 1, Classroom R357 & 356)	
Additional Comments:

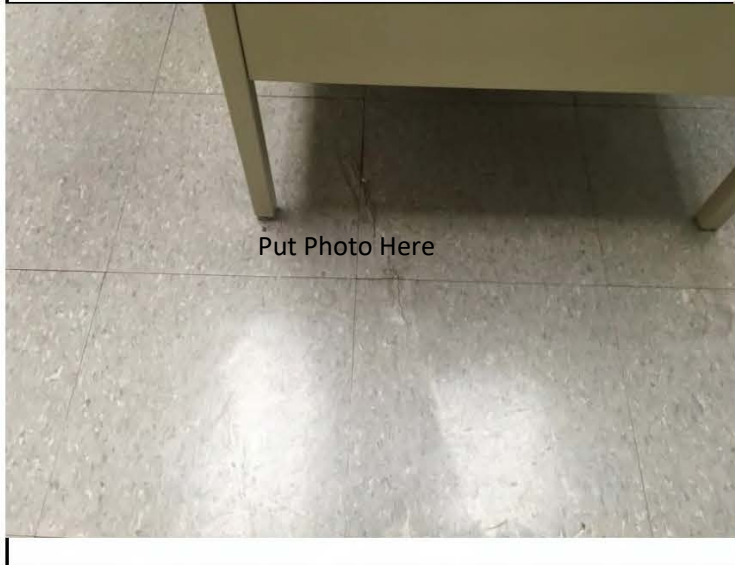
Damage Description:	Item #: 84
Floor, VCT, 12x12 IN, dislodged, caused by surface water flooding (Main Bldg., Floor 1, Office R202)	
Additional Comments:

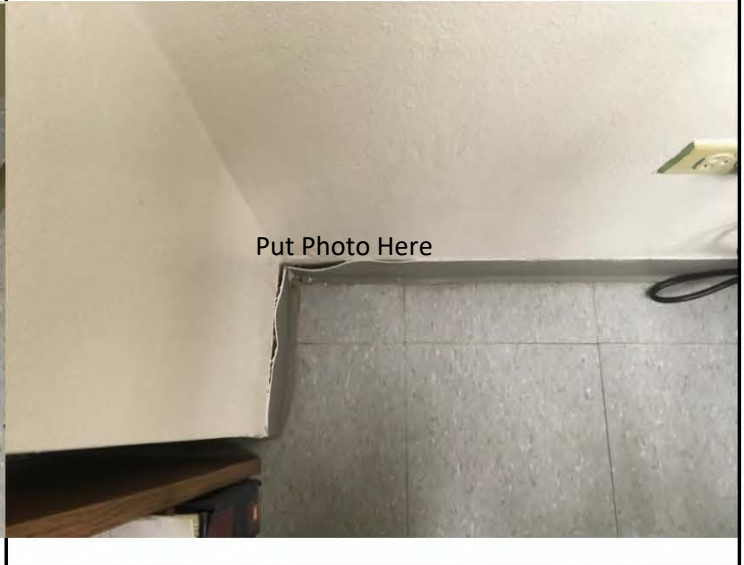
Damage Description:	Item #: 85
Base Lining, vinyl, 4 IN, dislodged, caused by surface water flooding (Main Bldg., Floor 1, Office R202)	
Additional Comments:

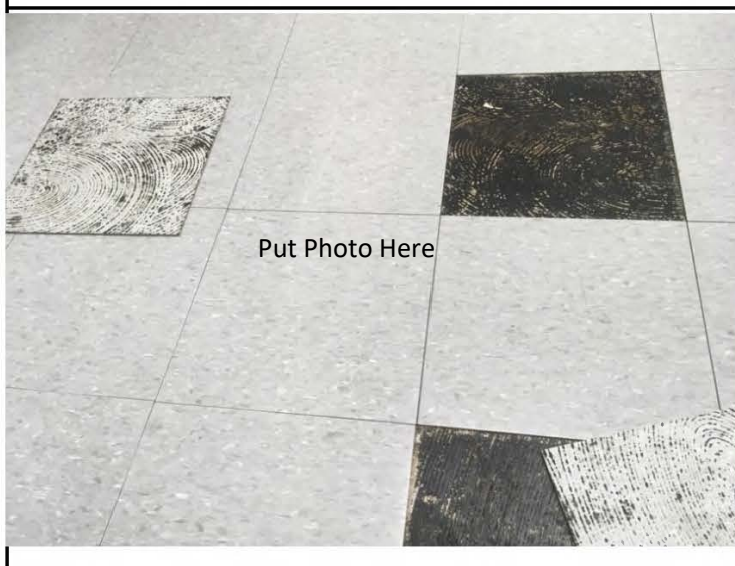
Damage Description:	Item #: 86
Floor, VCT, 12x12 IN, dislodged, caused by surface water flooding (Main Bldg., Floor 1, Office R200)	
Additional Comments:

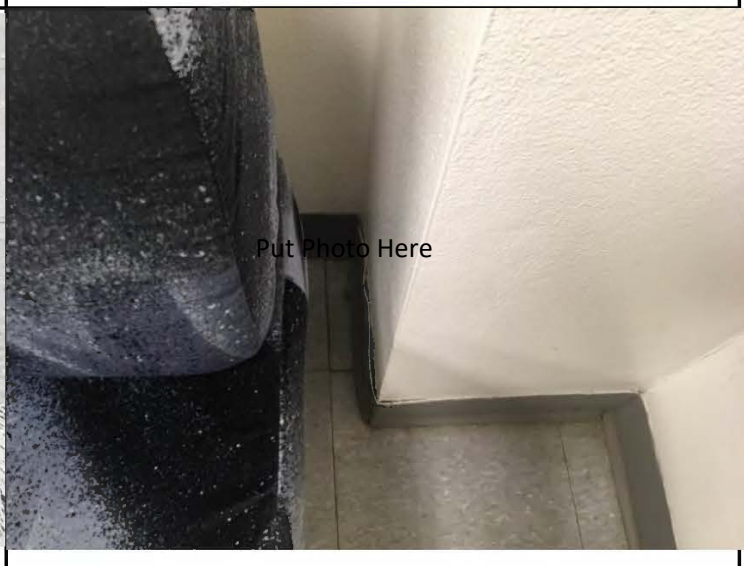
Damage Description:	Item #: 87
Base Lining, vinyl, 4 IN, dislodged, caused by surface water flooding (Main Bldg., Floor 1, Office R200)	
Additional Comments:

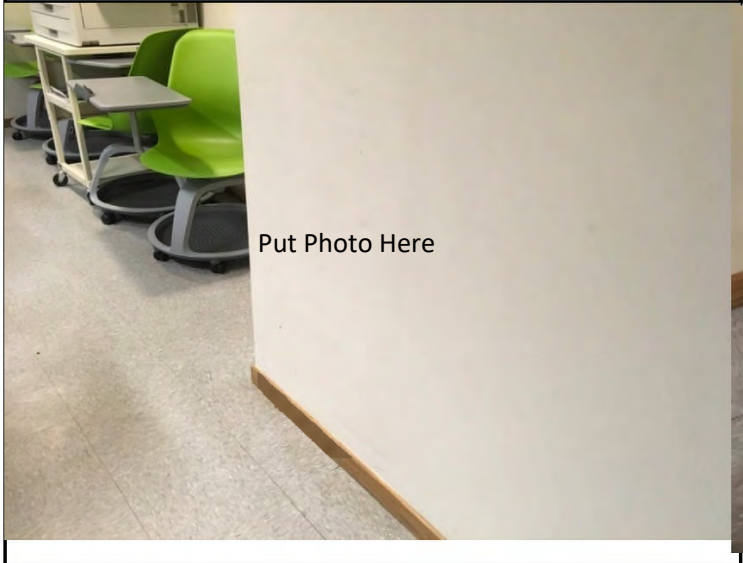
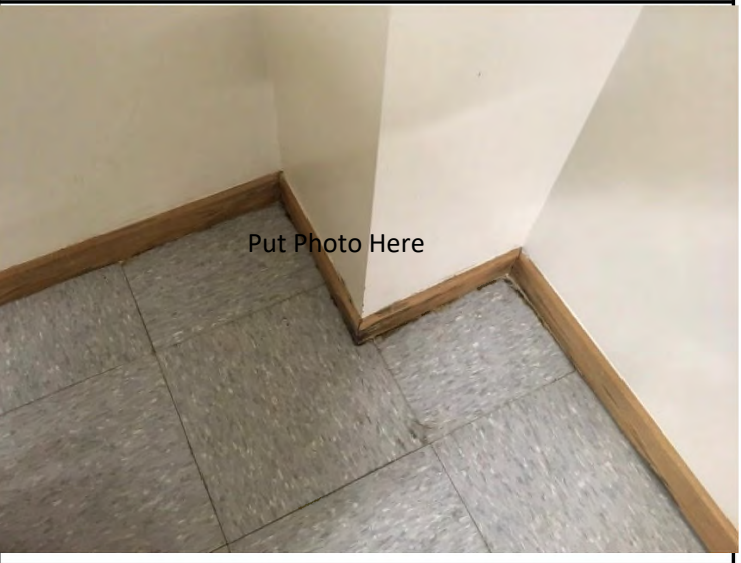
Damage Description:	Item #: 90	Damage Description:	Item #: 91
Wall, drywall, repair, discolored, caused by rainwater intrusion (Main Bldg., Floor 2, Classroom R555, Computers Room)		Base Lining, Base molding, wood, 2 5/8 IN x 1/2 IN, stained and urethane-finished, discolored, caused by rainwater intrusion (Main Bldg., Floor 2, Classroom R555, Computers Room)	
Additional Comments:		Additional Comments:

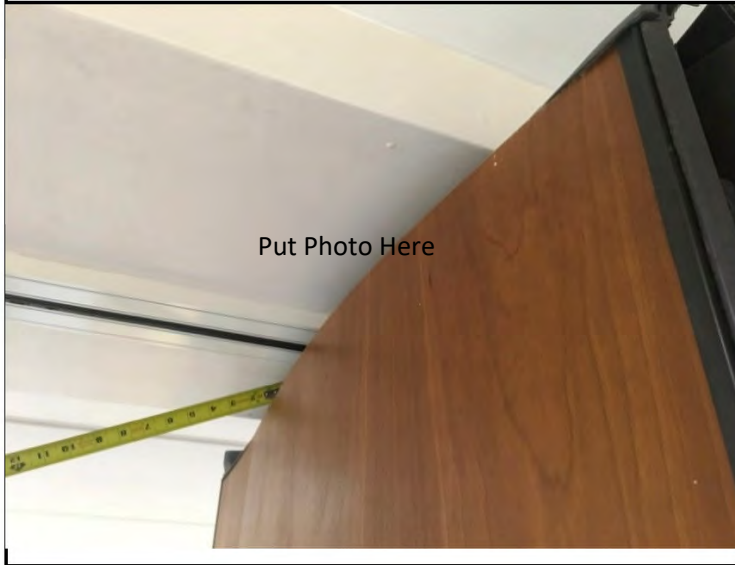
Damage Description:	Item #: 93
Commercial, manually-operated, sliding room partitions, suspended from top rail, double-faced wood veneer finish, and perimeter rubber gaskets, deformed, caused by rainwater intrusion (Main Bldg., Floor 2, Classroom R555, Computers Room)	
Additional Comments:

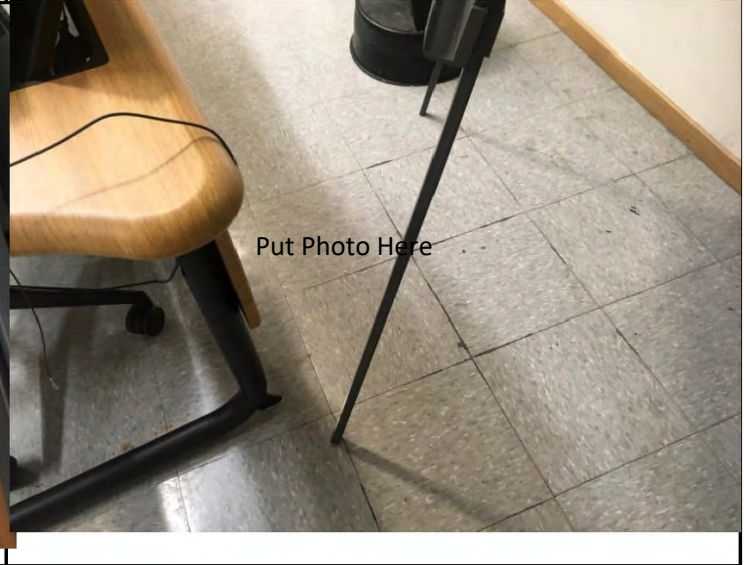
Damage Description:	Item #: 92
Floor, VCT, 12x12 IN, detached, caused by surface water flooding (Main Bldg., Floor 2, Classroom R555, Computers Room)	
Additional Comments:

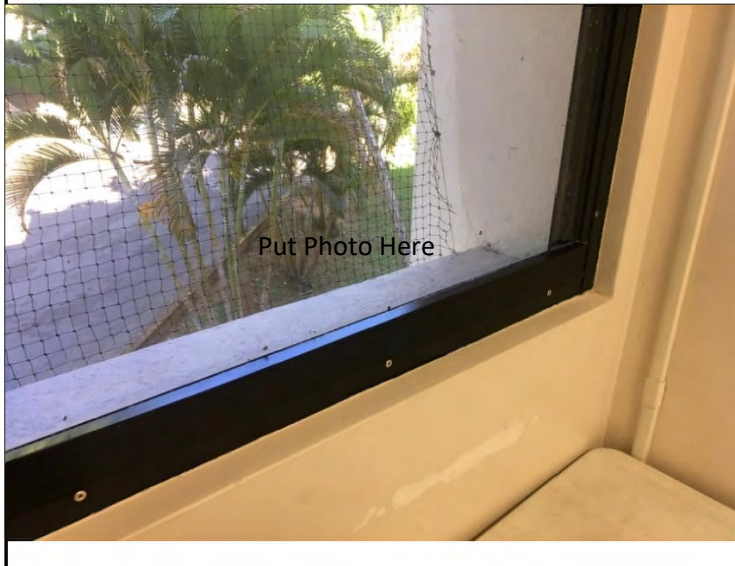
Damage Description:	Item #: 94
Window, Alum. window frames, perimeter caulking/sealing only, cracked, caused by wind-driven rain (Main Bldg., Floor 2, Classroom R553, Study Room)	
Additional Comments:

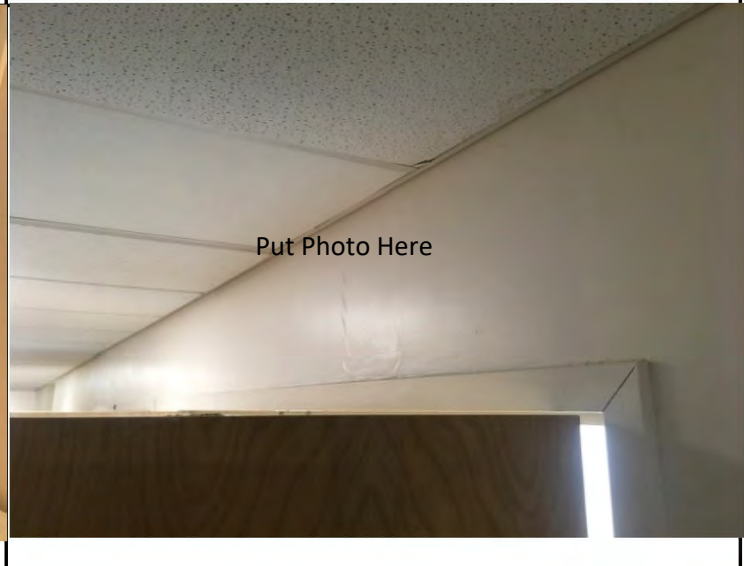
Damage Description:	Item #: 95
Wall, drywall, repair, deformed, caused by rainwater intrusion (Main Bldg., Floor 2, Hallway Computer Laboratory)	
Additional Comments:

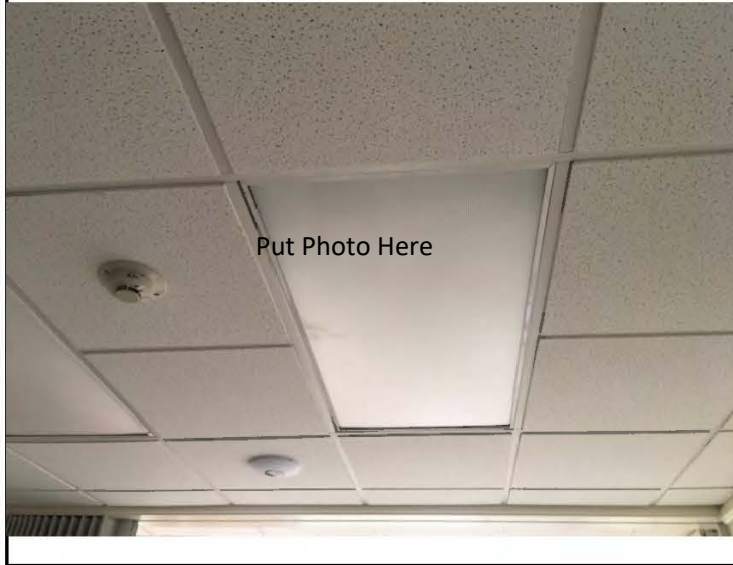
Damage Description:	Item #: 100
Light, fluorescent, recessed Troffer, acrylic prismatic lens only, discolored, caused by rainwater intrusion (Main Bldg., Floor 2, Study Room)	
Additional Comments:

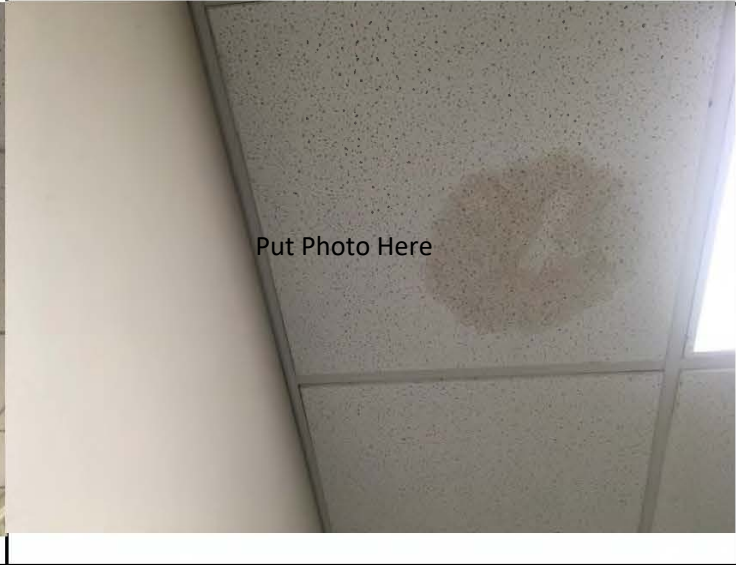
Damage Description:	Item #: 101
Ceiling, 2 FT x 2 FT acoustic tile, suspended, tegular, discolored, caused by rainwater intrusion (Main Bldg., Floor 2, Hallway Production)	
Additional Comments:

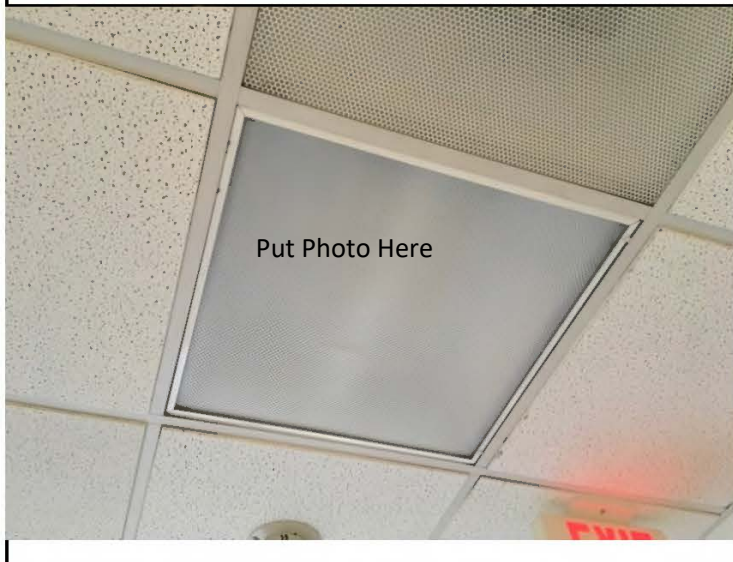
Damage Description:	Item #: 102
Light, fluorescent, recessed Troffer, broken components, caused by rainwater intrusion (Main Bldg., Floor 2, Hallway Production)	
Additional Comments:

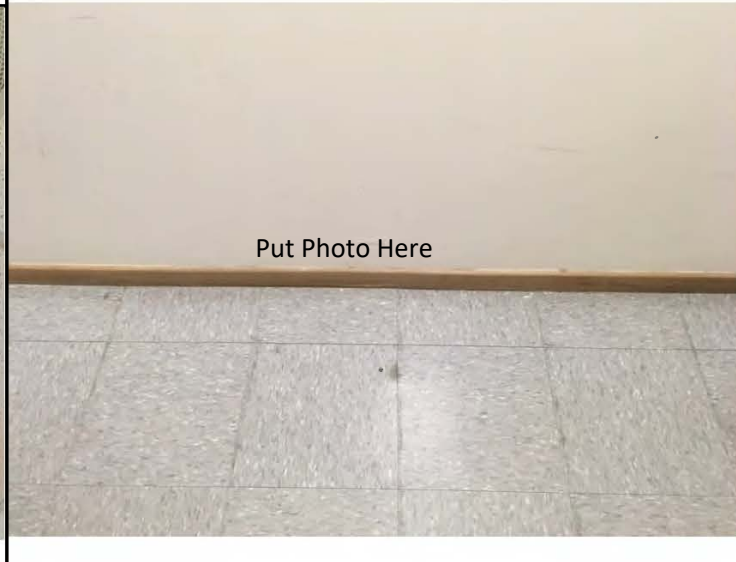
Damage Description:	Item #: 104
Base Lining, Base molding, wood, 2 5/8 IN x 1/2 IN, stained and urethane-finished, discolored, caused by surface water flooding (Main Bldg., Floor 2, Hallway Production)	
Additional Comments:

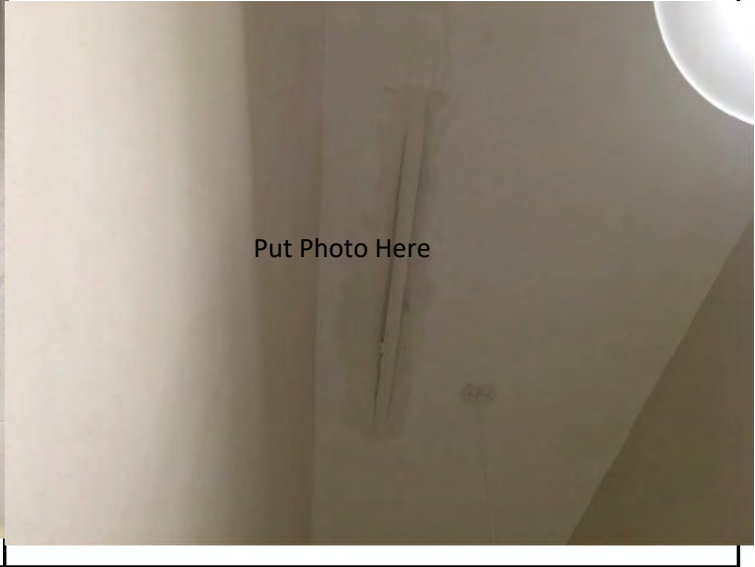
Damage Description:	Item #: 114	Damage Description:	Item #: 115
Light, Fluorescent, recessed, round, 8 IN Dia., 26-Watt, electrical issues, caused by rainwater intrusion (Main Bldg., Floor 2, Hallway Stairway)		Ceiling, drywall, repair, cracked, caused by rainwater intrusion (Main Bldg., Floor 2, Stairway Library)	
Additional Comments:		Additional Comments:

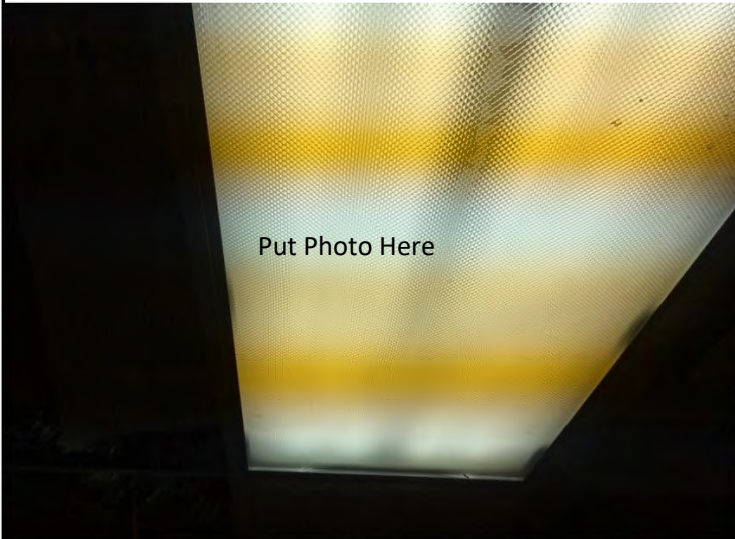
Damage Description:	Item #: 120
Light, fluorescent, recessed Troffer, acrylic prismatic lens only, deformed, caused by rainwater intrusion (Main Bldg., Floor 1, Server Room)	
Additional Comments:

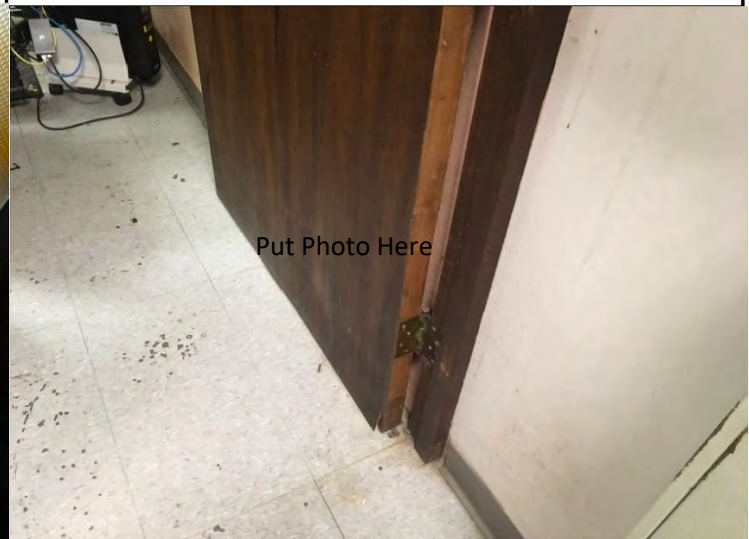
Damage Description:	Item #: 121
Door, 3070, wood slab, hollow-core, birch veneer, stained and urethane-finished, deformed, caused by rainwater intrusion (Main Bldg., Floor 1, Server Room)	
Additional Comments:

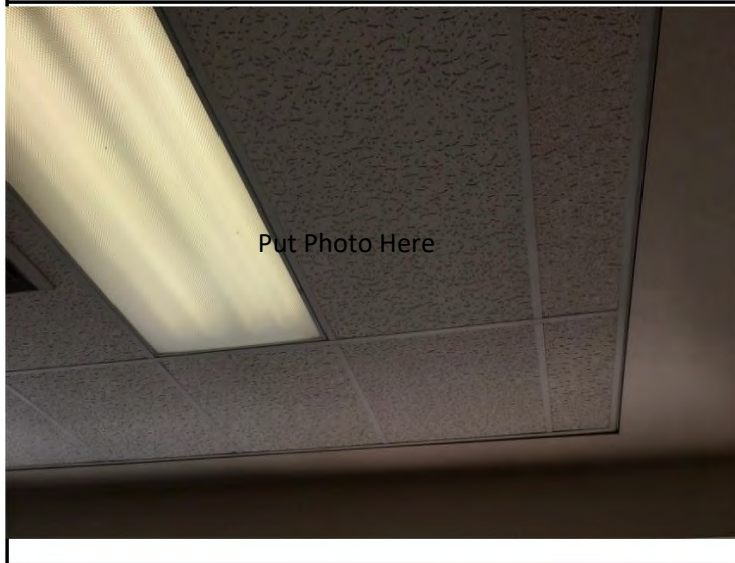
Damage Description: **Item #:** 124
 Ceiling, 2 FT x 4 FT acoustic tile, suspended, grid only, dislodged, caused by rainwater intrusion (Main Bldg., Floor 1, Entrance Lobby)

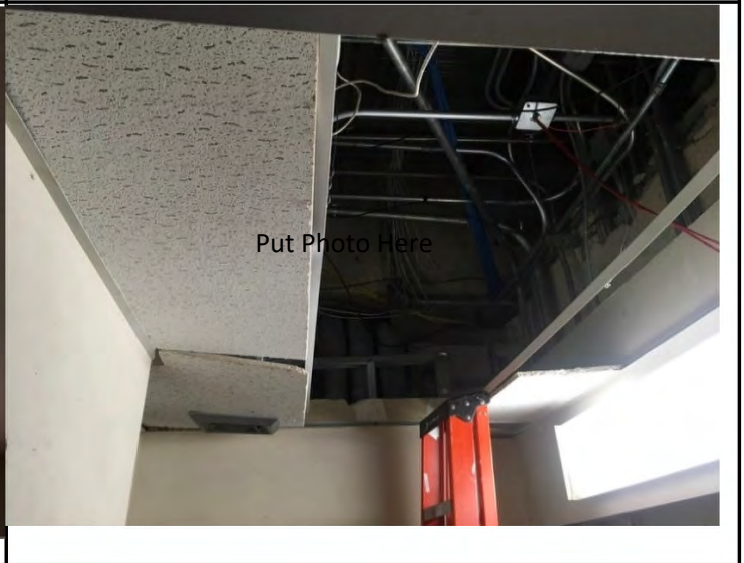
Damage Description: **Item #:** 125
 Ceiling, 2 FT x 4 FT acoustic tile, suspended, broken components, caused by rainwater intrusion (Main Bldg., Floor 1, Electrical Room)

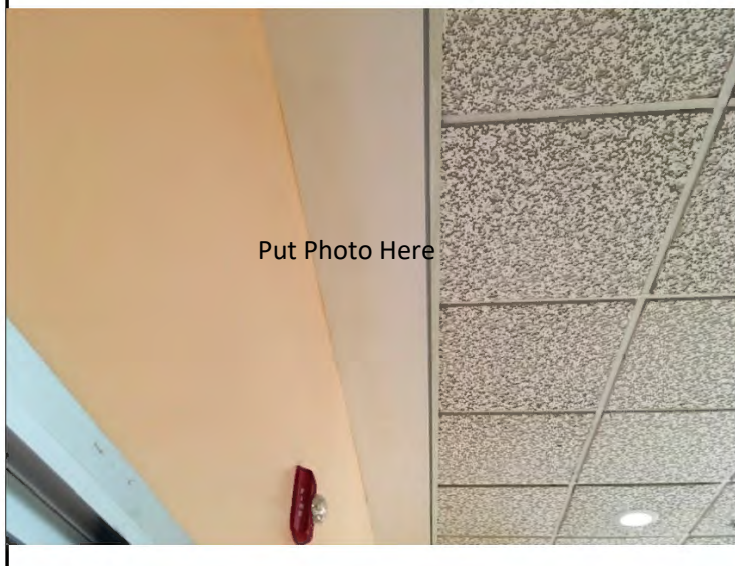
Damage Description:	Item #: 128
Ceiling, drywall, paint, discolored, caused by rainwater intrusion (Main Bldg., Floor 1, Lobby)	
Additional Comments:

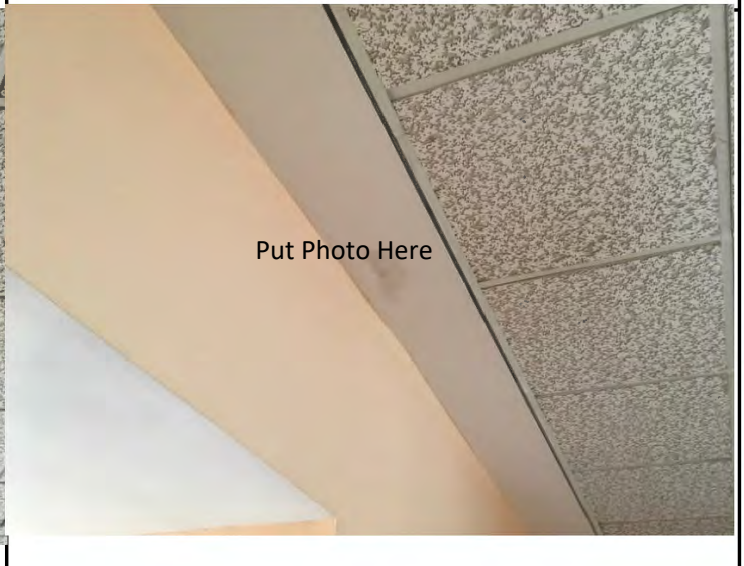
Damage Description:	Item #: 129
Ceiling, drywall, soffit, repair and paint, deformed, caused by rainwater intrusion (Main Bldg., Floor 1, Lobby)	
Additional Comments:

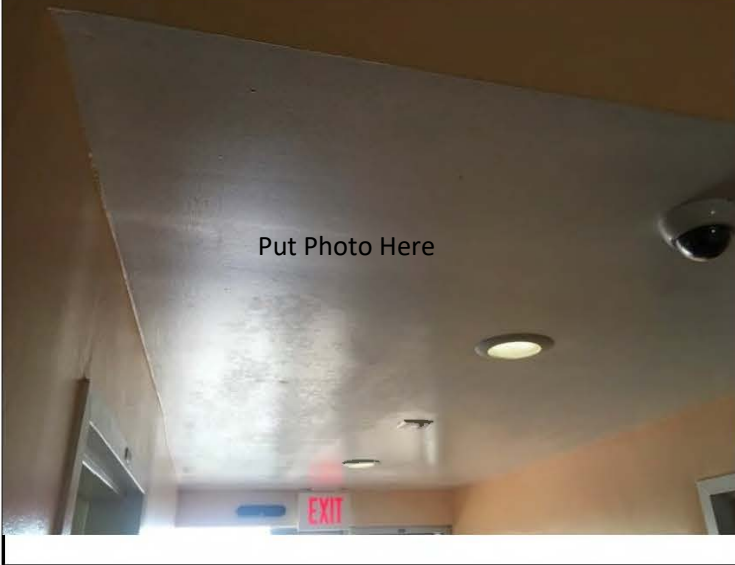
Damage Description: **Item #:** 130
 Ceiling, drywall, paint, discolored, caused by rainwater intrusion (Main Bldg., Floor 1, Lobby)

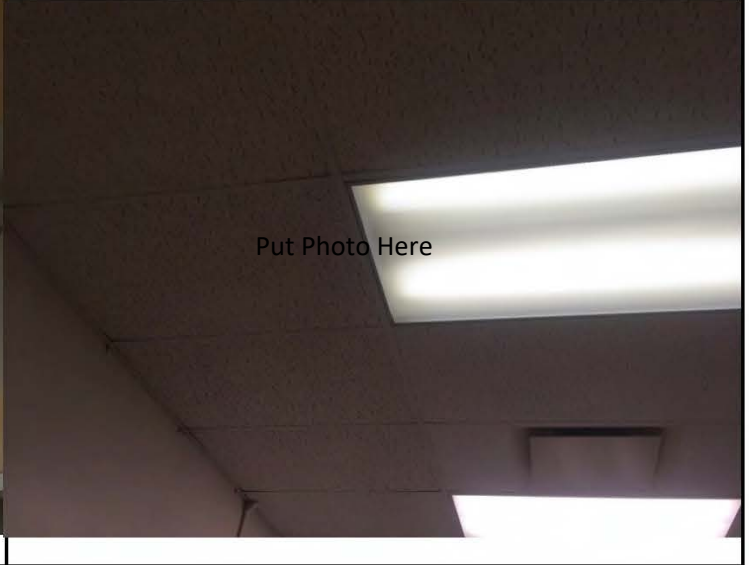
Damage Description: **Item #:** 131
 Ceiling, 2 FT x 4 FT acoustic tile, suspended, discolored, caused by rainwater intrusion (Main Bldg., Floor 1, Office R198)

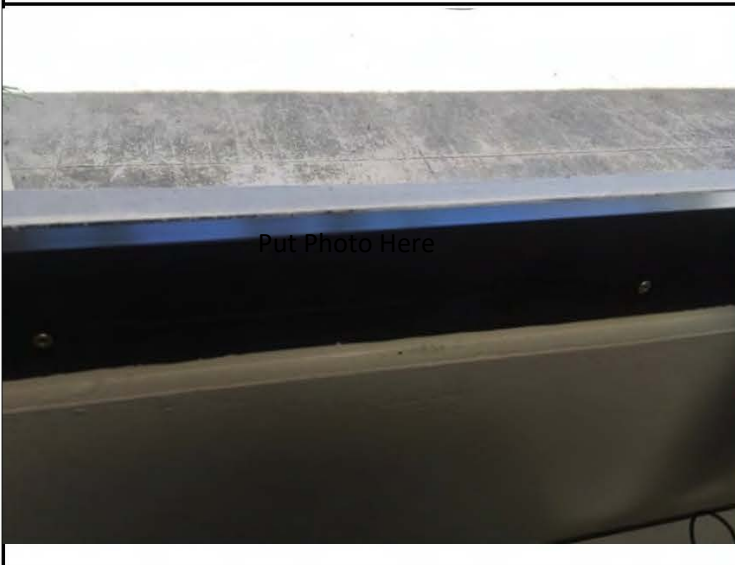
Damage Description: **Item #:** 132
 Window, Alum. window frames, perimeter caulking/sealing only, cracked, caused by wind-driven rain (Main Bldg., Floor 1, Office R198)

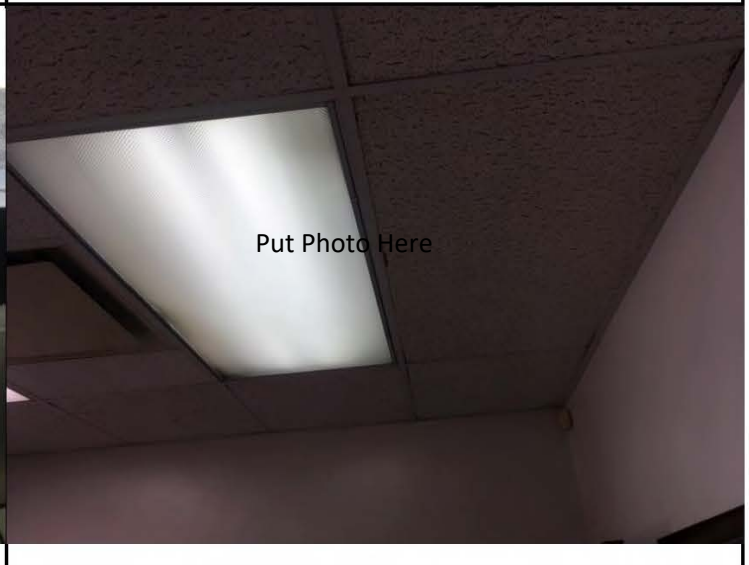
Damage Description: **Item #:** 133
 Ceiling, 2 FT x 4 FT acoustic tile, suspended, discolored, caused by rainwater intrusion (Main Bldg., Floor 1, Office R197)
