Applicant: Universidad Central Del Caribe, Inc.	Damage Inventory: 305240	Category: E
WO # 46525 FIPS# 021-UNUGB-00	Date: 09/04-17/2019 GPS: 18.365953, -66.153767	
Inspector: Gregory Sondergeld / Alexander Nieves	Damage Facility: Main Bldg.

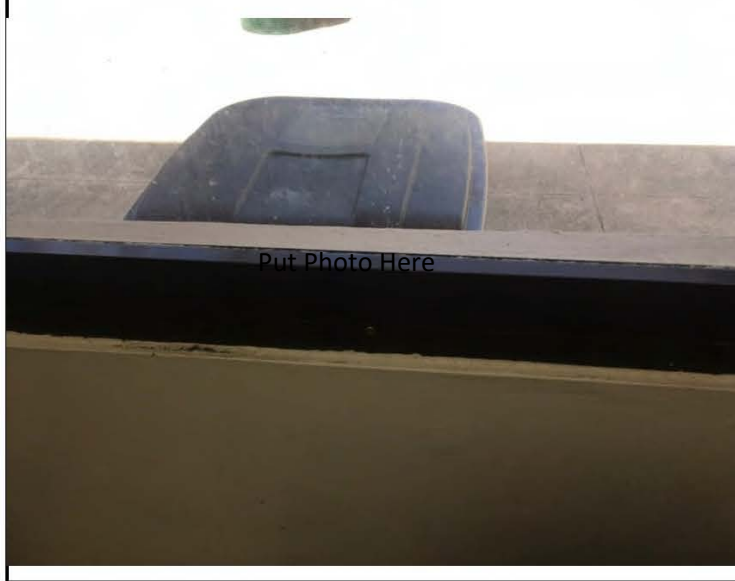
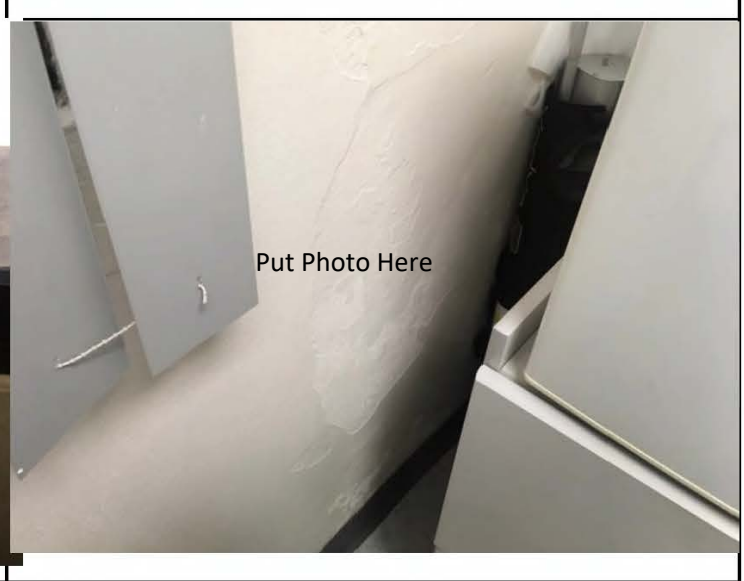
Damage Description:	Item #: 134	Damage Description:	Item #: 135
Window, Alum. window frames, perimeter caulking/sealing only, cracked, caused by wind-driven rain (Main Bldg., Floor 1, Office R197)		Wall, ¼ IN thick plaster on concrete, repair, cracked, caused by rainwater intrusion (Main Bldg., Floor 1, Office R197)	
Additional Comments:		Additional Comments:

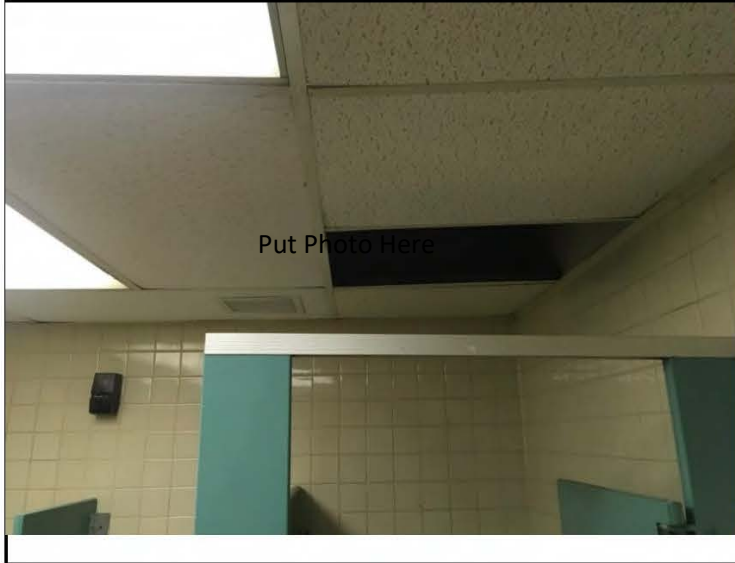
Damage Description:	Item #: 142
Ceiling, 2 FT x 4 FT acoustic tile, suspended, discolored, caused by rainwater intrusion (Main Bldg., Floor 1, Bathroom R107)	
Additional Comments:

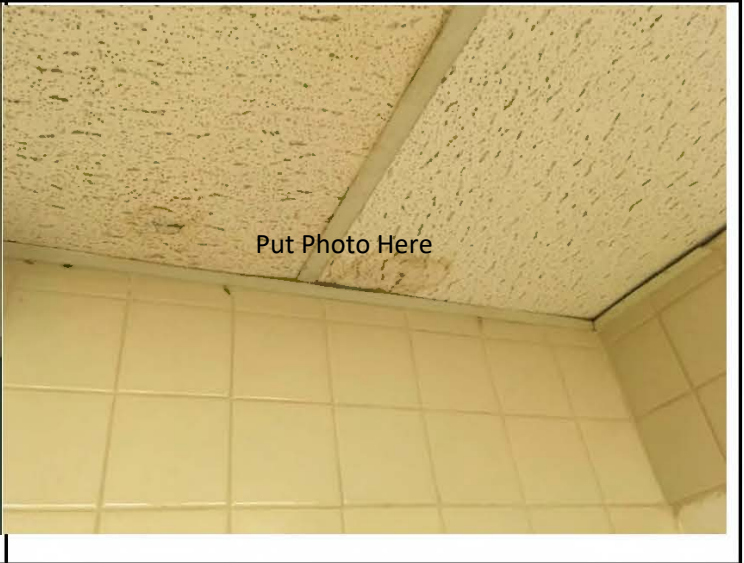
Damage Description:	Item #: 143
Ceiling, 2 FT x 4 FT acoustic tile, suspended, grid, outside L-angle only, discolored, caused by rain water intrusion (Main Bldg., Floor 1, Bathroom R107)	
Additional Comments:

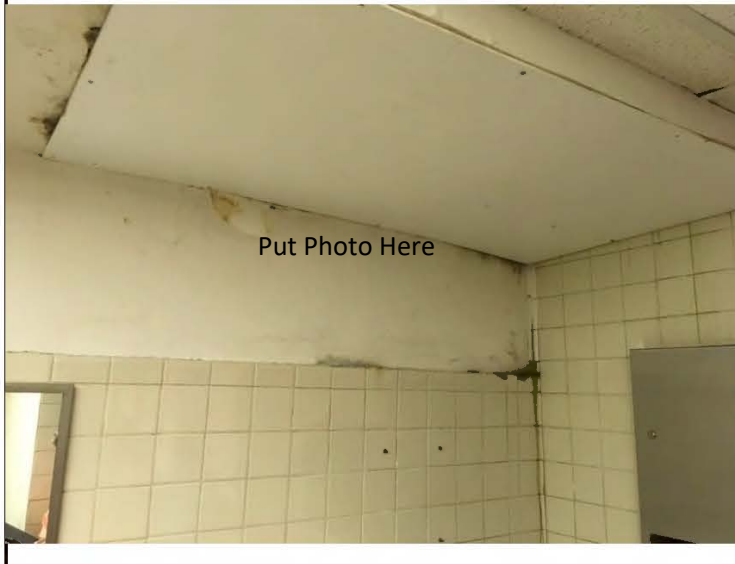
Damage Description:	Item #: 144
Wall, drywall, repair and paint, deformed, caused by rainwater intrusion (Main Bldg., Floor 1, Bathroom R107)	
Additional Comments:

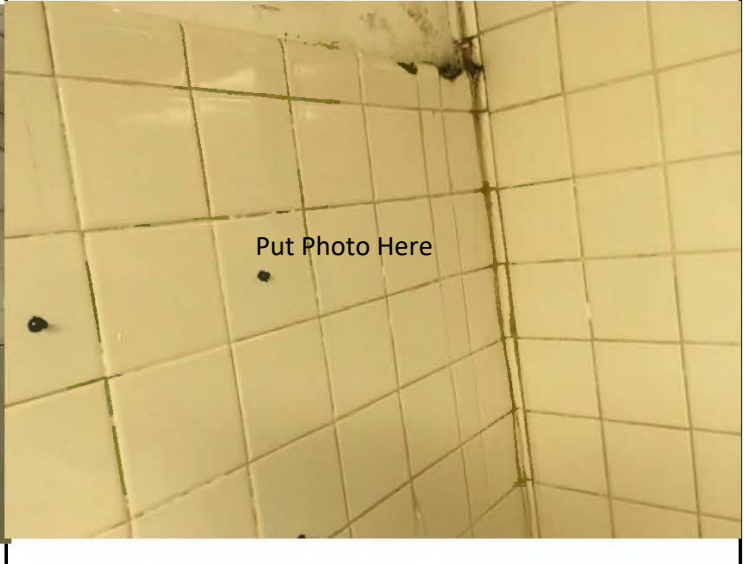
Damage Description:	Item #: 145
Wall, 4 IN x 4 IN ceramic tile, detached, caused by rainwater intrusion (Main Bldg., Floor 1, Bathroom R107)	
Additional Comments:

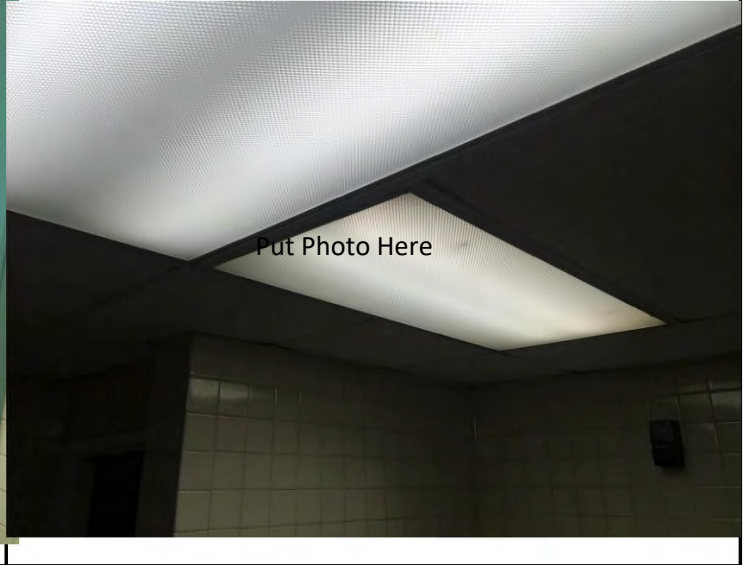
Damage Description: **Item #:** 147
 Light, fluorescent, recessed Troffer, acrylic prismatic lens only, discolored, caused by rainwater intrusion (Main Bldg., Floor 1, Bathroom R107)

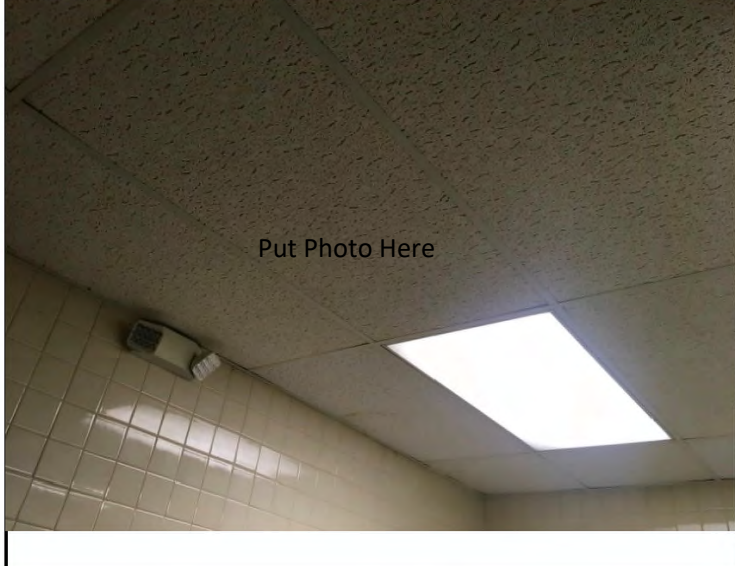
Damage Description: **Item #:** 148
 Ceiling, 2 FT x 4 FT acoustic tile, suspended, deformed, caused by rainwater intrusion (Main Bldg., Floor 1, Bathroom R106)

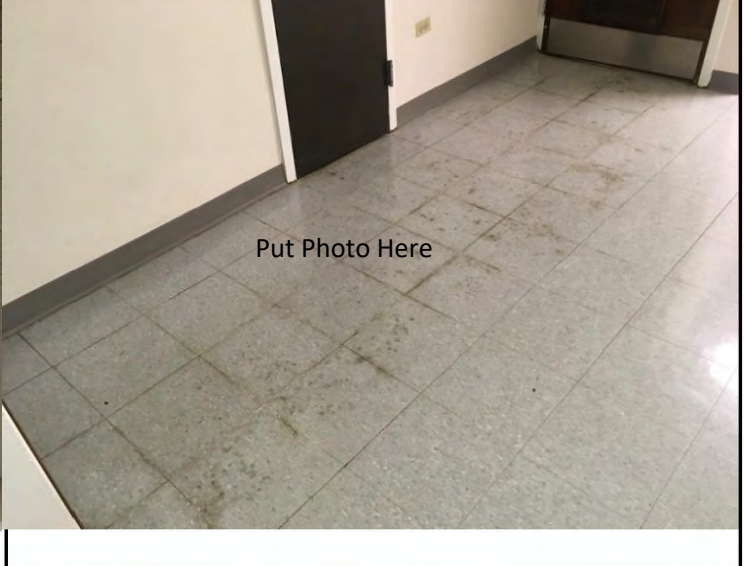
Damage Description: **Item #:** 149
 Floor, VCT, 12x12 IN, detached, caused by surface water flooding (Main Bldg., Floor 1, Hallway, Faculty Bathroom)

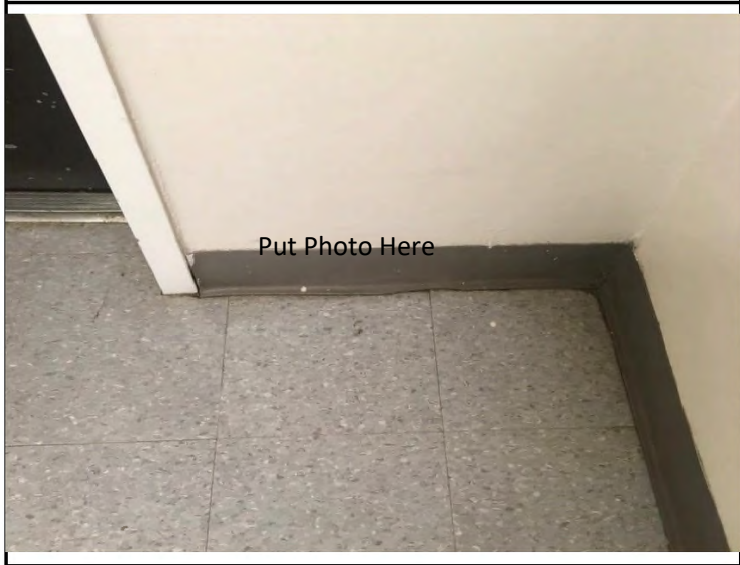
Damage Description:	Item #: 150
Base Lining, vinyl, 4 IN, detached, caused by surface water flooding (Main Bldg., Floor 1, Hallway, Faculty Bathroom)	
Additional Comments:

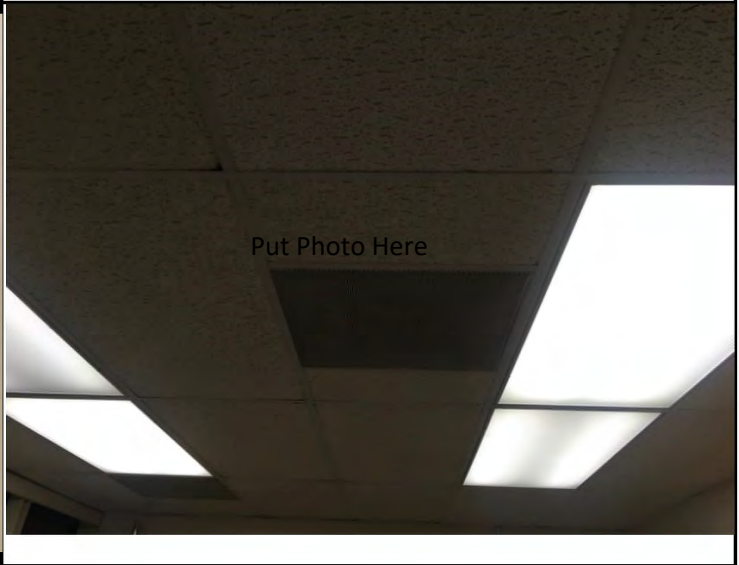
Damage Description:	Item #: 151
Ceiling, 2 FT x 4 FT acoustic tile, suspended, deformed, caused by rainwater intrusion (Main Bldg., Floor 1, Dining Room 101)	
Additional Comments:

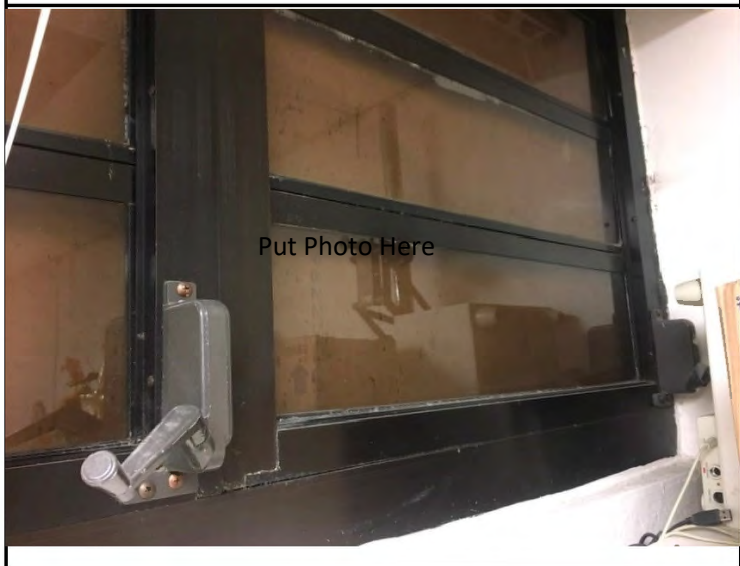
Damage Description:	Item #: 152
Window, Alum. window frames, Jalousie-style vent, perimeter caulking/sealing only, cracked, caused by wind-driven rain (Main Bldg., Floor 1, Dining Room R101)	
Additional Comments:

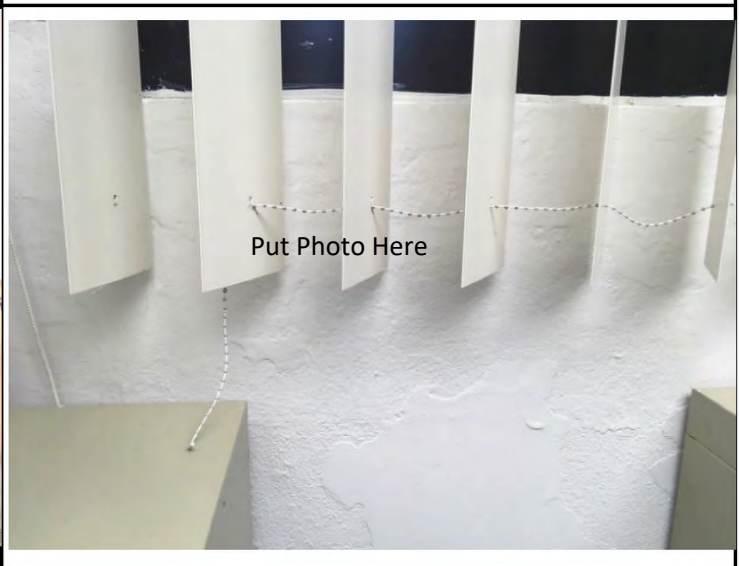
Damage Description:	Item #: 153
Wall, ¼ IN thick plaster on concrete, painted, cracked, caused by rainwater intrusion (Main Bldg., Floor 1, Dining Room R101)	
Additional Comments:

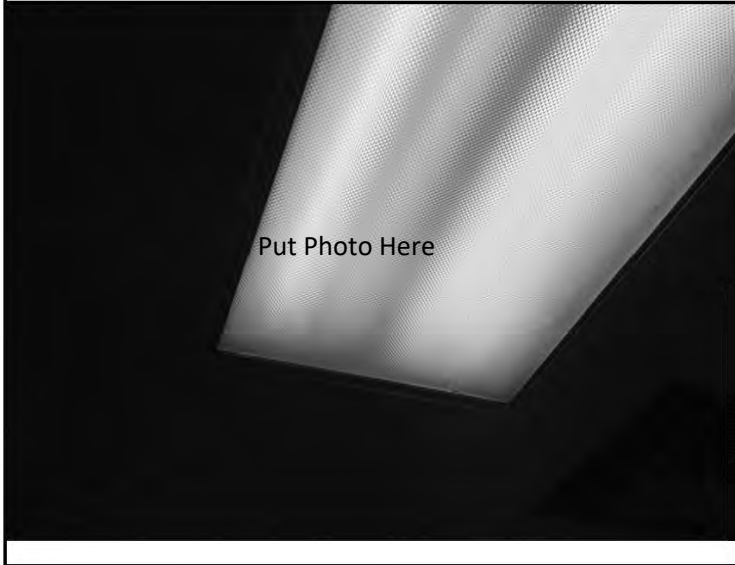
Damage Description:	Item #: 158
Light, fluorescent, recessed Troffer, acrylic prismatic lens only, cracked, caused by rainwater intrusion (Main Bldg., Floor 1, Laboratory R097)	
Additional Comments:

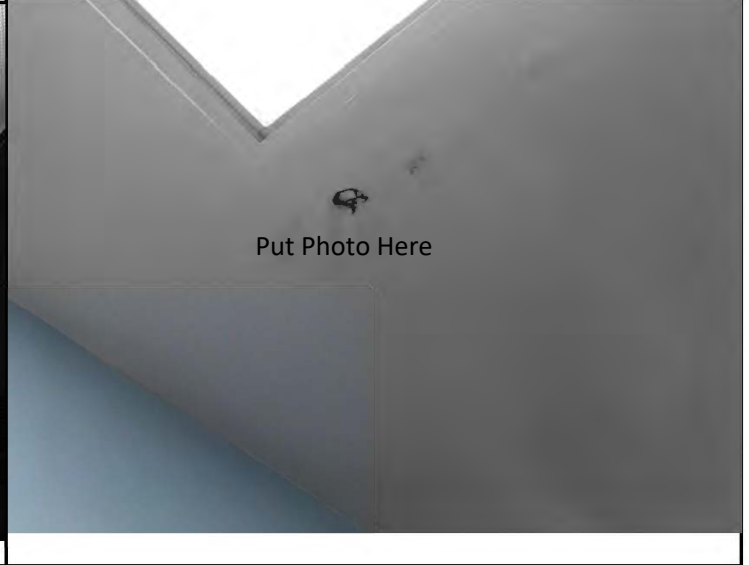
Damage Description:	Item #: 159
Ceiling, drywall, repair, deformed and moldy above, caused by rainwater intrusion (Main Bldg., Floor 1, Laboratory R097)	
Additional Comments:

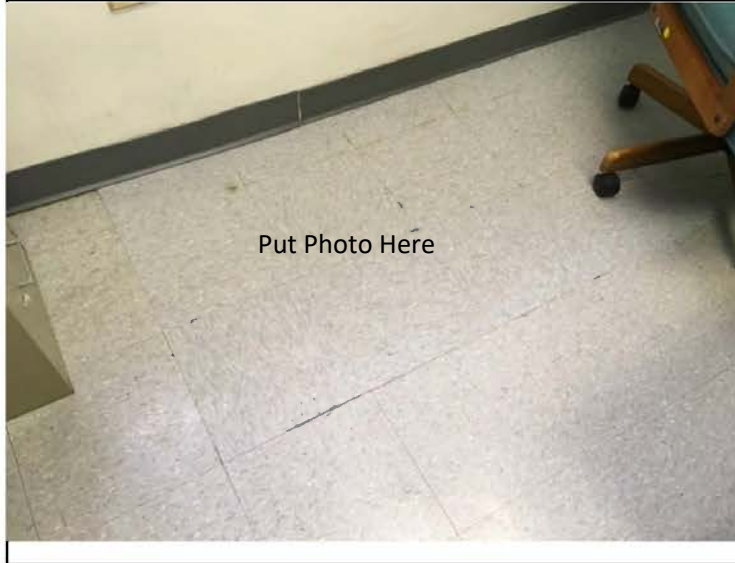
Damage Description:	Item #: 166
Floor, VCT, 12x12 IN, detached, caused by surface water flooding (Main Bldg., Floor 1, Office R067)	
Additional Comments:

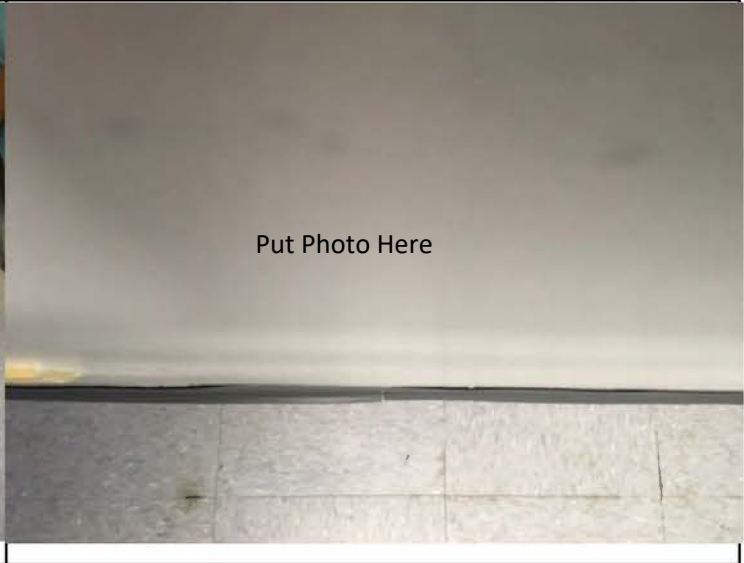
Damage Description:	Item #: 167
Base Lining, vinyl, 4 IN, detached, caused by surface water flooding (Main Bldg., Floor 1, Office R067)	
Additional Comments:

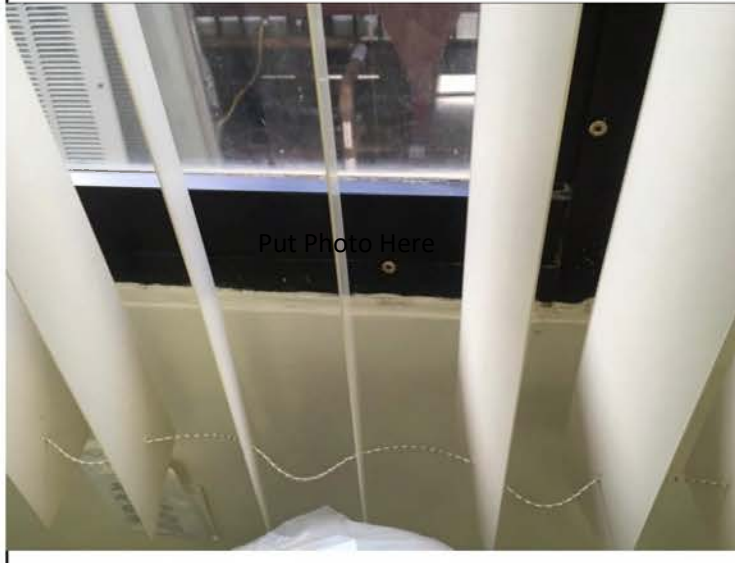
Damage Description:	Item #: 168
Window, Alum. window frames, perimeter caulking/sealing only, cracked, caused by wind-driven rain (Main Bldg., Floor 1, Office R069)	
Additional Comments:

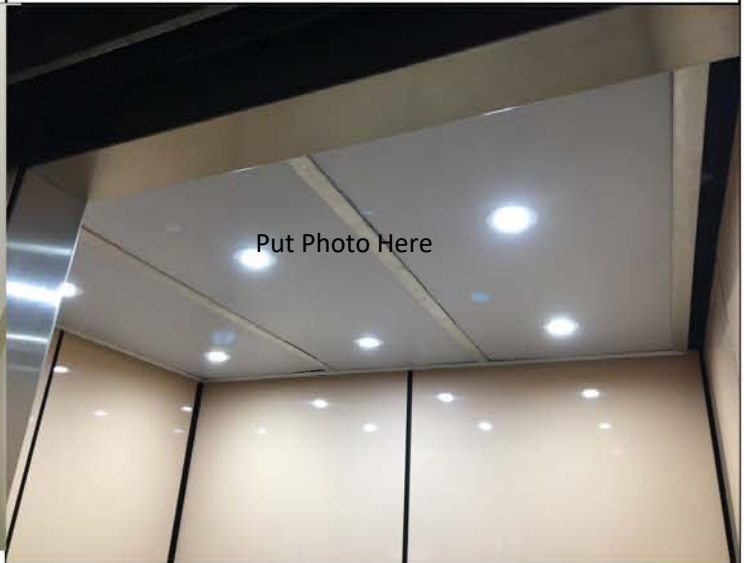
Damage Description:	Item #: 169
Building Interior, Elevator 340 at lobby, ceiling, wood plastic laminated and recessed LED down lights, damaged due to water infiltration.	
Additional Comments:
