Applicant: Universidad Central Del Caribe, Inc.	Damage Inventory: 305240	Category: E
WO # 46525 FIPS# 021-UNUGB-00	Date: 09/04-17/2019 GPS: 18.365953, -66.153767	
Inspector: Gregory Sondergeld / Alexander Nieves	Damage Facility: Main Bldg.

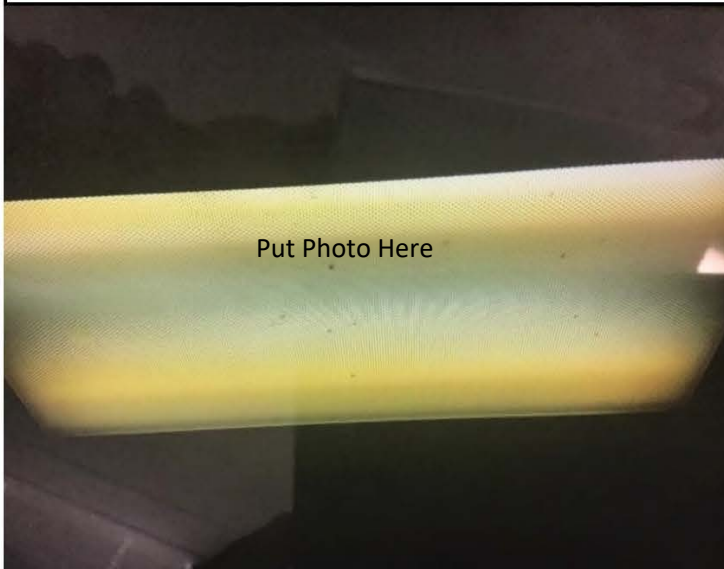
Damage Description:	Item #: 1	Damage Description:	Item #: 2
Light, fluorescent, recessed Troffer, acrylic prismatic lens only, discolored, caused by rainwater intrusion (Main Bldg., Basement, Laboratory ARC 010)		Floor, VCT, 12x12 IN, detached, caused by surface water flooding (Main Bldg., Basement, Laboratory ARC 010)	
Additional Comments:		Additional Comments:

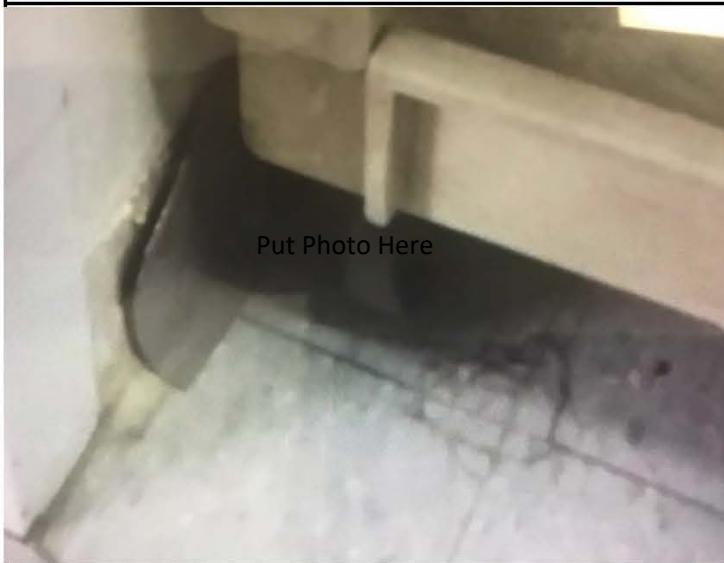
Damage Description:	Item #: 3	Damage Description:	Item #: 4
Base Lining, vinyl, 4 IN, detached, caused by surface water flooding (Main Bldg., Basement, Laboratory ARC 010)		Floor, VCT, 12x12 IN, detached, caused by surface water flooding (Main Bldg., Basement, Laboratory ARC 014)	
Additional Comments:		Additional Comments:

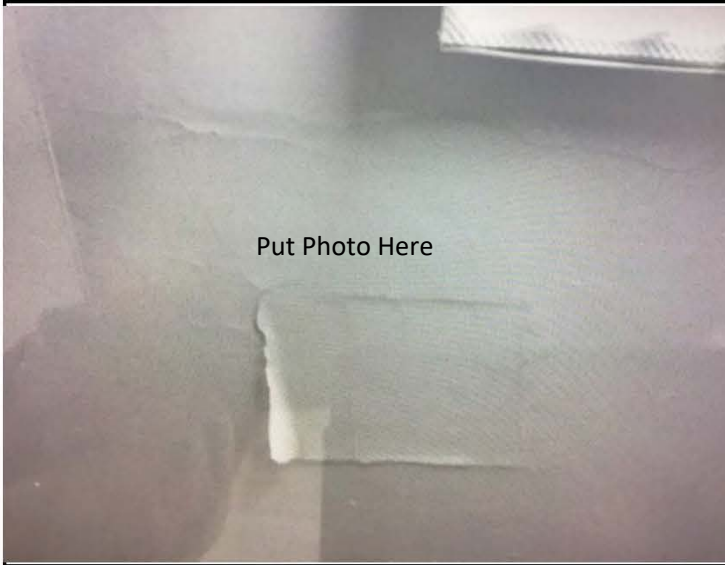
Damage Description:	Item #: 13	Damage Description:	Item #: 14
Ceiling, drywall, repair, detached, caused by rainwater intrusion (Main Bldg., Basement, Laboratory ARC 024)		Wall, ¼ IN thick plaster on concrete, painted, discolored, caused by rainwater intrusion (Main Bldg., Basement, Laboratory ARC 024)	
Additional Comments:		Additional Comments:

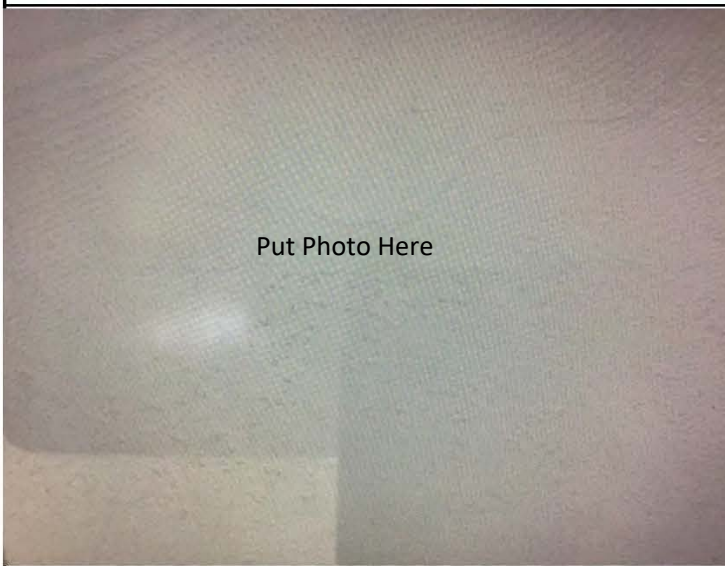
Damage Description:	Item #: 15	Damage Description:	Item #: 16
Wall, ¼ IN thick plaster on concrete, repair spalling and paint, cracked, caused by rainwater intrusion (Main Bldg., Basement, Laboratory ARC 025)		Light, fluorescent, surface-mounted, vapor-resistant, 6 IN x 48 IN, acrylic lens cover only, discolored, caused by rainwater intrusion (Main Bldg., Basement, Laboratory ARC 025)	
Additional Comments:		Additional Comments:

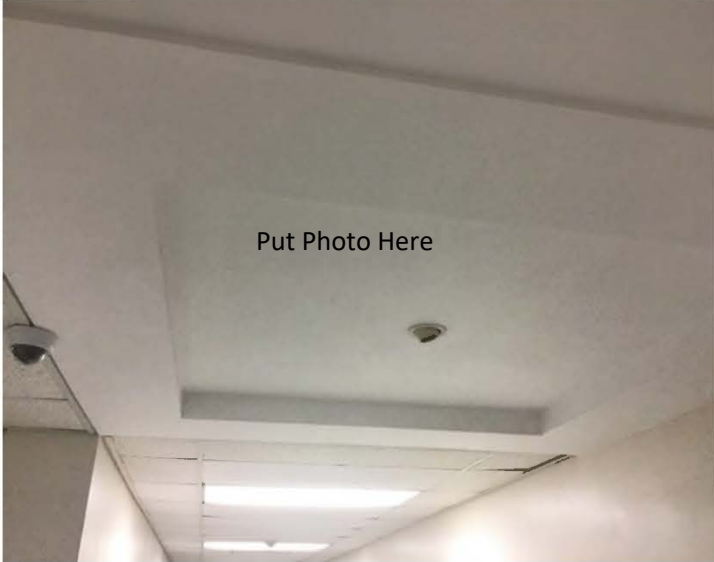
Damage Description:	Item #: 21	Damage Description:	Item #: 22
Ceiling, drywall, soffit, paint, discolored, caused by rainwater intrusion (Main Bldg., Floor 1, Hallway)		Wall, ¼ IN thick plaster on concrete, repair spalling, cracked, caused by rainwater intrusion (Main Bldg., Floor 1, Hallway)	
Additional Comments:		Additional Comments:

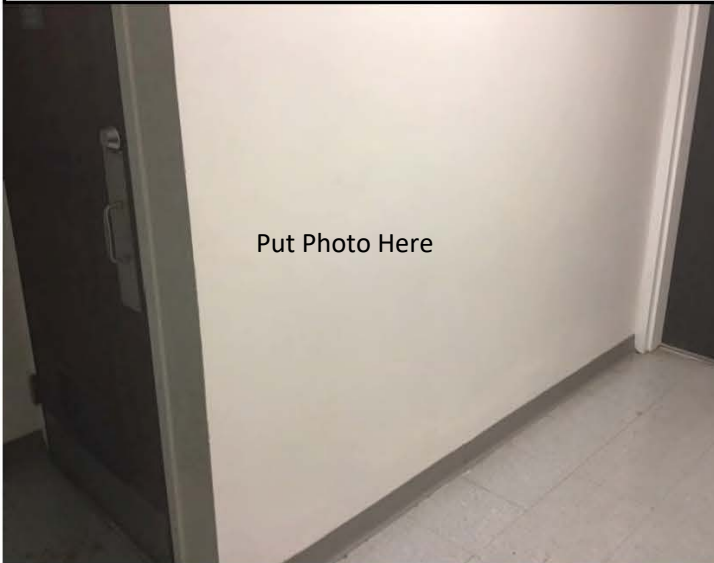
Damage Description:	Item #: 23	Damage Description:	Item #: 24
Wall, ¼ IN thick plaster on concrete, painted, discolored, caused by rainwater intrusion (Main Bldg., Floor 1, Hallway)		Wall, ¼ IN thick plaster on concrete, repair spalling, peeling paint, caused by rainwater intrusion (Main Bldg., Floor 1, Hallway)	
Additional Comments:		Additional Comments:

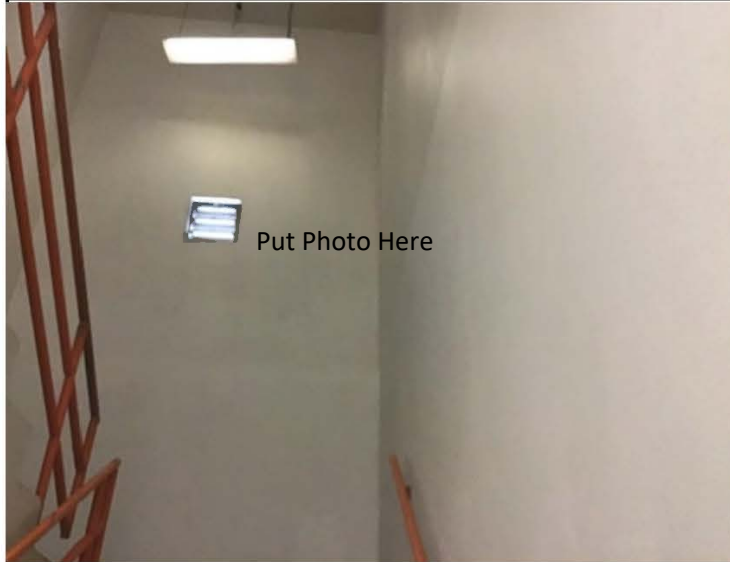
Damage Description:	Item #: 46	Damage Description:	Item #: 47
Wall, ¼ IN thick plaster on concrete, painted, discolored, caused by rainwater intrusion (Main Bldg., Floor 1, Stairway South)		Floor, sealed concrete, painted, discolored, caused by rainwater intrusion (Main Bldg., Floor 1, Stairway South)	
Additional Comments:		Additional Comments:

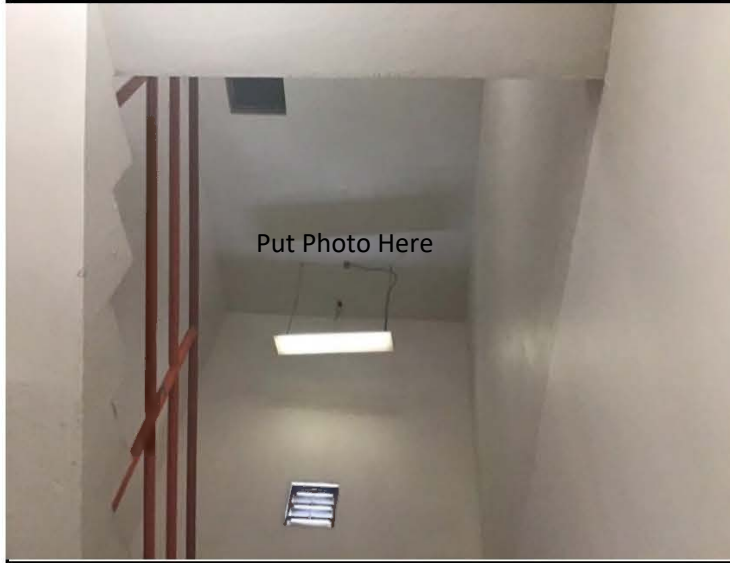
Damage Description:	Item #: 48	Damage Description:	Item #: 49
Ceiling, ¼ IN thick plaster on concrete, painted, discolored, caused by rainwater intrusion (Main Bldg., Floor 1, Stairway South)		Wall, ¼ IN thick plaster on concrete, repair spalling and paint, cracked, caused by rainwater intrusion (Main Bldg., Floor 1, Stairway South)	
Additional Comments:		Additional Comments:

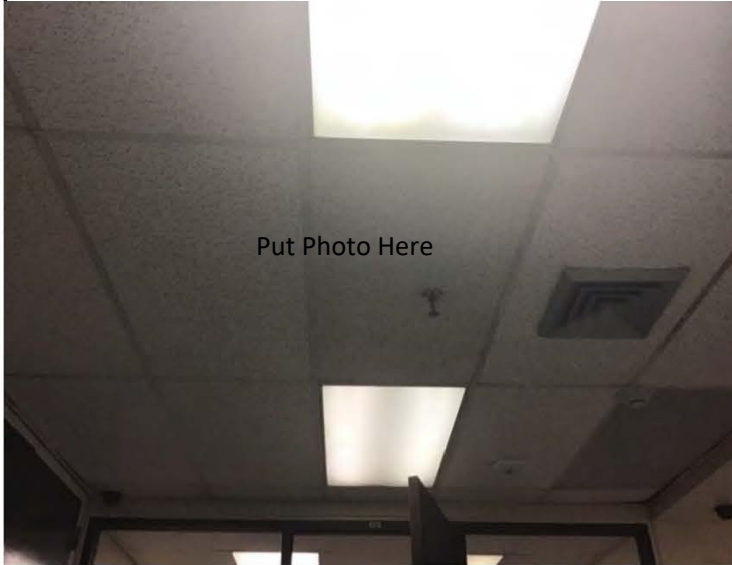
Damage Description:	Item #: 62
Ceiling, 2 FT x 4 FT acoustic tile, suspended, deformed, caused by rainwater intrusion (Main Bldg., Basement, Laboratory Reception Lobby)	
Additional Comments:

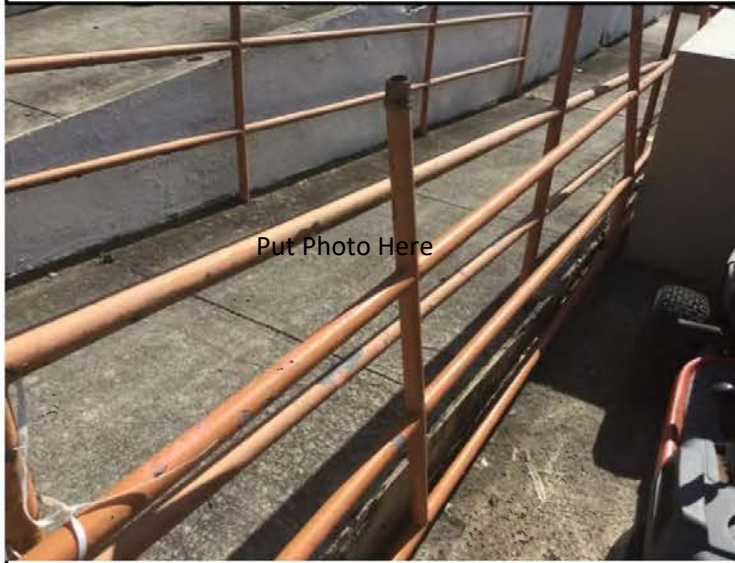
Damage Description:	Item #: 83
Hand Rail, Guard rail, galvanized steel piping, 1 1/2-IN dia., triple rail, painted finish, broken components, caused by wind-blown debris (Main Bldg., Exterior, Ramp)	
Additional Comments:
